Archaeological trial trench evaluation on land off Meadow Lane, Bedford, July 2012

Report 12/131

July 2012

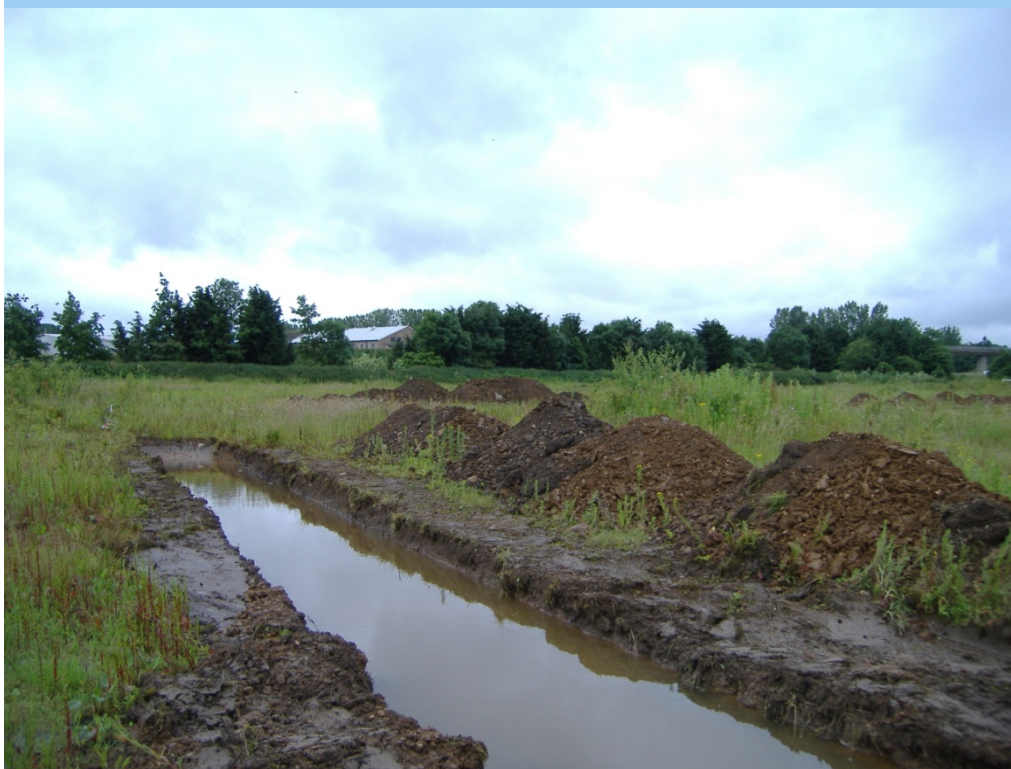
Cover image: Trench 4 after flooding

Some revision to the proposed trench plan was necessitated by the extensive areas of flooding across the northern and north-eastern parts of the site, which in some places formed standing water at least c. 0.30m in depth (Fig 2, rear cover image). Trench 7 was only 30m in length, as the proposed northern 20m was under standing water. Trench 8 was moved 10m further to the west, but it was still only possible to machine 20m of its length due to the standing water to the east. In order to compensate for this reduced sampling, an extra 10m of trench was added to the northern end of Trench 4, as Trench 4a, but standing water again prevented any additional machining northwards of this. The lowest-lying sections of Trenches 2, 4, 5, 7 and 8 also began to take in water soon after machining, and in the case of Trenches 4 and 7 this ingress of water flooded them completely (front cover image).

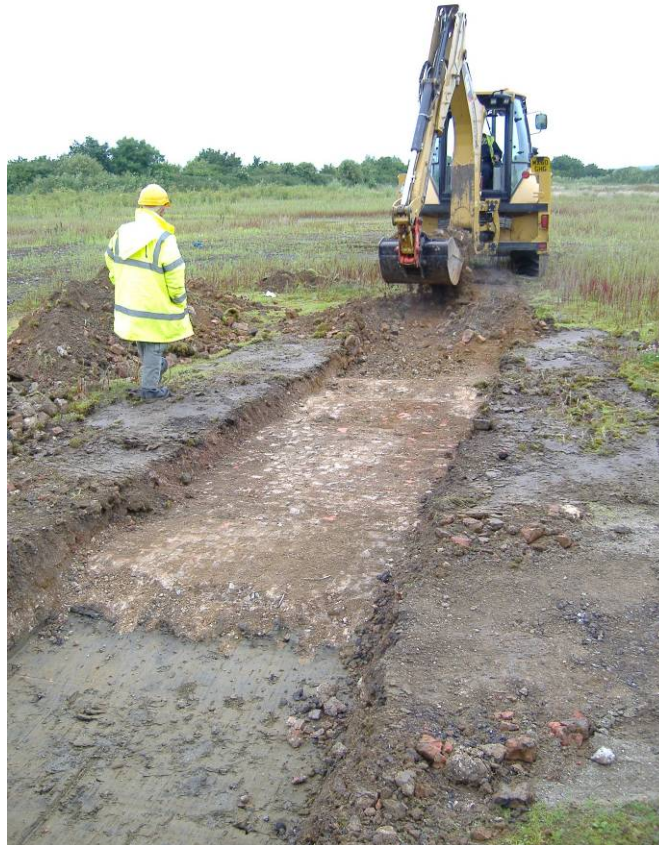
Machining Trench 2, showing part of the compact made ground deposit (201) Fig 3

The total depth of Trench 2 to the top of the undisturbed natural subsoil (203) varied between 0.40m to 0.74m. The extremely compact and tenacious nature of the made ground deposit (201) made machining very difficult, and it was not possible to strip all of it from the full length of the trench, even with a toothed bucket. In agreement with the Bedford Borough Council Historic Environment Planning Services Team Officer Mr Geoff Saunders, however, three smaller test pits 3-5m long were excavated through the made ground where it was possible to do so, revealing the full depth of the deposits. No archaeological features or deposits were identified at the base of the three deeper sections, which very quickly flooded with water.

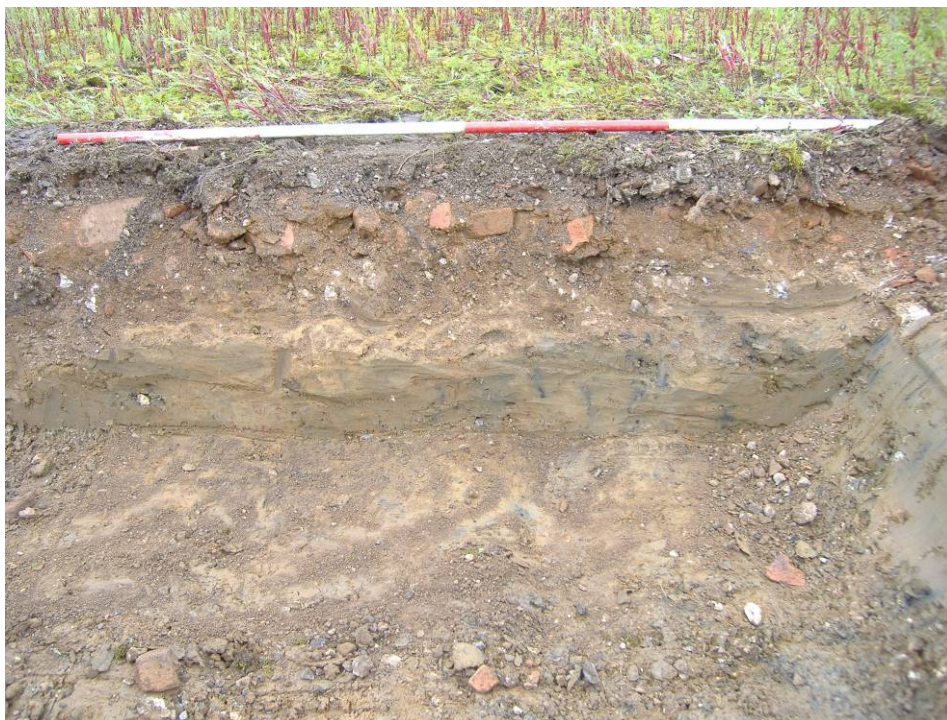
West facing section of Trench 2 in one of the deeper test pits, showing the depth of made ground (201) and also staining caused by diesel contamination Fig 4

Much of the central and southern part of the site had then been covered in a Terram-type membrane, along with layers of made ground up to 0.40m thick, formed from compacted concrete, stone, brick and tarmac fragments. A thin topsoil had begun to form over this due to the growth of scrub vegetation, but in places it was not possible to machine through this compacted made ground, and instead smaller 'test pits' or sondages had to be machined at intervals along the trench – this was the case in Trenches 2 and 5. In places there had also been considerable disturbance caused by large service trenches that had supplied water and electricity to the construction compound, and in Trenches 2 and 5 in particular there had also been some contamination of the natural subsoil by spilled diesel.

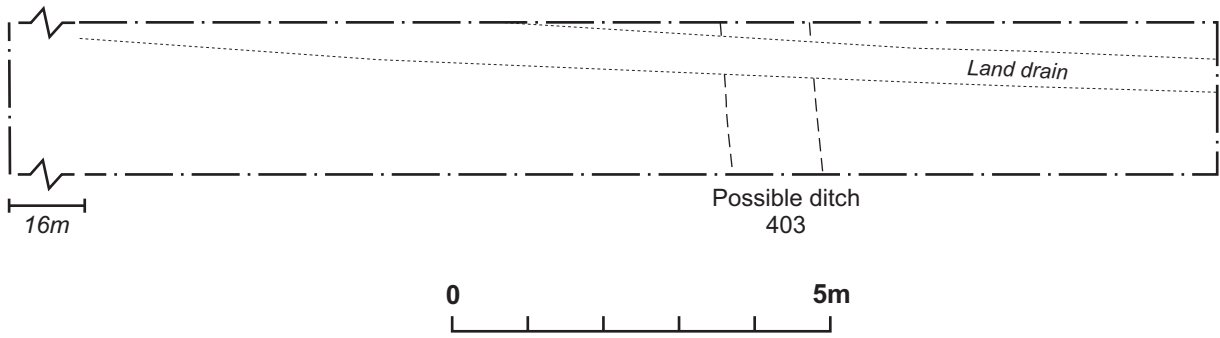
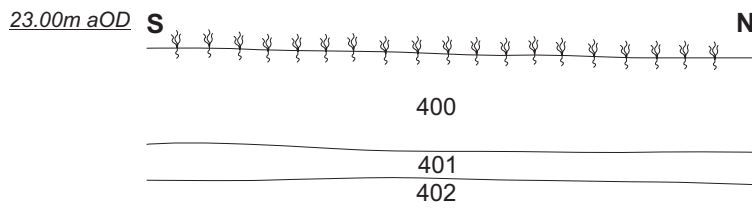
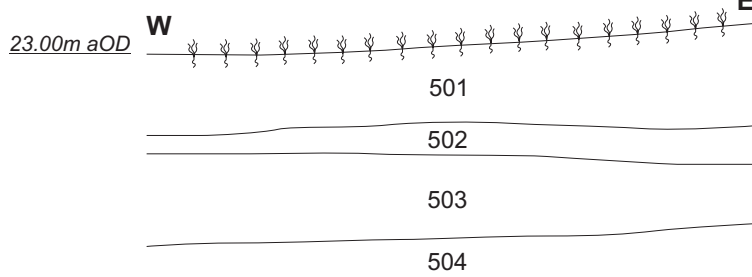
Section 1 - Trench 1

Section 2 - Trench 2

Section 3 - Trench 5

Section 4 - Trench 6

filled with material almost identical to the surrounding natural subsoil, indicating that it had been backfilled soon after being dug. These characteristics make it unlikely to have been an 'open' archaeological feature such as a gully or ditch. This probable land drain cut across another earlier feature 5m from the northern end of Trench 4 with a mottled, slightly darker greyish-brown silty fill (403) on a broadly east to west alignment, and up to c 1m wide (Fig 5).

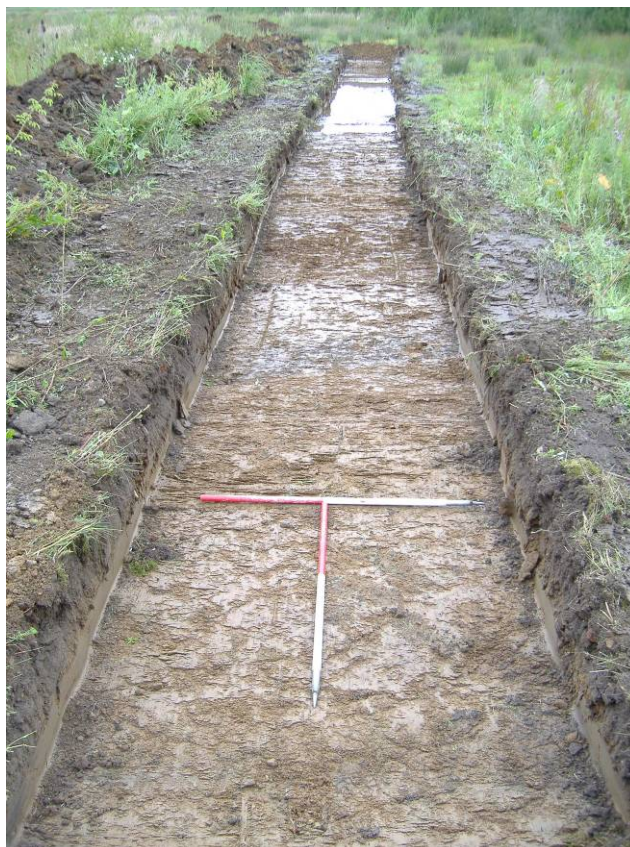
Trench 4 looking north, with the southernmost land drain cut just visible beyond the photographic scales, prior to it being investigated Fig 6

A modern land drain up to 0.30m wide was identified 4.5m from the southern end of Trench 4, on a near south-south orientation, and confirmed through a quick hand-dug spade slot. Extending obliquely along the trench for approximately 16m again on a near north-south alignment was another probable land drain cut up to 0.40m wide – although it was not excavated it was very straight edged and narrow and

The soil in this eastern part of the site was heavily waterlogged, and so soon after machining water began to seep into Trench 4 and 4a. Unfortunately, the trench had flooded completely by the time it came to hand excavate sections through the near north-south orientated land drain and the possible underlying feature, and so no further investigation of these putative features was possible (see Discussion, section 5 below), although they were planned (Fig 6). The total depth of Trench 4 to the top of the undisturbed natural subsoil (102) varied between 0.25 to 0.37m.

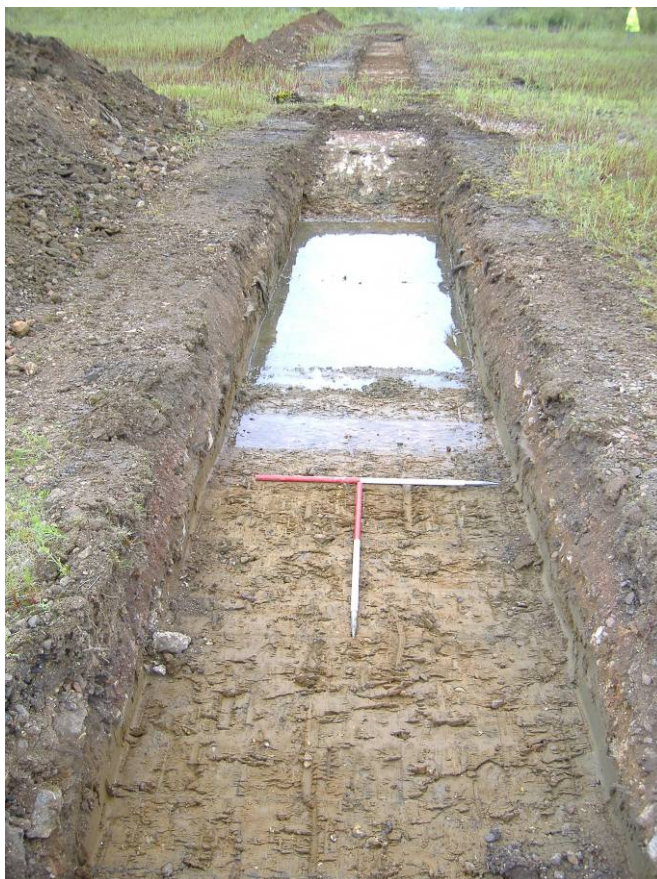
Trench 5 looking west, with the greatest disturbance and depth of made ground in the foreground, and unexcavated hard standing in the distance Fig 7

The total depth of Trench 5 to the top of the undisturbed natural subsoil (504) varied between 0.25m to 0.58m. The extremely compact nature of the made ground (501) near the centre of the trench made machining difficult, and as with Trench 2 it was not possible to strip all of it from the trench. In agreement with Mr Geoff Saunders, however, the most tenacious 5m length of this made ground was left unexcavated, though elsewhere the full depth of the deposits was revealed. No archaeological features or deposits were identified at the base of the deeper eastern section of the trench, which soon flooded with water (Fig 7).

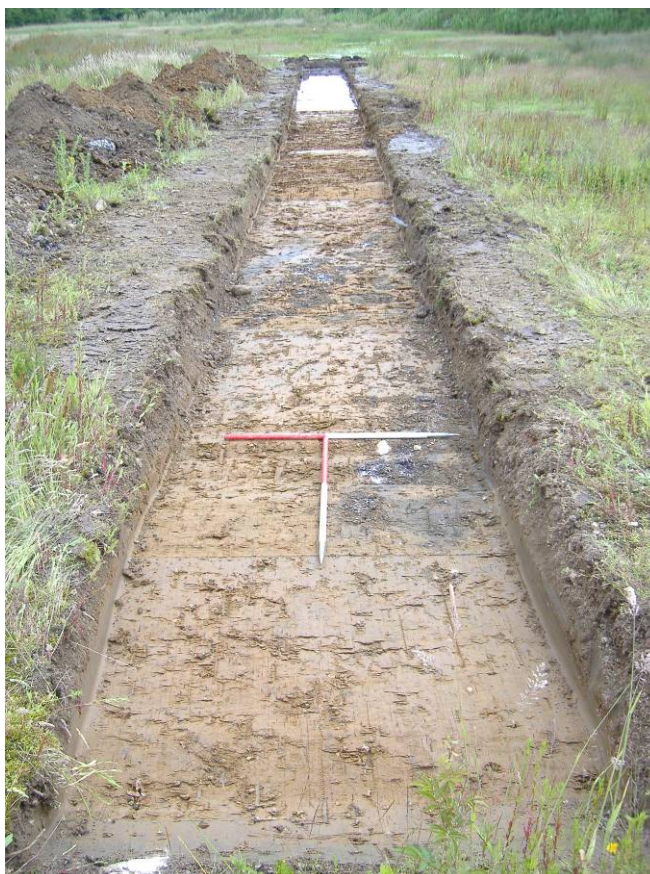
Trench 7 looking north, with disturbance in the foreground Fig 8

The southern end of the trench had also been subjected to a great deal of irregular modern disturbance, with narrow irregular, sinuous channels or 'gullies' dug into the natural subsoil (703) and filled with dark grey-brown topsoil, sand and gravel. These may have been animal burrows, or the result of disturbance associated with the construction compound.

The total depth of Trench 7 to the top of the undisturbed natural subsoil (703) varied between 0.30m to 0.44m, being shallower to the north and deepest where the made ground layer had been deposited. No archaeological features or deposits were identified. The trench began to flood soon after it was machined, and eventually completely filled with water.

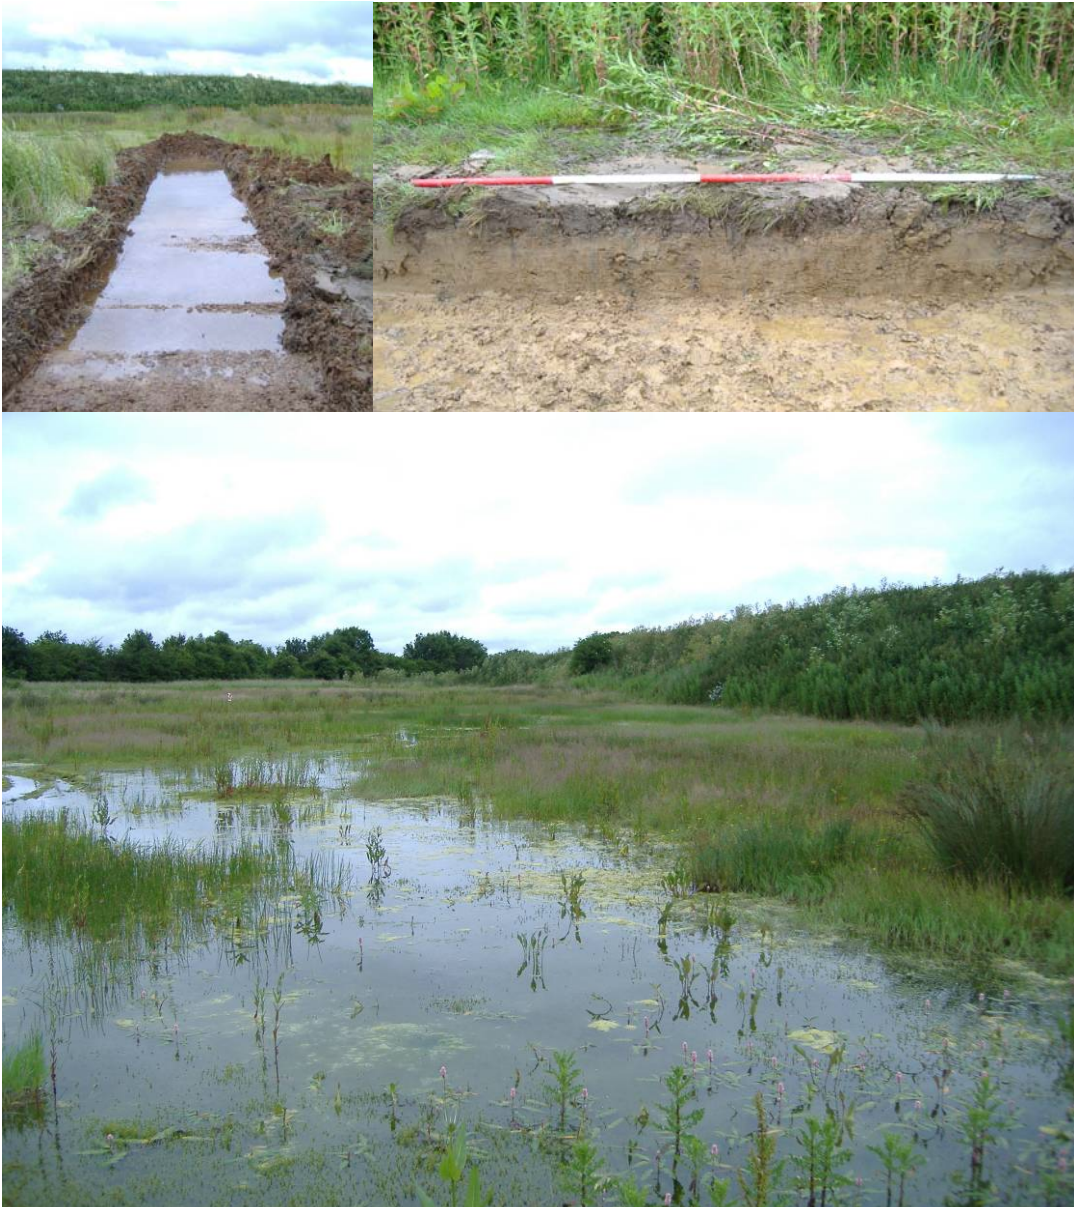
Rear image: Trench 8 looking east (top left), representative section Trench 2 (top right); and general view of the flooded northern area (bottom)

The total depth of Trench 8 to the top of the undisturbed natural subsoil (802) varied between 0.22m to 0.27m, being deeper to the west. No archaeological features or deposits were identified. The eastern part of the trench began to flood soon after it was machined (rear cover, top left).
