Archaeological Building Recording at 1 Green Lane, Ashley, Northamptonshire July 2012

Report 12/135

July 2012

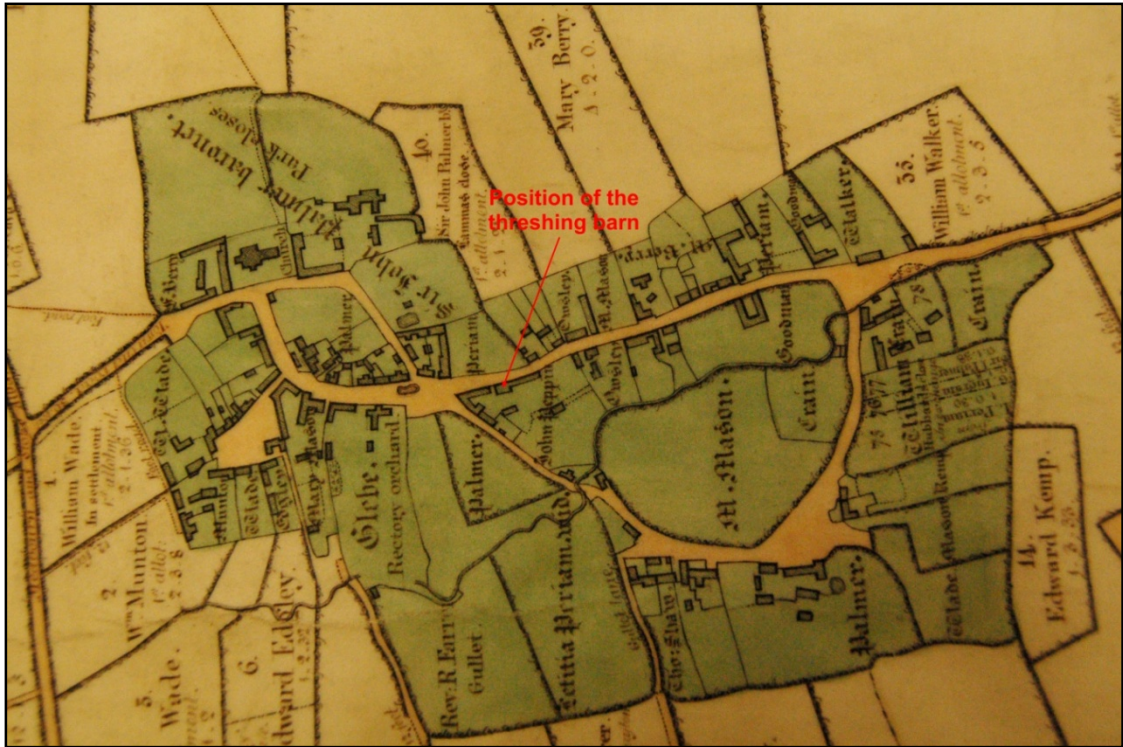
1807 Inclosure map of Ashley Fig 2

This map shows several buildings on the site including a range of buildings concurrent with the position of the threshing barn (Fig 2). It is difficult to say with certainty how this range relates to the threshing barn but it is likely that these are earlier structures which were demolished prior to the construction of the current building. The barn shows no evidence to indicate that other structures previously abutted it. The site is shown on the plan as belonging to a John Peppin.

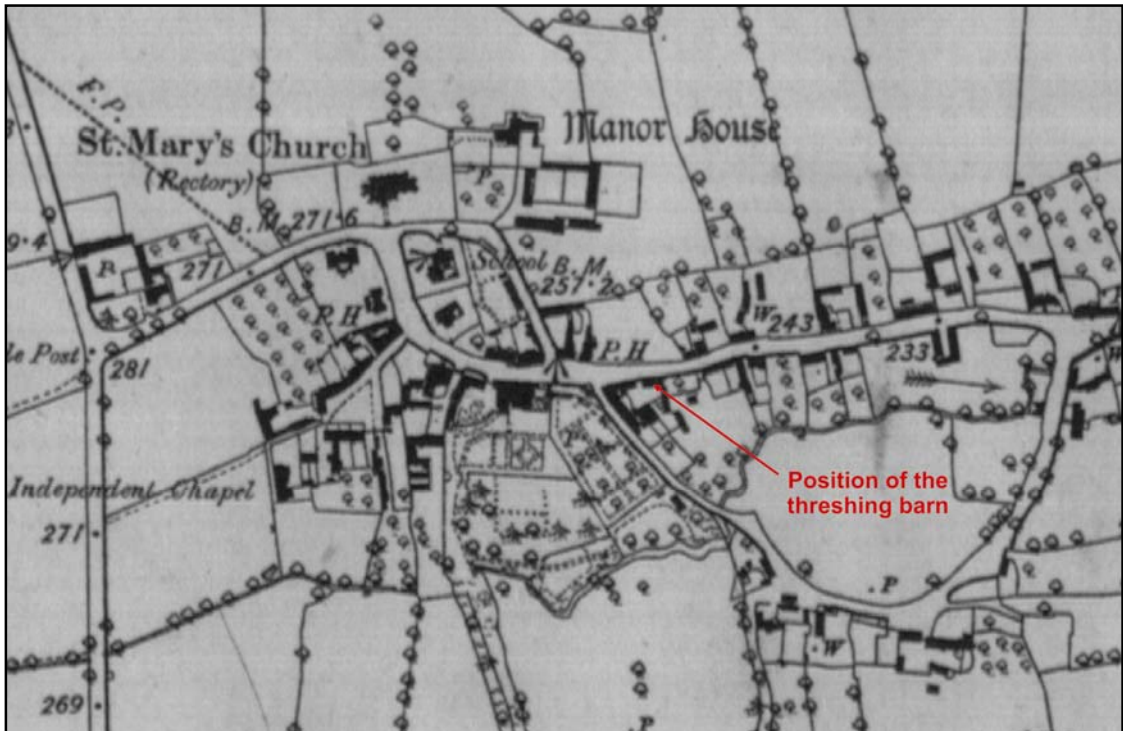
1886 1st Edition Ordnance Survey map Fig 3

The current barn is shown on the 1886 1st edition Ordnance Survey map of Ashley with another structure, aligned north-south, to the south. The farm has undergone some changes with additional buildings present which are not visible on the 1807 Inclosure map.

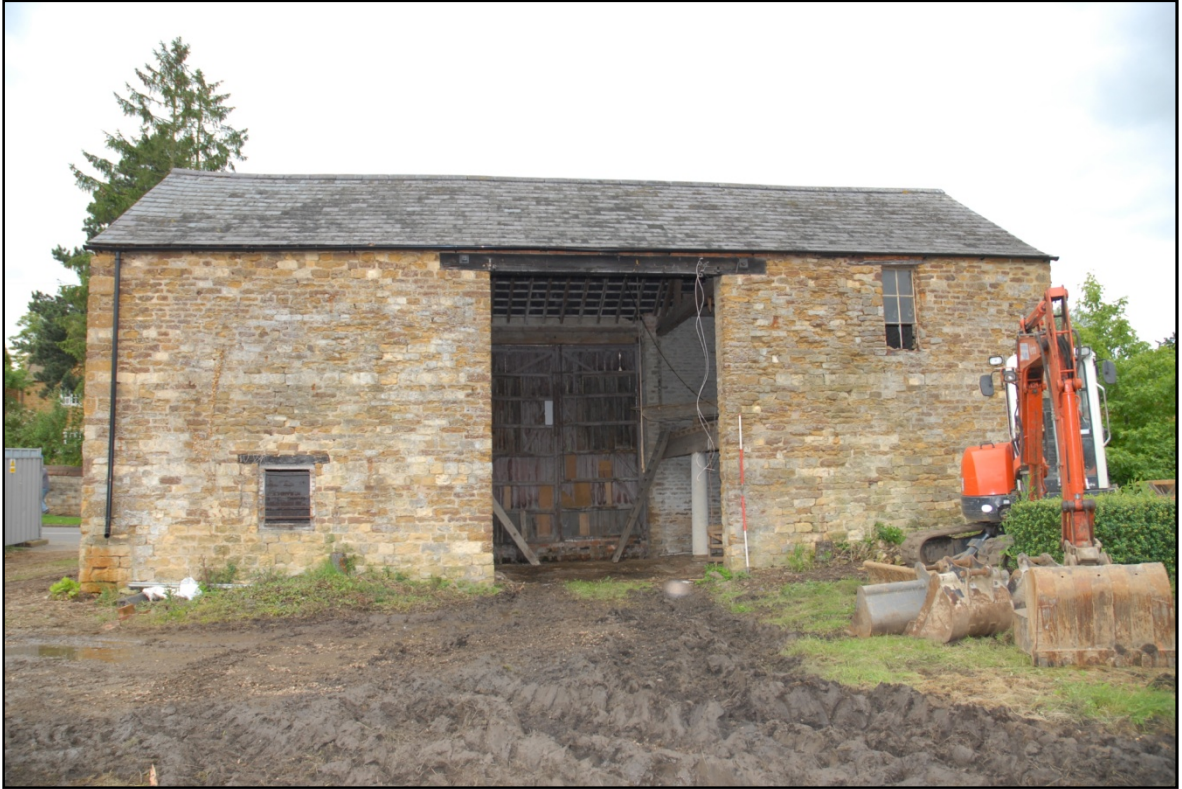
The southern elevation, looking north Fig 6

The building is primarily constructed from ironstone and pale yellow sandy limestone set in a lime mortar (Figs 6-9). Fragments of other stone, including flint, are also present in the fabric. The internal partitions of the barn are constructed from red brick and abut the main stone walls. Levelling timbers are also built into the fabric of the building.

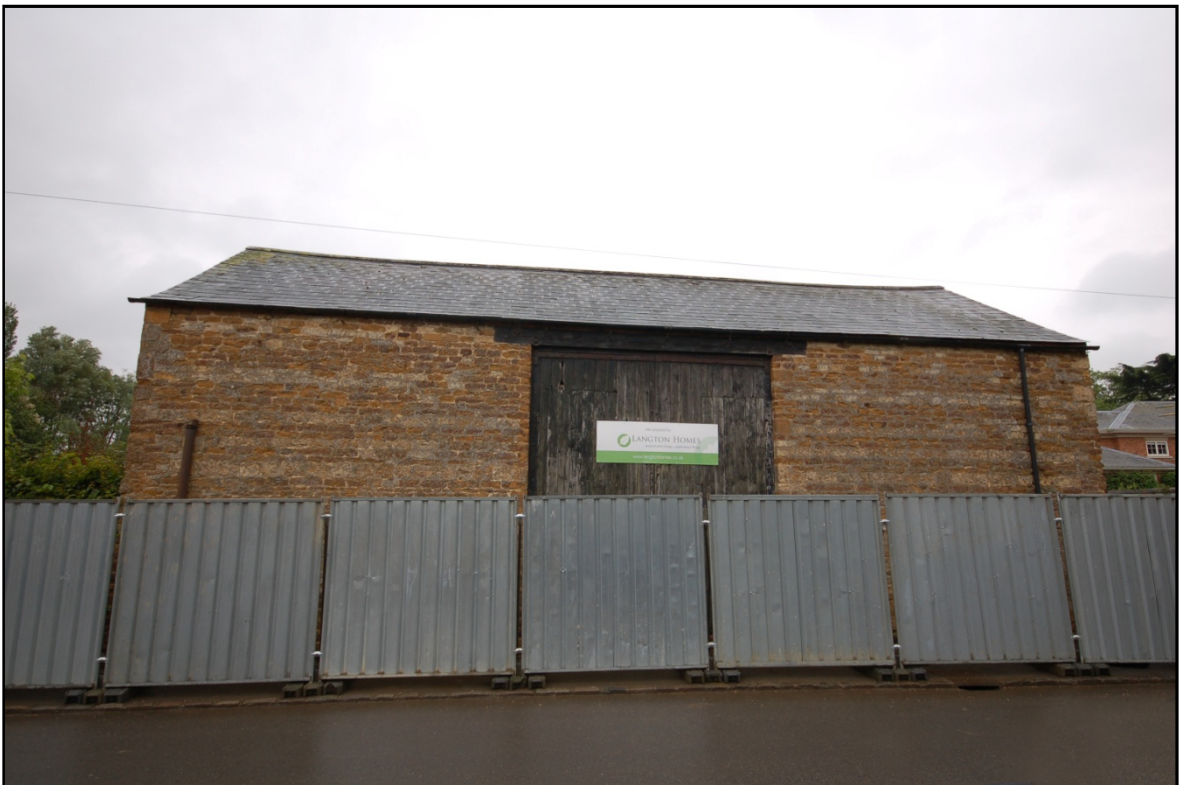
The northern elevation, looking south Fig 7

The building has two large entrances on the north and south elevations. A large wooden, double door is present on the northern elevation (Figs 7 & 10). Due to a roughly 0.3-0.4m drop in ground level from the street to the interior of the building, the door is atop an internal brick plinth and rises to eaves level, topped with a black painted timber lintel which is only visible externally. The interior face of the door features an iron locking and opening mechanism (Fig 10). The 2011 surveyors drawings of the building show boarding across the top half of the southern entrance. This boarding was not *in situ* during this survey but was present on site.

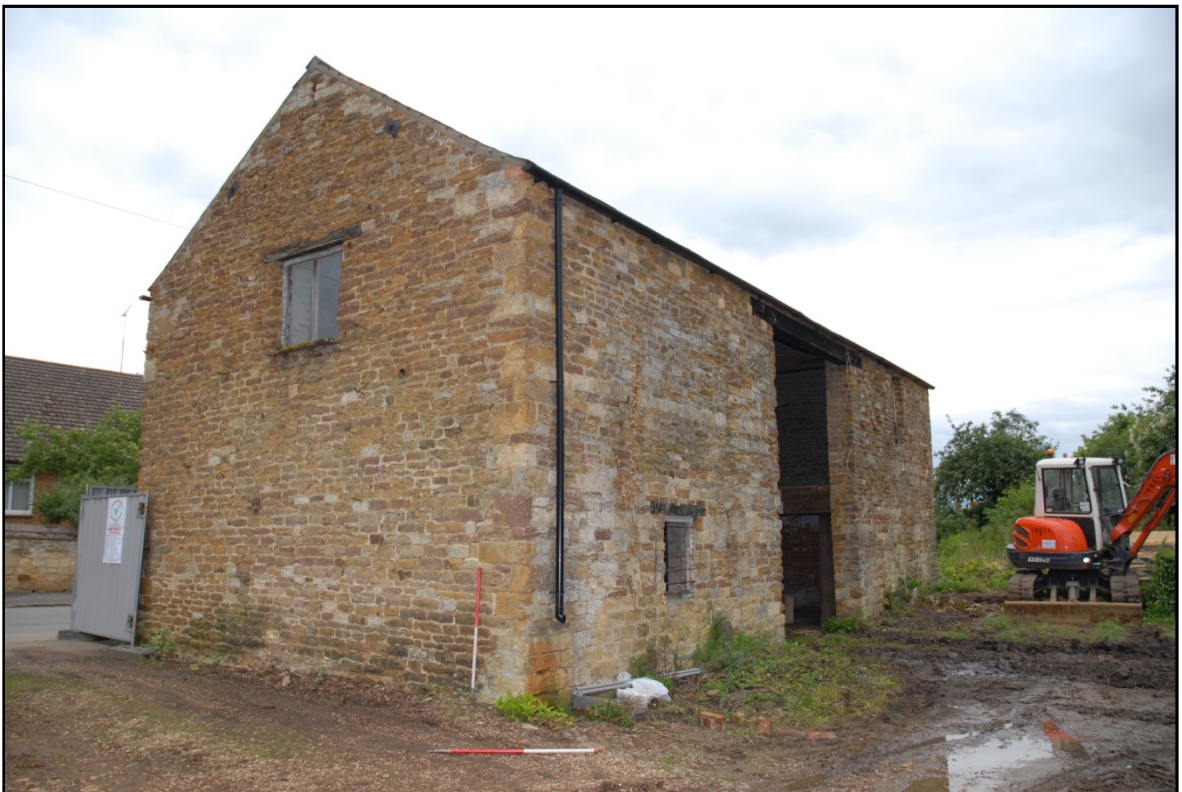
The western elevation, looking north-east Fig 9

A two light, timber framed window with a curved, concrete sill is built midway up the western elevation, topped with a timber lintel just below eaves level (Figs 9 & 26). A narrow, rectangular vent is present just below the peak of the gable (Fig 26).

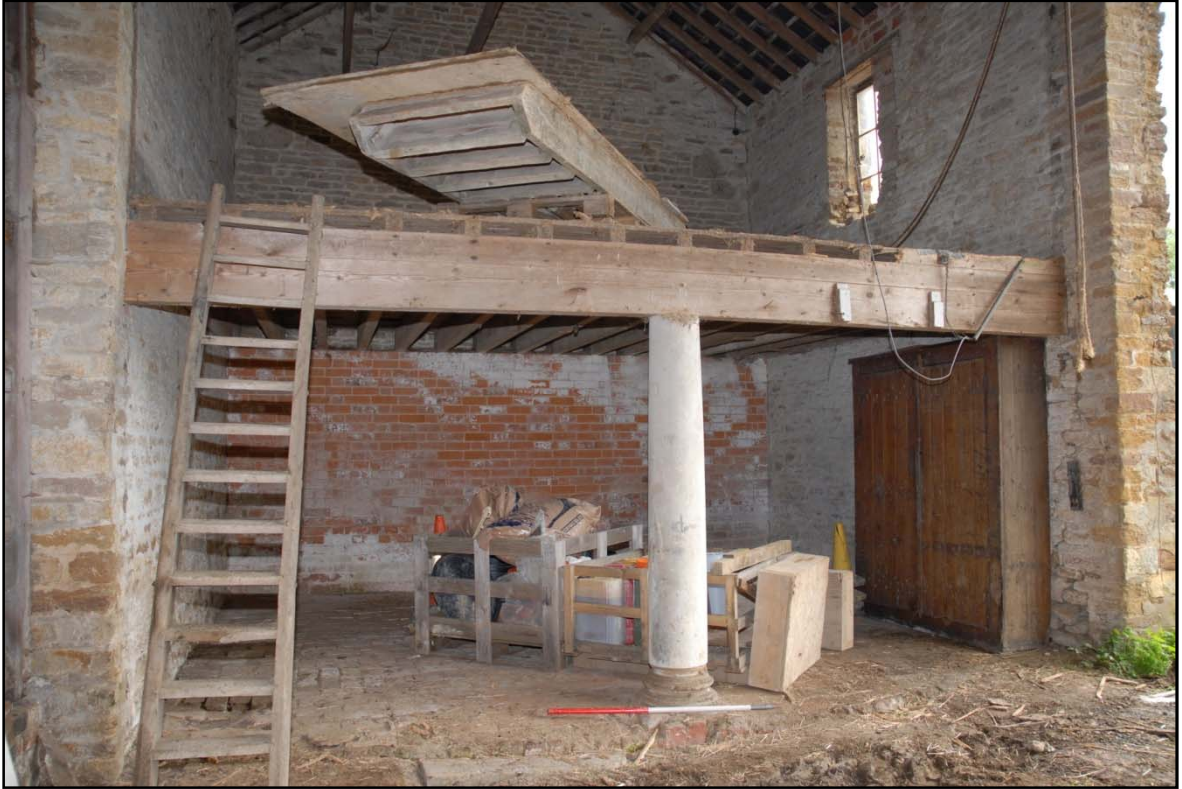
Room G1, looking east Fig 12

Room G1 is a simple, open fronted room in which no functional fixtures or fittings were present. A wall of red brick is built against the eastern elevation of the room up to joist level, running the full width of the building (Figs 12 & 13). This wall supports the joists of the second floor. A concrete column with a classical style stone base is present, central to the western edge of the room, supporting the timber axial beam of the first floor (Figs 10 & 12). The stone base of the column rests on concrete slabs atop the brick floor of the room (Fig 15). The top of the column has been roughly cut to the required height, indicating that it was reused from a different location (Fig 14).

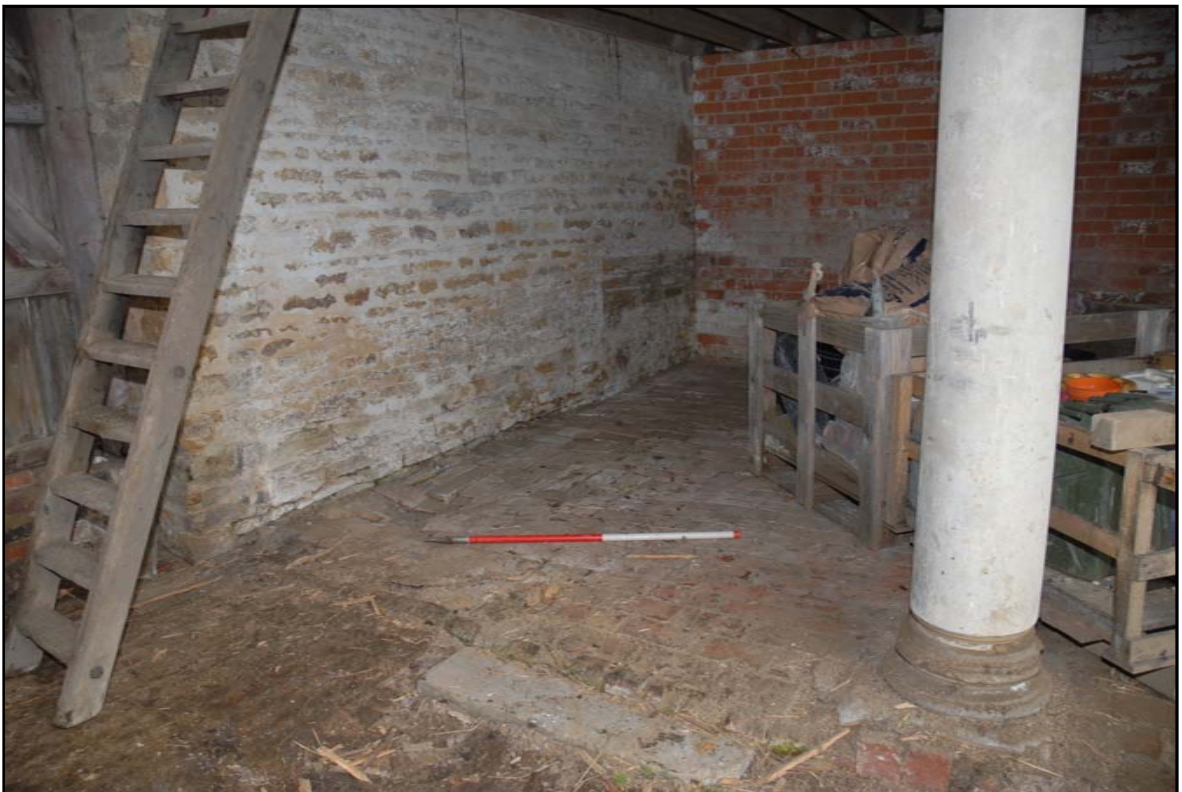
The threshing floor and the floor of Room G1 with the column to the right Fig 13

The room has a floor of flat lain, red bricks, lined with bricks on edge where they meet the threshing floor (Fig 13).

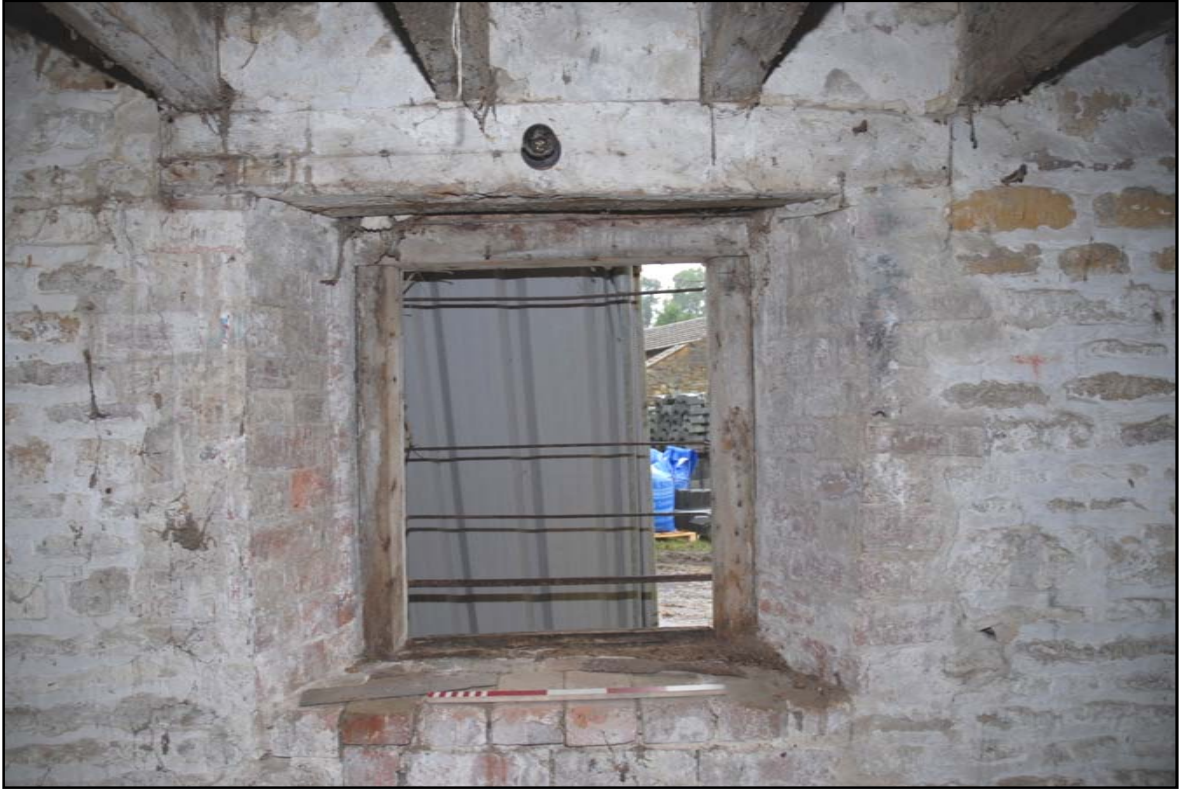
The window in G2 with floor joists resting on the lintel Fig 18

Room G2 is approximately 3.2m wide with a timber framed, white painted window in the southern elevation. The window has white painted, red brick reveals and brick sill internally and has a white painted timber lintel which also supports joists for the first floor (Fig 18). A door (not *in situ* at the time of this survey) previously separated this room from the threshing floor. The room has a floor of red bricks laid flat. The walls, including the brick partition were painted white.

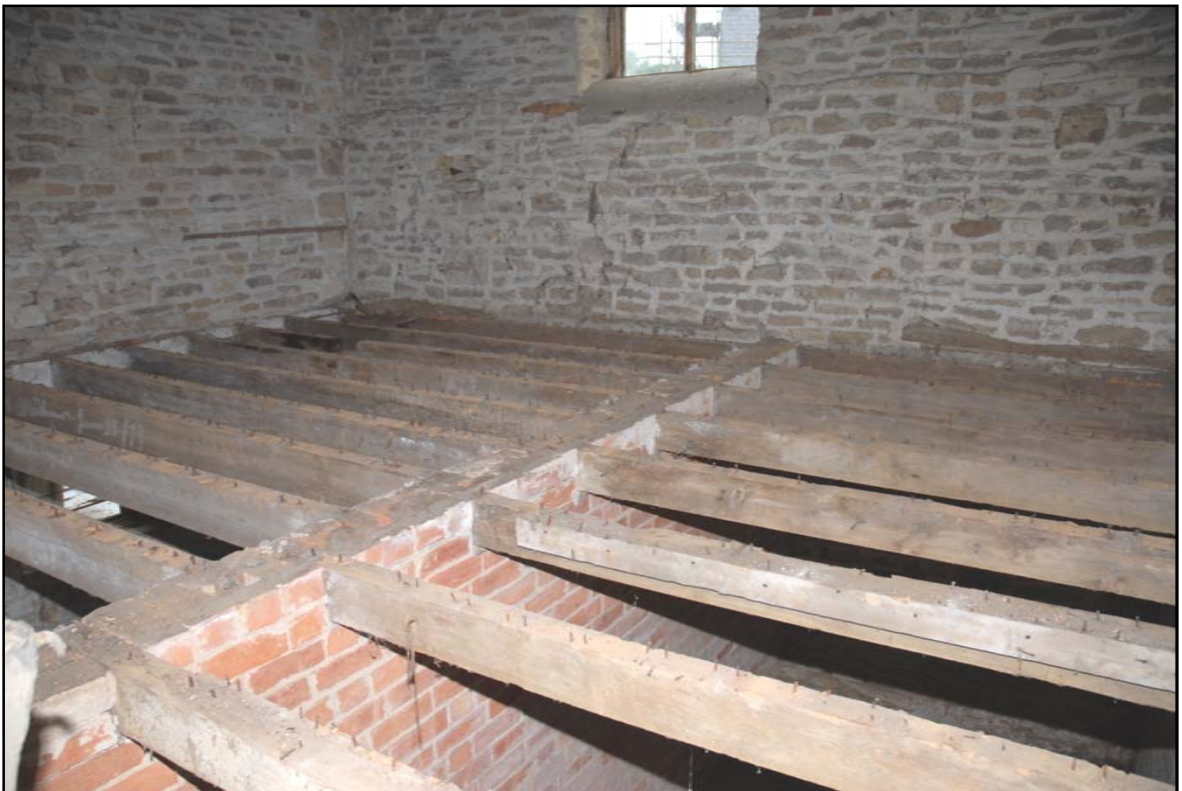
The brick partition supporting joists above rooms G2 and G3 Fig 19

Rooms G2 and G3 are separated by a partition of red brick which supports the joists of the first floor (Fig 19). This partition abuts the western, stone wall of the main structure. The bricks are chamfered at the entrance to room G3.

The floor structure of Room F2 consists of two runs of joists on a north-south alignment, spanning rooms G2 and G3 (Fig 19). These are supported at either end by the brick partition and the north and south elevations. One joist above room F2 showed signs of reuse. Lengths of timber in the north elevation provide support for the joists at that end. The floor boards had been removed by the time of this survey and the room was inaccessible.

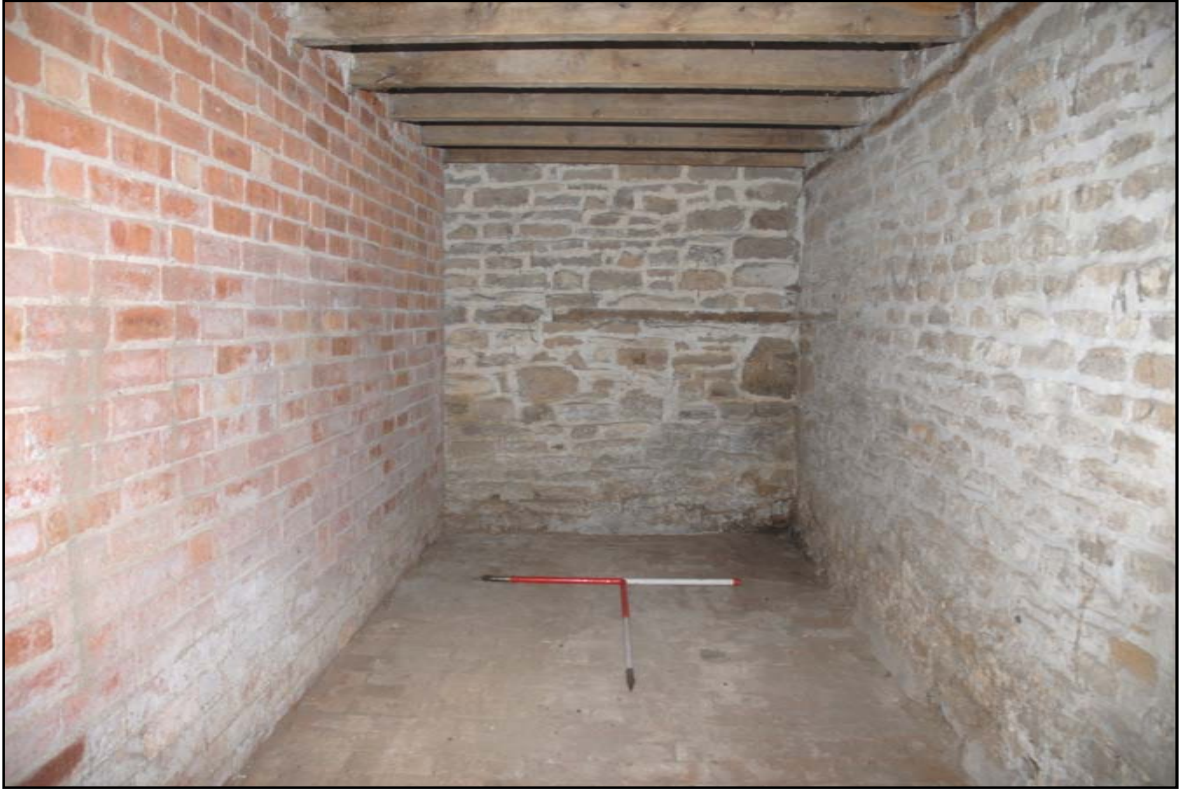
Room G3, looking west Fig 20

Room G3 is approximately 1.8m wide with no windows and no remains of a door. It is uncertain if a door had once separated the room from the threshing floor. The walls of the room, including the brick partition are painted white (Fig 20). The bricks of the partition to the south of the entrance to the room are chamfered. As with G2 and G1, room G3 has a floor of red bricks laid flat.

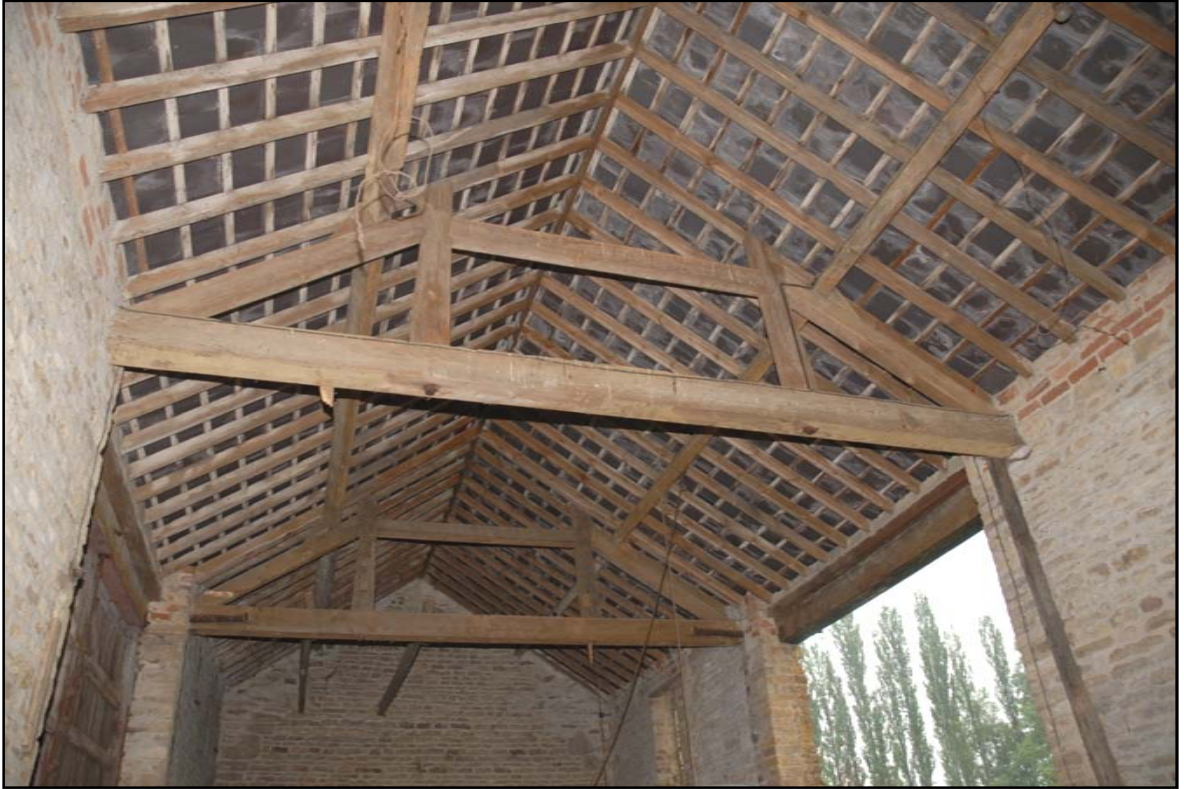
The roof structure, looking east Fig 22

The structure is covered by a timber roof with grey Welsh slate tiles. The two doorways are flanked by a pair of queen post trusses with iron ties, which support a frame of machine sawn purlins, rafters and battens (Fig 22). The purlins are supported externally with iron ties. Two transverse beams join the truss tie beam of room F1 to the eastern wall (Figs 22 & 23). These are not supported externally with iron ties.

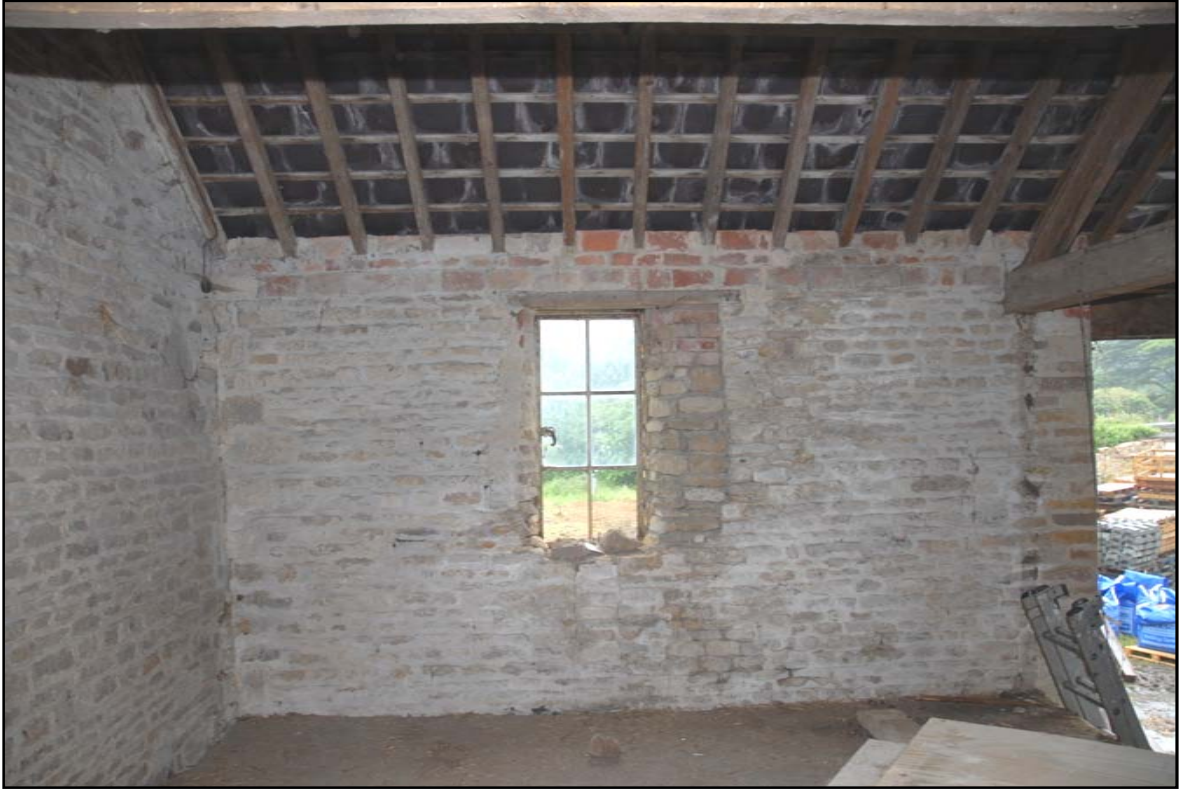
Room F1 showing the altered window with scar of former boarding visible to the right, looking south Fig 24

The 2011 surveyors plan of the barn shows boarding along the western edge of room F1 (Fig 4). Evidence for this boarding was still visible on the wall of the room (Fig 24).

A single window is present in the southern wall of room F1 and shows signs of alterations, suggesting that it was originally wider than its current form (Fig 24). The window is topped with a timber lintel which runs the width of the current and former window.
