A Programme of Archaeological Work at the former
Princess Marina Hospital, Kent Road,
Northampton
February 2012

David J Leigh
and Tim Upson-Smith
Report 12/79
July 2012

**A PROGRAMME OF ARCHAEOLOGICAL WORK AT
THE FORMER PRINCESS MARINA HOSPITAL
KENT ROAD, NORTHAMPTON
FEBRUARY 2012**

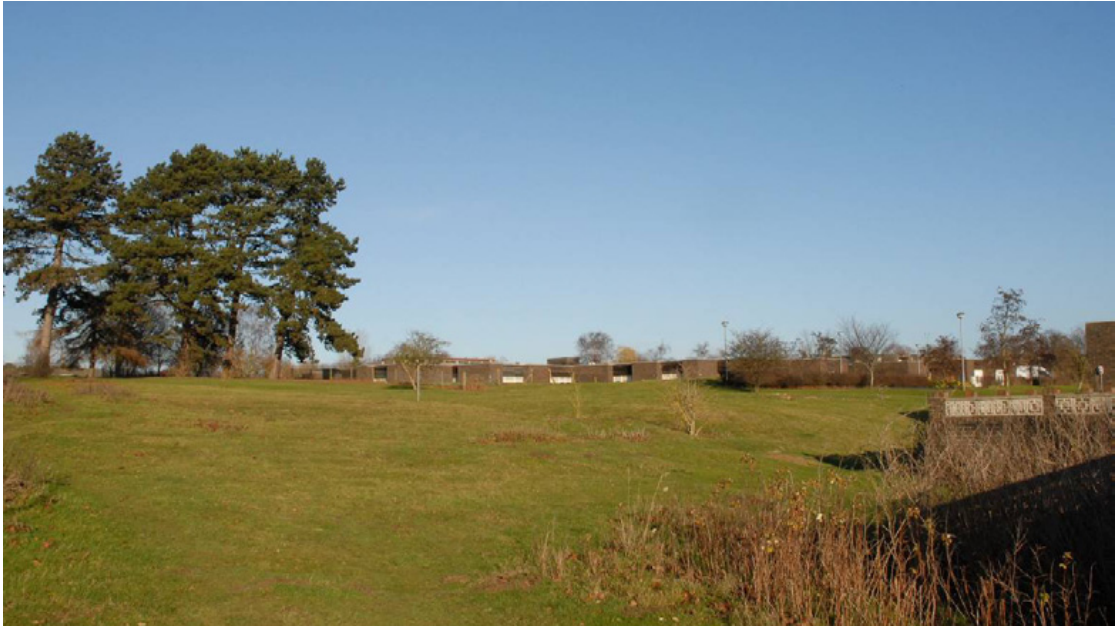
General view, looking north, showing the low profile of the buildings Fig 5

The former hospital buildings were constructed between 1964 and 1972 and were designed by Stillman and Estwick-Field Partnership for what was the first psychiatric hospital to be purpose built for patients with acute disorders. The hospital was opened by Her Royal Highness Princess Marina Duchess of Kent on the 28th May 1968 and was the first psychiatric unit to be purpose built for patients with acute psychiatric disorders. The buildings are ordered in four main units, which are further made up of interconnecting blocks (Fig 3). The buildings are predominantly of low single storey construction with an emphasis on the horizontal line and rectangular in form (Fig 5 & 6),

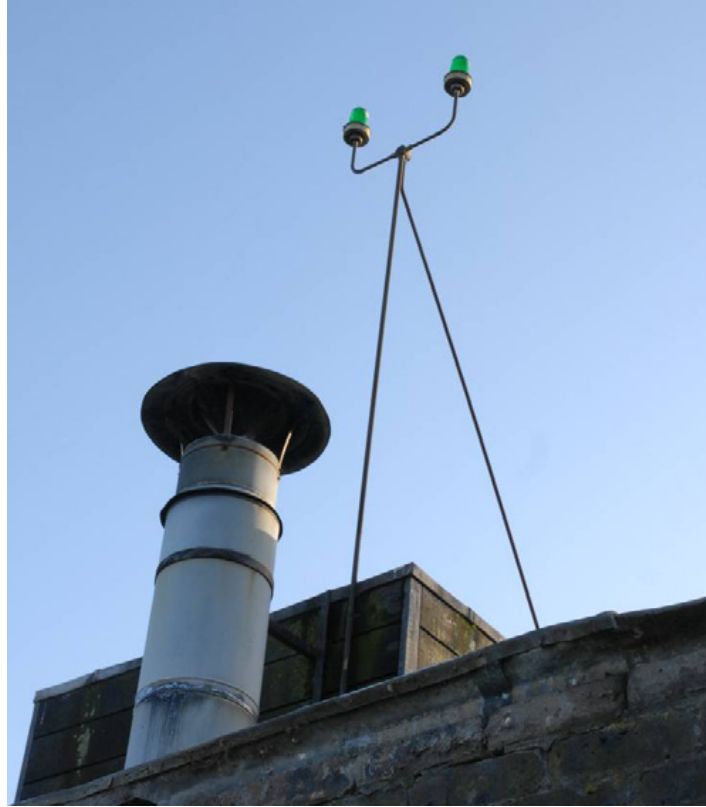
The green light beacons over the staff station Fig 7

The central block had a row of shops, a chapel, the main reception area, estates office, post-graduate medical centre, gym and physiotherapy along with wards. Each block had a pair of green light beacons mounted on a pole on the roof, perhaps indicating the position of the staff station (Fig 7).

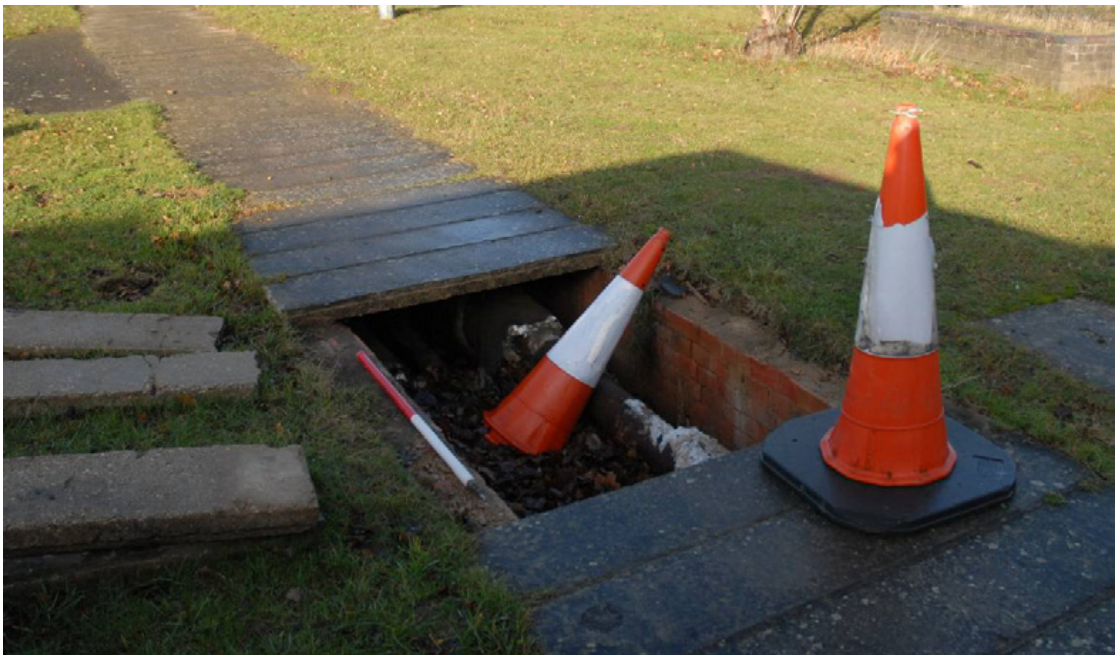
Ducting for pipes Fig 8

All of the cabling and pipework for the site was contained within brick ducts with concrete sleeper tops (Fig 8).

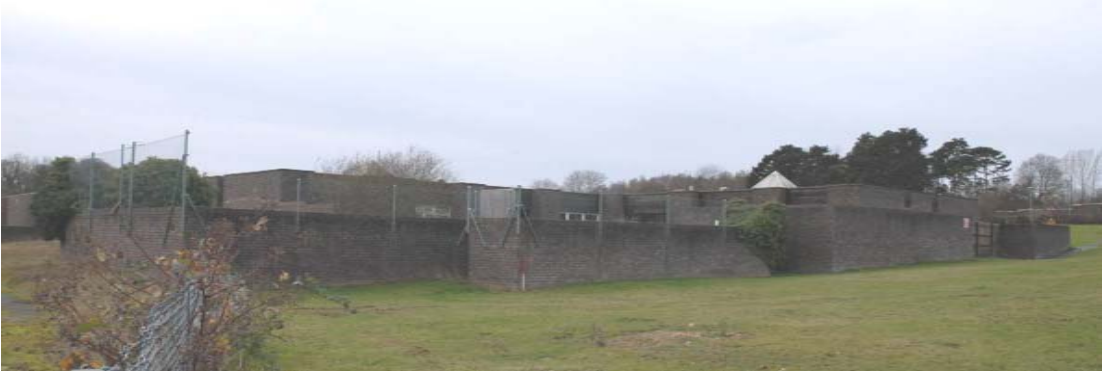
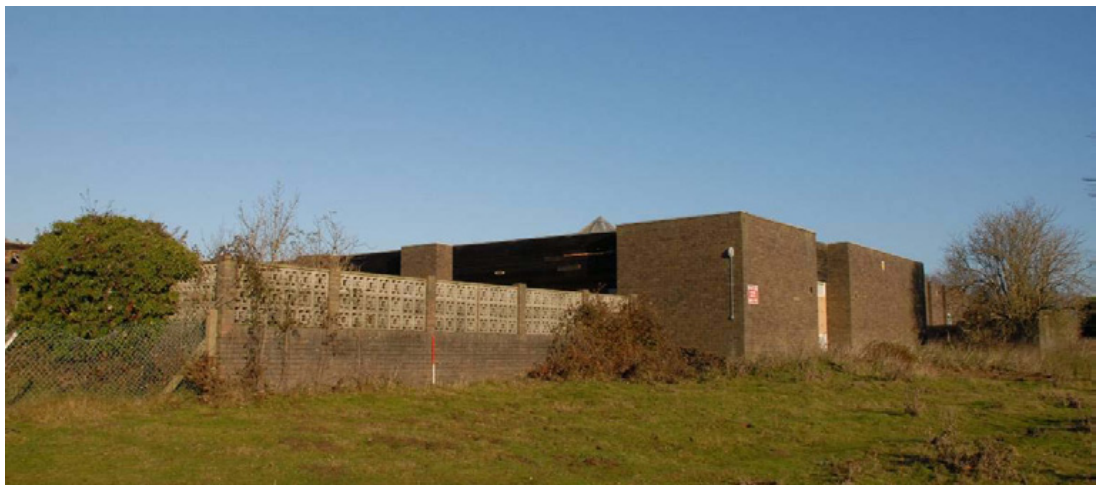
This was the most southern of the blocks and appeared to be for patients who required a higher level of security, as evidenced by the high walls (Figs 9 & 10) Only the lack of barbed wire indicated that the block was not a penal facility, the impression being exacerbated by the stark architectural style employed in the construction.

Block 1 showing the high wall surmounted by a fence, looking west Fig 9

Block 1, looking north Fig 10

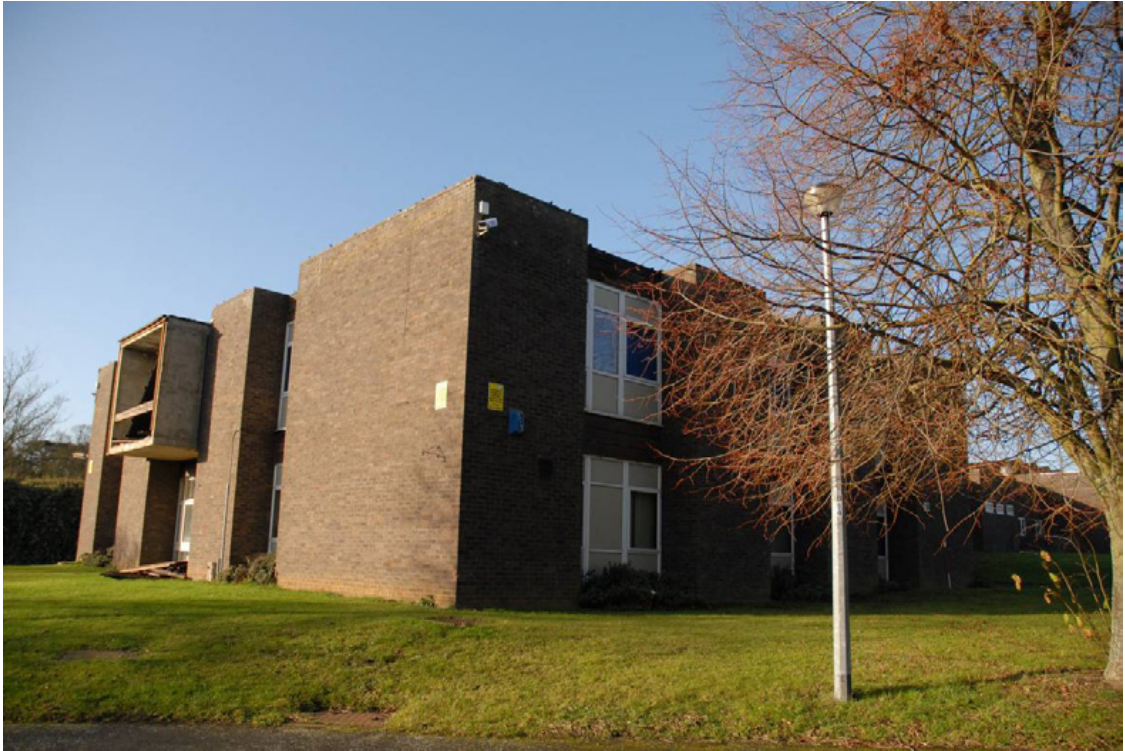
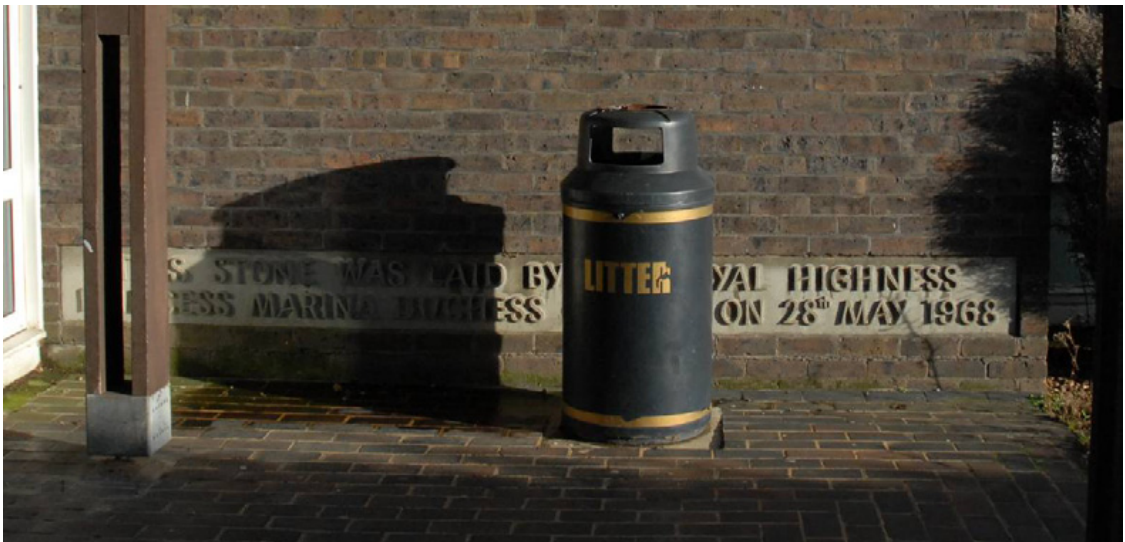
The central block was split into a number of smaller blocks with specific functions, the reception block, with its dated foundation stone (Figs 11 & 12). The litter bin in front of the foundation stone was clearly a later addition masking as it does the inscription.

The reception block Fig 11

The foundation stone Fig 12

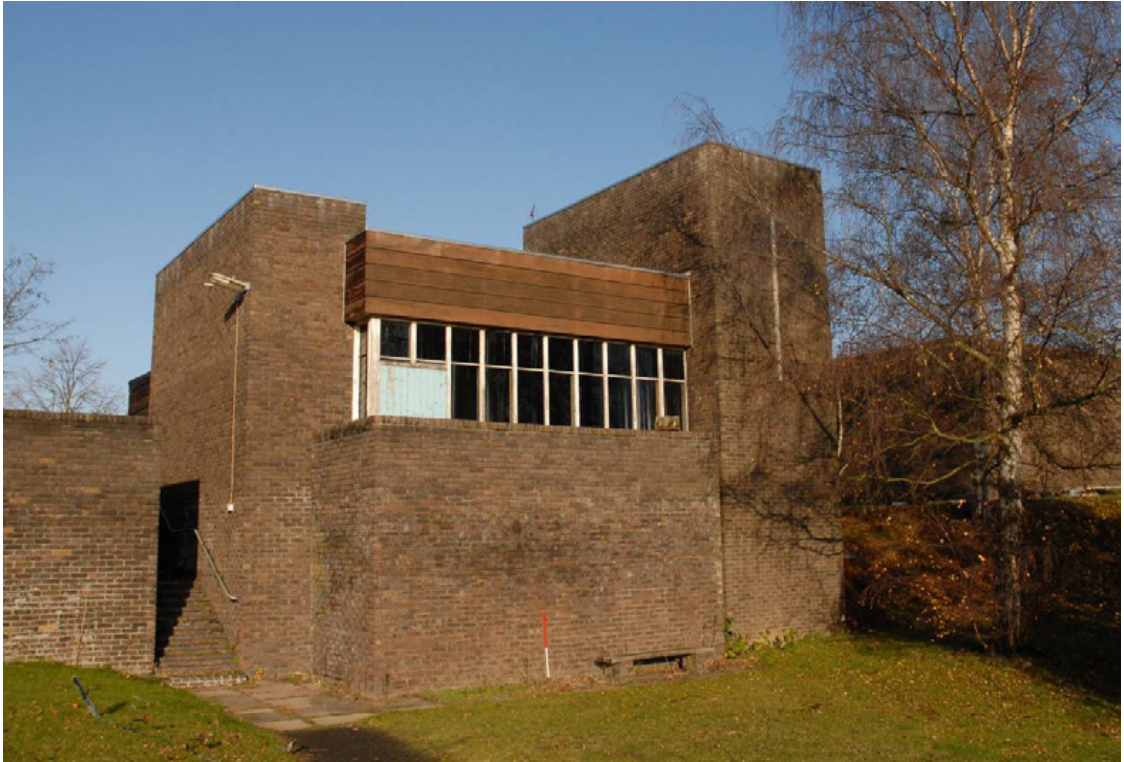
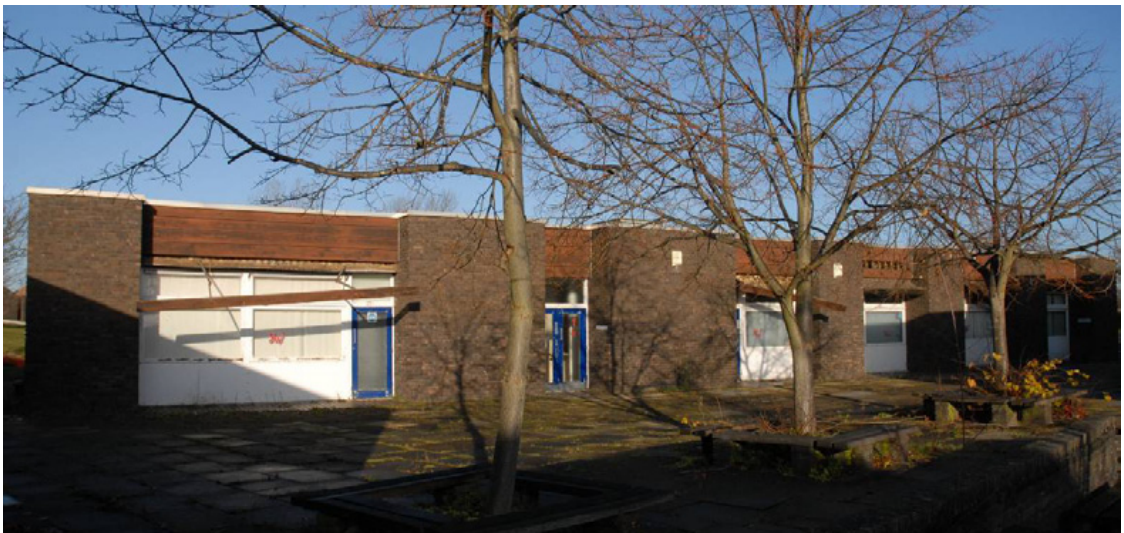
The shops including a hairdressers and a shop where milk and sundries could be bought, were located north of the chapel (Figs 13 & 14). Between the shops and chapel was a social space centred around trees.

The chapel, looking north Fig 13

The shops, looking north Fig 14

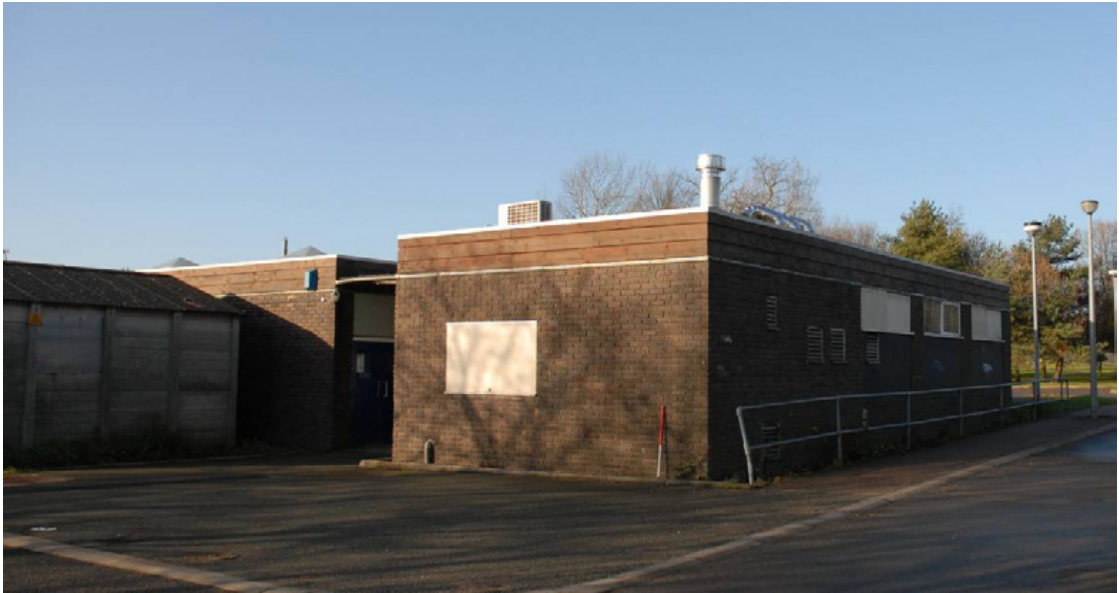
The estates office, looking north-west Fig 15

The estates office was a separate block and appeared to contain a workshop for running repairs along with a fenced compound (Fig 15).

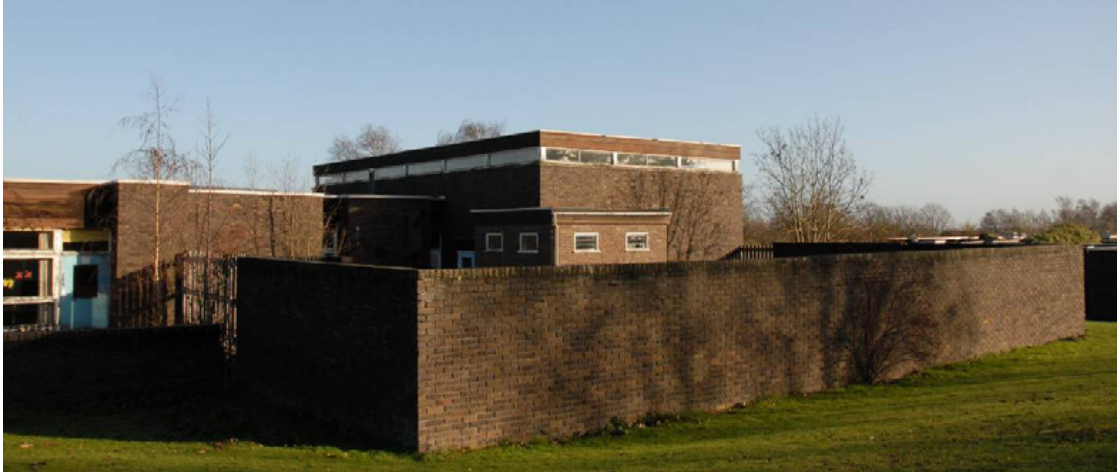
The gym, looking east Fig 16

The gym and physiotherapy block were positioned next to each other, serving complementary functions (Fig 16).

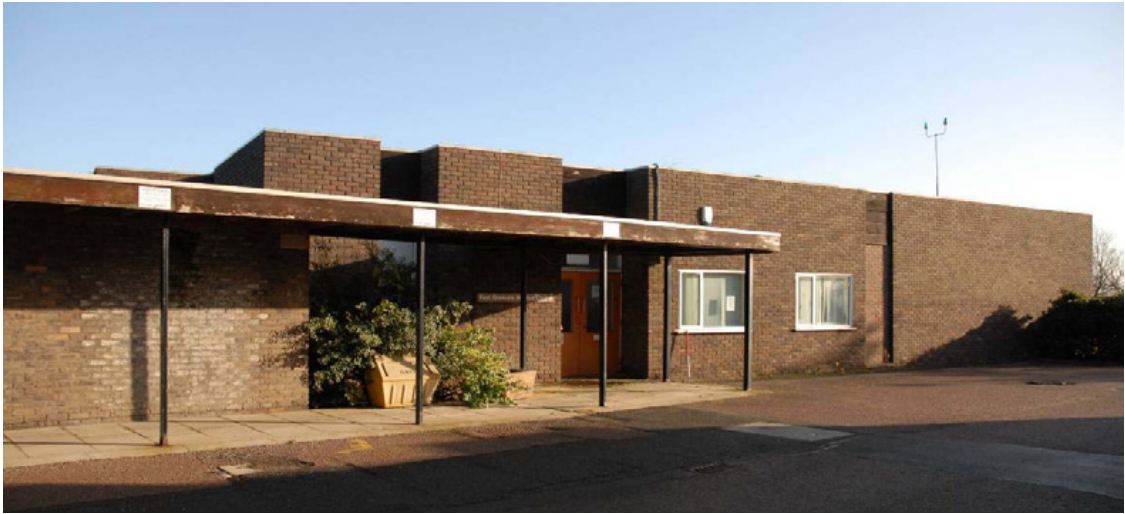
The post-graduate medical centre, looking east Fig 17

The post-graduate medical centre would suggest that, at least latterly the hospital had a training section (Fig 17).

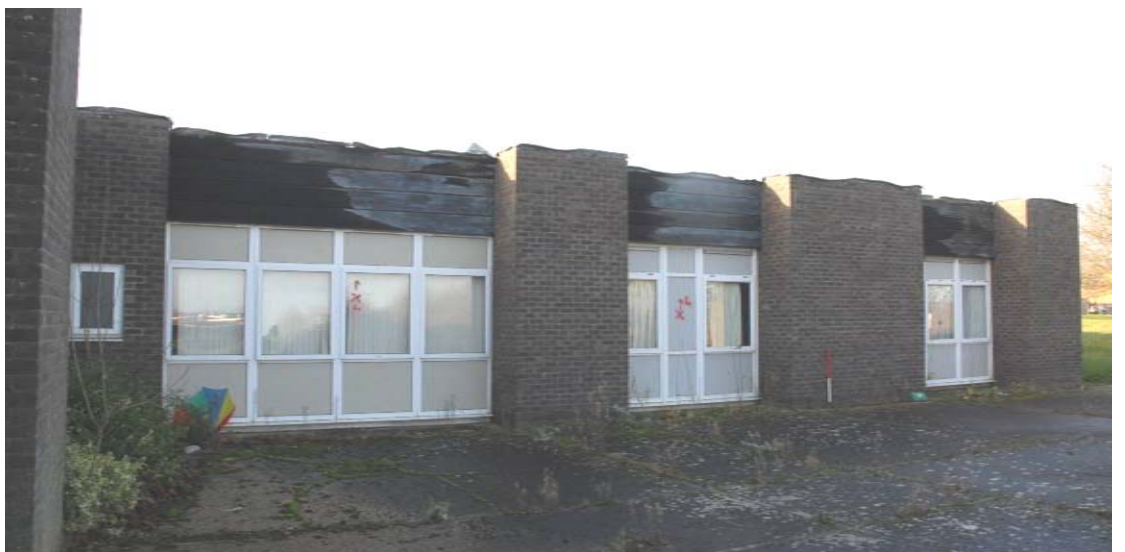
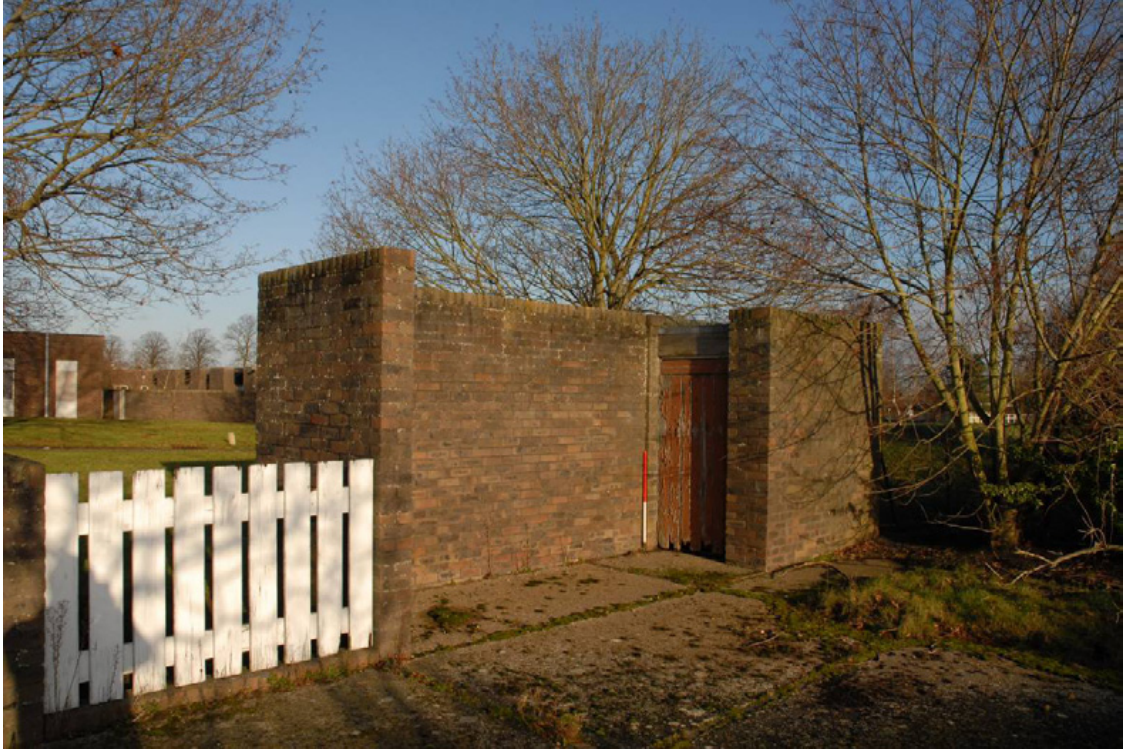
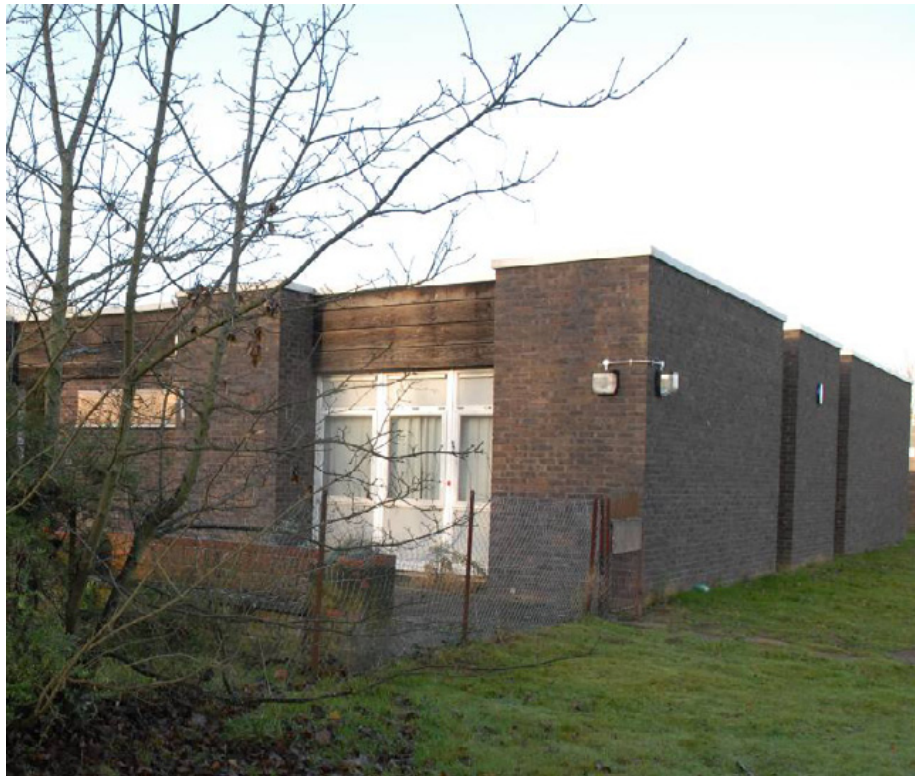
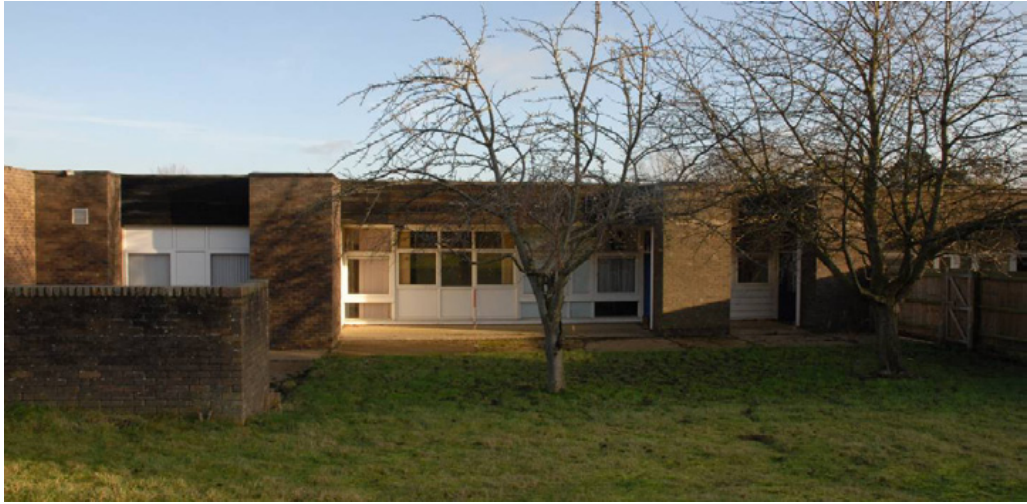
Block 3, Bronte Ward, looking north-west Fig 19

This block was located in the north-western part of the site (Fig 19). The two eastern blocks had gardens in the centre, with outside toilets (Fig 20). The southern block latterly housed clinical records (Fig 21). The ward on the north-western side of block 3 had windows opening out onto a grassed area (Fig 22).

Garden outside toilet, looking north-east Fig 20

Block 3 clinical records, looking north-west Fig 21

Block 3, ward opening onto grassed area, looking east Fig 22

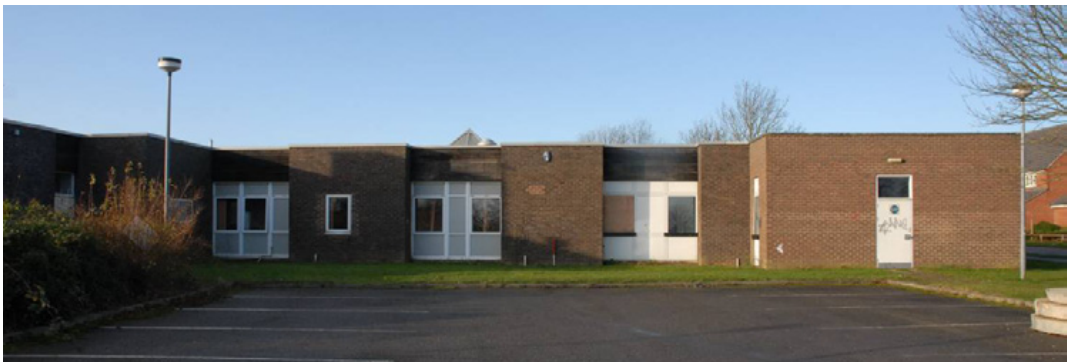
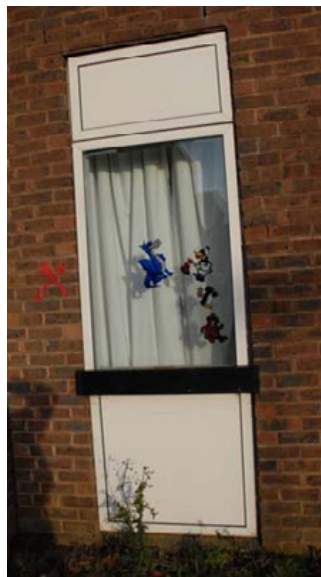
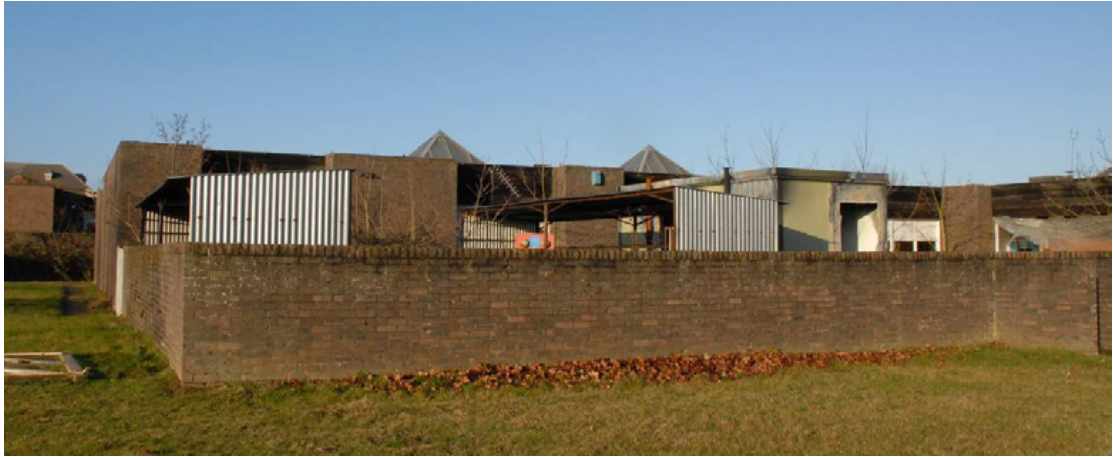
This was located in the northern part of the site (Fig 23) and consisted of three interconnected blocks, the most northern of which is likely to have been latterly used for children, as evidenced by the surviving window decoration (Fig 24). The eastern block had smoking shelters positioned in the gardens (Fig 25).

Block 4, looking west Fig 23

Block 4, Children's ward window Fig 24

Block 4, smoking shelter, looking north-west Fig 25

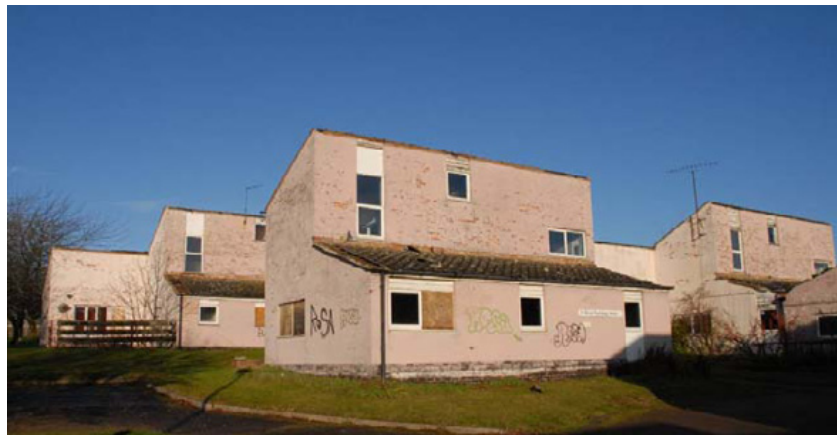
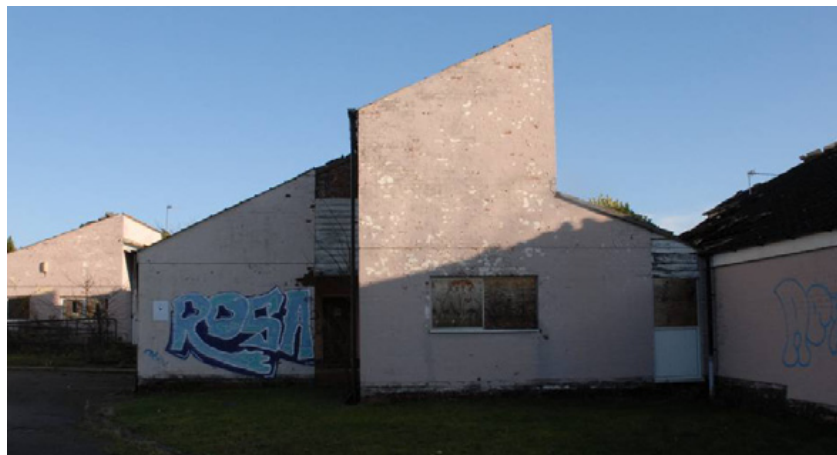
The accommodation for the staff (Figs 26 and 27) was located in the south-eastern corner of the site. These were constructed in a distinctive almost triangular style, differing to the main hospital buildings which focussed on the horizontal and were constructed in dark brickwork, whilst in contrast the staff accommodation featured brickwork brightly painted in pastel pink, augmented by graffiti since the closure of the hospital.

The staff accommodation Fig 26

The staff accommodation showing the triangular lines of construction Fig 27

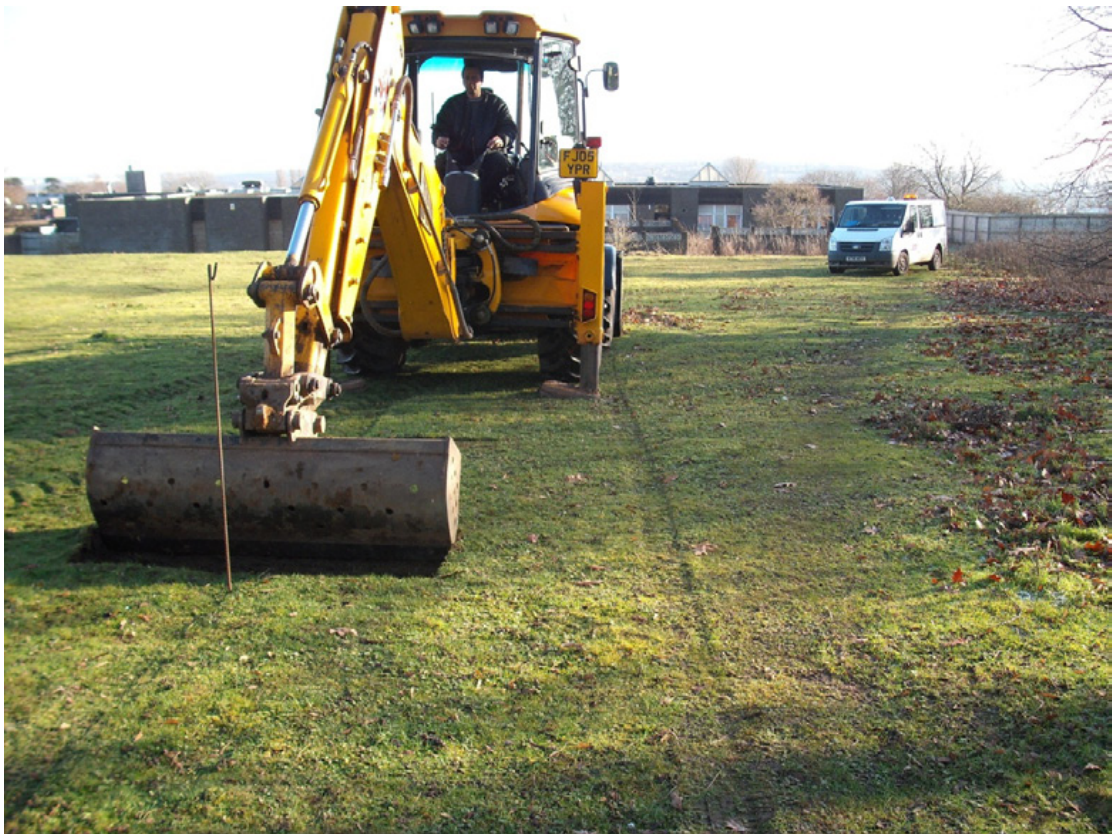
General view of the excavation of the trial trenches Fig 29

The trenches were excavated using a JCB 4CX excavator fitted with a toothless grading bucket (Fig 29). Topsoil and overburden was excavated to expose the upper strata of the natural substratum. Once opened, each trench was recorded in accordance with standard NA procedures (NA 2011).

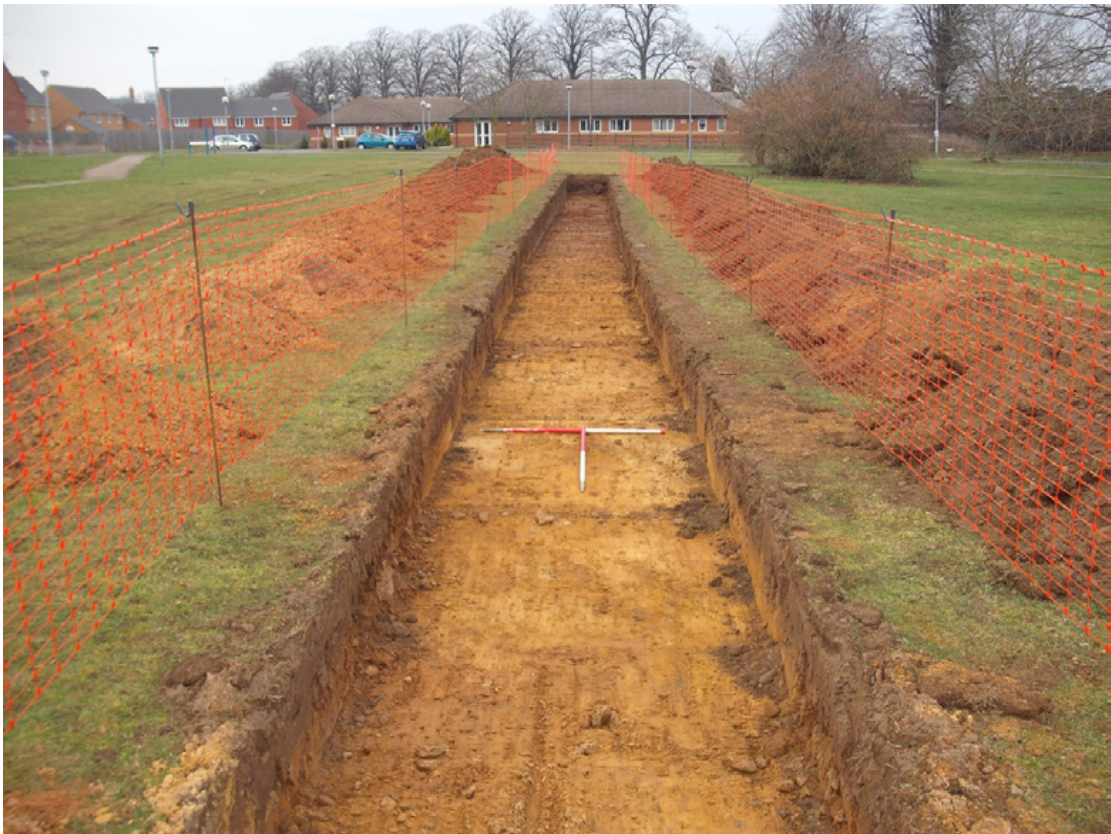
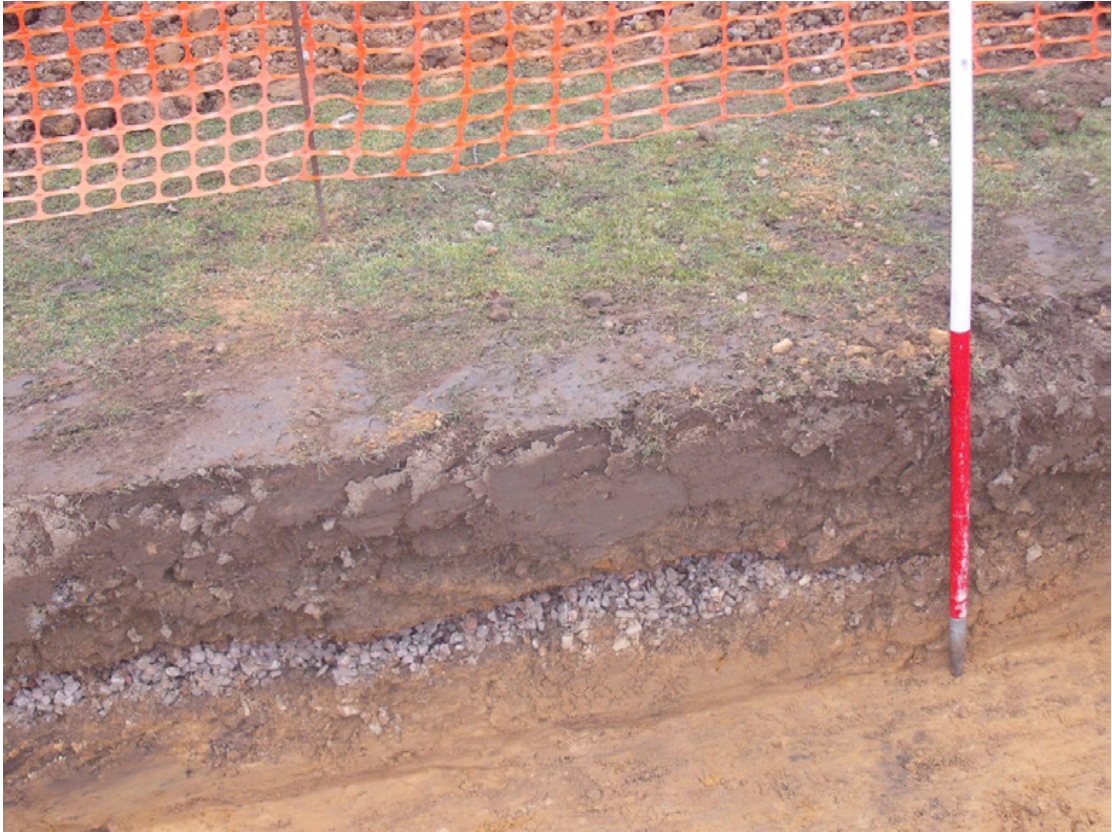
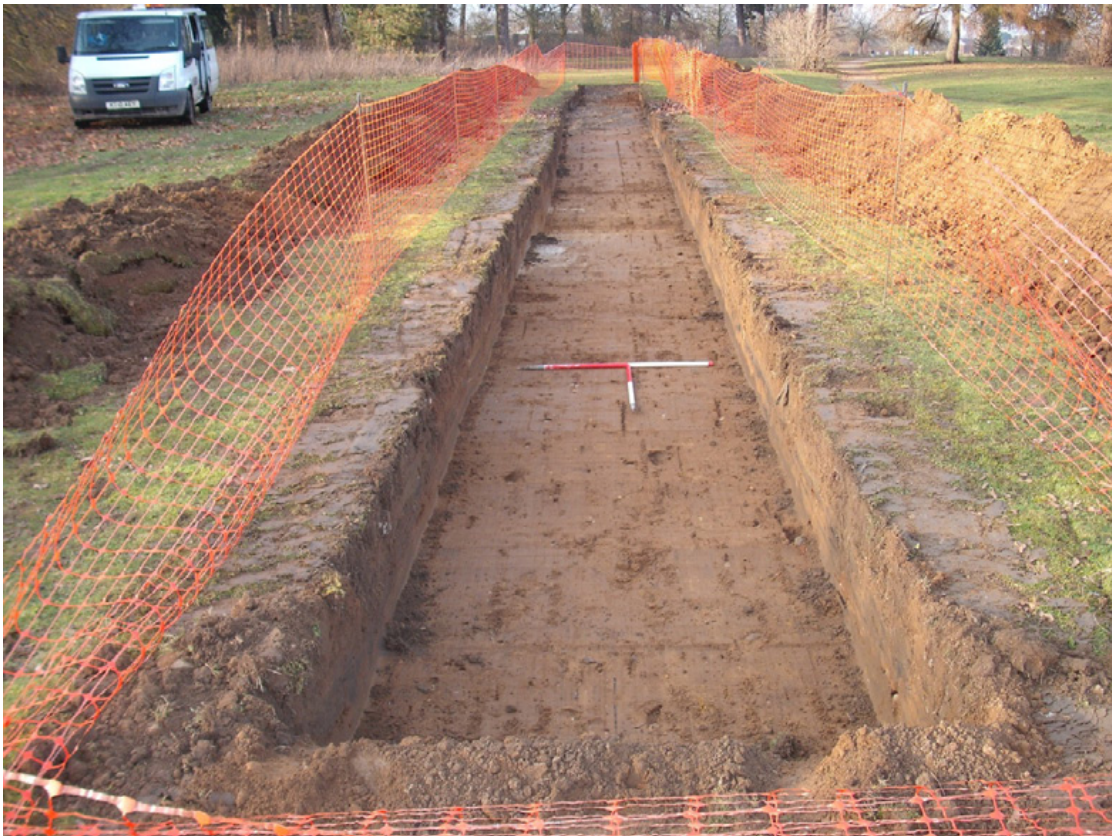
A consistent stratigraphic sequence was recorded throughout trenches 1 – 3. The natural substratum was encountered at a depth of 0.45m below present ground level and comprised orange-brown sand, containing occasional irregular stones. In the south-western end of trench 1 a single modern service pipe was noted cutting the natural. Overlying the natural substratum in the southern half of trench 2 was a spread of modern sub-base material (203). This was overlain by mid brown silt loam, up to 0.30m thick, containing occasional irregular stones and numerous small fragments of modern ceramic building material. (Fig 31 and 35). Sealing this was grey-black topsoil, up to 0.15m thick, containing occasional irregular stones and very occasional small fragments of modern ceramic building material.

Trench 1 after excavation, looking north-east Fig 30

Trench 2, west facing section Fig 31

Trench 3, looking north Fig 32

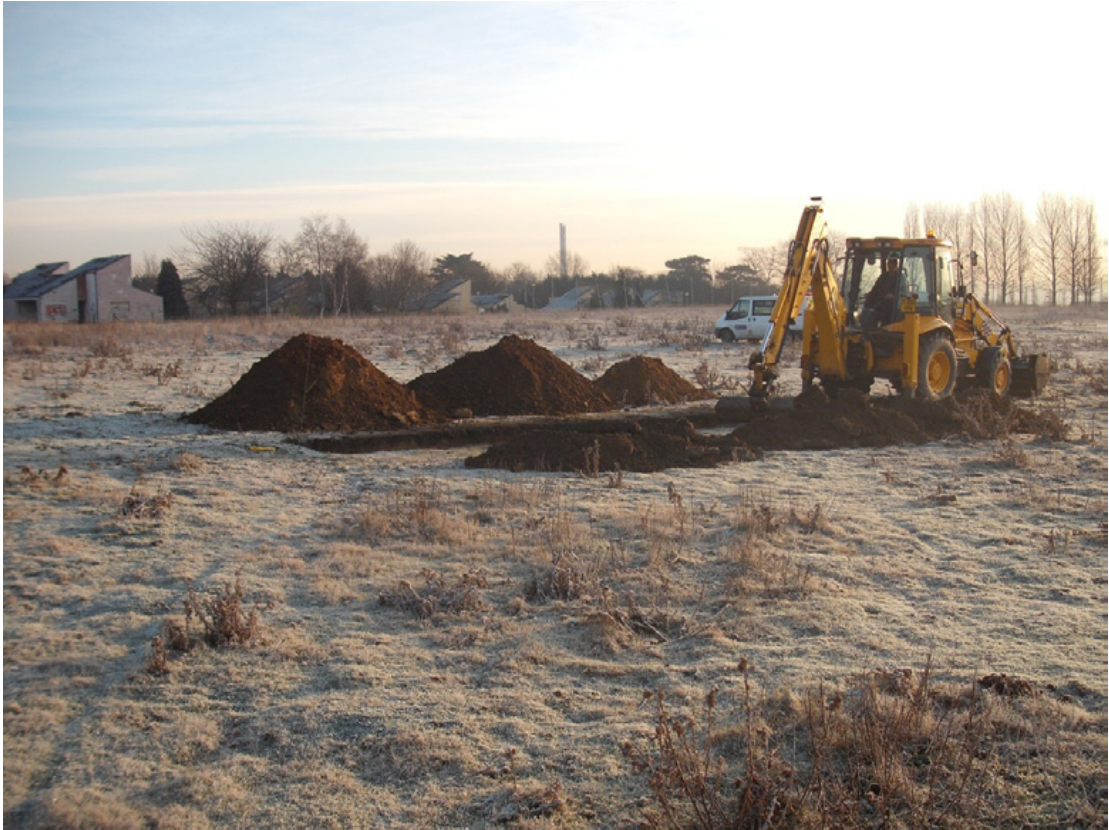
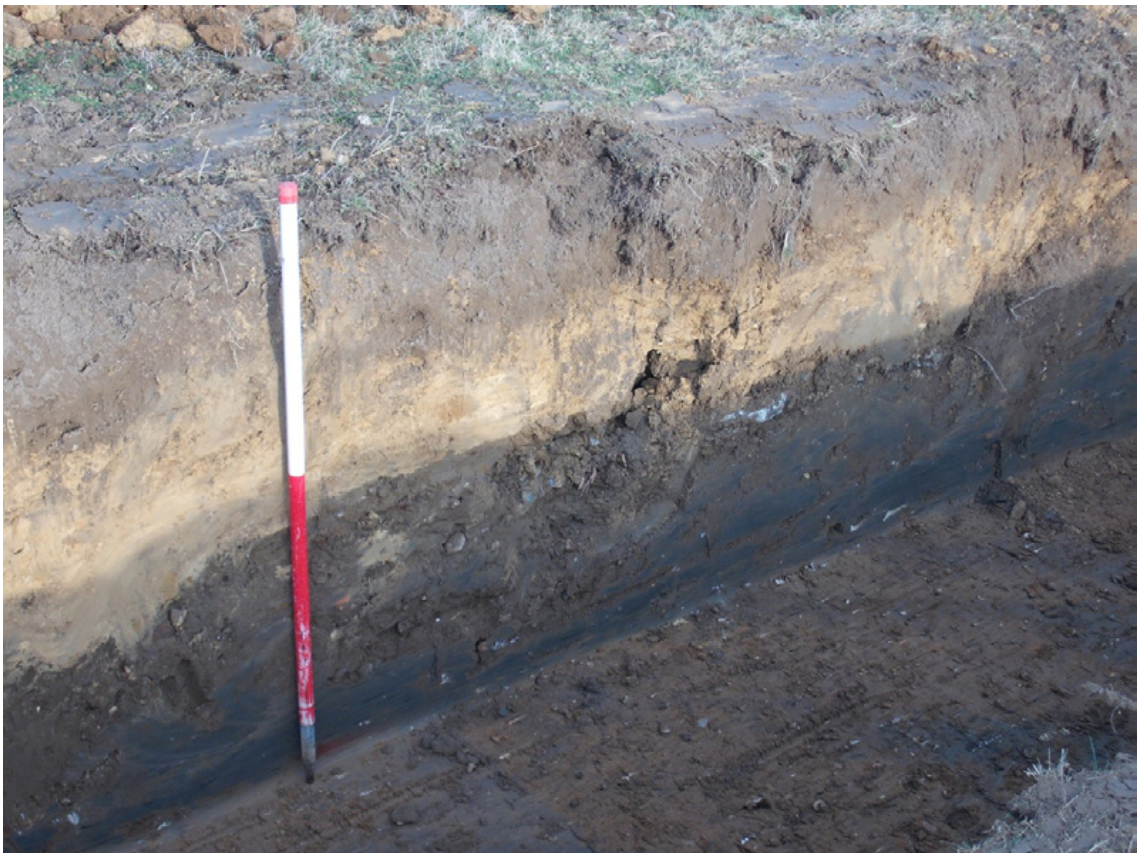
Trench 4 during excavation, looking east Fig 33

Trench 4 west facing section Fig 34

Trenches 4 (Fig 32) and 5 were located within the sports field on the southern boundary of the investigation area. A consistent stratigraphic sequence was recorded within both trenches.

The natural substratum was (404) encountered between 1.10m below present ground level in the northern end of trench 4 and sloped down towards the south to a depth of approximately 1.30m below present ground level. It comprised orange-brown sand containing occasional irregular stones.

The natural was overlain by mid-dark brown silt loam, up to 0.50m thick, containing numerous fragments of modern ceramic building material and corroded iron constructional fittings and a plastic storage drum (403). Overlying this was pale grey-brown silt loam, up to 0.70m thick, containing occasional fragments of modern ceramic building material and irregular stones (402). Sealing this was grey-brown silt loam topsoil (401), up to 0.10m thick, containing very occasional small fragments of modern ceramic building material and irregular stones.
