A programme of archaeological observation and recording
of groundworks on land at Helmdon House 87 Church
Street, Helmdon, Northamptonshire
August 2012

Report 12/169

November 2012

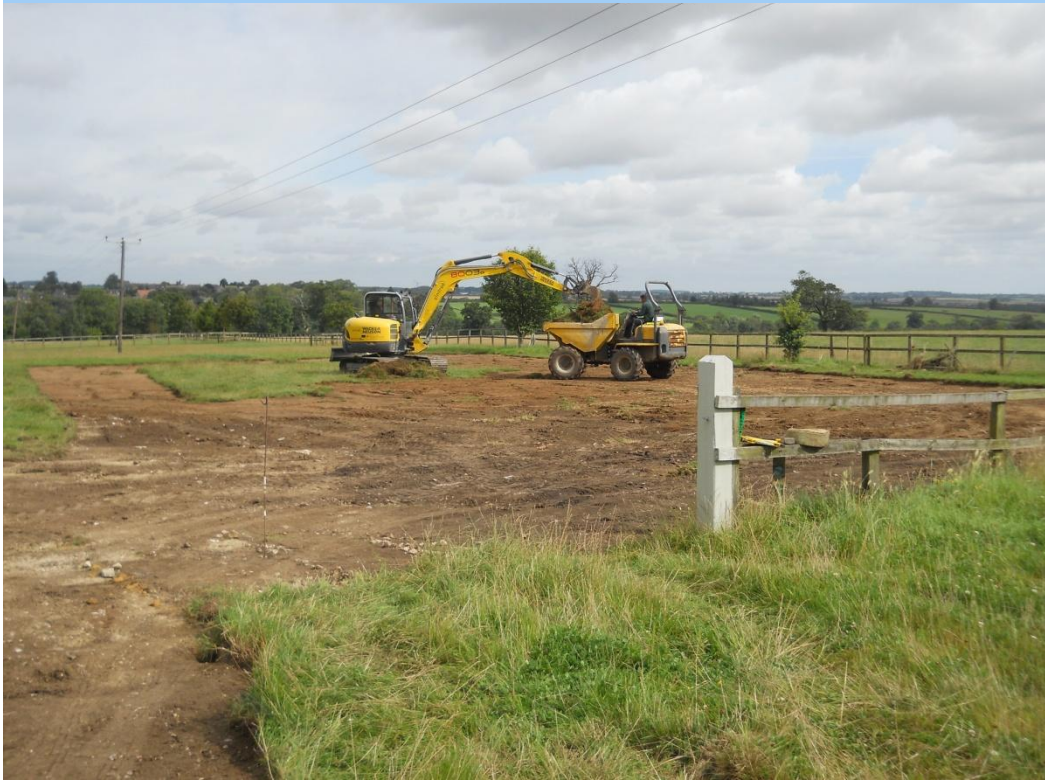
Cover: The ménage area being stripped, looking north

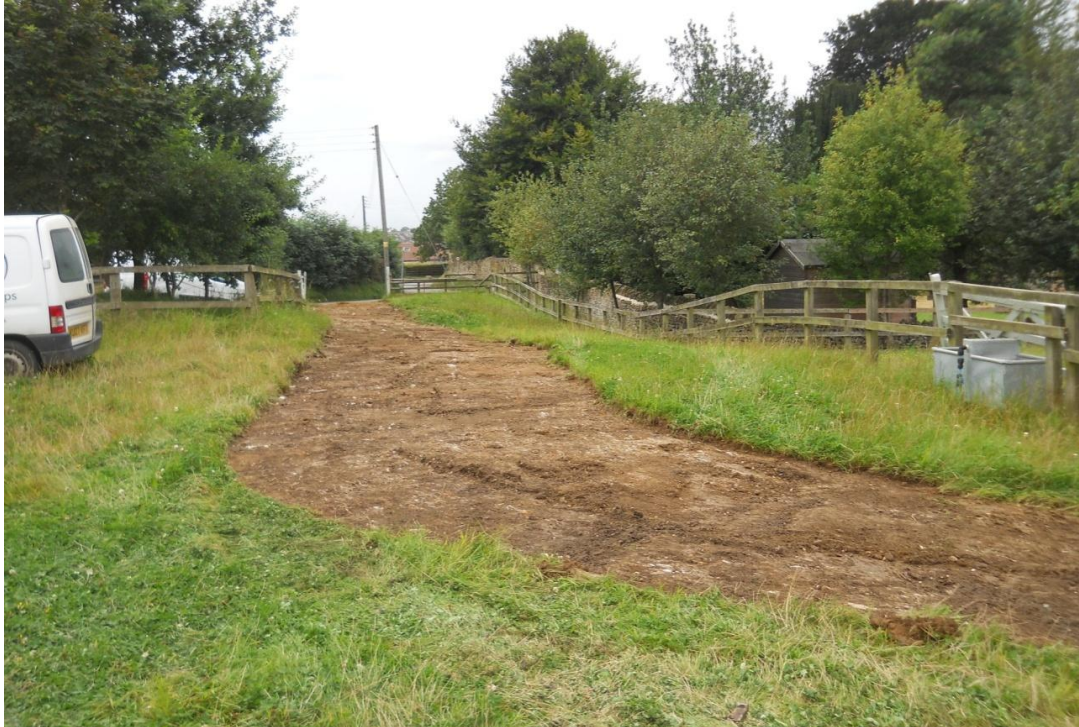
The access road, 3m wide, was stripped of 0.10m of topsoil down to previous made ground, possibly from an earlier path or trackway (Figs 3 and 4).

Topsoil removed from new access road, looking east Fig 3

Earlier made ground along the route of the new access road indicates a previous trackway. There has been disturbance in the field where the equestrian ménage is to be developed as shown by the large area of dumping and the rubble in the topsoil. However, no archaeological features or artefacts were present within the investigation area.

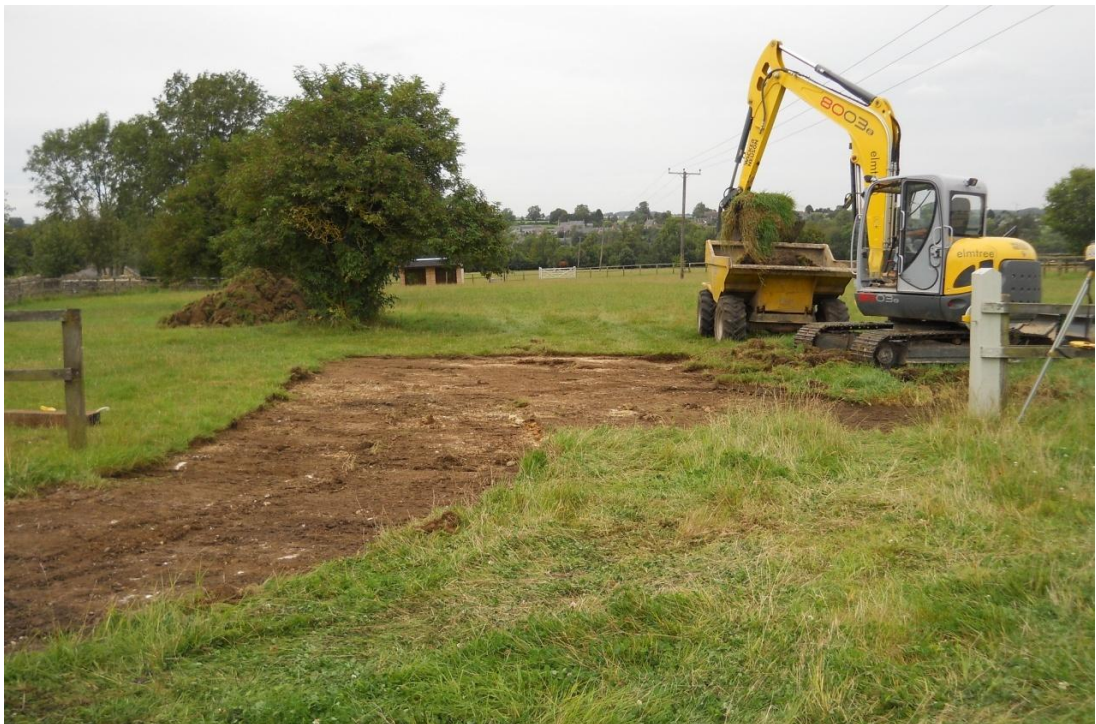
Topsoil removed from new access road going into ménage area, looking north Fig 4

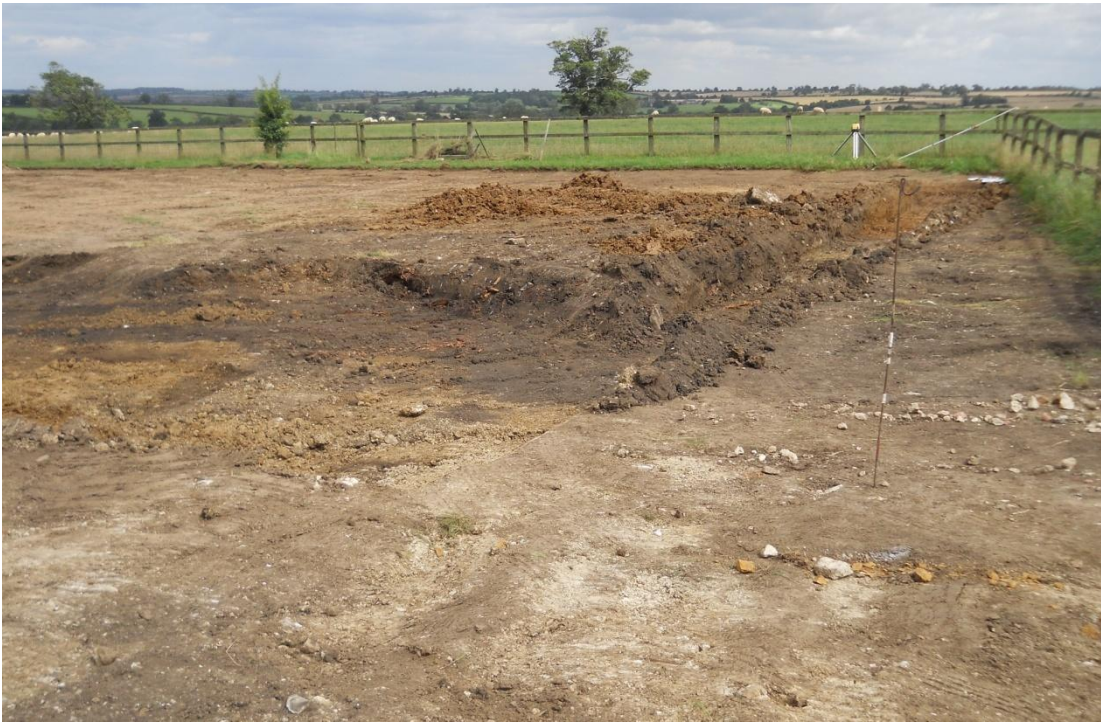
The ménage area was stripped onto the natural, 0.60m below the present ground surface (Figs 5, 6 and 7). The natural in most of the area comprised sand and gravel mixed with clay including frequent flint and stone (4). In the far south-west side the natural comprised light brown and white clay with large blocks of limestone (6).

Overlying these was a natural layer (3), 0.40m thick, of dark brown clay with isolated stones.

South side of ménage area during stripping, looking east Fig 5

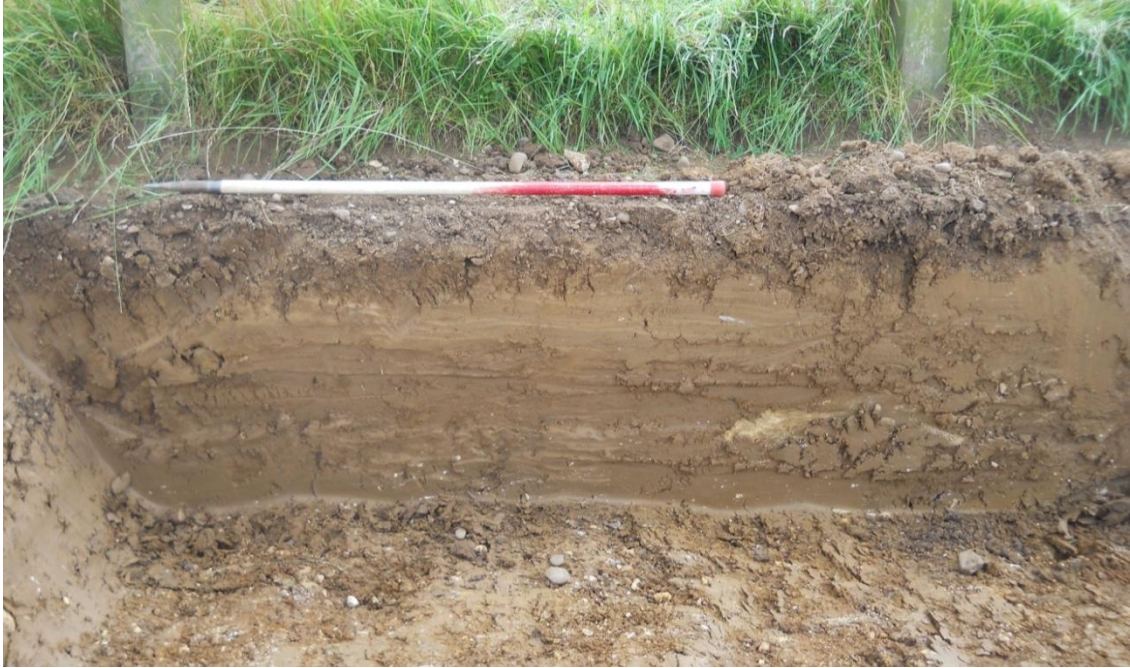
The subsoil (2) was light brown clay, 0.10m thick, overlain by dark grey-brown clay loam topsoil (1), 0.10m thick and containing modern rubble (Fig 7).

Section on south side of ménage area, looking south Fig 7

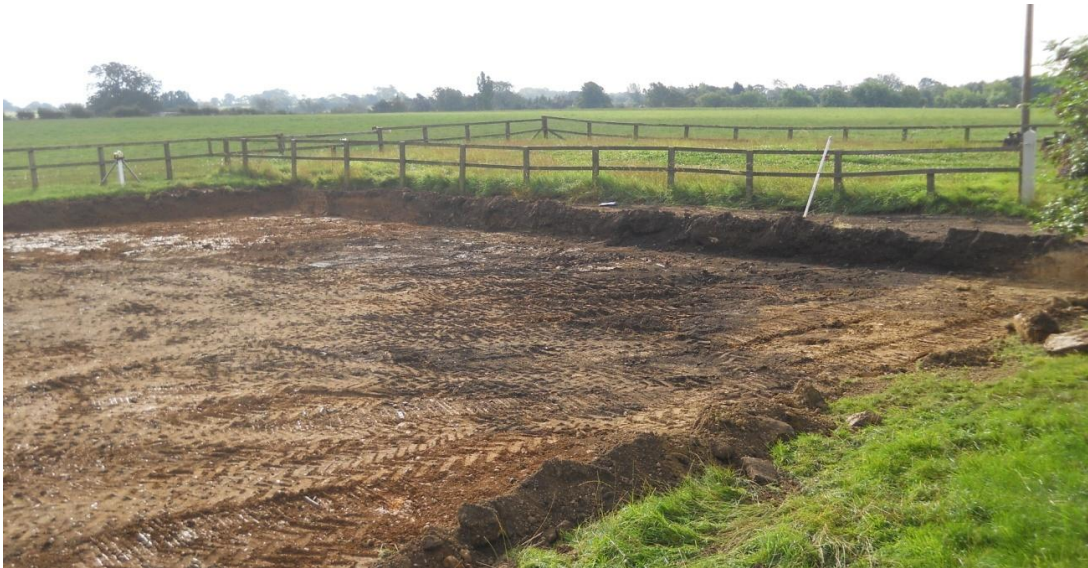
Ménage area after stripping, looking south Fig 8

In the south-western part of the area post-medieval/modern disturbance comprising waste consisting of glass, plastic, brick and metal mixed with topsoil (5) had been cut into the natural (Figs 8 and 9). Tree stumps were machined out.

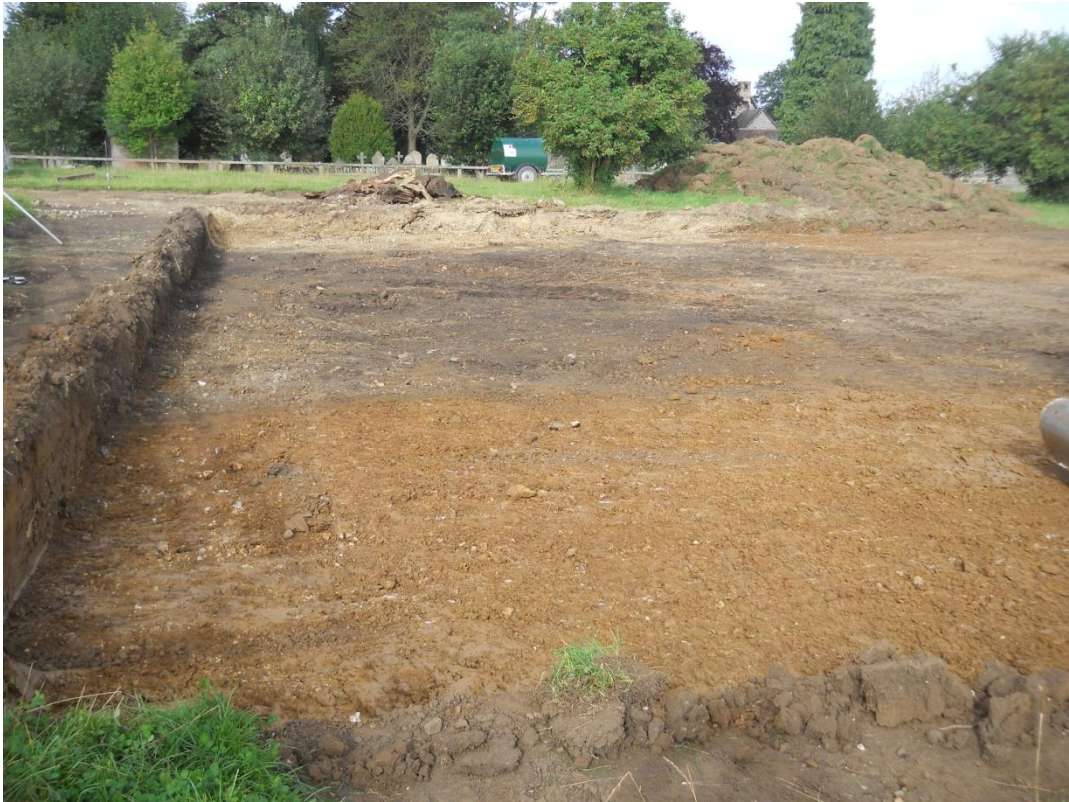
South end of ménage showing area of disturbance, looking west Fig 9
