Archaeological evaluation of the Concourse at Northampton Castle Station October 2012

Report 12/188

November 2012

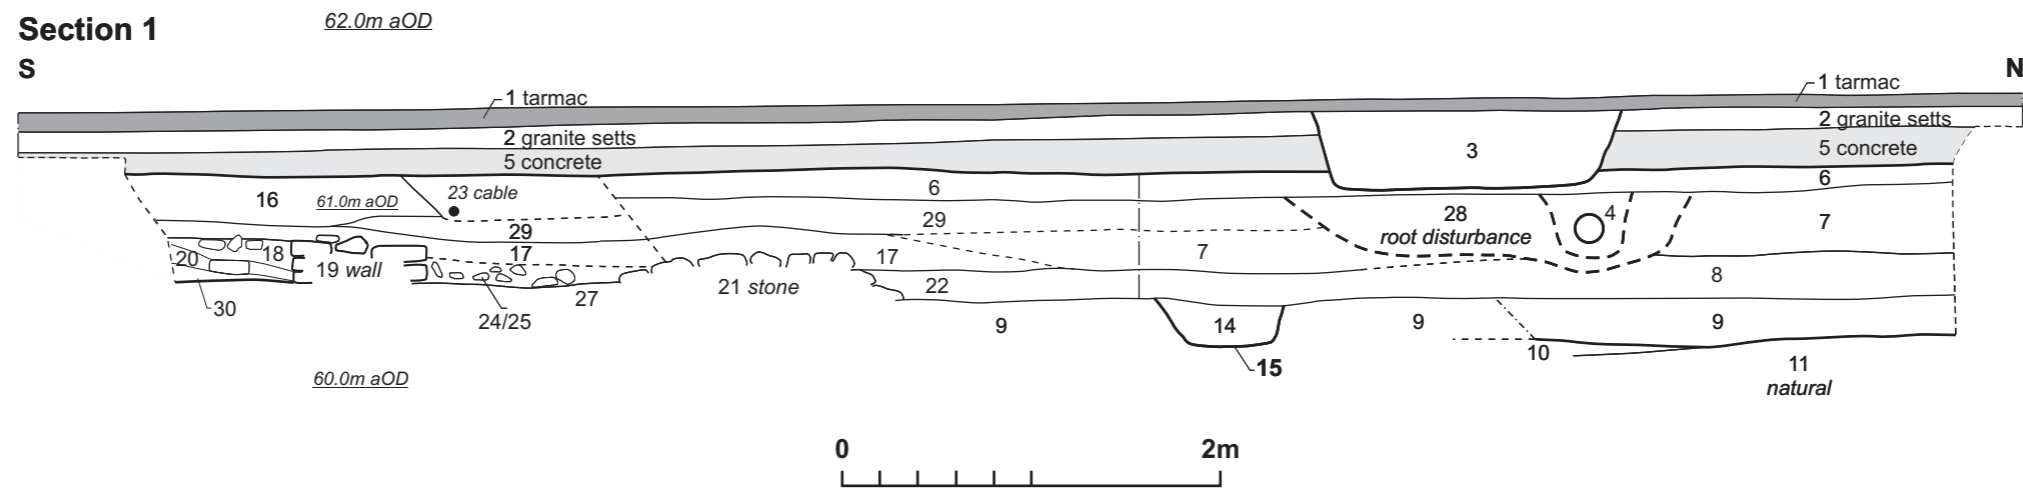
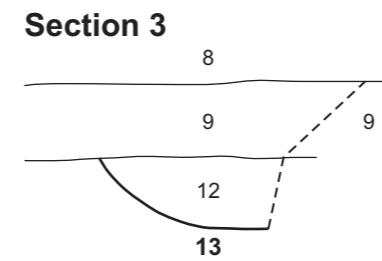
At the northern end of the trench, a 2.2m length of undisturbed natural of orange-brown compact sand, containing mottles and pieces of decayed ironstone (11) was uncovered by machine excavation through soil layer (9). The natural was overlain by a thin deposit of dirty natural (10), 10-30mm thick (Figs 4 & 8).

Cut into the natural and sealed by soil horizon (9), there was a shallow bowl-shaped pit [13], up to 0.18m deep, of which perhaps a quarter was available for excavation (Fig 4, S.3 and Fig 7). The fill (12) was of dark grey-brown slightly clayey loam, containing frequent flecks and small pieces of charcoal, and sparse small stones, some of which were burnt. The fill produced two sherds of St Neots ware, dating to the 11th century, and a little animal bone.

Pit [13] was sealed beneath a soil horizon (9), 0.20-0.25m thick, of compact medium brown clayey loam, containing small chips of ironstone (Fig 4, S.1). In straightening the exposed end of the layer where it had been cut through by machine adjacent to pit [13], some animal bone, a single sherd of Northampton ware and a copper alloy brooch, were recovered from the base of the layer, potentially debris from activity contemporary with the pit. Northampton ware is dated to the 10th century and this, together with the presence of St Neots ware in the underlying pit, provides a 10th to 11th century date for the pre-Castle activity in this area.

A linear slot [15], 0.60m wide by 0.30m deep, had a U-shaped profile, with near vertical sides and a rounded break onto a flat bottom (Fig 4, S.1 & S.2 and Figs 10 & 11). It crossed the trench on a similar alignment to wall [19].

Layers (6) and (16) were cut by a trench containing an old heavy-duty electric cable (23) that ran diagonally across the trench (Fig 4), and may have supplied the signal box contemporary with the old station (station staff pers comm). To the north, there

The granite setts (2) of the old station yard were 100mm (4") high, and were set on a bed of yellow sand above a layer of concrete (5), which was 0.16m thick. They were intact across most of the trench (Fig 16), with a small area missing at the southern end of the trench and an area to the north where there was a modern pit related to drainage [3] (Fig 4, S.1).

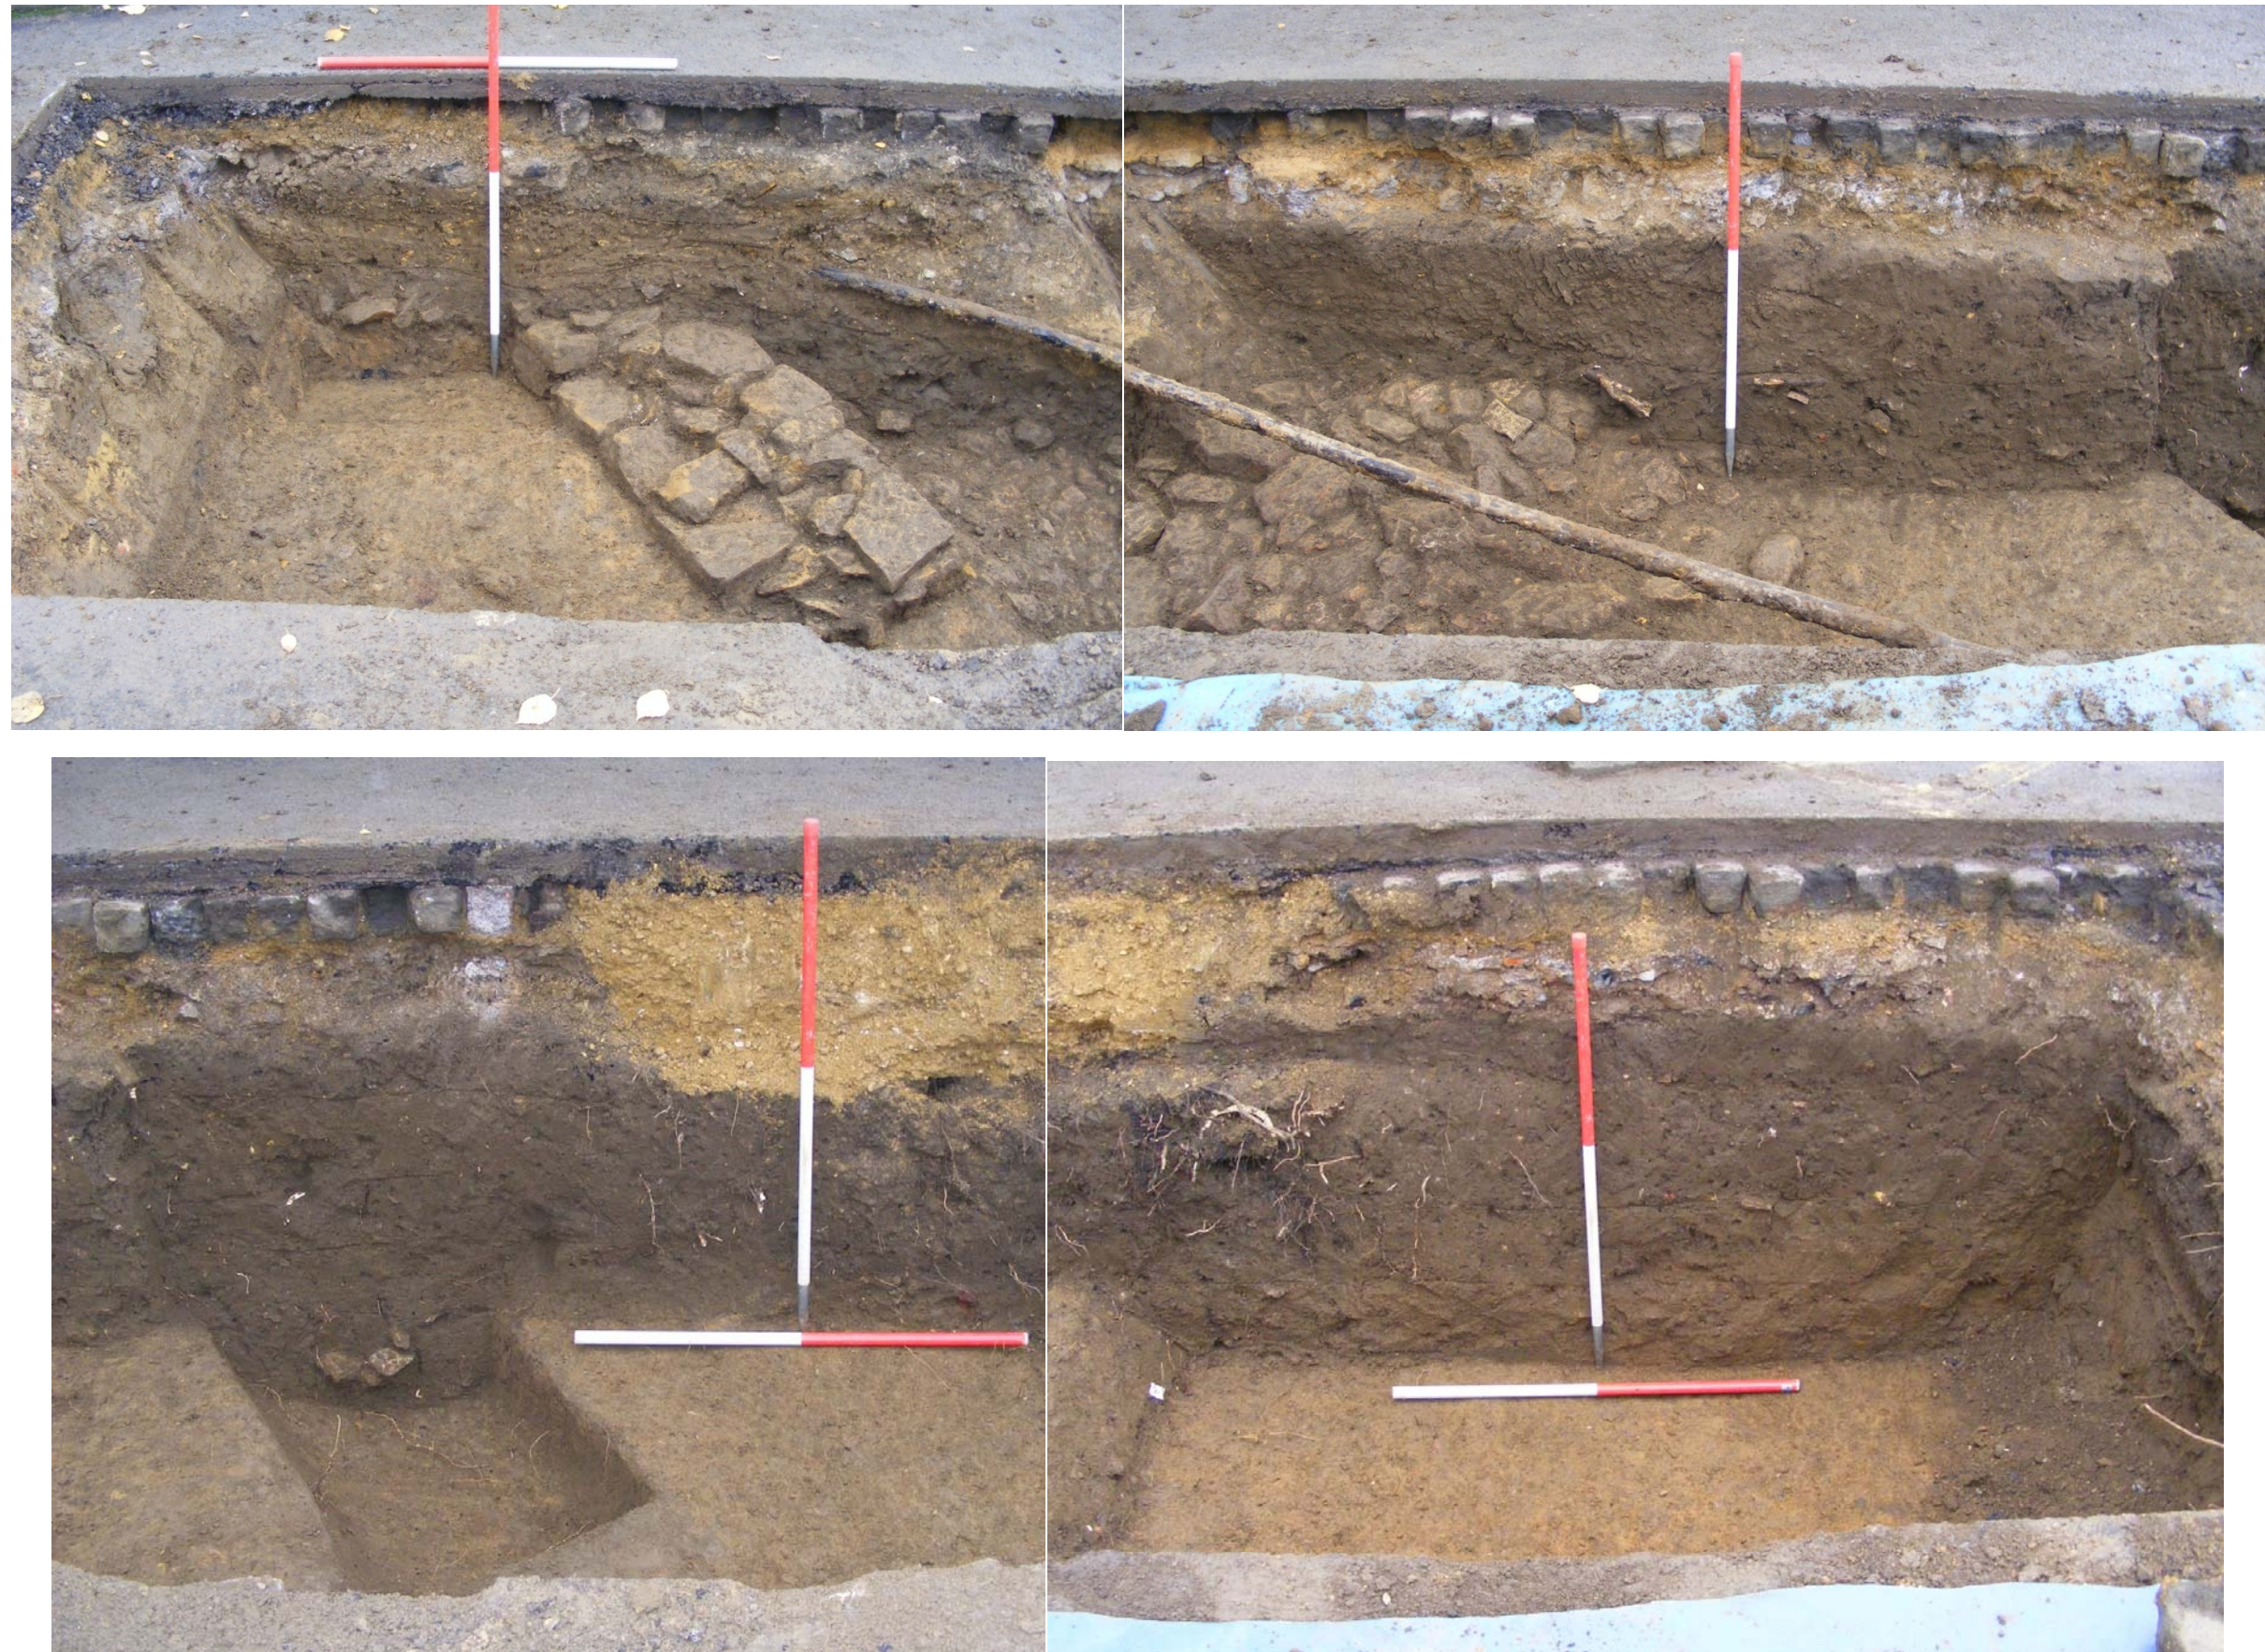
Fig 5

The west face of the trench, composite images (Scales 1m)

To the south of the wall, the three courses of the wall face were abutted by a sequence of probable floor surfaces (Figs 4, 5 & 12). Layer (30) was light grey-brown silty sand, 80mm thick, containing charcoal with particularly large pieces directly beneath a slab of ironstone within the overlying floor surface (20). To the east there were patchy areas of reddened scorching. The overlying layer (20), which abutted the lowest course of the wall, was up to 100mm thick, and comprised clean yellow-brown slightly clayey coarse gritty sand, with the occasional flat fragment of ironstone bedded into the deposit. Above the floor surface, there was a layer of disordered smaller fragments of ironstone (18), in a matrix of light grey sandy loam. This layer contained some charcoal and pottery and bone, and is probably contemporary with the levelling of the wall and the deposition of layer (17).

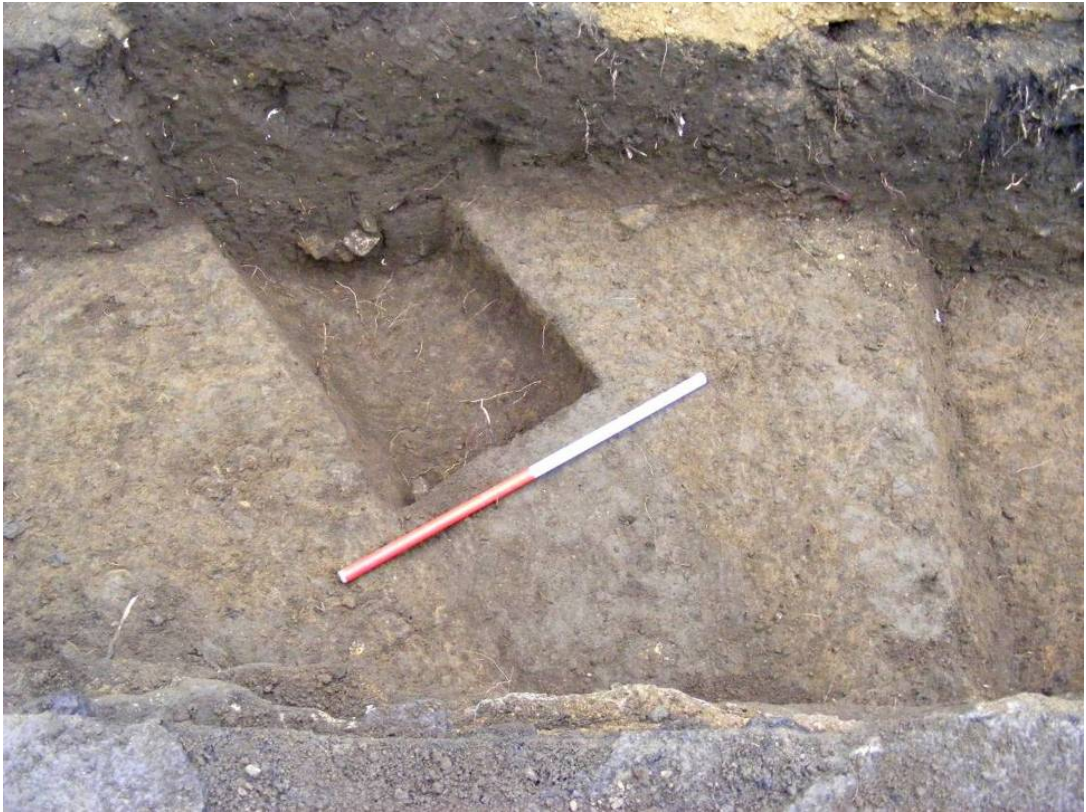
Fig 10

The fill (14) was of medium brown loam containing frequent irregular fragments of ironstone and some limestone, including a block of ironstone measuring 200x150x150mm, and some charcoal flecks and fragments. The fill produced the largest pottery assemblage from the trench, with a wide range of sizes from small sherds to large fresh sherds, all dated to the 12th century. There was also an assemblage of animal bone comprising kitchen waste, including bones with cutting marks and an articulated ankle joint from a cow.

Linear slot [15] cutting the late Saxon soil horizon (9), looking west

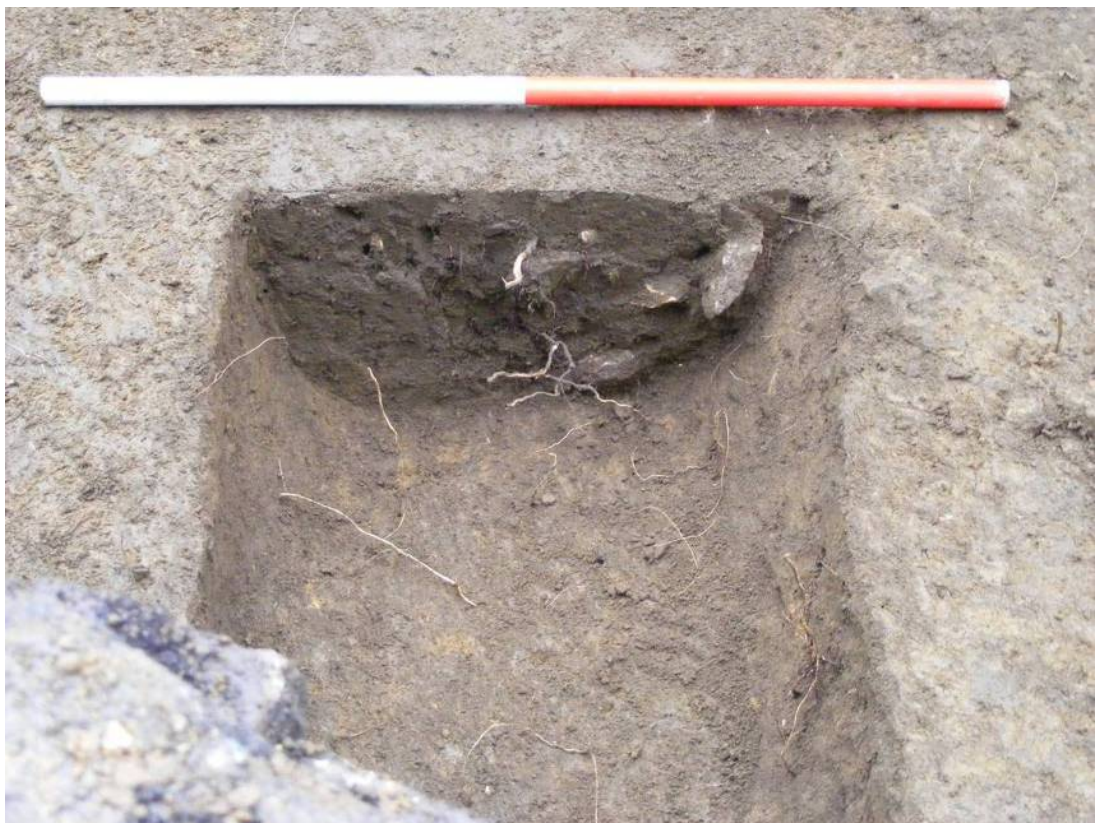
Fig 11

Section of linear slot [15], looking north-east

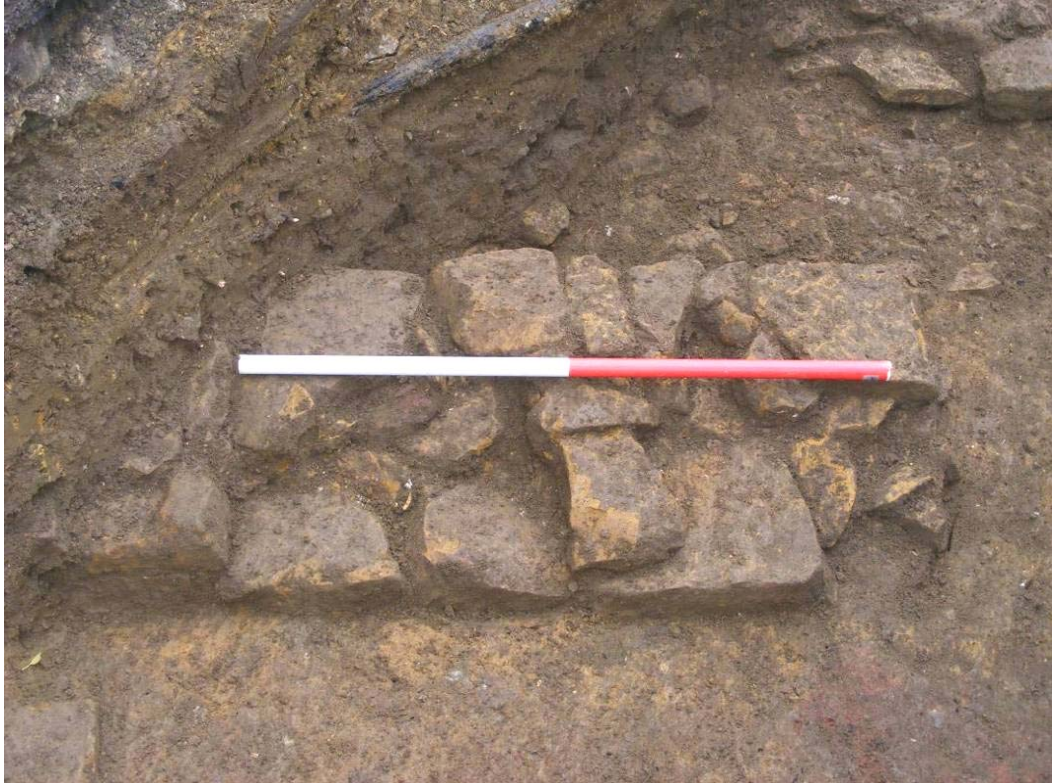
Ironstone wall [19] and floor surface (20) (foreground), looking north Fig 12

At the southern end of the trench there was a length of ironstone wall [19] running diagonally across the trench on a south-west to north-east alignment. This probably formed the north wall of a building. The wall was 0.60m wide and stood 0.2m high, comprising the bottom two or three courses faced with flat-laid roughly-squared ironstone, and a core of smaller rubble (Fig 4, S1 and Figs 12 & 13). There were some traces of an orange-brown gritty and sandy mortar both between the stones and on the base of the construction trench to the east, where the wall had been totally robbed.

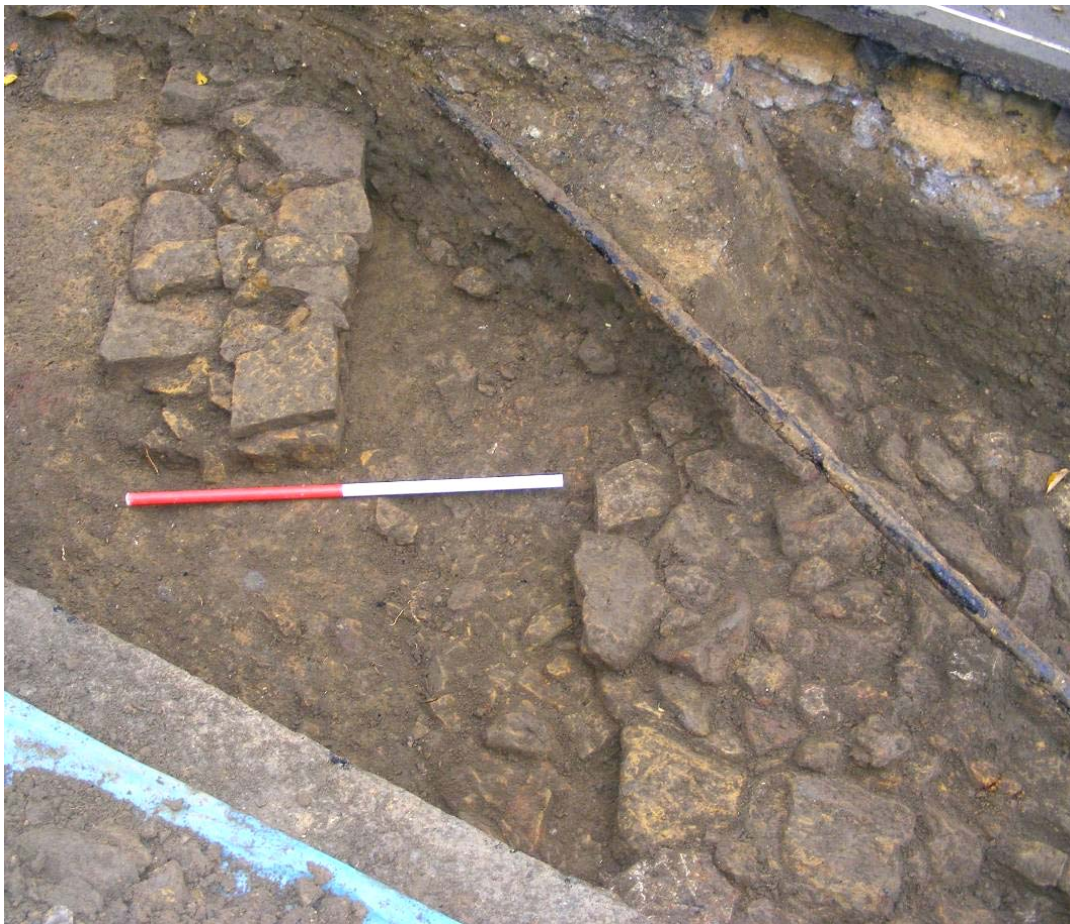
The wall [19], the stone deposit (21), right, and the intervening gap Fig 14

To the north, between wall [19] and the stone deposit (21), a small area of the underlying soil horizon (9) was exposed, but across the greater part of this area there was a layer or fill comprising dense small fragments of ironstone (27). This deposit continued under the stone layer (21), and as it was not excavated its true nature is unclear.

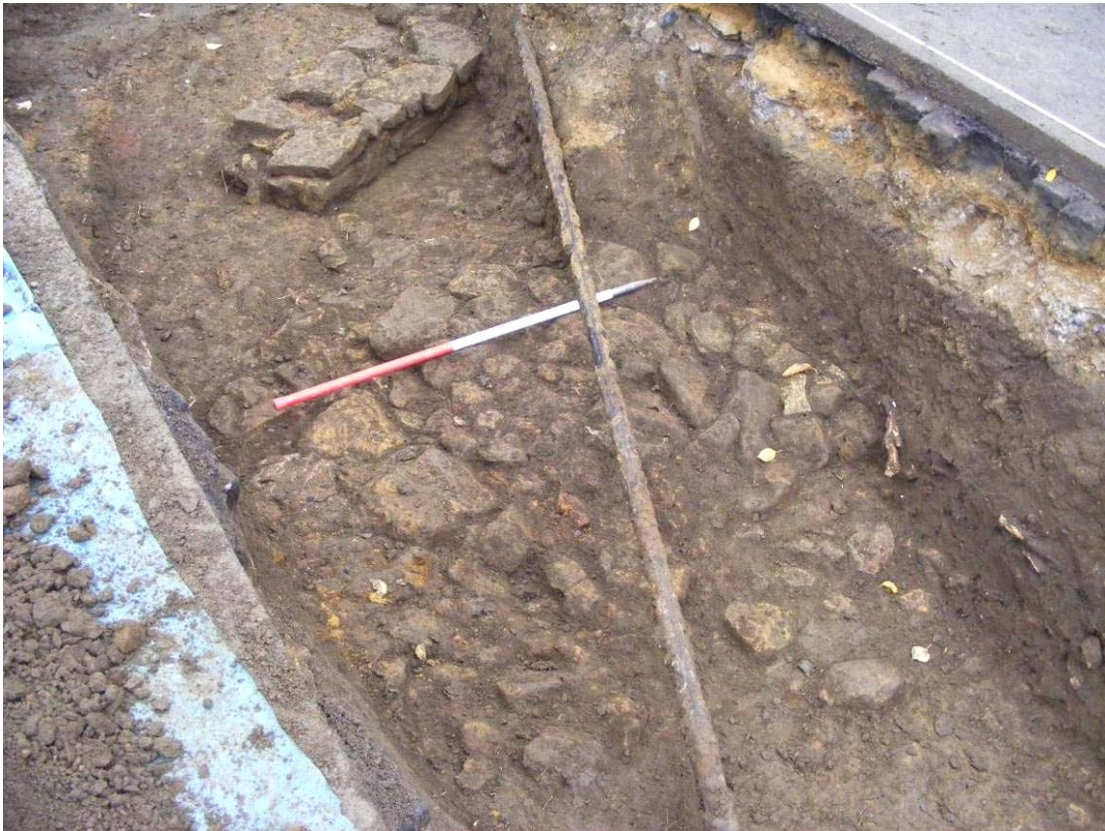
Fig 15

The stone deposit (21) to the north of the wall, was up to 1.3m wide and comprised a low heap of dense tumbled and disordered fragments of ironstone, and occasionally limestone, including pieces measuring up to 300mm long (Figs 4, 14 & 15). Many of the fragments of ironstone had reddened edges, indicating that they had come from stonework perhaps once forming part of an oven. The exposed stones typically had rounded edges and surfaces, indicating that they had been either worn or were exposed to the elements for some time.

To the south, a partially surviving line of larger ironstone slabs may have formed a rough kerb, but these stones were not squared and did not form a straight edge, and only a single course survived. The gap, 0.55m wide, between the wall [19] and stone layer (21) formed a sunken channel that would have acted as a *de facto* drain. It contained a sequence of deposits that abutted the wall face and abutted and overlay the southern edge of the stone layer. A layer of grey loam, containing charcoal flecks and fragments (25) had accumulated, and bedded into the surface (24) there were scattered fragments of small ironstone, 100-200mm, which may have been displaced from layer (21). Stones pitched at a steep angle in the area of later wall robbing show that this deposit had accumulated before the robbing of the wall, and the deposit contained both pottery and animal bone.

To the north the stone deposit thinned out with no clearly defined edge, and displaced stones were present in the soil horizon (22) that overlay the tail of the deposit (Fig 4, S.1). Layer (22) may have been a slow soil accumulation, comprising brown friable loam containing moderate flecks of charcoal and scattered fragments of ironstone, along with pottery and some animal bone. The layer was excavated by hand where it overlay the tail of the stone deposit. Further north, the continuation of this layer (8) had been removed by machine, although it was noted that to the north, away from the stone layer, it contained few stones. It would seem that the accumulation of this layer was broadly contemporary with the wall and the stone layer, suggesting that the linear slot had fallen out of use before these stone-built features.

The heaped stone deposit (21), looking south-west

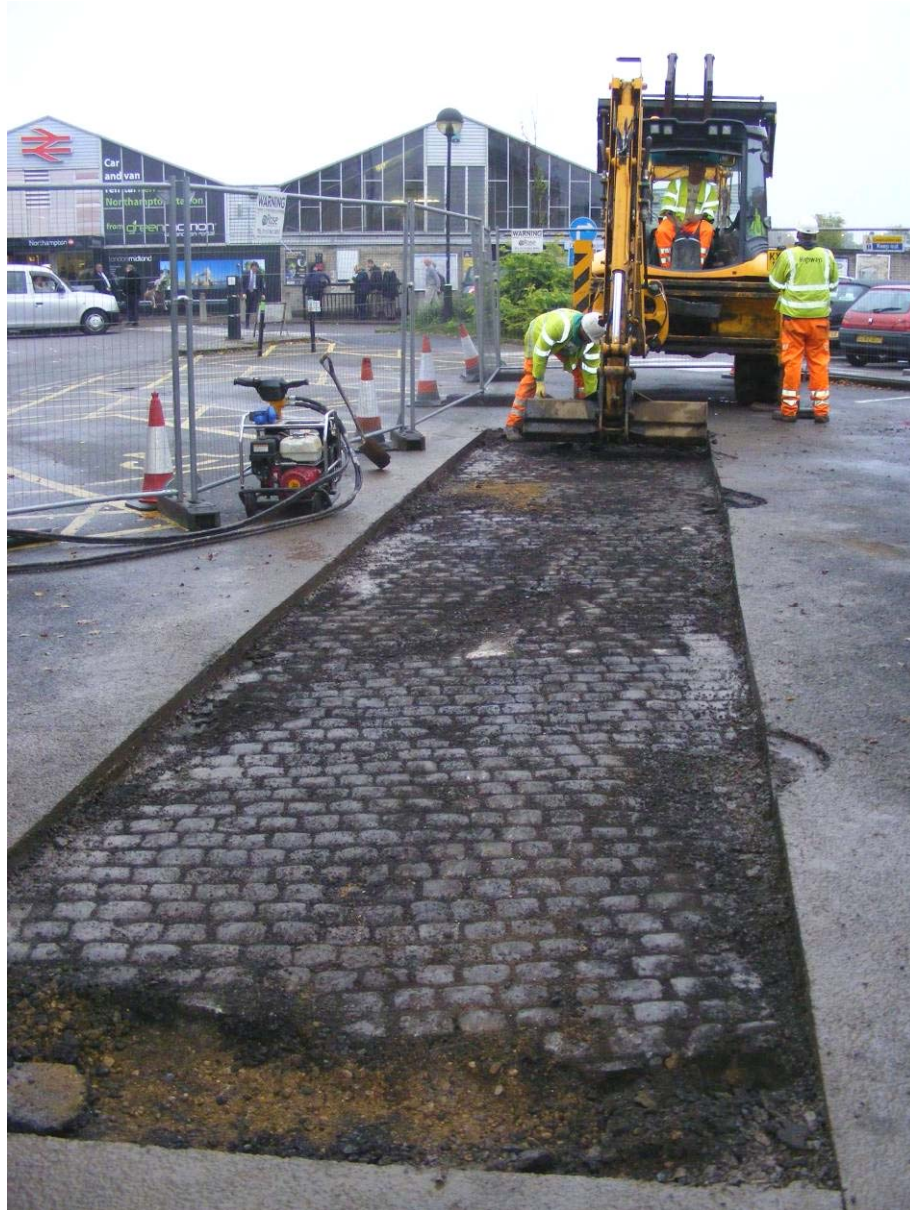
The granite setts of the old station yard, covered over in 1964 Fig 16

The cobbled station yard had been covered with tarmac in 1964 (station staff pers comm). The tarmac was 90mm thick, with a lower layer 60mm thick and an upper surface 30mm thick.

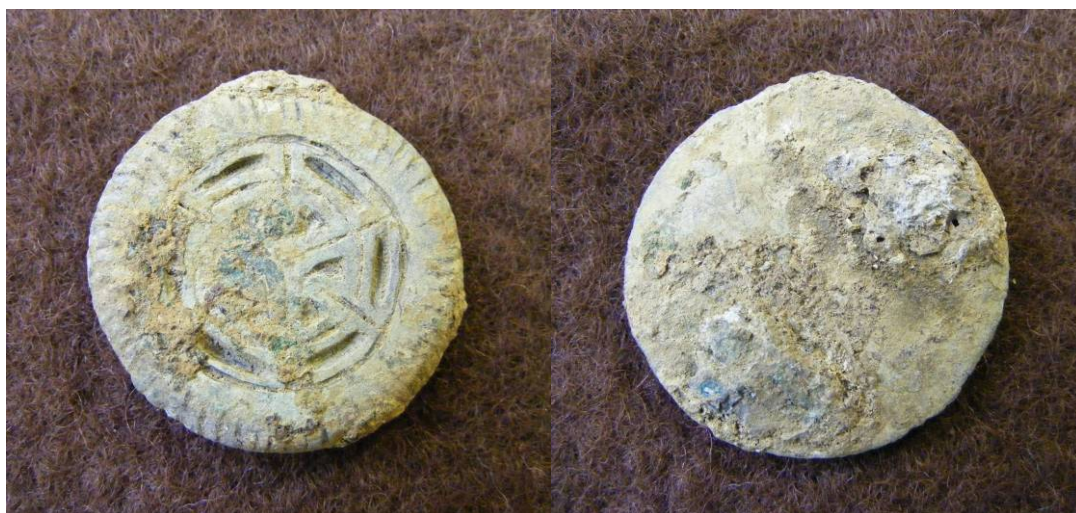
Fig 19

Brooch, copper alloy. Incomplete, rear loop and catch-plate missing (Fig 19). Small cast circular disc with bevelled edge and flat underside. The upper surface of the brooch is decorated with a centrally placed geometric motif comprising a roughly incised circle divided into 6 equal triangles, each with a rectangular horizontal recess/slot at the top and a small triangular recess at the base. The outside edge of the brooch is ornamented with closely-spaced, slightly oblique hatched lines. The underside of the brooch has two small patches of corrosion, presumably vestiges of the loop and catch-plate. Small disc brooches of this type are not uncommon, they are predominantly recovered from the Anglian Region and they date to the 10th/11th centuries. However examples decorated with a geometric design appear to be uncommon, only one example from Thetford has been located (Rogerson and Dallas 1984, fig 109, 6) but further research will need to be undertaken. Diameter: 23mm. Thickness: 2mm.

Late Saxon copper alloy brooch (23mm diameter)
