An archaeological watching brief

At The Hayloft, Bletsoe

Bedfordshire

Report 05/141

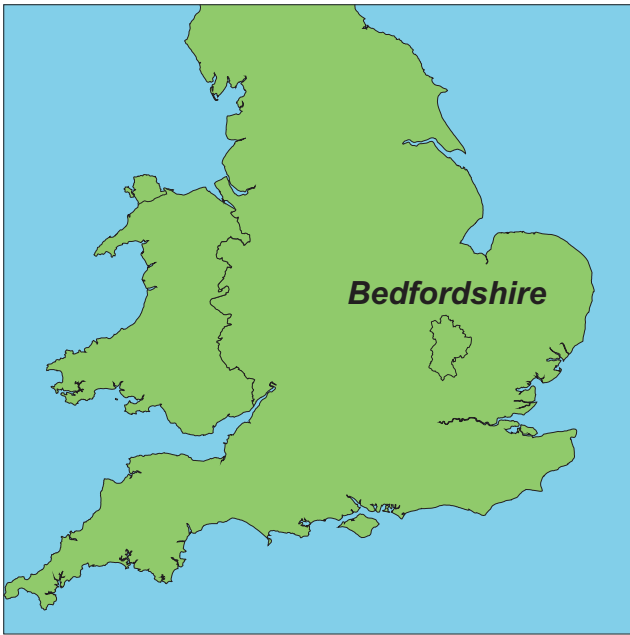
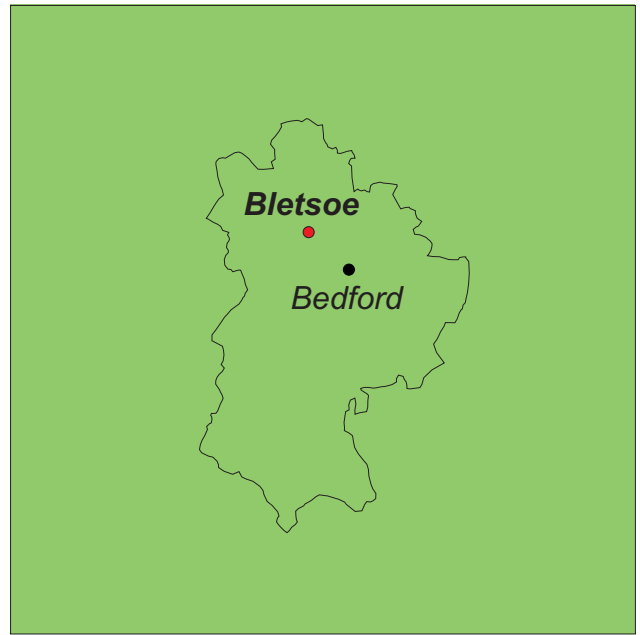
Fig. 1

Fig 1: Location of Castlebarns, Bletsoe, Bedfordshire

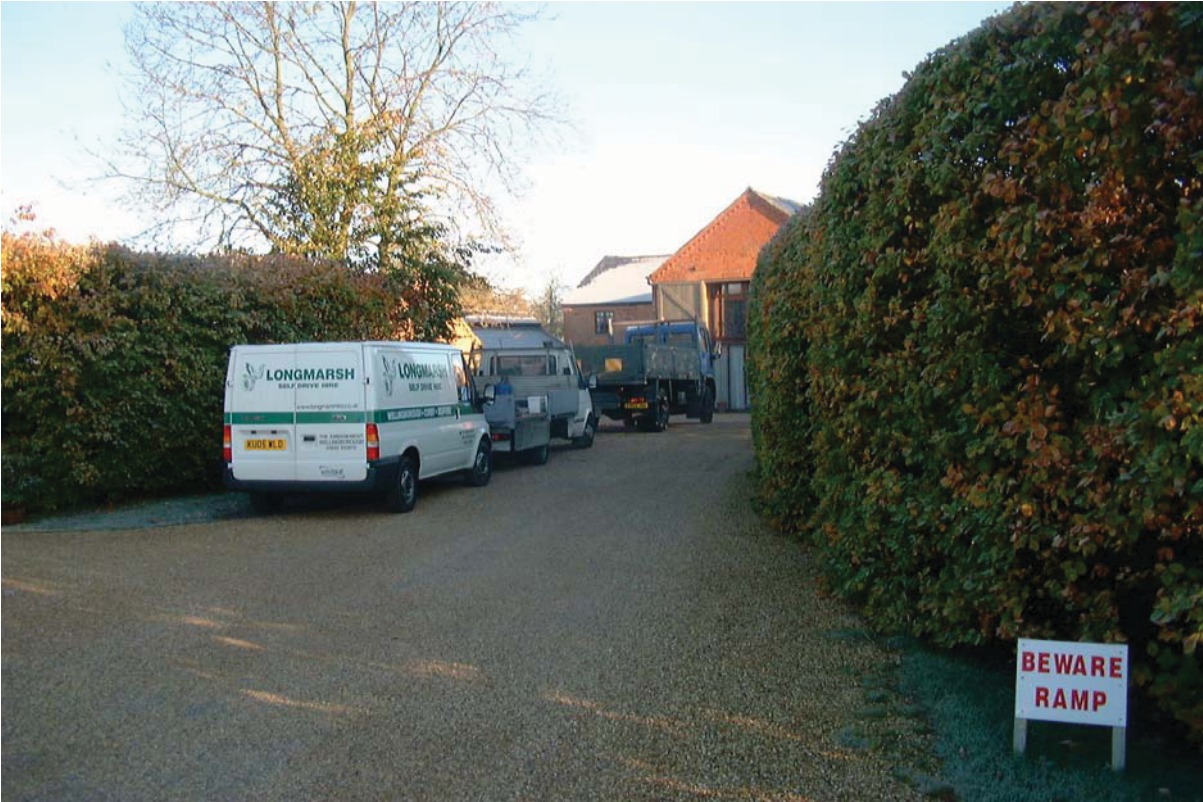
Plate 1: View of Castlebarns, Bletsoe, Bedfordshire

Plate 1: View of Castlebarns, Bletsoe from the entranceway

The fieldwork comprised a single visit to the site during the excavation of the foundation trenches (Fig 1; Plate 1). The foundation trenches were excavated using a combination of hand tools and electrical cutting tools. A photographic record in both black and white negative and colour slide was kept, along with supplementary photographs in digital format. The written record used Northamptonshire Archaeology pro-forma sheets. The watching brief was carried out in accordance with the standards and guidelines for an archaeological watching brief (IFA 1999).

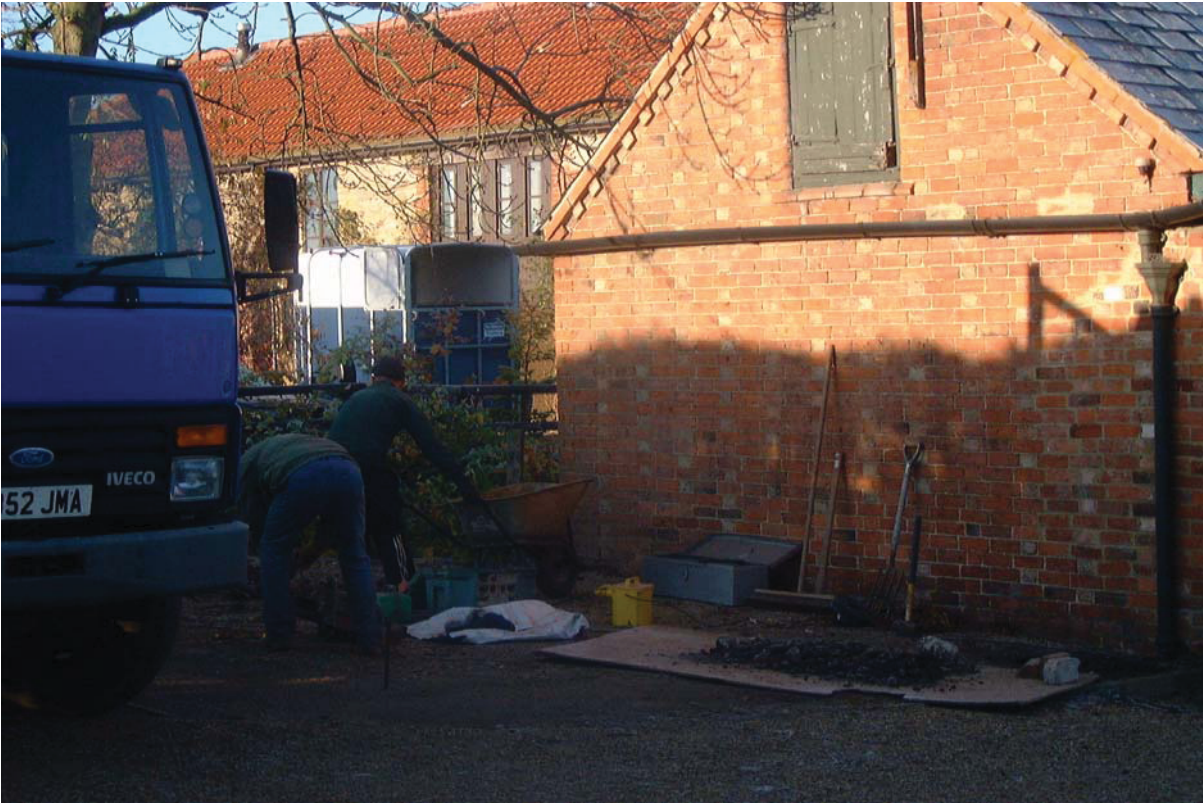
Plate 2: General view of the groundworks area

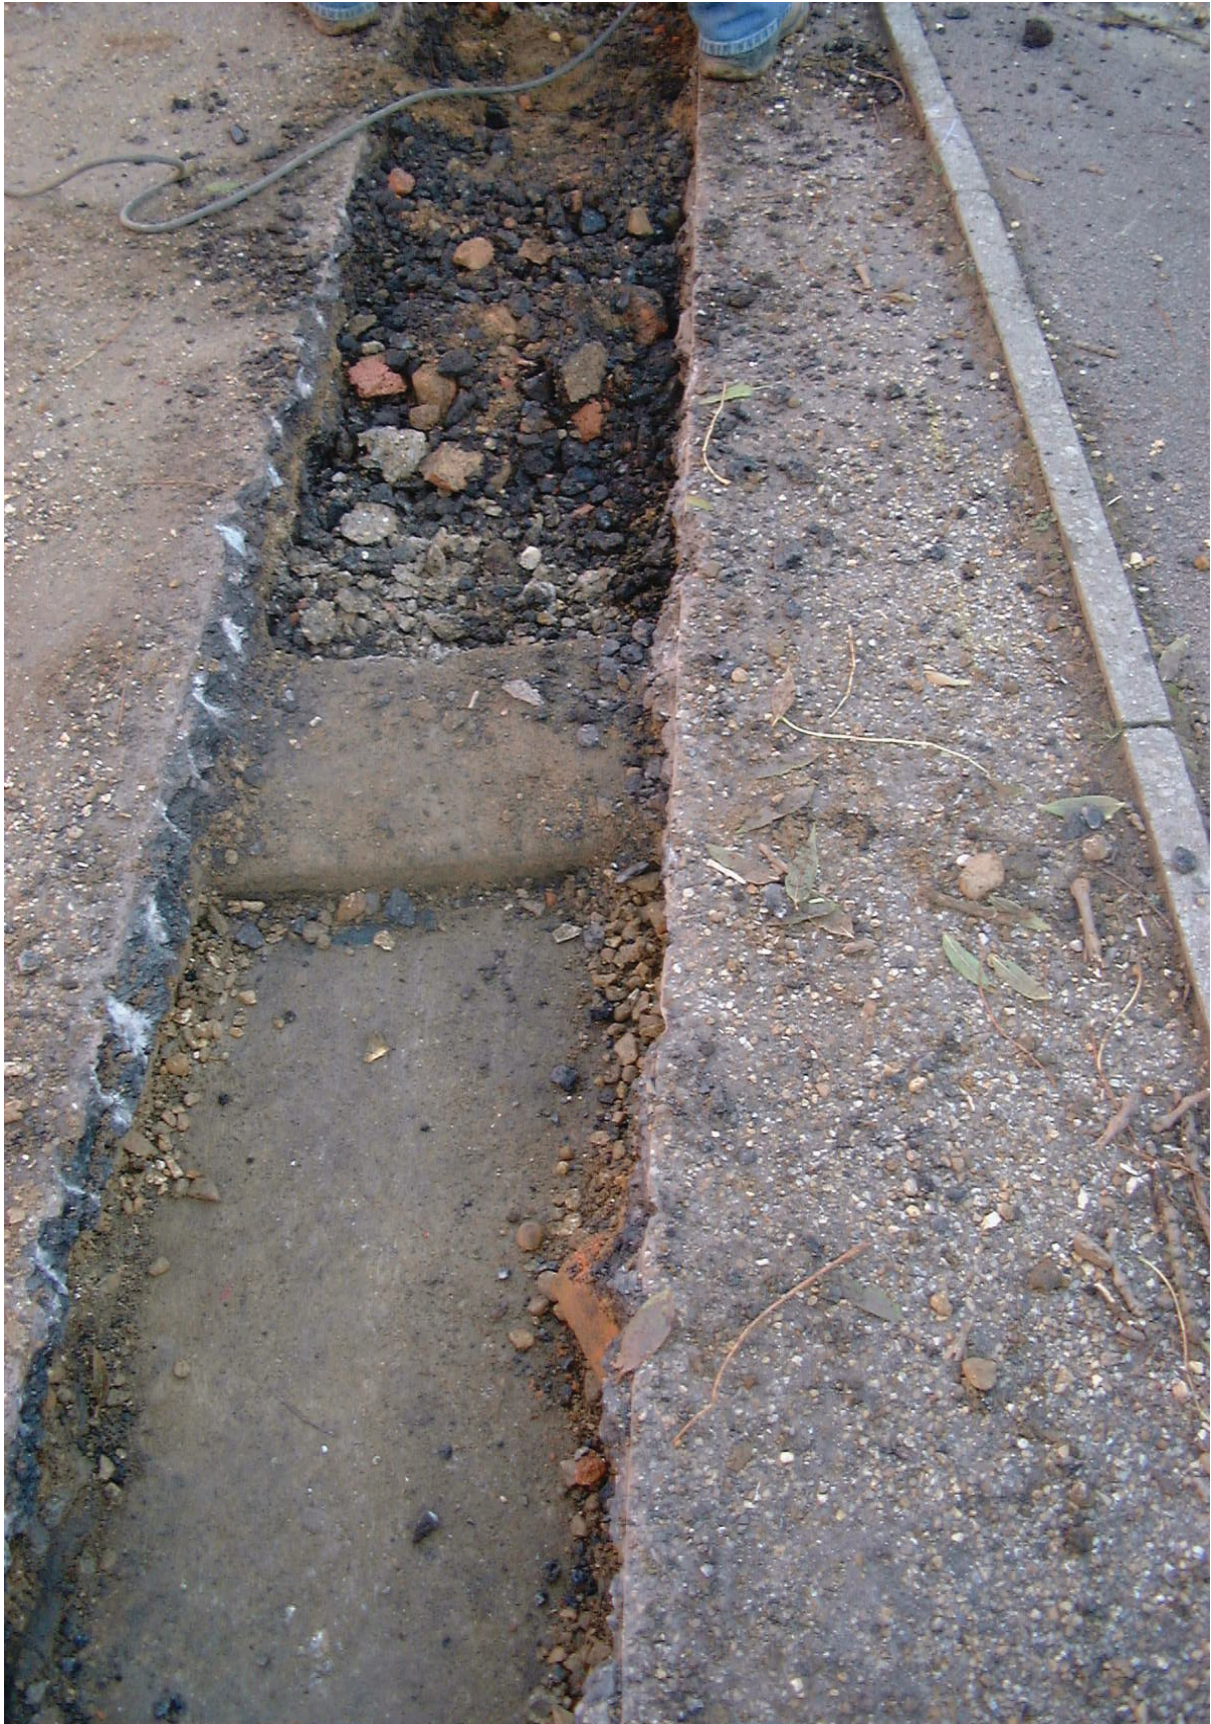
The foundation trenches were excavated to a maximum depth of 450mm with a maximum width of 450mm. Examination revealed a modern reinforced concrete hard-standing or driveway with kerb-stones at a depth of 430mm below present ground surface. This extended across all of the development area, with the exception of the western half of the southern east-west trench.

Overlying the concrete was grey/brown silt loam containing numerous fragments of modern concrete and fragments of ceramic building material and plastic sheeting. This was 330mm

Plate 3: The north-south foundation trench, viewed towards the north

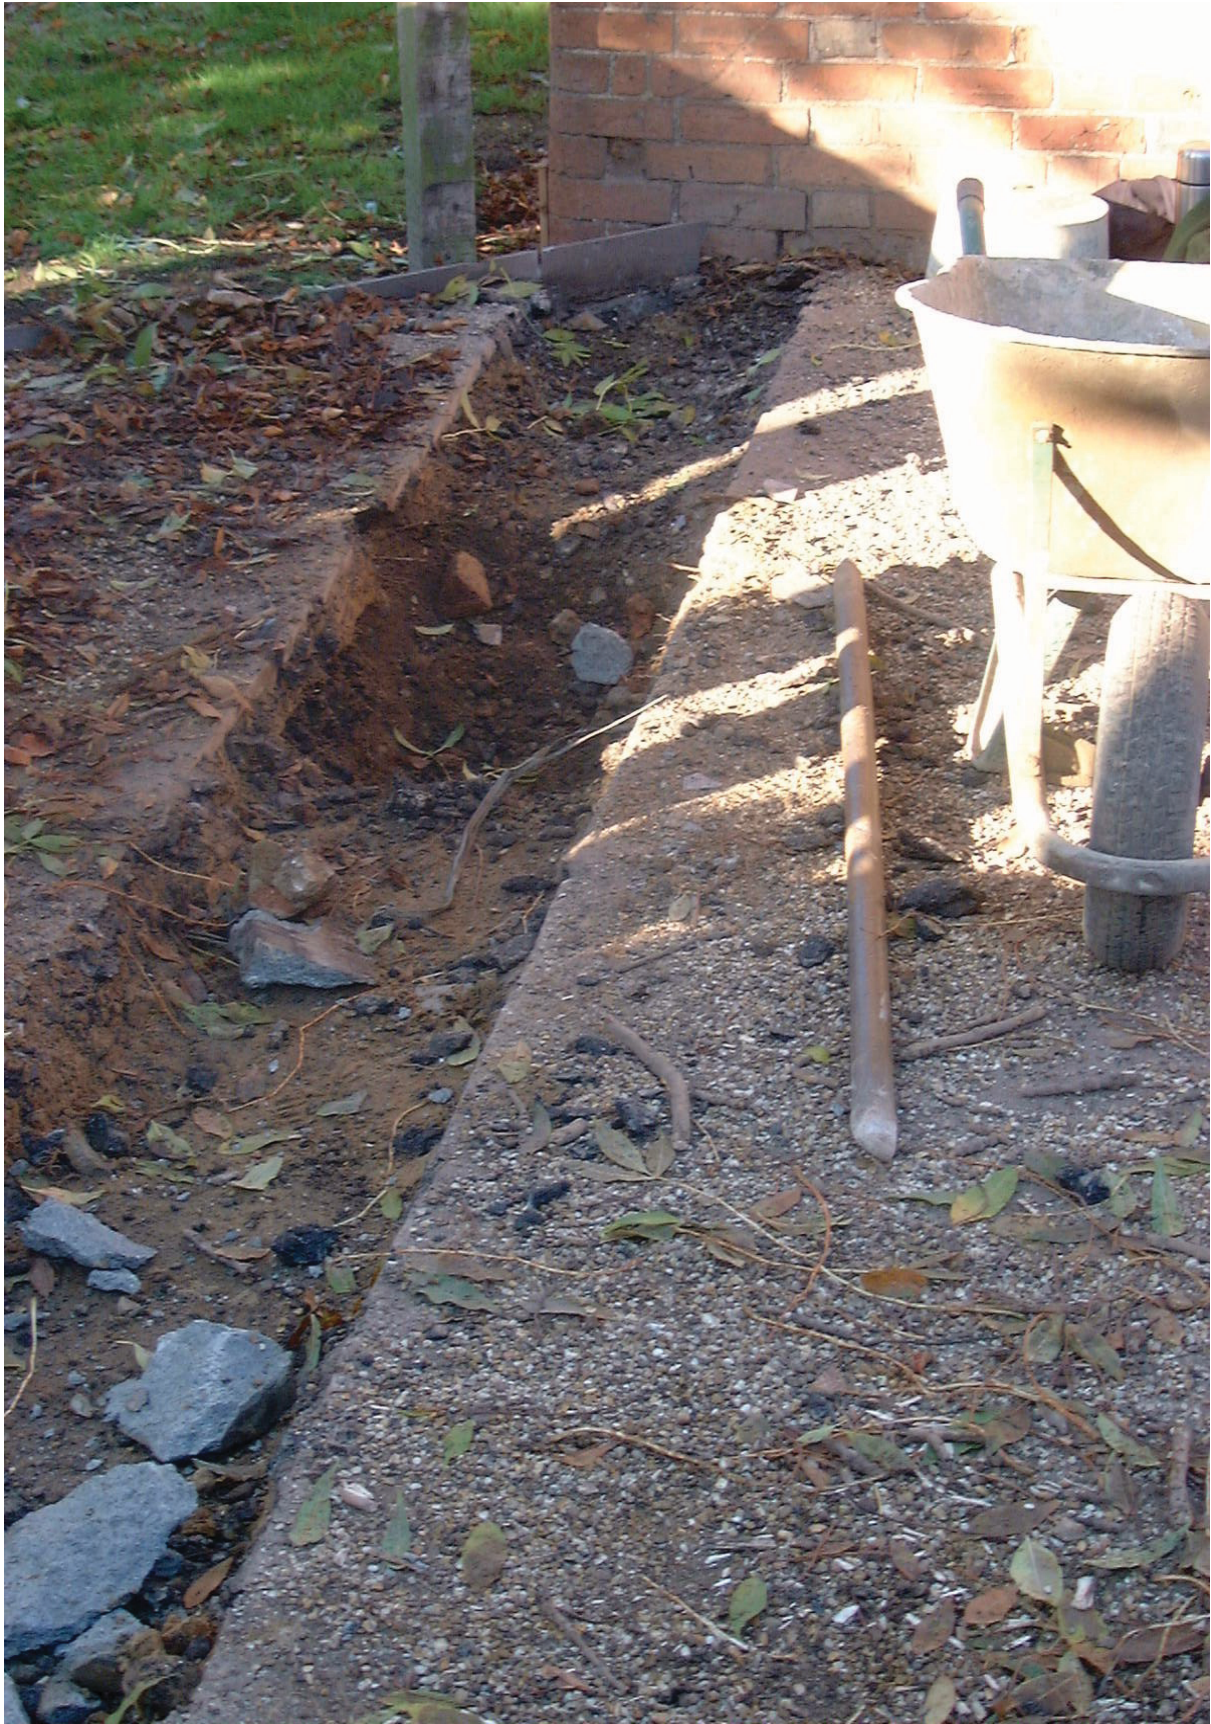
thick across the area of the concrete hard-standing and extended all the way to the base of the western half of the southern east-west trench.

The extent of the former hard-standing is defined by the material in the western half of the southern east-west trench. This material appears to have been used to level up this area to the same height as the new driveway. This is borne out by the ground to the west of the development which lies approximately 350mm lower and appears to be original ground.

Plate 4: View along the southern east-west foundation trench with the lower original ground in the background
