Archaeological evaluation at the Overlook The Swiss Garden, Old Warden Bedfordshire

Report 12/11

February 2012

**ARCHAEOLOGICAL EVALUATION AT
THE OVERLOOK, THE SWISS GARDEN,
OLD WARDEN, BEDFORDSHIRE**

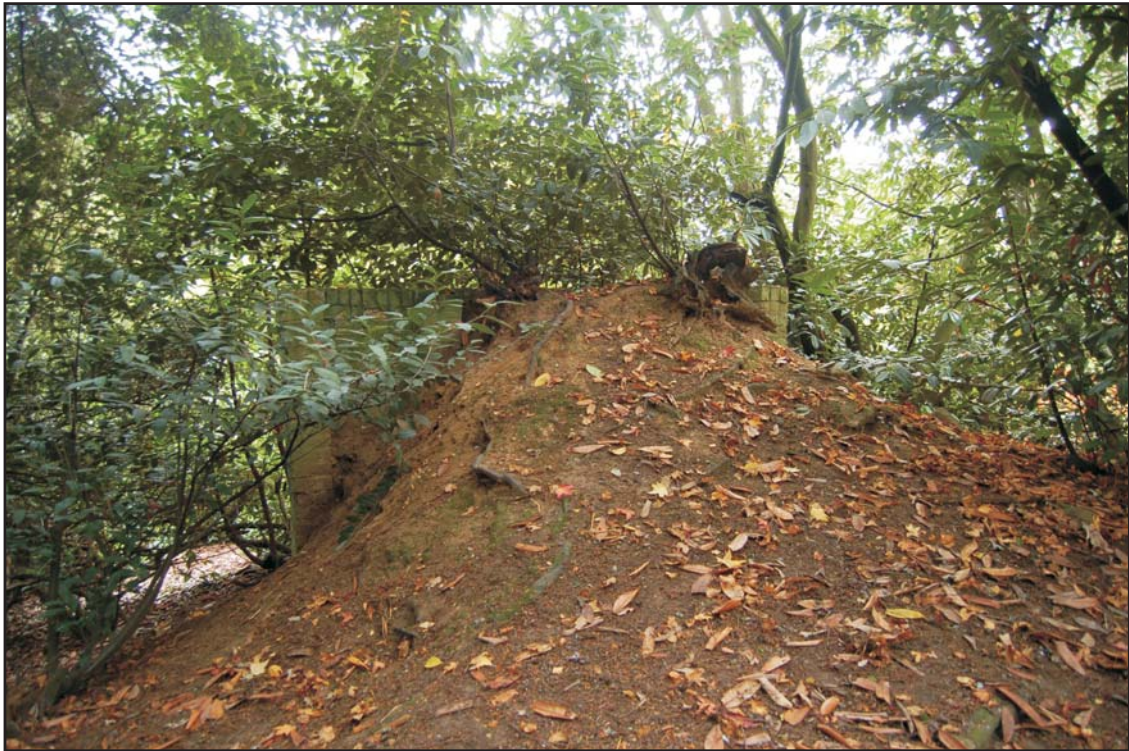
The Overlook mound, looking south-east Plate 2

The buildings within the garden are a mixture of the simple and elaborate, but nearly all are complete and are now in an excellent state of repair due to careful repair and maintenance over the last few years. One of the least complete and little understood is the Overlook which, as it currently stands, comprises a brick wall with five double attached piers on each face retaining a steep bank of soil. Its original completed form is unknown, but it is thought that originally the steep bank, situated on the west side, allowed access to a platform which either lay at the top of the slope, or possibly comprised a raised platform (balcony style) projecting outwards from the wall on the eastern side although prior to the present investigation no plans or photographs have been found which could confirm this. No other structural remains are currently visible. It lies close to the north-east of The Chapel, a small single-cell structure of brick with rendered external wall, and leaded windows at either end (Plates 1 and 4). Close by the entrance to the Chapel is a short flight of steps which leads up a low bank which probably passed between two yews, only one of which now survives as a large tree, although a stump indicates the location of its now lost companion. From that location it is possible that a path turned eastwards to the west side of the Overlook which from this aspect presents the appearance of a steep mound of soil (Plate 2).

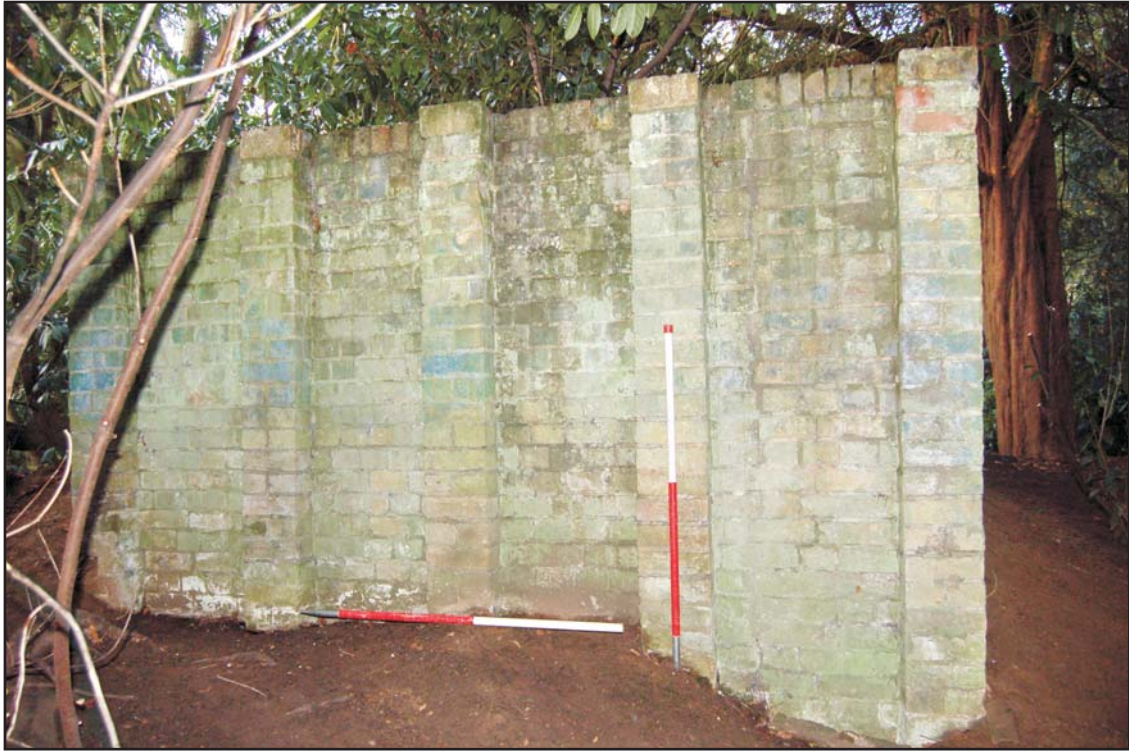
The east face of the Overlook wall, looking west Plate 3

The only other visible detail is the presence of blue colour wash (perhaps limewash?) on the east and north elevations (Plates 3 and 5). This colour is the same as that present on the Gardeners Cottage and is reportedly known as Shuttleworth Blue, the Estate colour. Its presence here is perhaps slightly unexpected since the only other building within the garden which appears to retain it still is the utilitarian gardener's structure which might indicate that its use reflects the status of the buildings to which it was applied. However, it might also be that it was formerly much more widespread and its survival here is merely an indication of which buildings have suffered more weathering or have been redecorated. The fragmentary survival of the colour wash makes it difficult to be certain whether it originally covered the entire wall surfaces or was restricted to specific areas. At present the colour is present in a band which extends across the centre of the wall on all three exposed sides (south, east and north) but is not present at either the top or bottom of the wall.

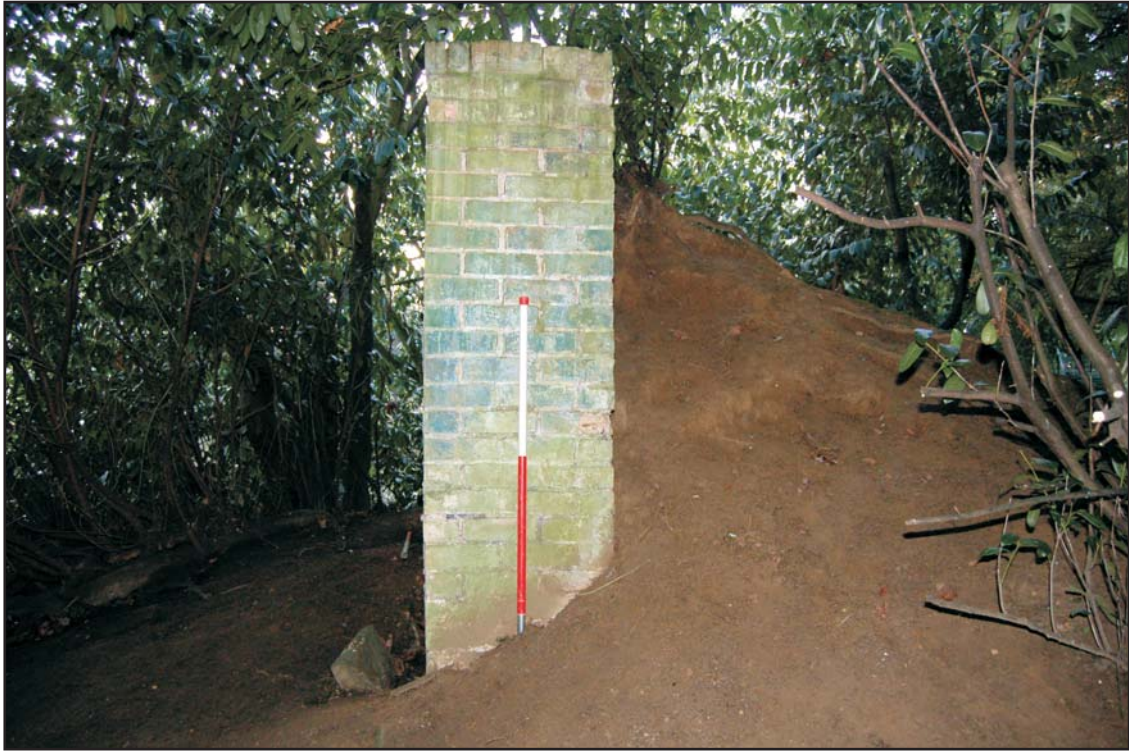
The north end of the Overlook wall showing the blue colourwash, looking south Plate 5

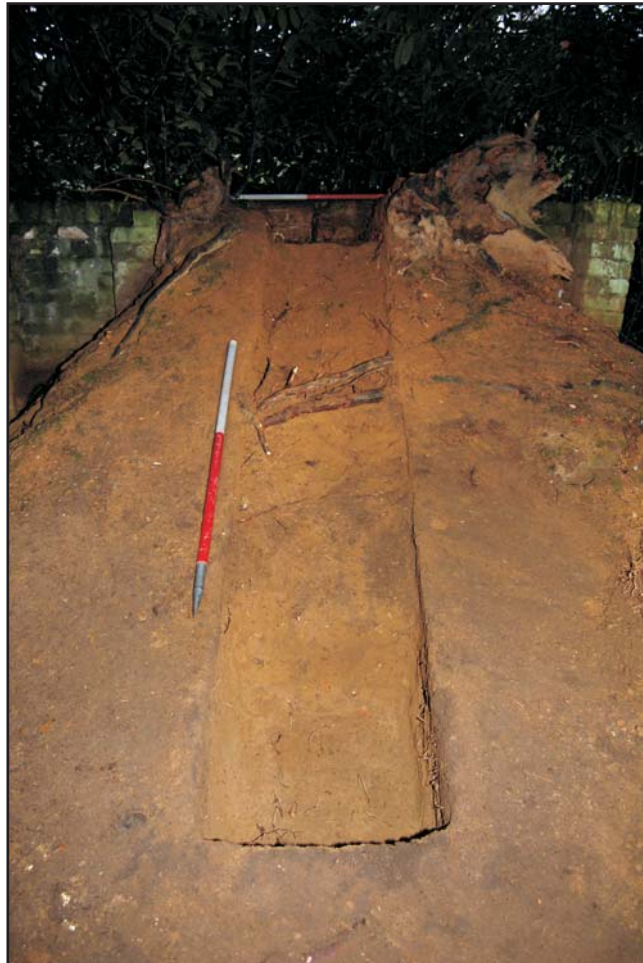
Trench One, looking east Plate 6

This trench was located at the top of the slope on the west side of the Overlook wall and was positioned perpendicular to the wall (Figs 3 and 4). The eastern end of the trench was located adjacent to the west face of the wall, and the width of the trench located between two stumps of laurel planted at the top of the slope (Plate 6). At this end of the trench there was no topsoil, and the core of the mound was visible on the surface. This comprises an orange, sandy soil visible throughout the garden and presumably a

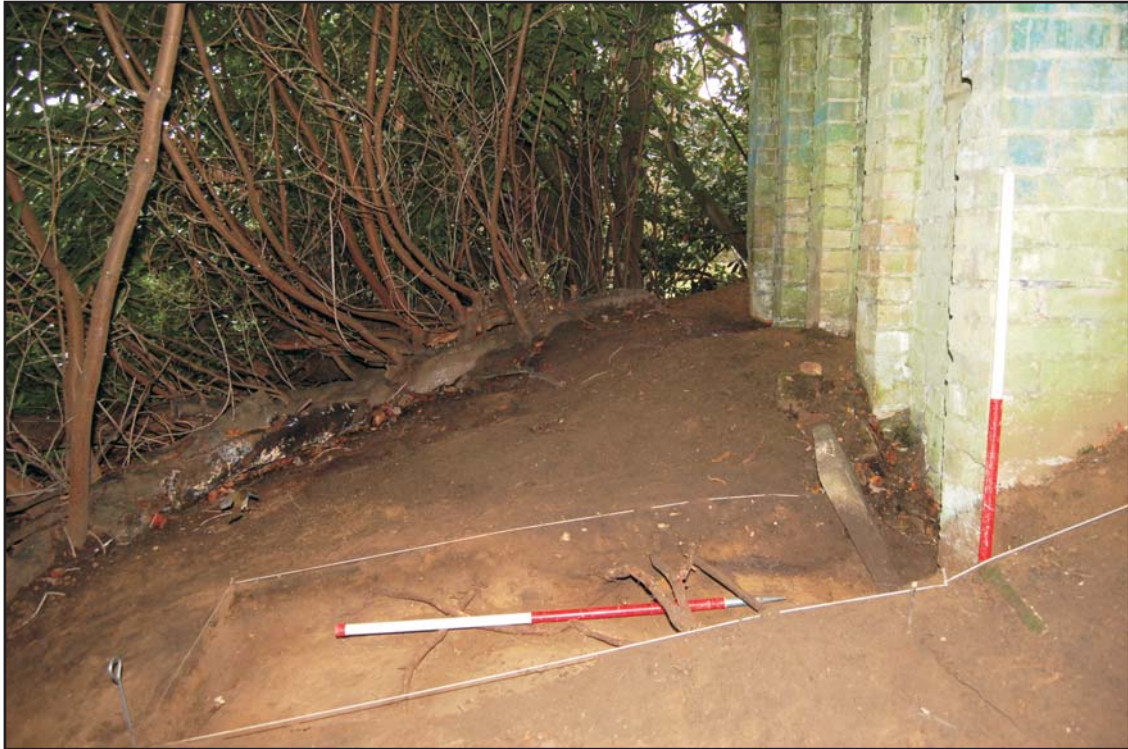
Trench Two, the eastern arm of the trench, looking south Plate 7

Close to the east face of the wall, and located roughly between the two north piers a slab of York stone was observed protruding from the ground at a steep angle, the top leaning away from the wall (Figs 4 and 5, section 3, Plate 7). This slab was removed and was found to be carefully smoothed on one side, and regularly dressed along all four edges with the back only being roughly tooled. Although the slab had suffered slight damage it was largely complete and its dimensions were 615mm x 400mm by 50-65mm in thickness (just over 2 feet x 15¾ x 2-2½ inches). The roughly dressed surface, here taken to represent the back or underside, retained irregularly positioned areas of a creamy white lime mortar which suggest that it had been bedded onto an underlying surface at some stage. Similar traces of mortar were also present on the smooth (upper) surface which indicates that some other material was at some stage bonded to that face

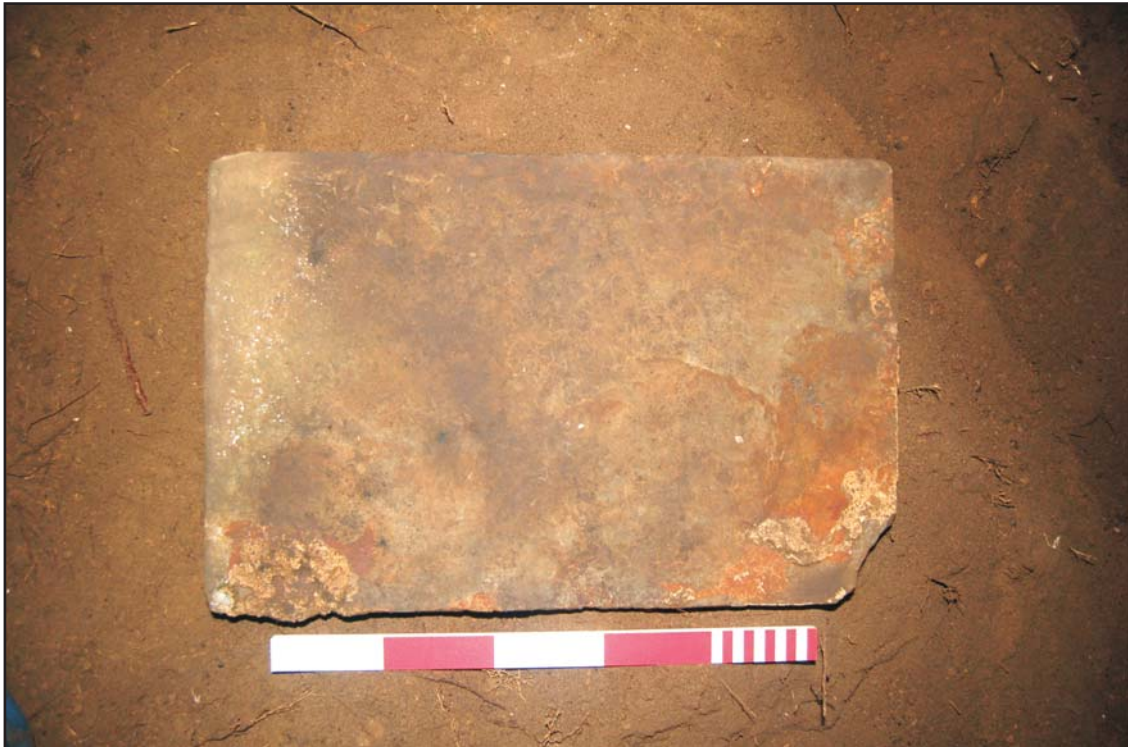
The top surface of the stone slab showing mortar remnants Plate 8

(Plate 8). In this instance the mortar was primarily present along one of the short and one of the long edges which appears to suggest that whatever was bonded to it was located along two edges only, although there remains the possibility that there was originally mortar along the other edges and this has either been deliberately or accidentally removed.

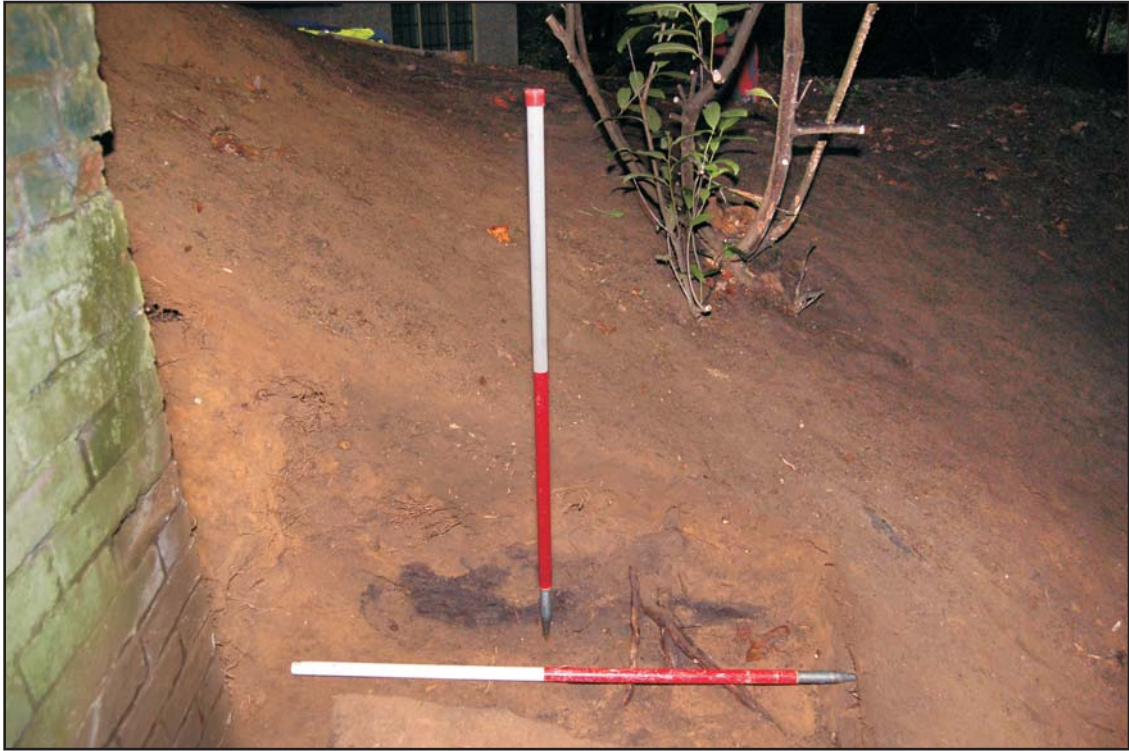
Trench Two, the northern arm, looking west Plate 9

The short north arm of the same trench which extended perpendicular to the north end of the wall cut into the steep north slope of the mound of soil located to the west of the wall (Figs 4 and 5, section 3, Plate 9). Beneath a much thicker deposit of topsoil the same orange core soil was located and which displayed an almost perfectly horizontal surface where it abutted the north edge of the wall, and which formed a nearly vertical face where it extended westwards beyond it (Fig 5). This configuration suggests the former presence of a type of revetting structure, particularly the almost vertical face which, given the friable nature of the soil, would not have withstood un-protected weathering for any length of time. It is thought, therefore, that this vertical face effectively represents a vertical 'robber trench' indicating the former presence of a revetting wall. Within the topsoil layer two small fragments of ironstone had been recovered, and were similar to other stone observed throughout the garden in similar locations where they had been used to form a retaining or revetting feature. It seems most likely, therefore, that a similar feature had been built against the north (and almost certainly the south) end of the brick wall to both retain the mound of soil and also present a more naturalistic surface where the feature would be more visible.

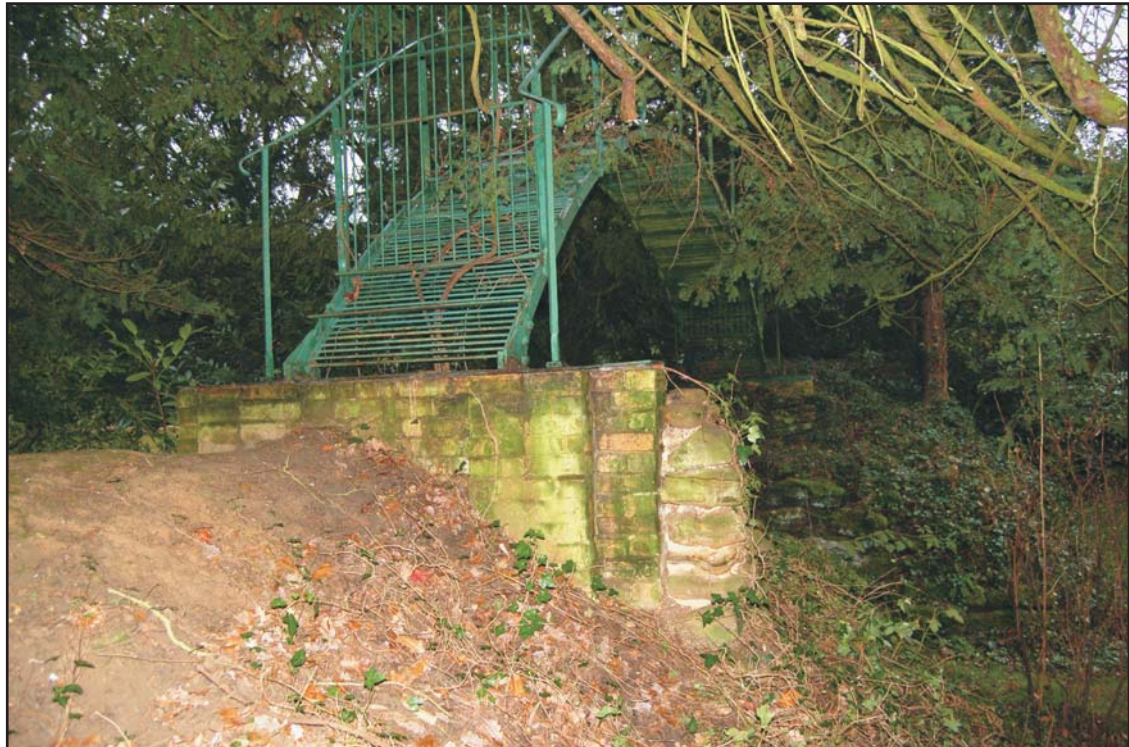
The Aerial Walkway showing the stone facing of the brick core, looking south Plate 10

It is also possible that the entire brick face was originally faced with similar stone work such as is present still at the Aerial Walkway (Plate 10). The sharply defined horizontal and vertical surfaces suggest that the stonework was deliberately robbed from this location, presumably as part of the deliberate dismantling of the Overlook or at an unknown date after its demolition or abandonment.
