Archaeological Excavation and watching brief at Woodhouse Farm, Aldford, Cheshire October 2011-April 2012

Report 12/85

April 2012

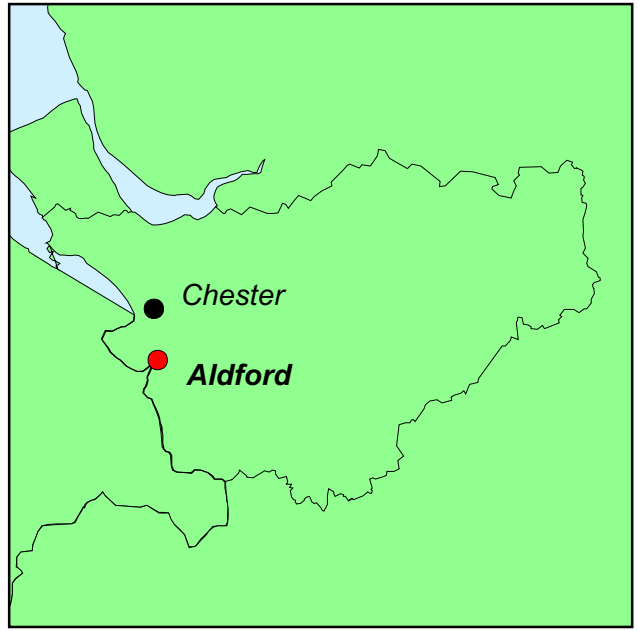
Site location Fig 1

The site lies adjacent to the farmhouse of Woodhouse Farm in the north-west corner of the village of Aldford, Cheshire (Fig 1). Close to the present border of Wales, Aldford lies 7km south of Chester and sits on a local focal point on the spur of the confluence of the River Dee to the north west, and Aldford Brook to the east.

Through their agents and architects Tweed Nuttall Warburton of Chester, The Grosvenor Estate has applied to Cheshire West and Chester Council for planning permission to build a block of commercial offices adjacent to the farmhouse of Woodhouse Farm, Aldford (NGR: SJ 4176 5955; Fig 1).

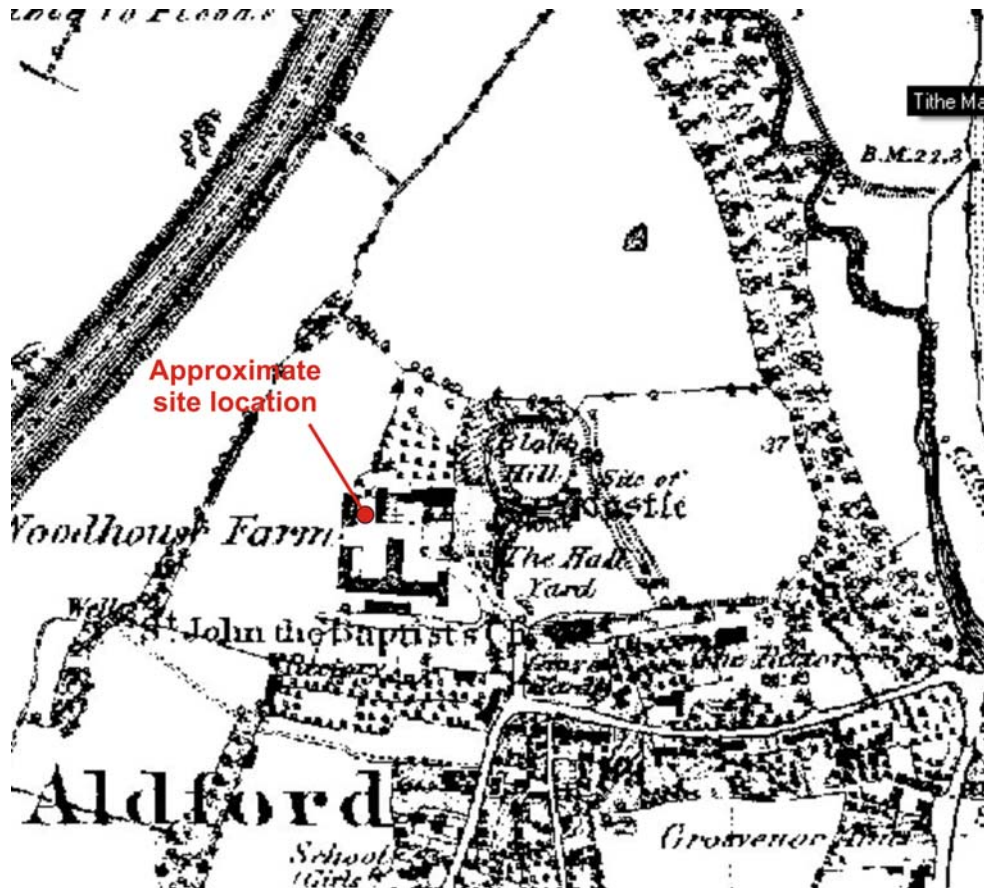
Fig 3

This map indicates the newly-built (1867) Woodhouse Farm (which is named as such on the map), when there was no side range. To the immediate north of Woodhouse Farm building, and to the west of 'Blabb Hill' (the motte earthwork of Aldford castle), is a wooded field or croft, with a clearance in its the north-east corner, which would appear to indicate the area of a smaller croft within the larger one outlined. The map is not annotated in this area, but it is suggested that by 1875 the previous crofts depicted on the 1738 map had been replaced by an orchard, which falls within the archaeology of the Woodhouse Farm site.

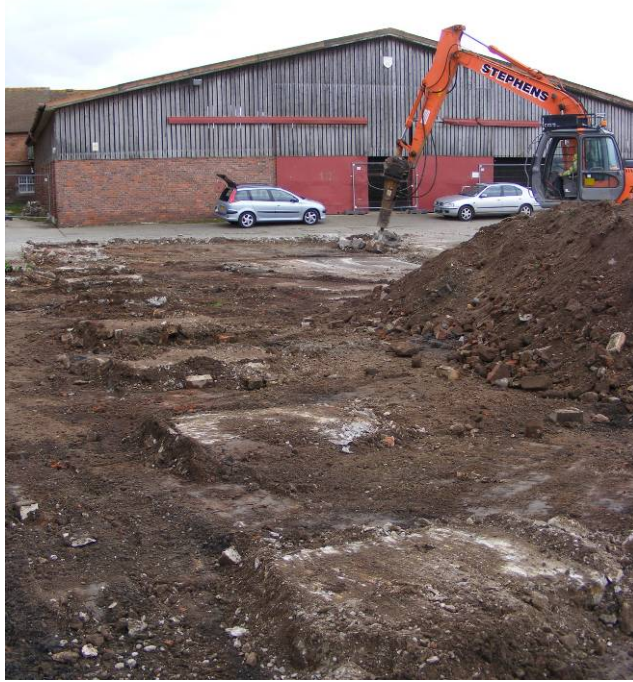
Breaking the concrete Fig 7

The uppermost portion of the archaeological sequence comprised large quantities of 200mm-thick concrete hardstanding [1] and 24 1m-cubed concrete stanchion bases [2] from the former silage clamp, which were removed by a 360-degree mechanical excavator, fitted with a hydraulic breaker and a toothed bucket (Fig 7). Nineteen lorry-loads of concrete and related hardcore were removed to tip. Other spoil was stockpiled to one side for later reuse.

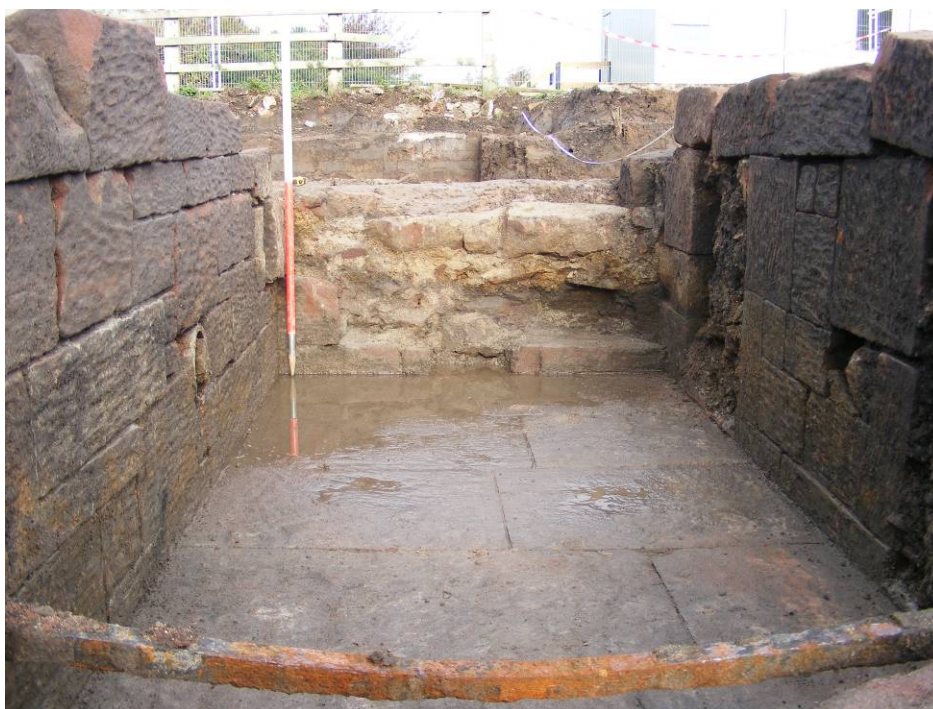
Agricultural trough, looking north

Separated from the rest of the main sandstone foundation range was a single compartment which lay within the narrow western 'corridor'. It differed from all the others in that the interior walls were of neatly-coursed ashlar blocks, each with a slightly rusticated face [13] carried down below ground level to form a sub-surface pit or trough the entire area of the compartment (2.8m x 1.2m and c1.0m deep). Its floor was of neatly laid close-fitting flagstones [25] and it was filled with demolition rubble (Figs 12, 13 and 14). The western wall incorporated a salt-glazed drain just up from the floor, draining under the farmyard to the west. Spanning the width of the compartment, and socketed into the walls just above drain-level, were three equidistant iron bars at least one inch (25mm) in diameter, strong enough to support considerable weight (of which two had been bent and smashed out by the rubble infilling). The entire eastern side of the pit incorporated two large rectangular apertures which opened into the adjacent compartment on that side where the west end of the compartment contained two deep troughs [14], divided off from the rest of the compartment foundations by a wall of sandstone and brick. It is most likely to have been a manure pit, of increasing popularity in the middle of the 19th century (cf Wade Martins 2002, 114, 123 & 148).

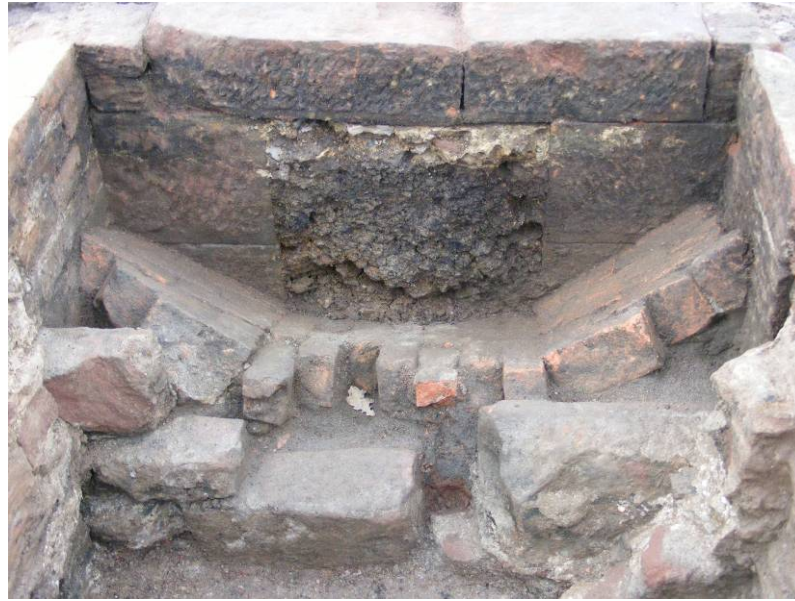
Chute on east side of agricultural trough Fig 14

The two troughs had been part filled-in and then further altered by the insertion of carefully-laid brick chutes [15] leading down into and through the apertures (Fig 14).

These were designed to direct the flow of something down through the apertures, collecting it above the level of the iron bars.

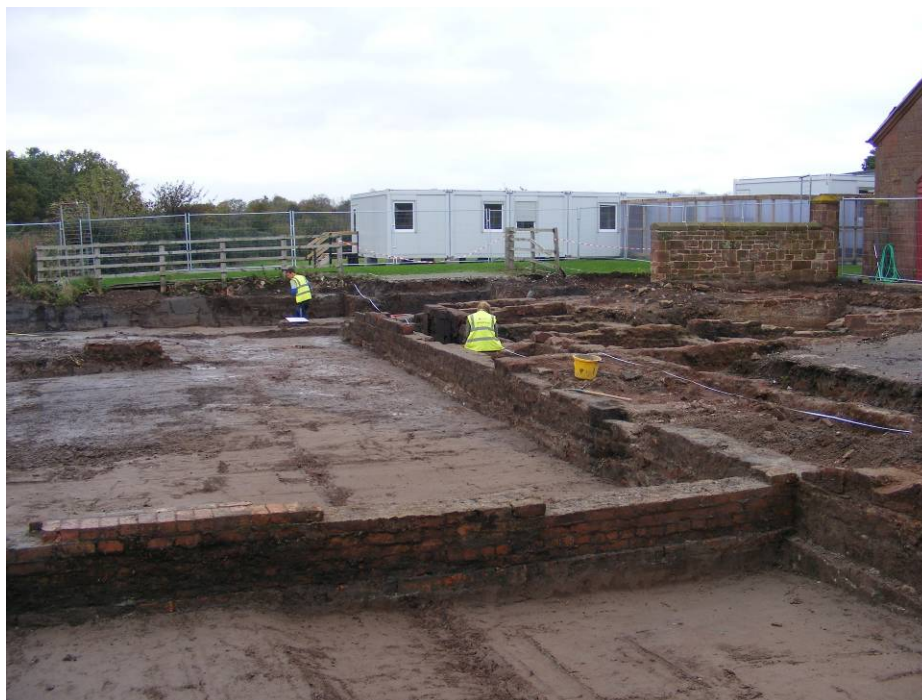
Brick addition to the farm buildings Fig 16

At the south end of the site lay a building which had clearly been added to the farm. It utilised the sandstone foundations for its east wall, but its north south and west walls [27, 28 and 29], the latter damaged by stanchion bases] were of mortared brick, neatly built and three-bricks in thickness, resting within the top 200mm of natural sand (Figs 6 and 16). Again about 1m or more of the foundation survived to just below the modern concrete hard-standing, including an offset at the base for stability. The building measured 6.5m east-west x 4.8m north-south. In the total absence of superstructure or distinguishing features, including floors, its use or uses are unknown. Within the footprint of the building the infill was similar to the sandstone range, being sandy clay overlain by mainly brick rubble.

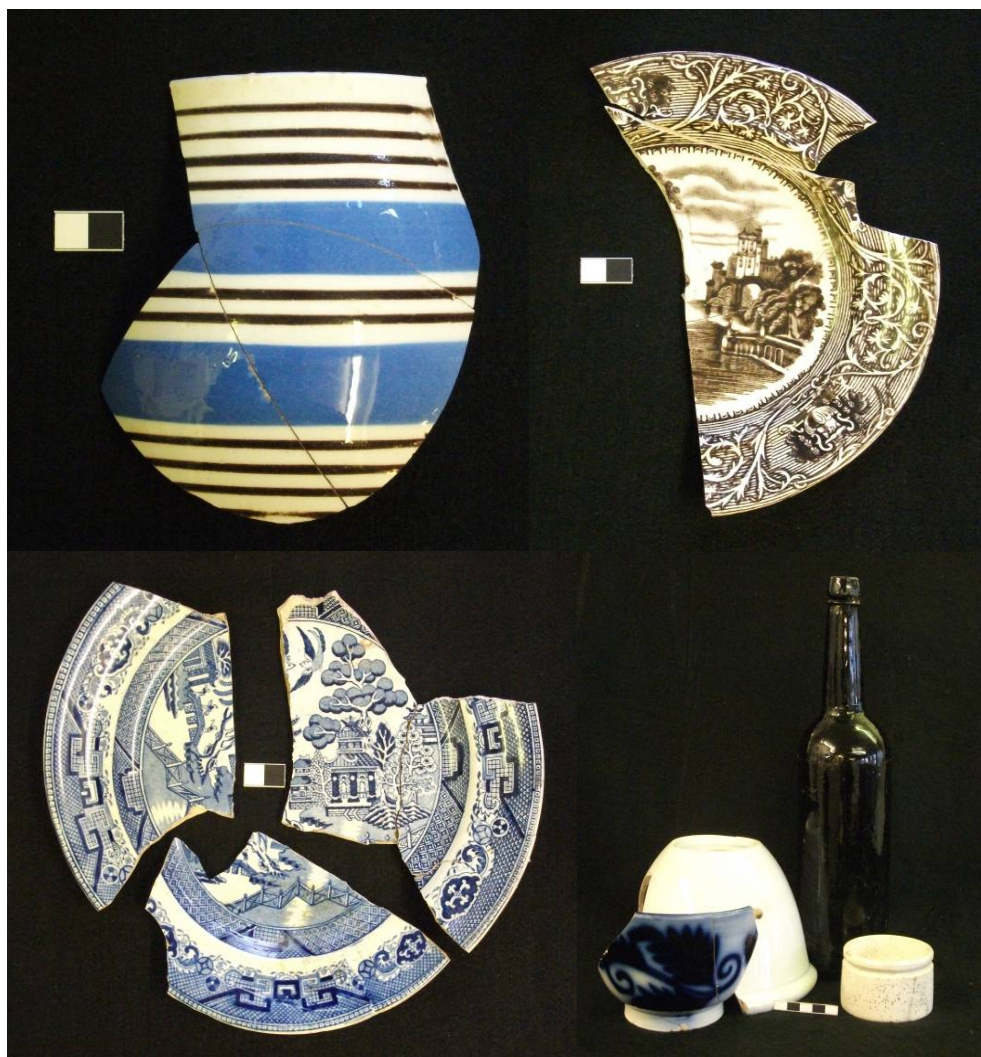
Selection of pottery and a bottle from context (7). Scale internal 10mm Fig 17

A single (complete) glass bottle present in the assemblage (Fig 17, bottom right, 280mm tall) is straight-sided and has a moderate kick and a tapering rim of a type produced throughout the period 1820-1920.

Fig 17 shows a selection of the few reconstructible vessels

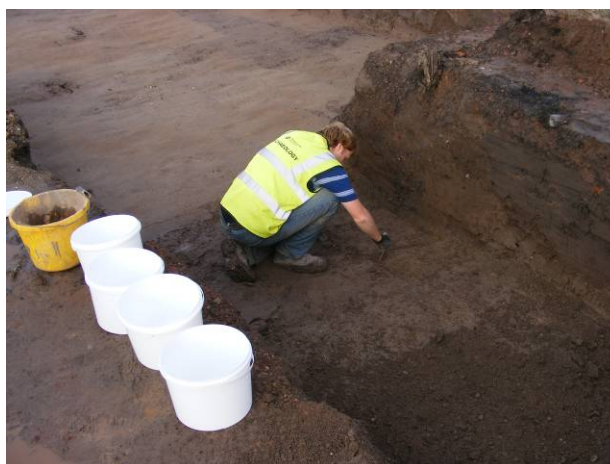
Environmental sampling Fig 18

A single 40-litre soil sample for the retrieval of the plant macrofossil assemblage was taken from the pre-farm ditch fill (feature 16; context 17; Fig 18).

The sample was bulk floated by NA and the flot was collected in a 300 micron mesh sieve. The dried flot was scanned under a binocular microscope at magnifications up to x 16 and the plant macrofossils and other remains noted are listed in Table 1. Nomenclature follows Stace (1997). All plant remains were charred. Modern fibrous roots and seeds were also recorded.

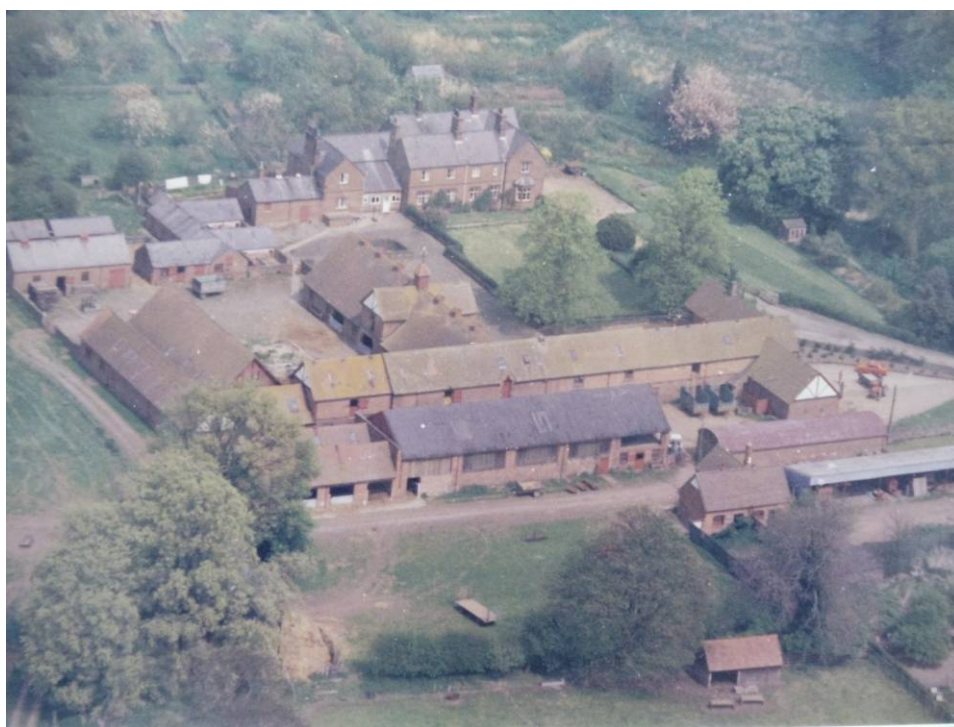
Oblique aerial photo of the farm in the 1970s, looking north

In structural terms the site has produced evidence of a range of farm outbuildings which Ordnance Survey map evidence suggests were in existence from the farm's earliest period (1867-74). The complex was built on a Regular Courtyard Plan, not atypical of Cheshire Sandstone Ridge and Cheshire Plain estate-farms of the period (www.Helm.org.uk: Historic Farmsteads Preliminary Character Statement, North West Region, part 3: 38-9, 48). A later addition in brick, also present, is noted on the 1910 Ordnance Survey Map for the first time. Nothing of the superstructure survived to indicate buildings' former uses. If, as maps suggest, the largest compartments were once open (as small yards) they may have begun life as piggeries (www.Helm.org.uk: Historic Farmsteads Preliminary Character Statement, North West Region, part 3: 68-9). These buildings were only demolished in the 1970s and survived long enough to appear on an aerial photograph (when they were all clearly roofed-over) (Fig 19). Their remains were plotted and surveyed.
