Heritage Asset Survey: archaeological building recording and desk-based assessment of Armada House, Weston, Northamptonshire

Report 12/34

**HERITAGE ASSET SURVEY:
ARCHAEOLOGICAL BUILDING RECORDING AND DESK-BASED ASSESSMENT
OF ARMADA HOUSE, WESTON, NORTHAMPTONSHIRE
PRELIMINARY REPORT - MARCH 2012**

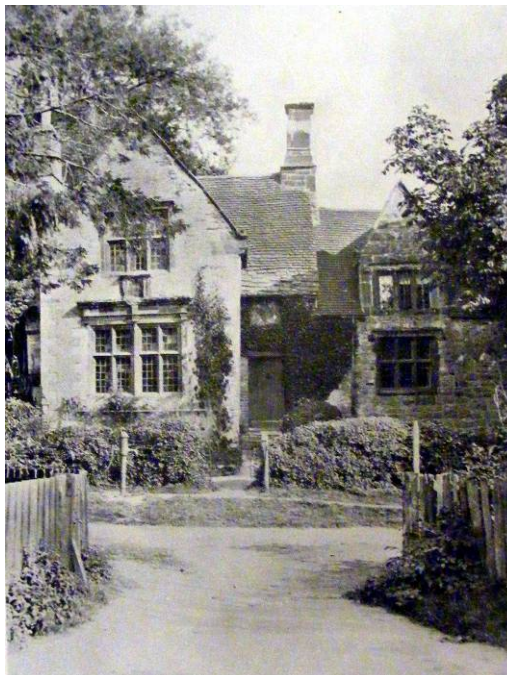
Armada House in c1936 Fig 4

In 1936, Gotch describes the house thus:

This is a charming example of a small house, built according to the good traditions of the times and in the good material of the district, without any particular desire for grandeur. It derived its name from the date of its erection, 1588, the year of the attempted invasion by the Spanish Armada. The date-stone, which is just over the ground window of the large gable, used to show the date plainly, but in recent years the face of the stone has suffered from the weather and the figures have disappeared. The date of 1588 applies to the taller part in which it occurs, the lower wing to the right is some 20-30 years later and is more plainly treated especially in the interior. In the earlier portion which comprises little more than two rooms on each floor, there is an

interesting original chimney piece, or fire-place, in each room; the ceiling beams are well moulded, and the front room downstairs has a moulded door frame with a flat pointed head, all indicating that the house was one of little pretension.

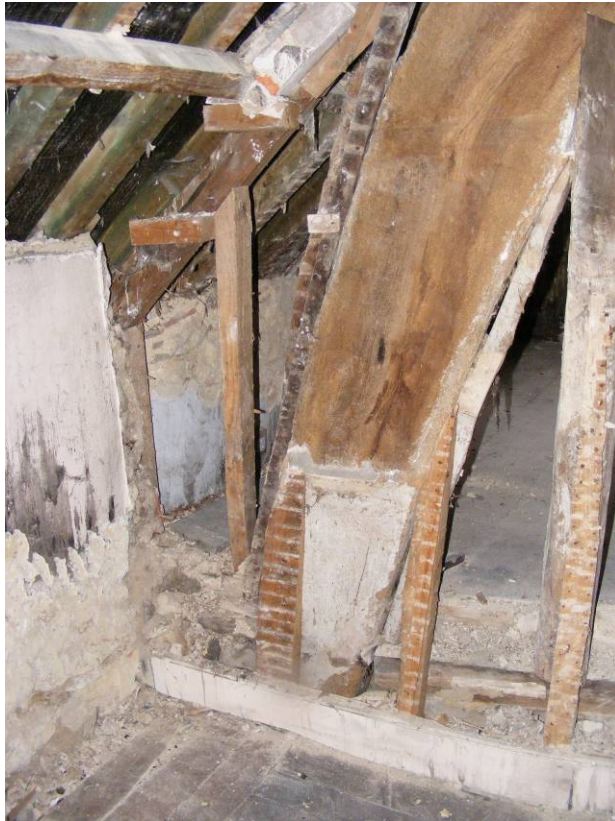
Potentially the most notable and far-reaching structural aspect of the south range is that its two of the three bays of building are divided internally by a massive pair of full-height cruck blades, fire-affected at the apex. They are visible at various points throughout the height of the house (Fig 6).

Their date is currently unknown but it is unlikely that such crucks, whether new or re-used from elsewhere, would have been put into a house of Manorial status as late as the late sixteenth century, when the construction method was old and largely relegated down the social scale. The western facing wall has been moved outwards, away from the crucks, probably in the seventeenth century. Understanding these exceptionally rare cruck blades is a key to dating the house's origins.

Cruck blade in south range (seen in Room F7) Fig 6

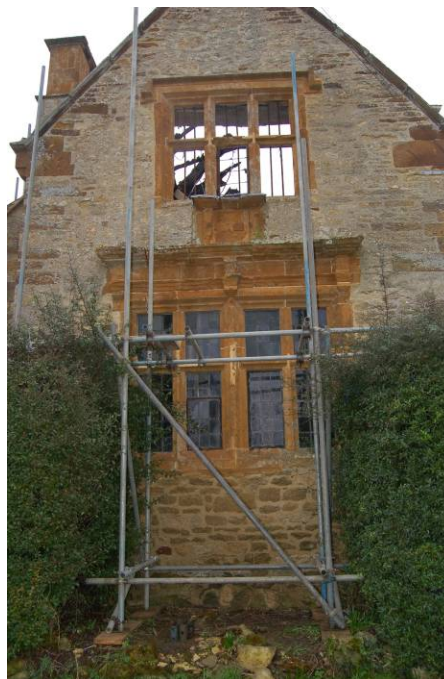
This is the principal face of this range and survives almost intact (Fig 7). The datestone at the top of the ground floor, purported to once have borne the date 1588, has long since been defaced irretrievably by frost.

The ground floor window of eight lights is mullioned and transomed and has a wide moulded entablature, just as the listing description. The upper storey window is of six lights with a drip moulding above. Both window forms include cavetto mouldings throughout.

North range, west gable Fig 7

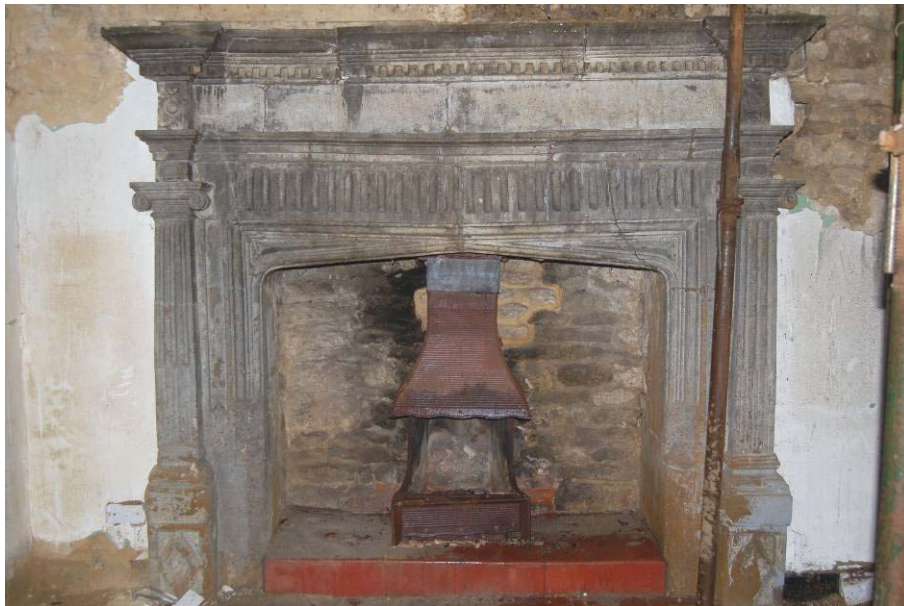
Fig 8

Room G1 measures approximately 5m east-west x 4m north-south. The floor is of wide hardwood timber boards on joists. There may be an earlier solid floor beneath. The north wall contains a fireplace with a very large and ornate late sixteenth-century stone surround with renaissance classical detailing (Fig 8). The east wall contains a nearly full-height cupboard, where a doorway once stood. The south wall is plain but for the four-centred arched doorway. The ceiling is coffered into four by a cross of moulded and well-scribed oak beams all round. The joists between are large and cumbersome, covering 50% of the area of the floor above, with only small gaps between. This excessive use of massive moulded timbering with small gaps suggests a late medieval or 16th century date but not necessarily as late as 1588.

Room G1, fireplace

G1: Replacement of the timber floor (close inspection of sub-floor); digging out.

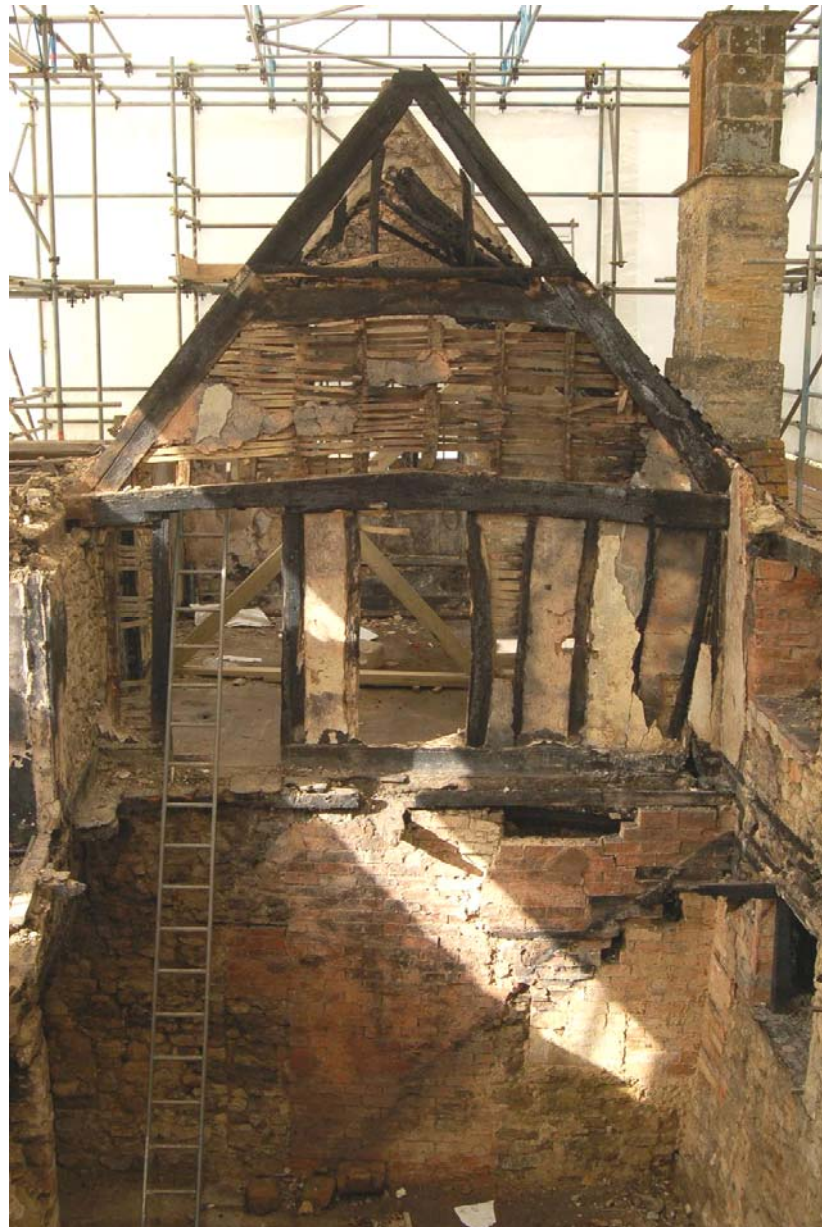
Fig 9

The west wall of the room, dividing it from G1, is stone-built but its middle portion comprises the 19th-century brick infill of a blocked doorway. This was replaced on the far side by a tall cupboard, but here in G2 a narrow stair was built up against it, evidence of a major reordering (Fig 9). The stairs in the range formerly stood up against this wall, but these cannot have been the original stair as the brick appears to be of 19th century date.

Room G2 (and F2), west wall and roof truss

The roof of the north range survived the fire only in part. The truss which divides Room F1 from the eastern portion of the range comprises tie beam, collar and principals, the spaces filled with hand-riven lath and plaster (Fig 9). A truss at the mid-point of Room F1 is only partial, but is founded upon a wall-fast corbel. The trusses are pegged to the purlins by curved wind-braces. The wall plate appears to be in two parts, but fuller recording will be possible when the restoration begins. Few common rafters survive. The former roof covering was pegged clay tiles.

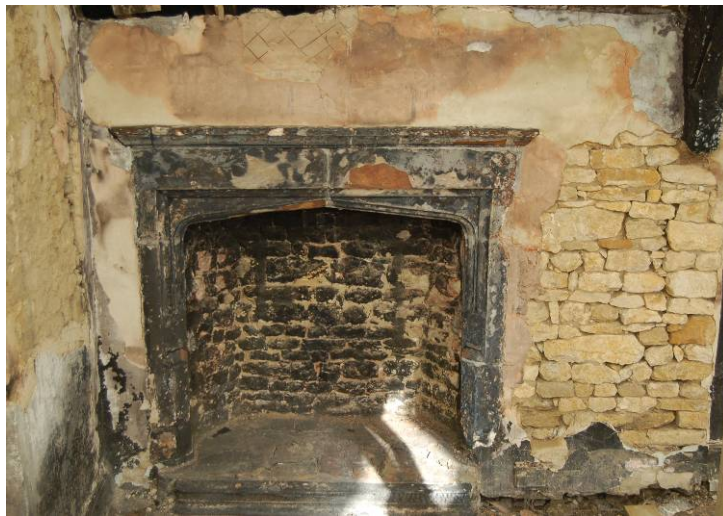
Fig 10

The north wall retains half of its plaster, which is featureless. The western half contains a large carved stone fireplace of seventeenth-century form, having a moulded four-centred arched head, plain overmantel, moulded mantelshelf and pumpkin stops. The pattern of plaster survival around it indicates that this is an inserted fireplace, moved from elsewhere, confirming the western chimney as the later, added one, some time after c1840 (Fig 10).

Room F1, north wall: fireplace

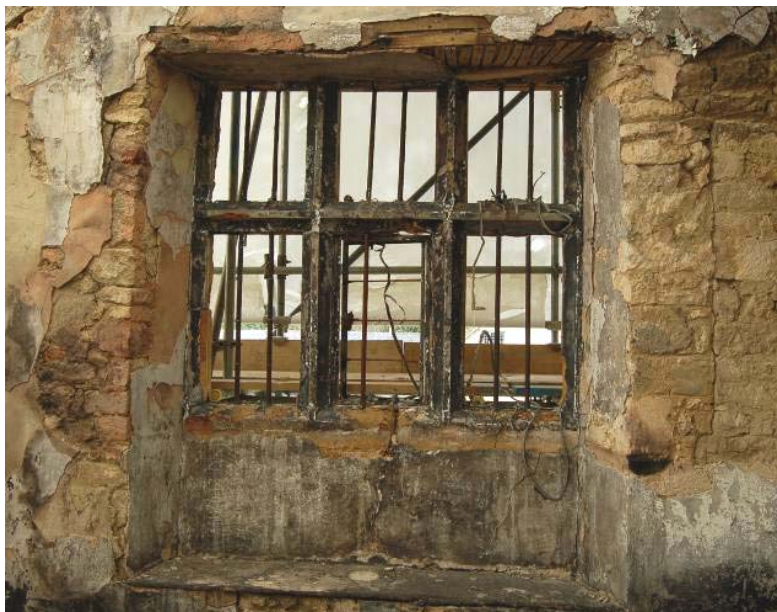
The west wall contains the west gable window. However, inspection of the wall clearly shows that the current window is not the original one, although it has been there since before c1840. The wall bears the vertical marks of a former splayed reveal on both sides, showing that the room once mounted an even bigger window facing west, possibly of a size similar to the room below (Fig 11).

Room F1, west wall: evidence of former window Fig 11

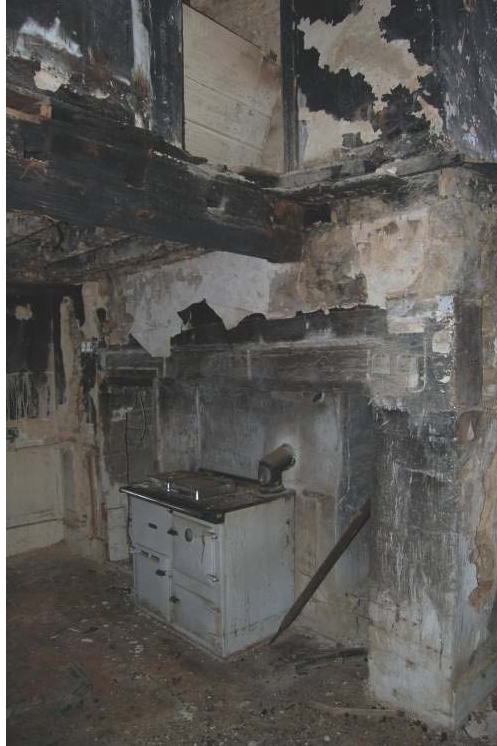
Room G4 is a kitchen, and probably has been throughout, served by a single chimney flue in the north gable. It measures 5m x 3m and is dominated by a massive fireplace

with a huge timber bressumer with chamfered underside (Fig 12). The room has a quarry-tile floor, while the ceiling comprises a stop-chamfered axial carrier beam with chamfered joists (meant to be seen originally), lost examples revealing housed diminished shoulders in mortices in the carrier beam, suggesting an 18th century (or possibly late 17th century) date.

Room G4: kitchen fireplace Fig 12

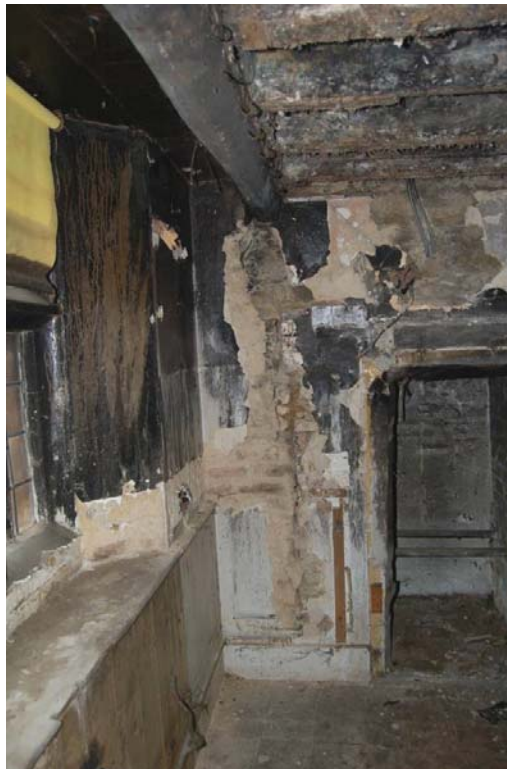
Room G4: moved west wall evidence Fig 13

The trimmer joist along the west side of the ceiling (carrying the joist-ends) rests clear of the west wall completely, at a point where the west wall has clearly been moved outwards or thinned considerably from the interior. A notable crack in both the north and south walls at this point confirms this (Fig 13). The window placed there now relates poorly to the levels, its upper portion level with the ceiling.

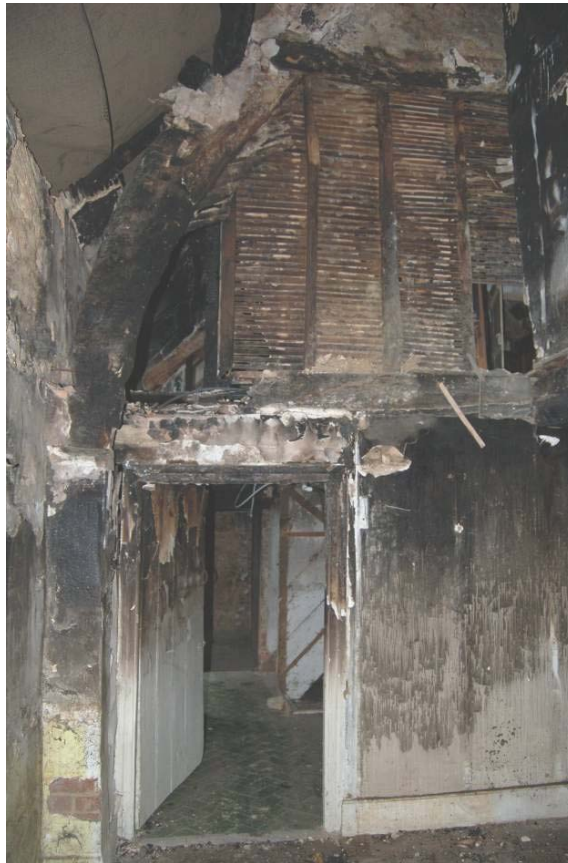
The south wall is dominated by one of two cruck blades which rises through the building on its east side, seated now on a short brick pier (Fig 14). The other example remains hidden behind plaster at this level.

Room G4, cruck blade rising through G4 and G9 Fig 14

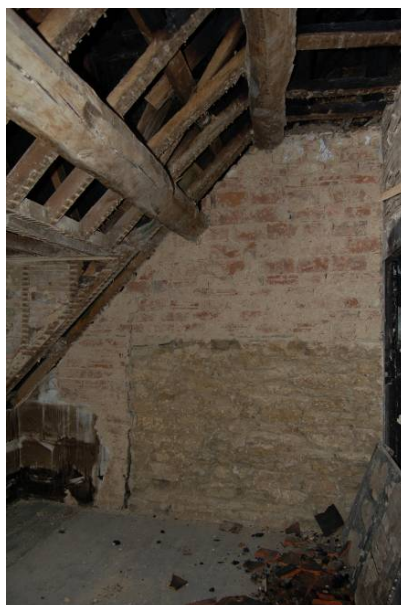
In a north-south line adjacent to the cruck blade, it is clear that the floorboards have also been replaced and run at right-angles to the main transverse trend. Across this line the floor level steps up into Room F8 above the kitchen G4.

Room F8: moved west wall evidence Fig 15

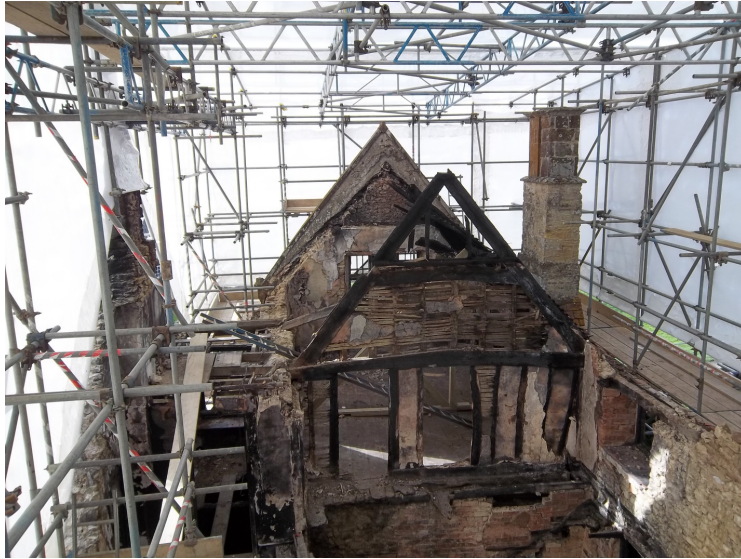
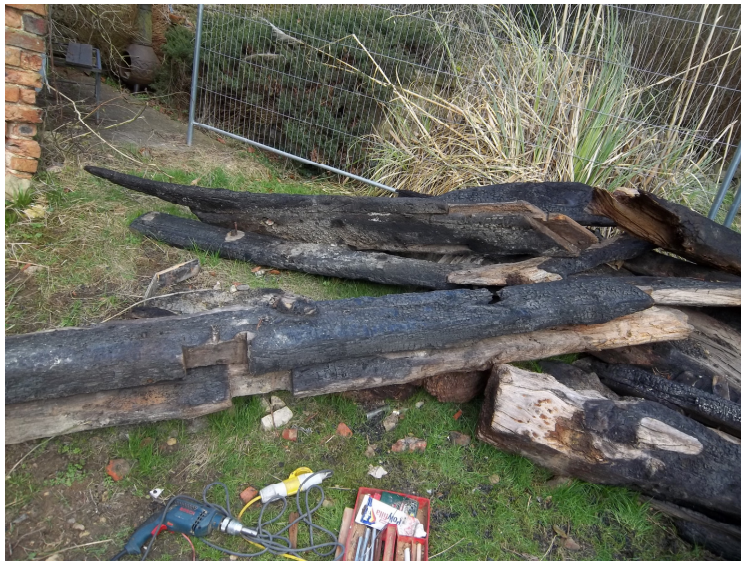
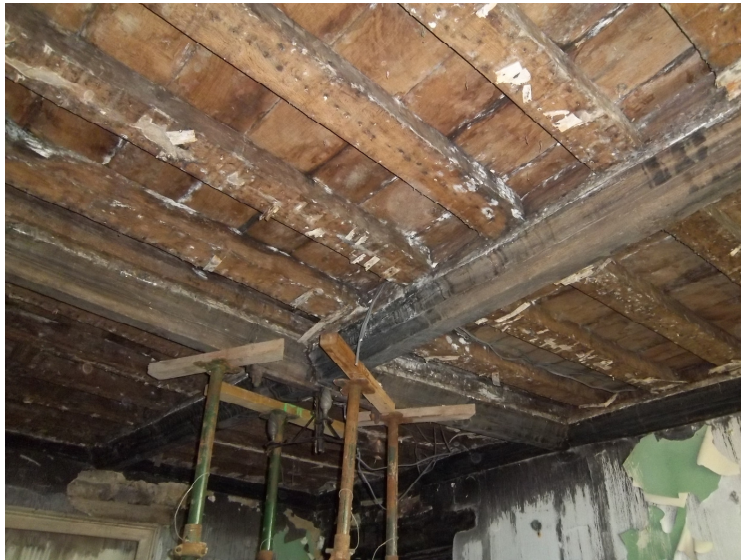
Analysis of 10 samples from Armada House would indicate that four phases of felling are found amongst the dated timbers. It would appear that the earliest phase is represented by the coffered ceiling to the ground floor of the north range, these timbers being felled in the very late fifteenth century to the very early sixteenth century.

Figure 3a/b/c: Views of the in-situ truss to the north range (top), the ex-situ timbers salvaged from this roof (middle), and the ground floor ceiling beams (bottom)

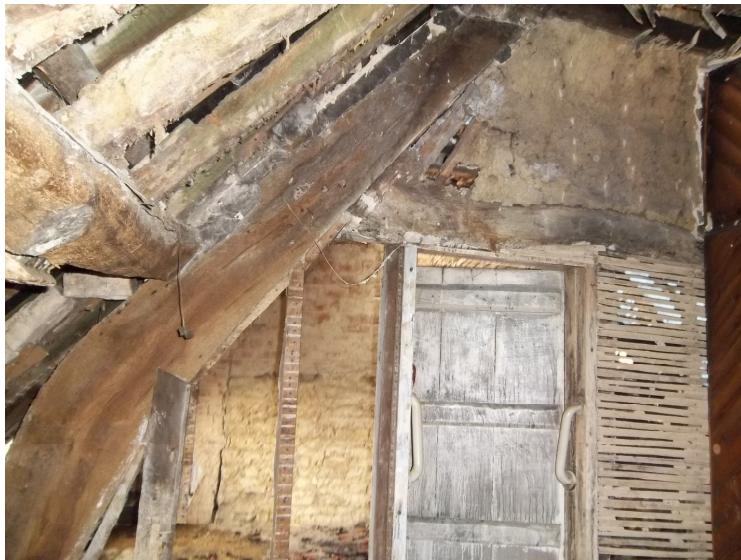
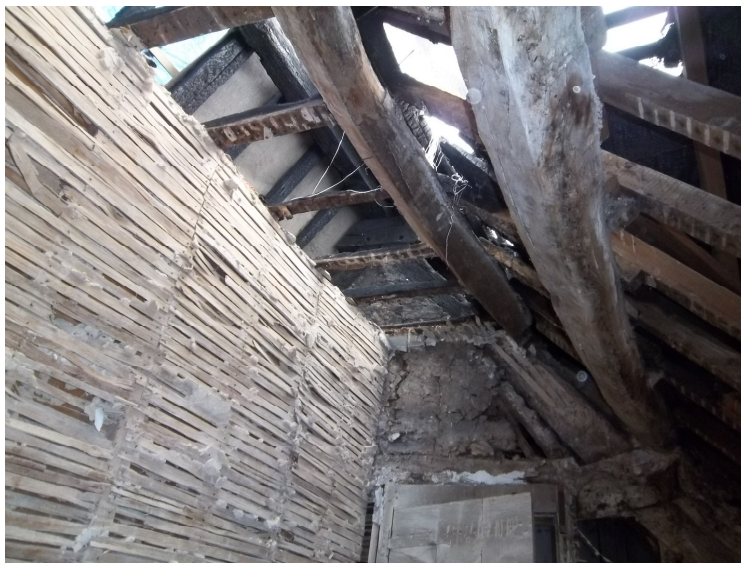
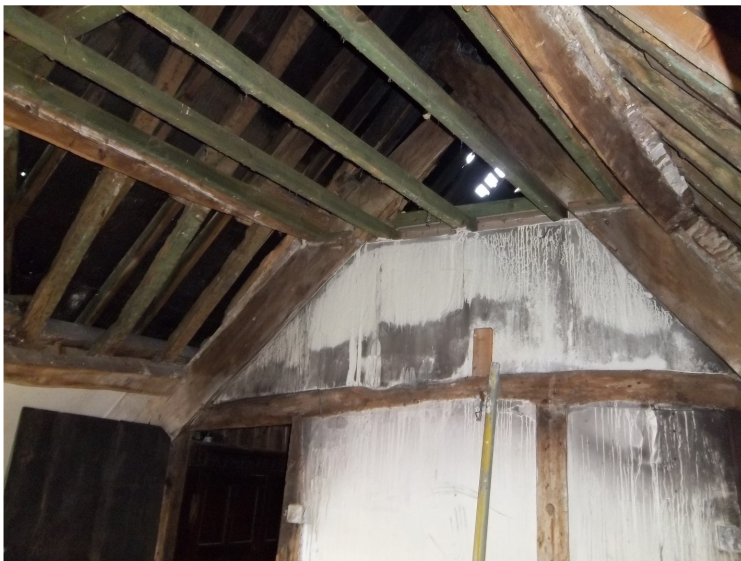
The fourth and final phase of felling is found in the two principal rafters to the southern truss of the south range. These were both felled in 1640.

Figure 3d/e/f: Views of cruck truss in the south range (top and middle), and the principal rafter truss to the southern end of the south range roof

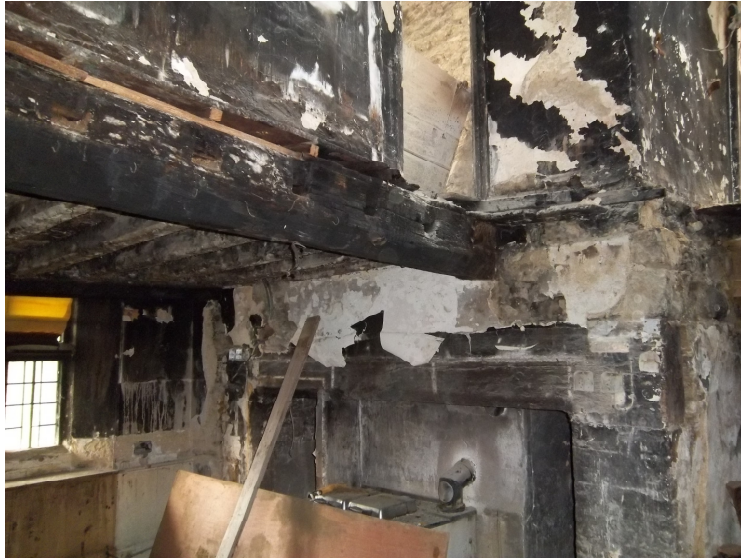
The next phase of felling is represented by the axial ceiling beam and fireplace bressumer of the kitchen to the south range, these being felled in the later sixteenth century, with a third phase of felling being found in two principal rafters to the roof of the north range, these felled in the very late sixteenth century or the very early seventeenth century.

Figure 3g: Views of the kitchen ceiling beam and fireplace bressumer to the ground floor of the south range

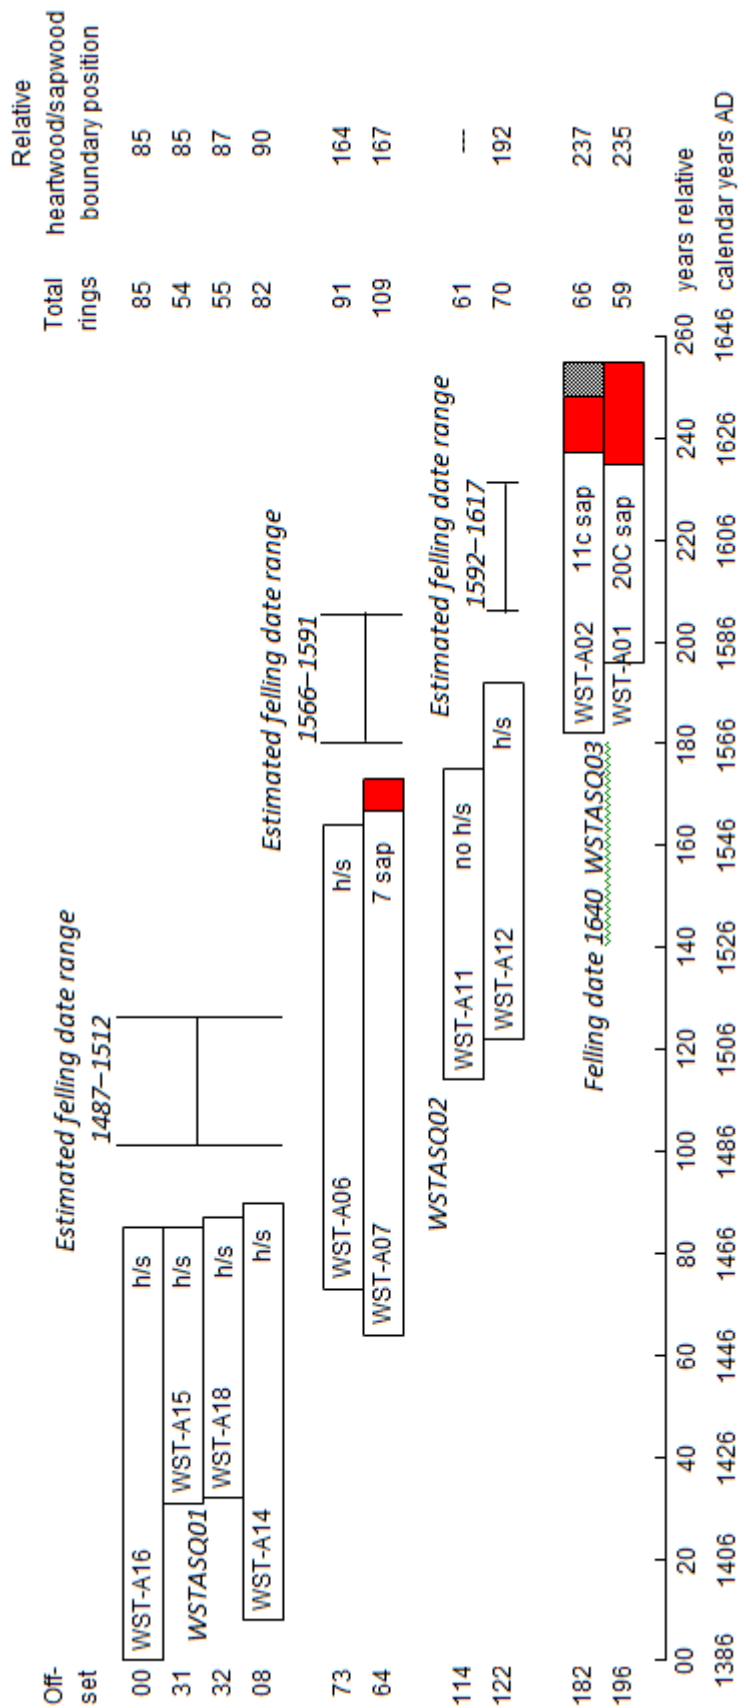
Blank bars = heartwood rings, shaded bars = sapwood rings, hatched bars = estimated lost sapwood rings
 h/s = heartwood/sapwood boundary, i.e. only the sapwood rings are missing
 c = complete sapwood is found on the timber but a portion of this has been lost from the sample in coring
 C = complete sapwood is retained on the sample, the last measured ring date is the felling date of the tree represented

Figure 4: Bar diagram of the samples in site chronologies WSTASQ01, SQ02, and SQ03 at positions indicated by their separate dating. The samples are shown in the form of bars at positions where the ring variations of the samples within each group cross-match with each other. This similarity is produced by the trees represented by each site chronology growing, *at the same time*. The samples of each cross-matching group are combined to form 'site chronologies', each of which is dated by comparison with the 'reference' chronologies (Tables 2-4).
