# Northamptonshire Archaeology

## Archaeological Buildings Recording at The Old Forge, Lower Green, Higham, Suffolk January 2012

**ARCHAEOLOGICAL BUILDINGS RECORDING AT THE OLD FORGE**  
**LOWER GREEN, HIGHAM,**  
**SUFFOLK**

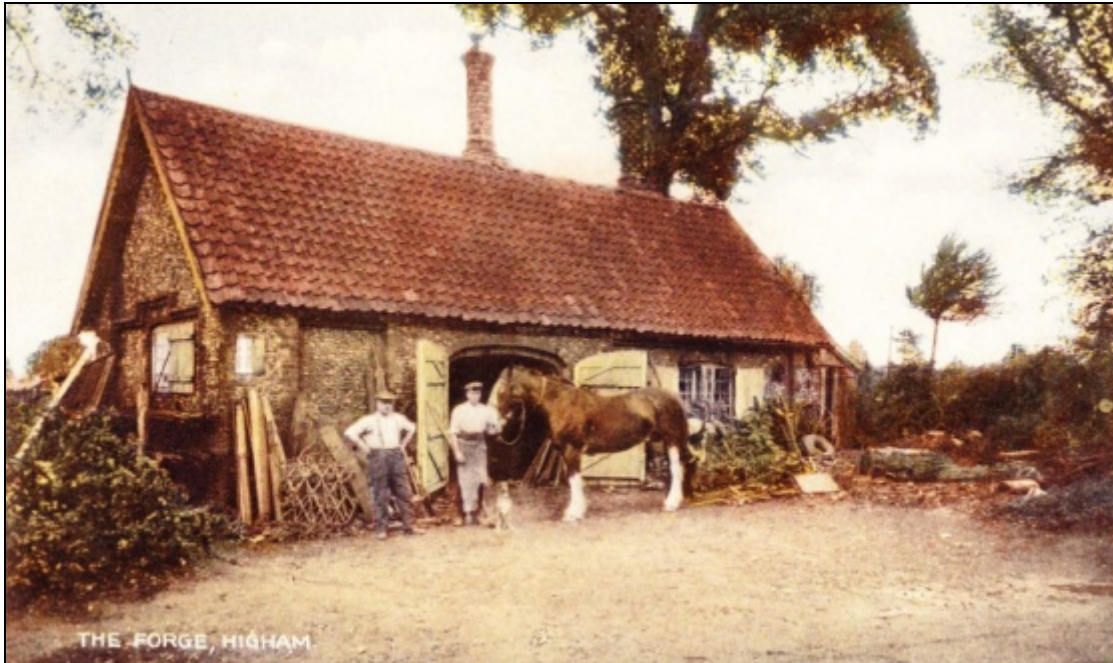
The postcard (Fig 5) shows a small lean-to at the north end of the building. By 1981 none of the buildings were being used for their original purpose.

Postcard of The Old Forge, early 20th century Fig 5

The chimneys at the time of the survey were square in plan and quite plain, however the evidence from the early 20th century postcard (Fig 5) shows that they have been rebuilt as previously they were round in section and the northern one quite decorative with its apparent chequer pattern brickwork. The change in the colour of the brickwork and where they step in is likely to be where they were rebuilt from (Fig 9).

The building has undergone external changes since it was built, the evidence from the early 20th-century postcard (Fig 5), shows that one of the most prominent changes was the shape of the chimneys, from the original round flues to the current plain square ones.

The lean-to extension on the northern side of the building also shown on the postcard has been removed. No evidence of its existence was visible on the northern elevation suggesting that this lean-to may have been a temporary wooden structure with external access as there was no door from the main building.

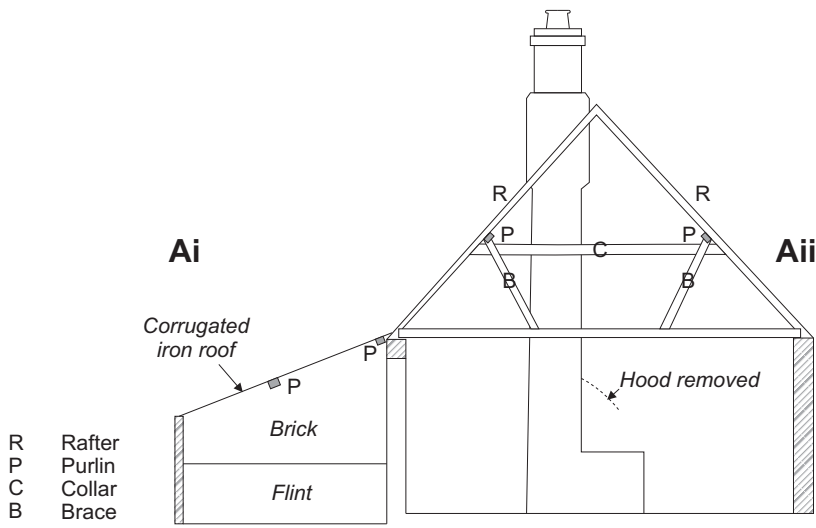
The building is free standing and rectangular in plan with a lean-to extension on its western side (Fig 6). The building is constructed from un-knapped flint (roughwork), in a lime mortar matrix, with brick detailing around the doors and windows and on the corners of the building, which are further enhanced by clasped buttresses, as are the door openings (Figs 7, 8 and 13). The original wooden doors to the building had been replaced with sheet metal doors (Fig 20). The windows, whilst retaining their wooden frames had been boarded over, the one on the gable elevation with wood and that on the principal elevation with sheets of metal.

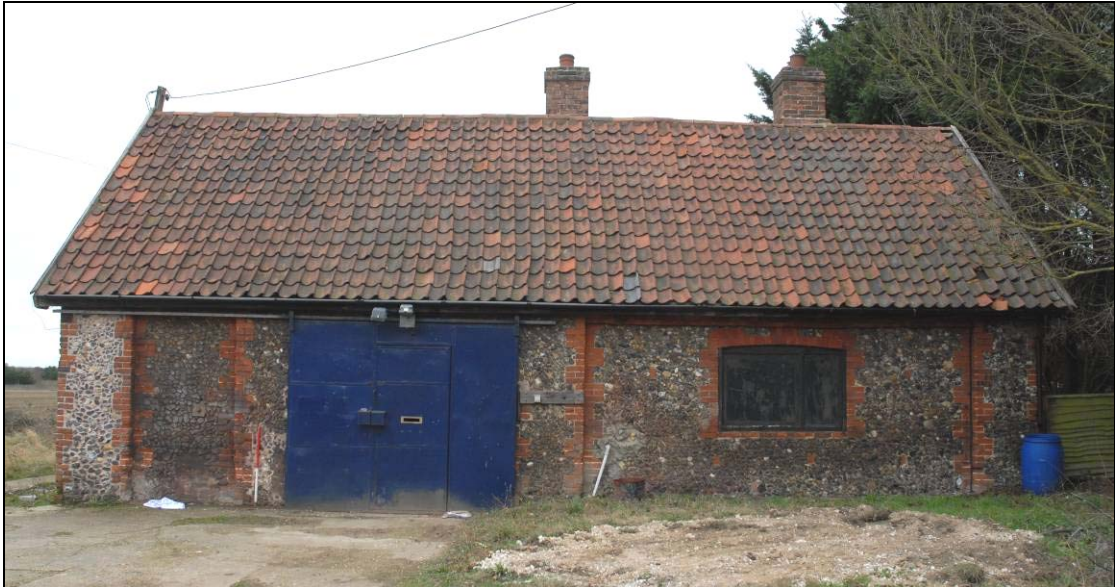
Fig 7

The roof covering is terracotta pantiles, some of which have a black glaze (Fig 7).

Principal elevation, looking west

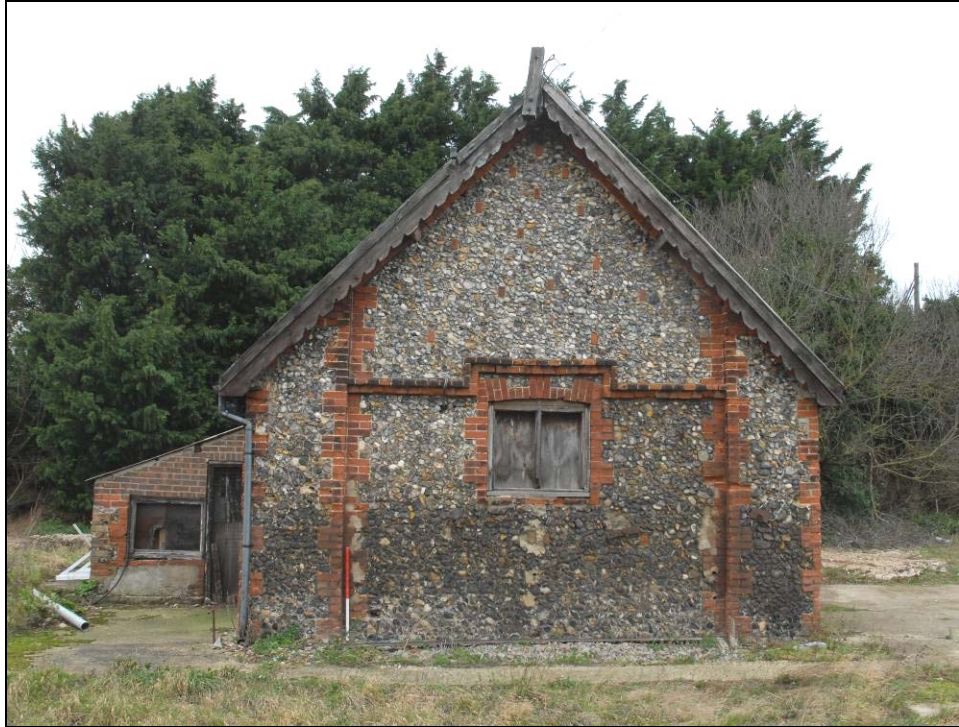
Fig 8

The roof of the lean-to is corrugated iron. The over-hanging gables have decorative barge boards (Fig 8).

Gable elevation, looking north

Historically there was a lean-to on this side of the building, but the existing one which, maybe on its footprint, only retains a small amount of the fabric associated with it, in the form of the previously mentioned length of flint walling. On the southern elevation of the lean-to there was a plain plank door and boarded-over window next to it (Fig 8).

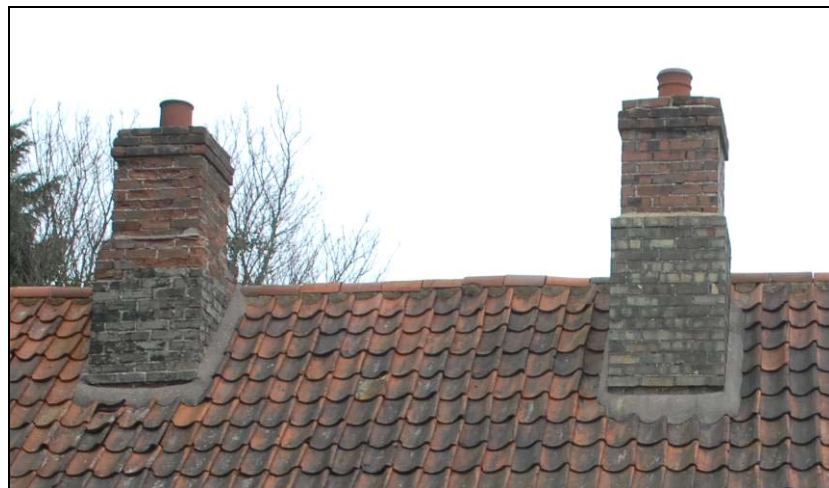
Fig 9

Chimney detail, looking east, showing the change in brickwork

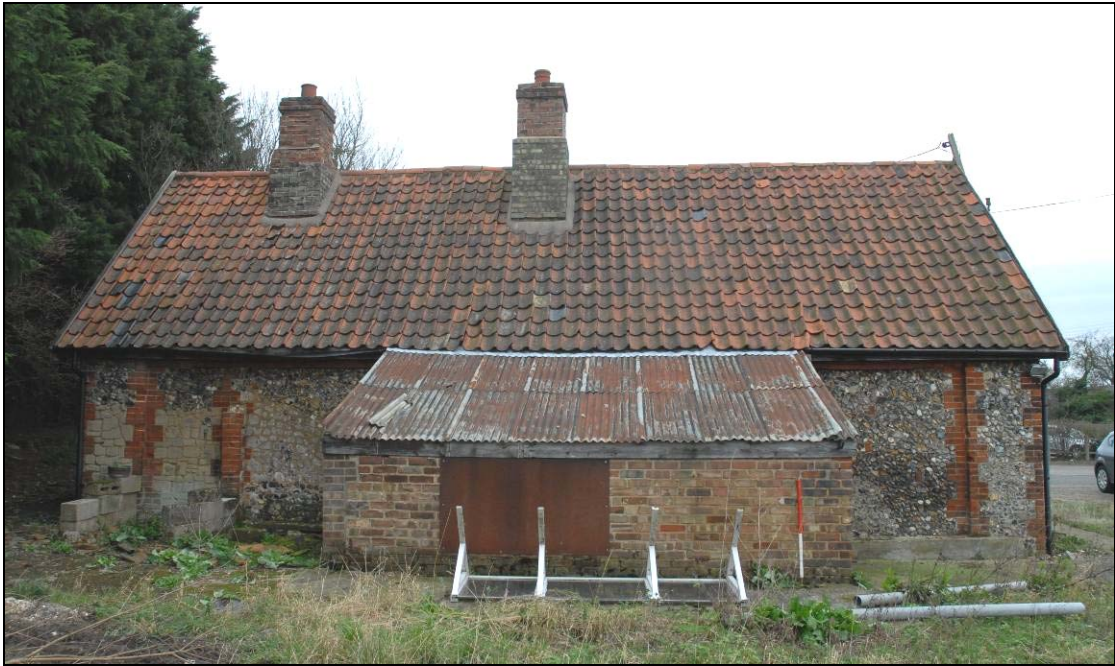
Fig 10

Rear elevation, looking east

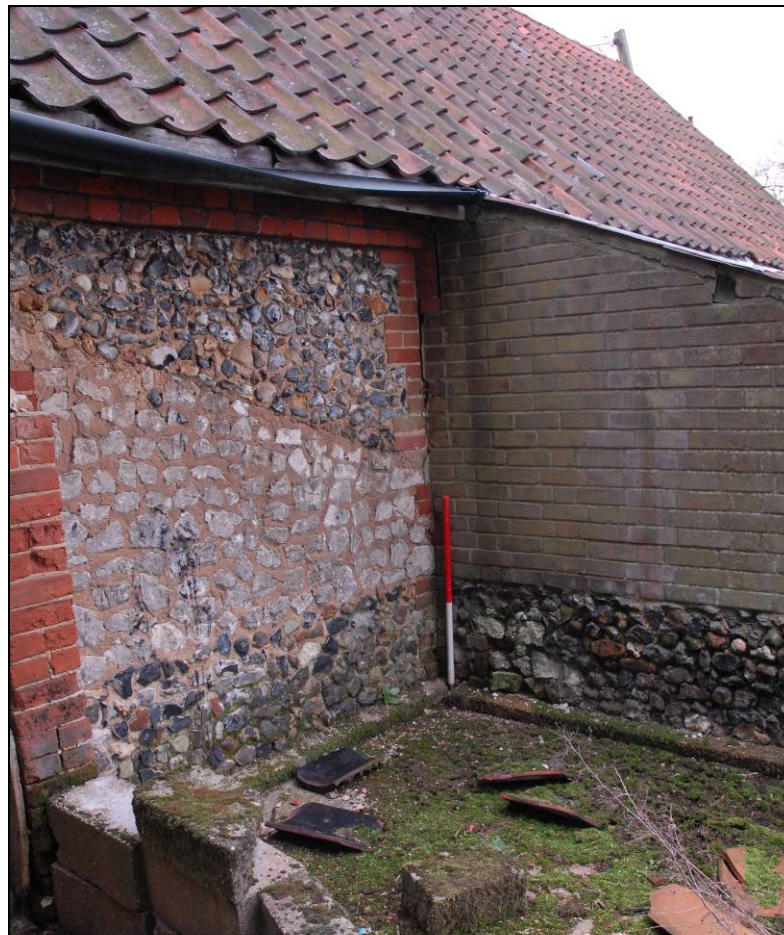
Fig 11

The lean-to on the western side in its current form has undergone modification and has several phases of brickwork over flint walling on its northern side (Fig 11).

Northern elevation of the lean-to showing the more recent brickwork over the original flint walling, looking south-east

The extension on the rear elevation, (western side), has also been altered over time, with areas of more modern brick work visible in its current form. The northern part of the rear wall differed from the rest of the building, in that amongst the flint walling, there were patches of limestone and chalk blocks, there appeared to be no reason for this change in the use of stone as neither section of wall was completely limestone or chalk. If this had been the case it may have indicated a blocked opening.

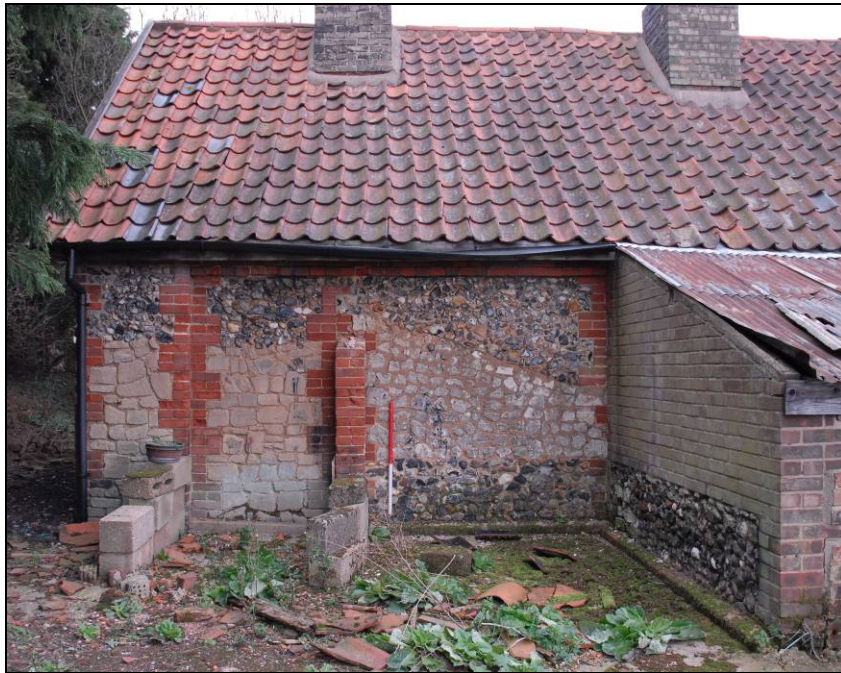
North of the lean-to on the western elevation of the forge there are areas of limestone and chalk blocks in the wall with flint above (Fig 12). The purpose for this is not known as it rather spoils the effect of the flint, however this elevation is to the rear of

the building so would not have been on public view.

Rear elevation, looking east, showing the panels of limestone and chalk blocks Fig 12

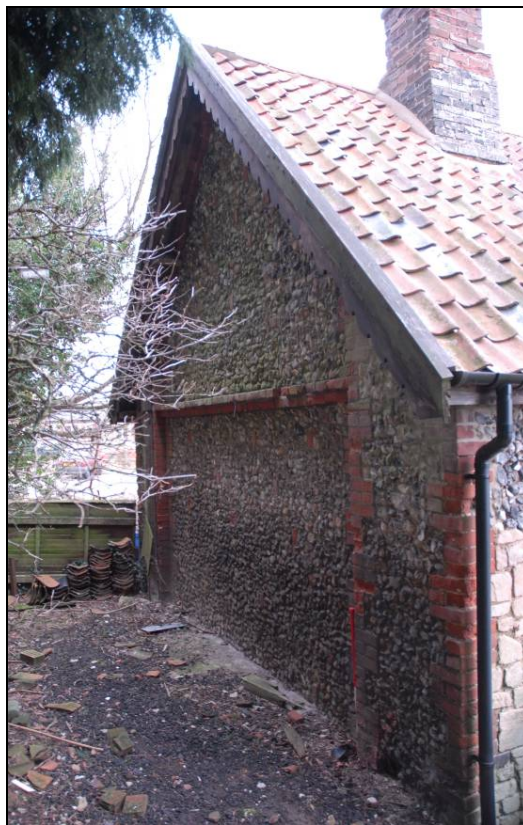
There is no evidence of the lean-to on the northern elevation shown on the historic postcard (Fig 5), which would suggest that this structure was a temporary one (Fig 13).

North gable end, looking south-east Fig 13

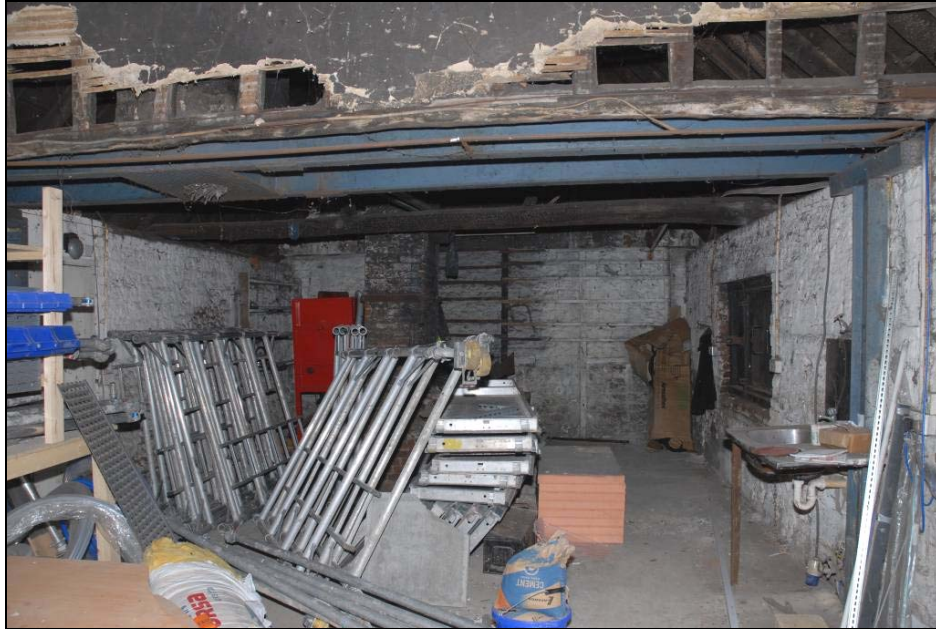
The walls within the main part of the building were white-washed over the flint and brick, the floor was modern concrete (Fig 14).

Forge interior, looking north, showing the lath and plaster partition at loft level  
Fig 14

A lath and plaster partition survived at loft level across the middle of the building, this had been painted dark brown, no evidence survived at a lower level to suggest whether the partition split the room into two (Fig 14). At the southern end of the building there was an open loft space for storage which is likely to be an original feature of the building (Fig 18).

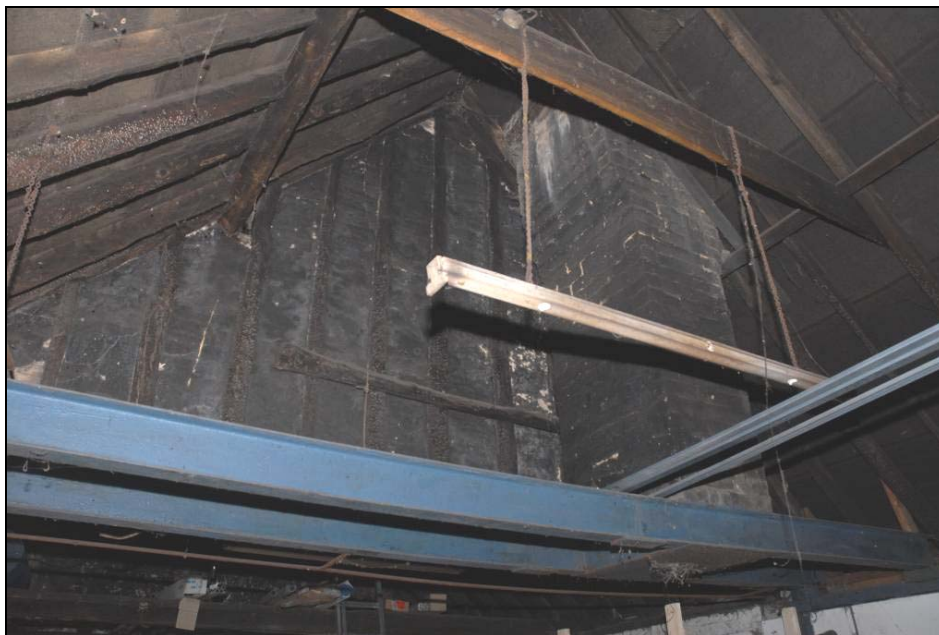
The central chimney had had its lower part removed and the upper part supported on RSJ girders (Fig 15).

The central chimney looking south-west, supported on RSJ girders,  
also visible is the lath and plaster partition  
Fig 15

Internally the floor of the building had been replaced with concrete. One of the chimneys had its lower part removed, prior to the new concrete floor. The other chimney still retained elements of the forge hearth although the smoke hood had been removed. The doorway through into the lean-to extension on the western side of the building had been reduced in width with fibre board, suggesting that this was a more recent internal alteration.

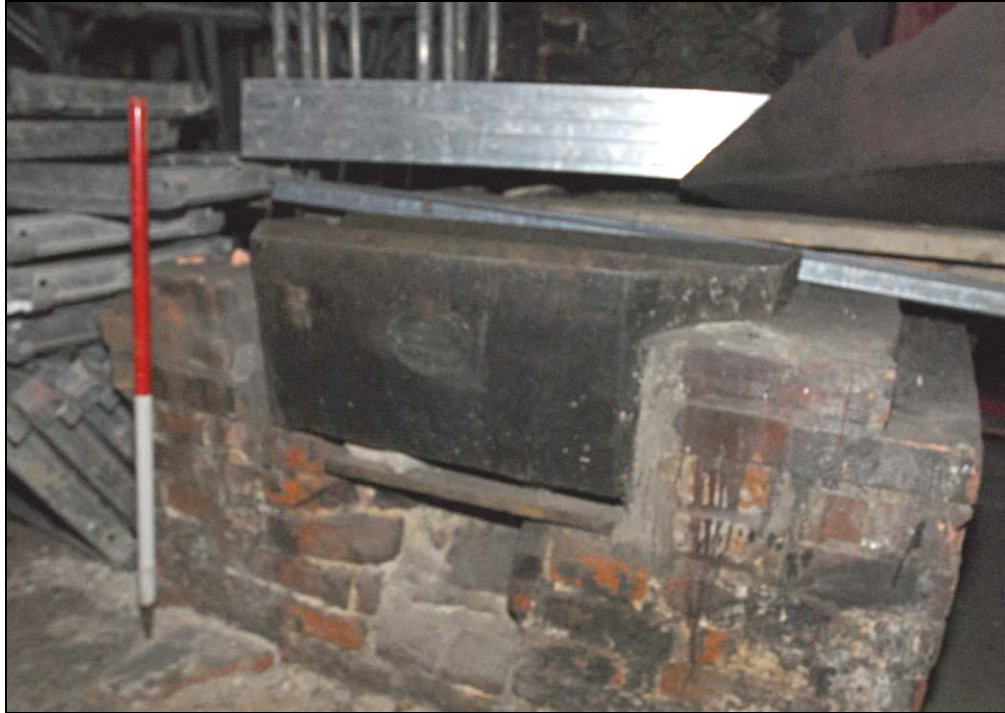
Fig 16

The other chimney retained its hearth at the front of which was a cast iron tank, likely to have been used for quenching (Fig 16). The tank was made by *Alldays & Onions Ltd Makers Birmingham & London*.

The hearth with the *Alldays & Onions* quenching tank

This engineering firm made motor lorries, cars, vans, cycles and motorcycles, complete outfits for foundries and workshops, hammers, fans, hearths, forges, cranes and pulley blocks. The company was formed in 1885 through a merger so the tank whilst being a surviving forge feature does not date to when the forge was likely to have been built between 1855 and 1869, although it may have been installed shortly thereafter ([http://www.gracesguide.co.uk/Alldays and Onions](http://www.gracesguide.co.uk/Alldays_and_Onions)).

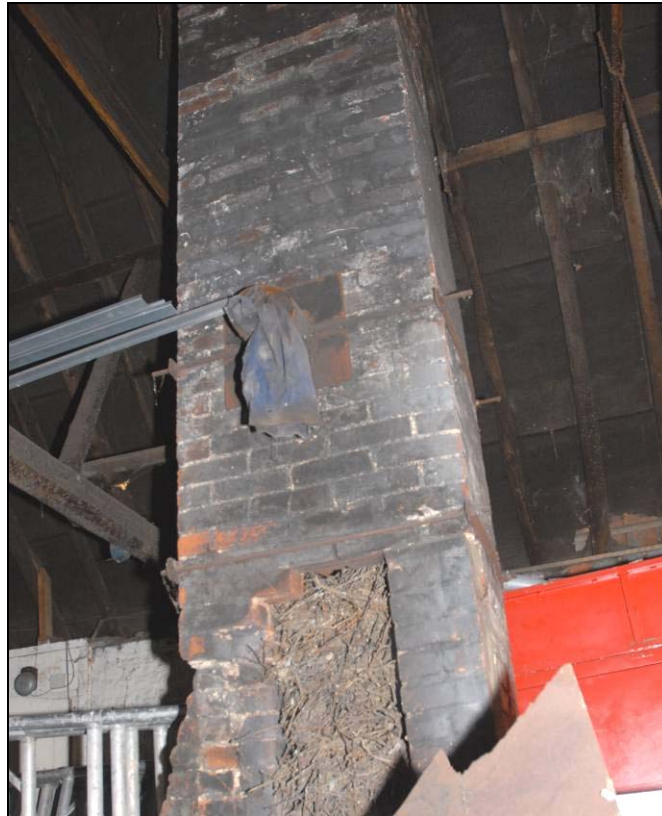
The hood for the hearth has been removed and the flues of both chimneys were full of small twigs evidence of generations of birds nesting at the top of the chimneys (Fig 17).

Chimney over the hearth where the smoke hood has been removed Fig 17

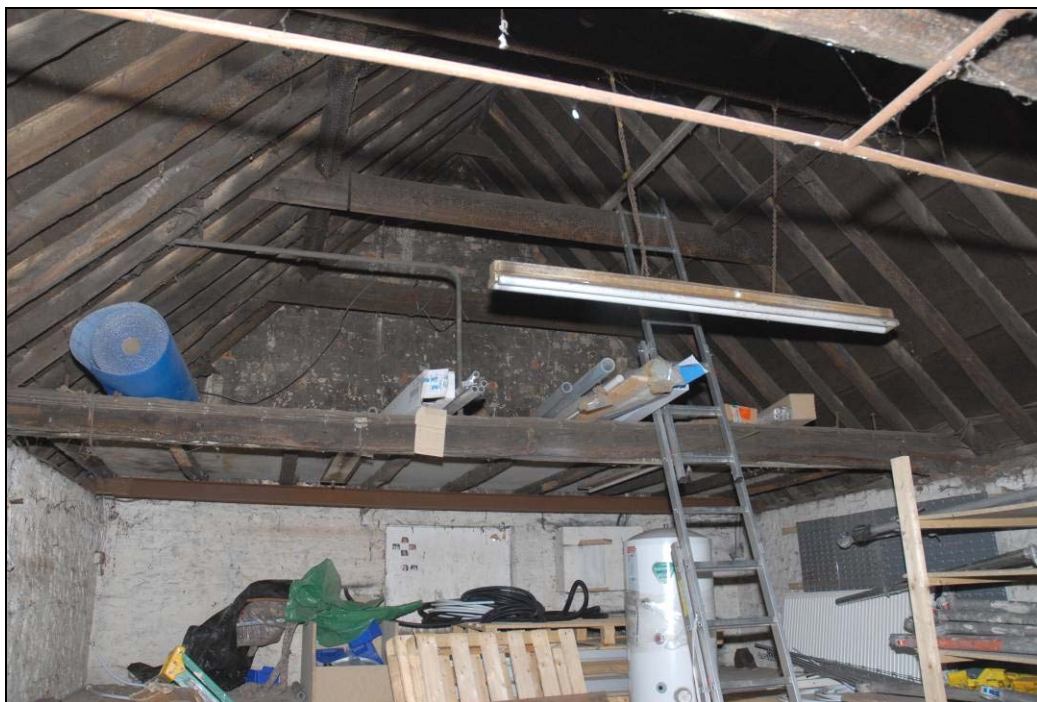
Open loft space at the southern end of the building Fig 18

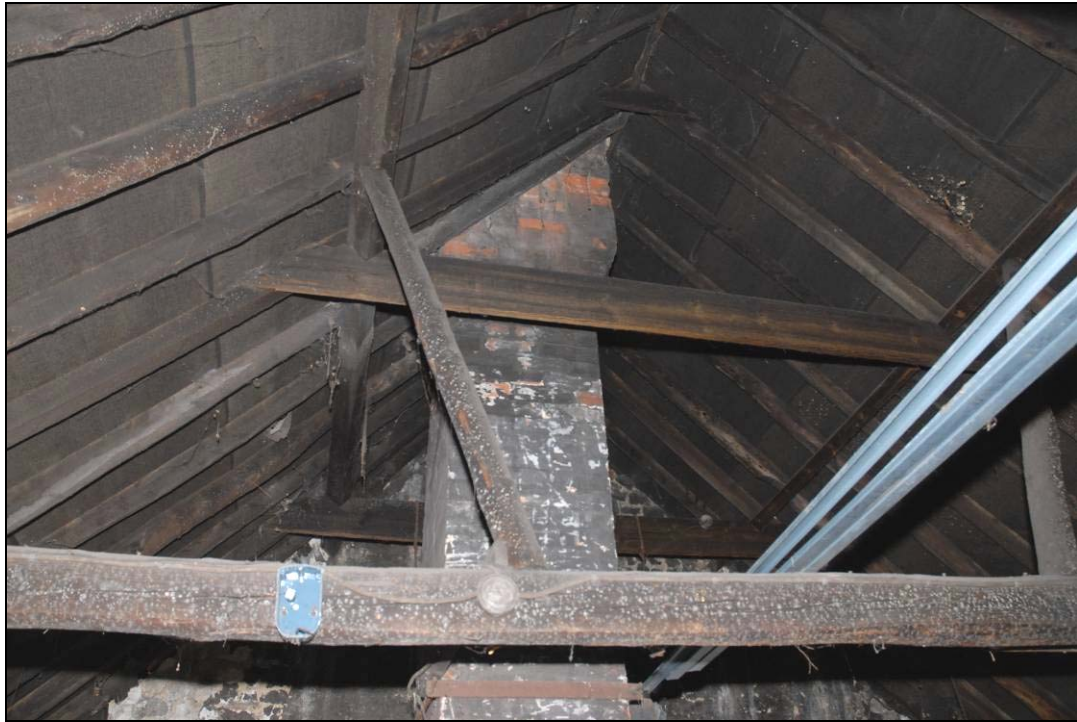
The roof was a hybrid of a *double framed roof* with purlins supported by braces from the tie-beams and a *coupled rafter roof* where pairs of rafters are joined by a collar-beam (Figs 6 and 19).

Roof structure, looking north, showing tie-beam, brace supporting the purlin, and the collar-beam between the rafters Fig 19

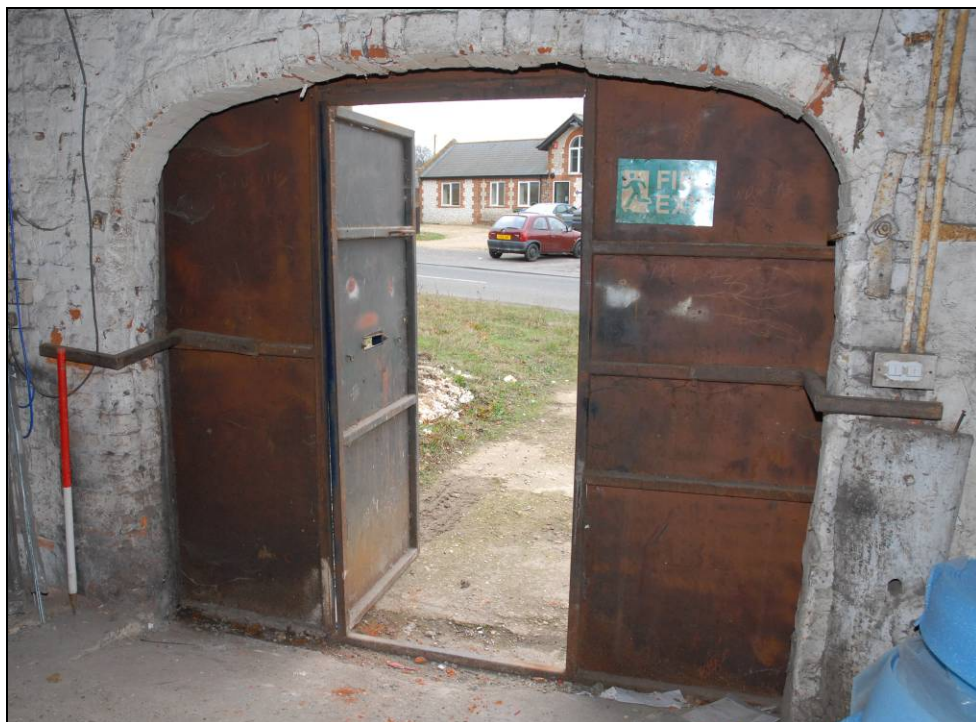
Adjacent to the main door into the building and attached to the wall was a curved block of wood, which had also been white-washed (Figs 20 and 21). The purpose of this is not clear but it may relate in some way to the life of the forge.

Main door into the forge showing the low brick arch over, looking east Fig 20

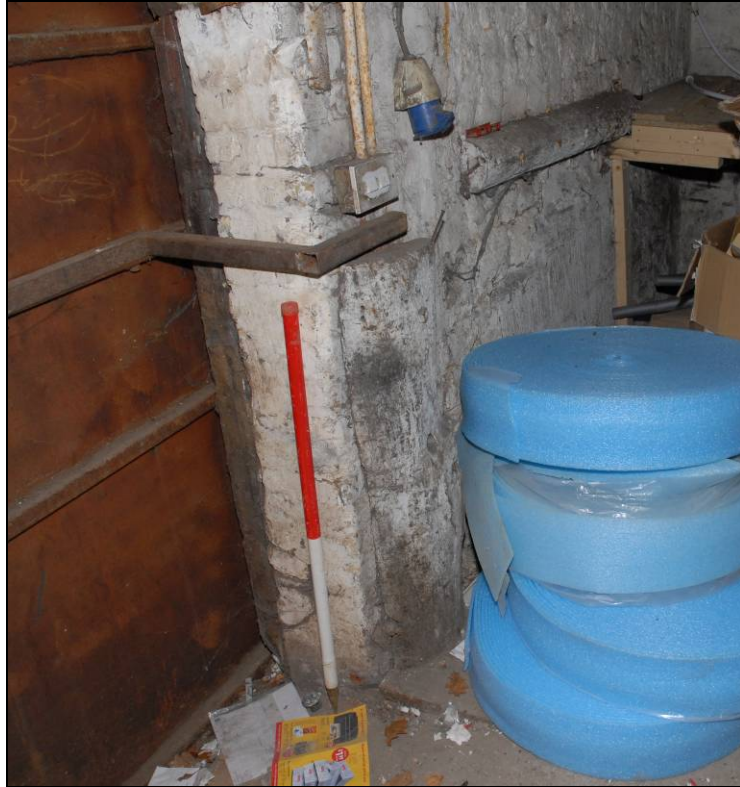
Curved wooden block adjacent to the entrance Fig 21

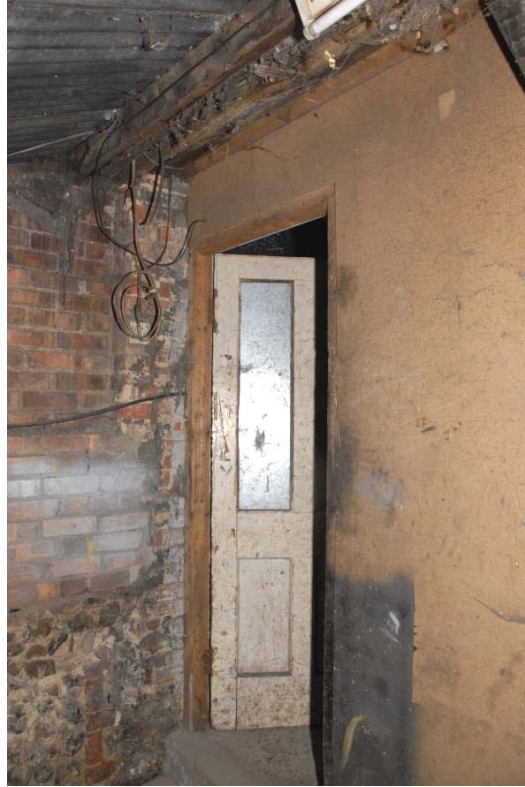
The doorway through into the lean-to had been reduced in width with fibre board panelling, the door was a plain four panel door the top panels of which, had been replaced with a metal sheet (Fig 22). At the time of the survey the lean-to was being used for storage and the floor consisted of pallets with a partial covering of fibre board, to keep the contents off the concrete floor and prevent damp (Fig 23).

Interior of the lean-to showing the join, the door and the reduced opening Fig 22

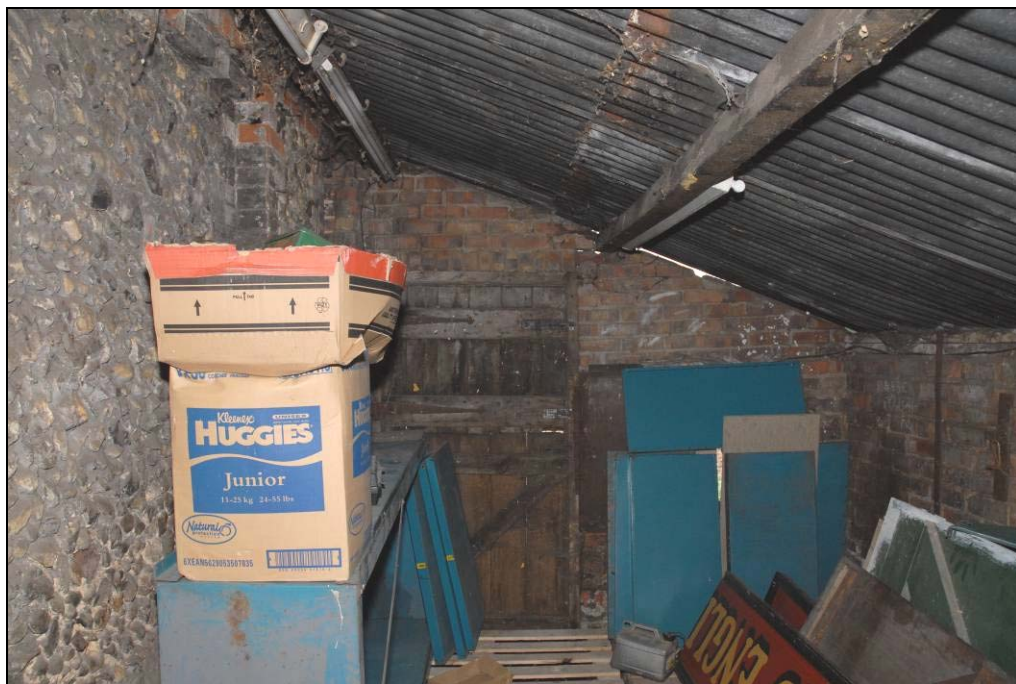
Fig 23

Interior of the lean-to looking south
