Archaeological building survey at
Yardley Chase Cadet Training Centre
Denton Road, Denton, Northamptonshire
March 2013

Gemma Hewitt
Charlotte Walker
Report 13/61
April 2013

**ARCHAEOLOGICAL BUILDING RECORDING
AT YARDLEY CHASE, CADET BASE TRAINING CENTRE
DENTON ROAD, DENTON
NORTHAMPTONSHIRE
MARCH 2013**

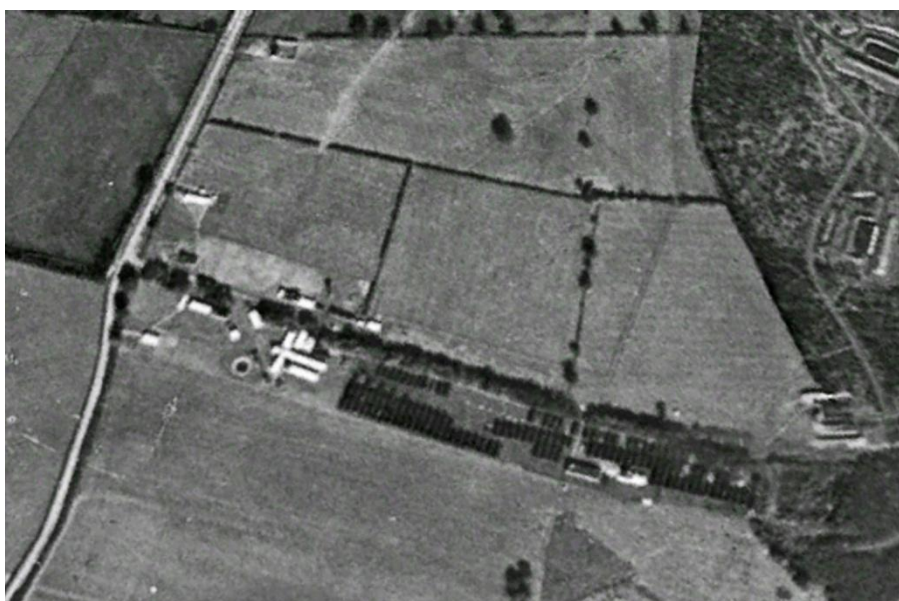
1945 aerial photograph of the office and accommodation buildings Fig 2

Most of the buildings on site were enclosed by large earth banks, which were in turn surrounded by annular quarry ditches. The blast banks are c 13m wide and c 5m high. Associated with these buildings were groups of three small ancillary brick buildings assumed to be contemporary with the storage bunkers. In each case they comprised a latrine, office and blast shelter (comprising three bays with the central entrance protected by an external blast wall). The domestic buildings and offices were located adjacent to the Horton-Denton road and are the subject of the current survey. The 1945 aerial photograph of the area indicates that most of the buildings were present by this date (Fig 2).

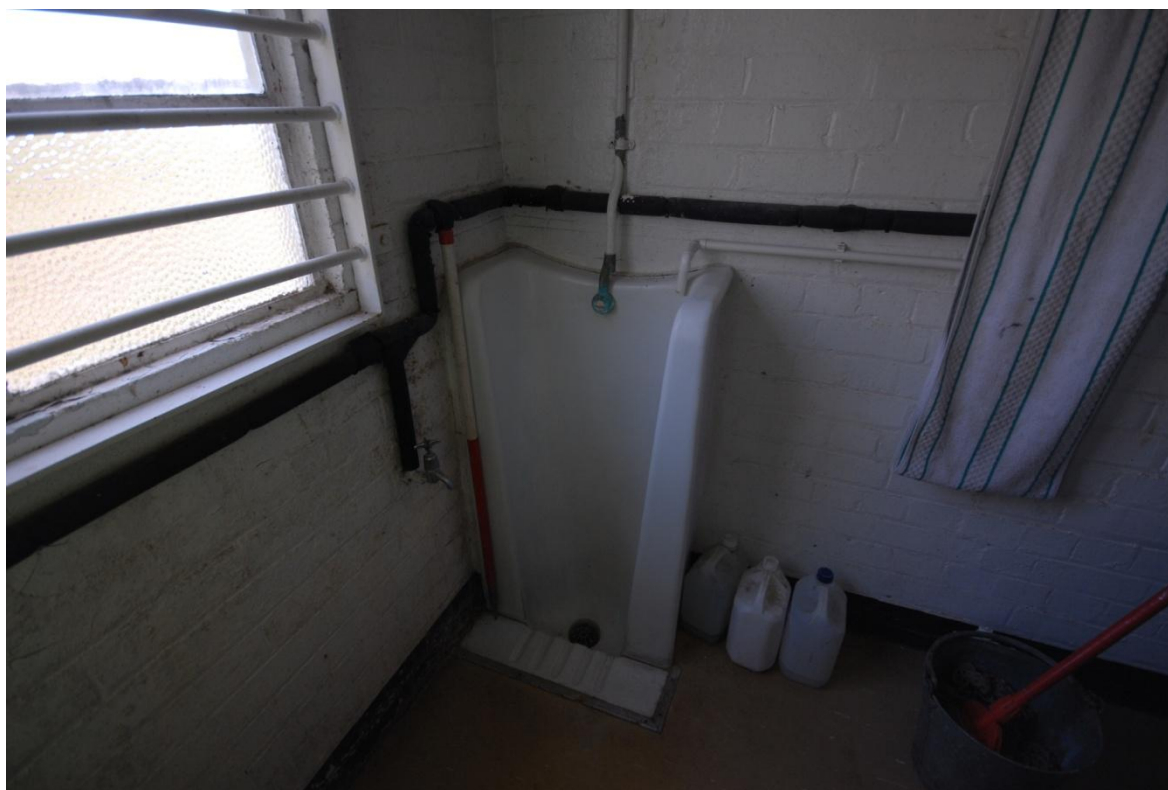
Fig 6

Building 1; the guardhouse, original urinal room B1/5

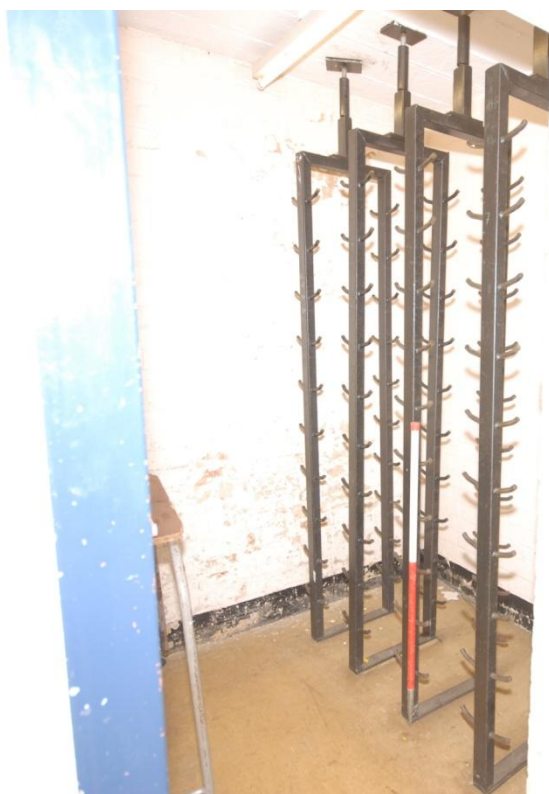
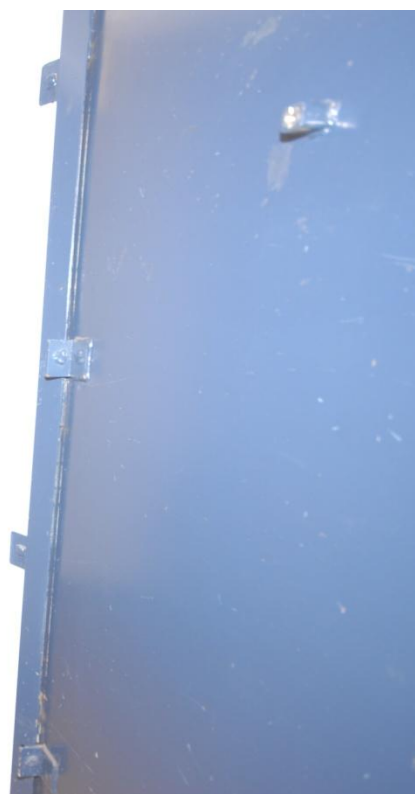
Fig 7

Building 1; guardhouse, gun storage room B1/6

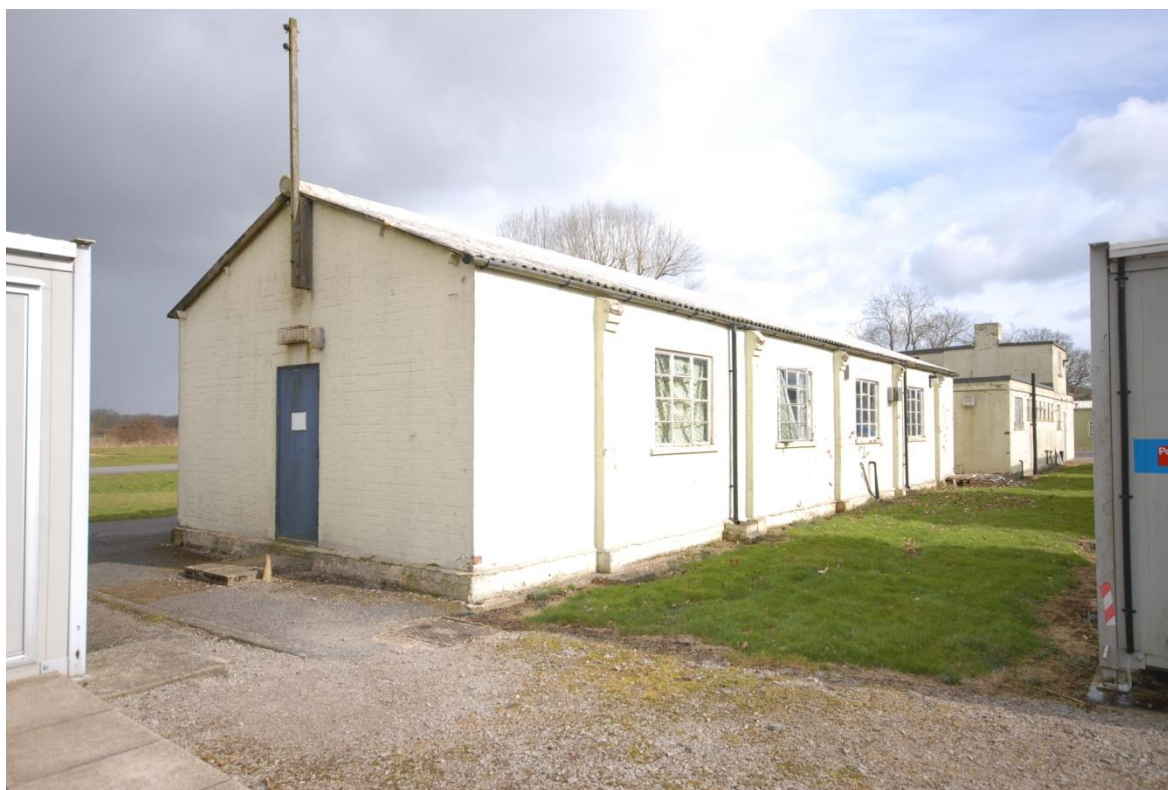
Fig 8

This building has a gabled roof at the north-west and flat concrete roof at the south-east end. It is of brick and cast iron with whitewash over (Fig 8).

Building 2; east elevation facing

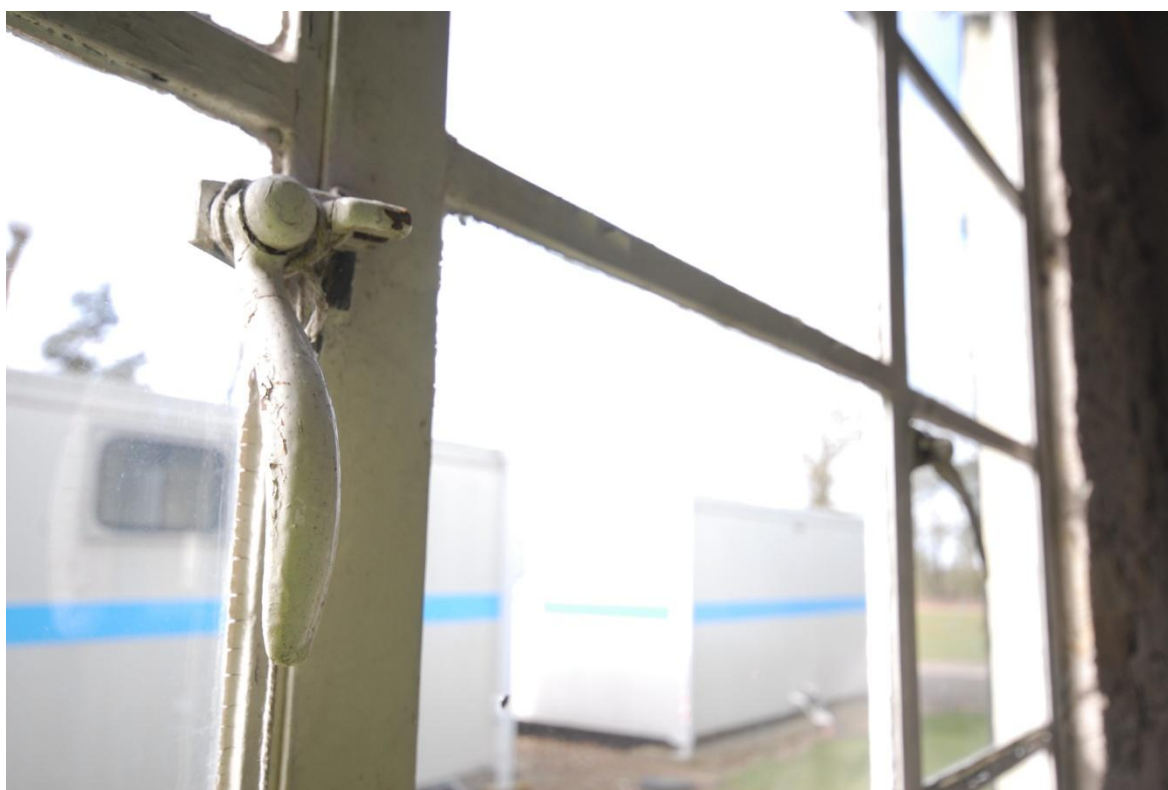
Fig 9

There have been some later room divisions making the large space at the north-west end of the building into three rooms, one of which is being used as a kitchen but still features the original crittall windows and their fittings (Fig 9). On the south-west end of the building are a further eight rooms, only the function of three can still be seen. Rooms B2/8 & B2/13 are toilets; room B2/13 retained an original door and hinges as well as a Belfast sink (Fig 10). Room B2/6 seems to have acted as a secure room with two cast iron clad storage areas (Fig 11), one of which has a metal plate which dates the time of erection as 1940 (Fig 12).

Building 2; original Crittall window with fittings

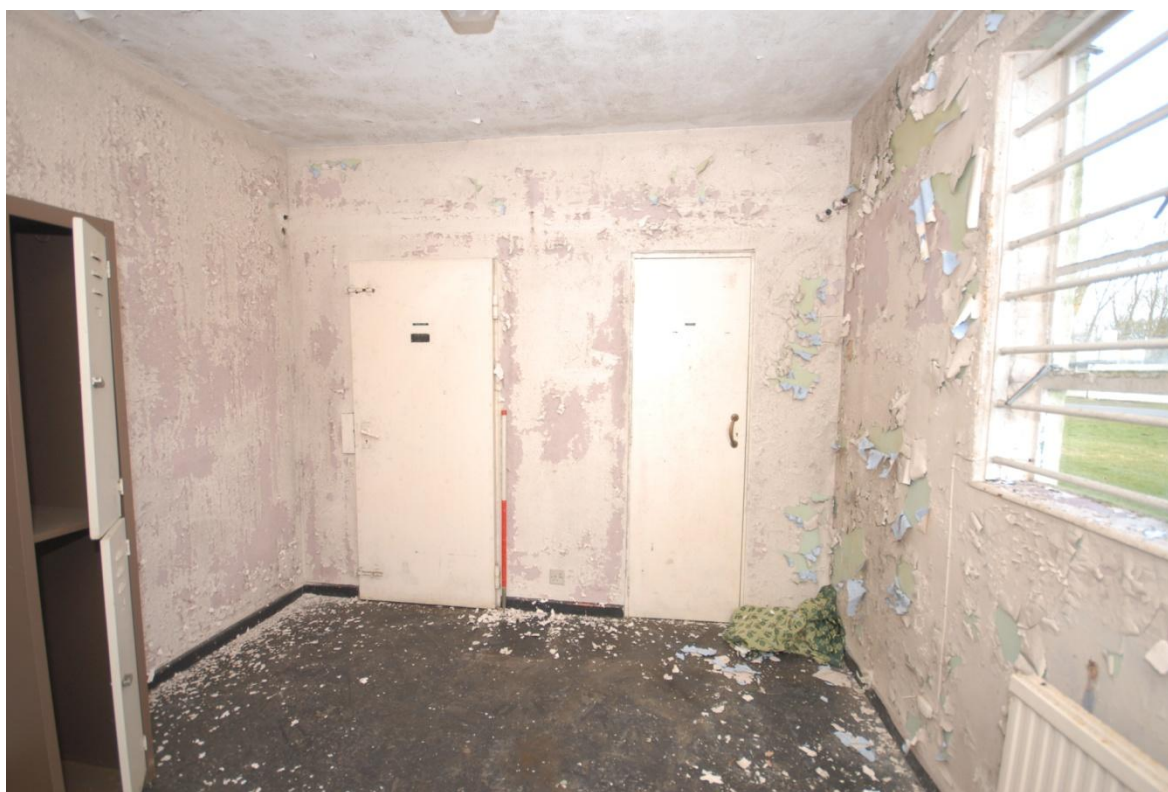
Fig 11

Building 2. secure door room B2/6

Some original doors remained in the building, these were barred and ledged (Fig 5) and cast iron secure doors (Fig 11) which still have their original fittings on. Many of the windows were still original to the building which were steel Crittall and still feature some of the original fittings.

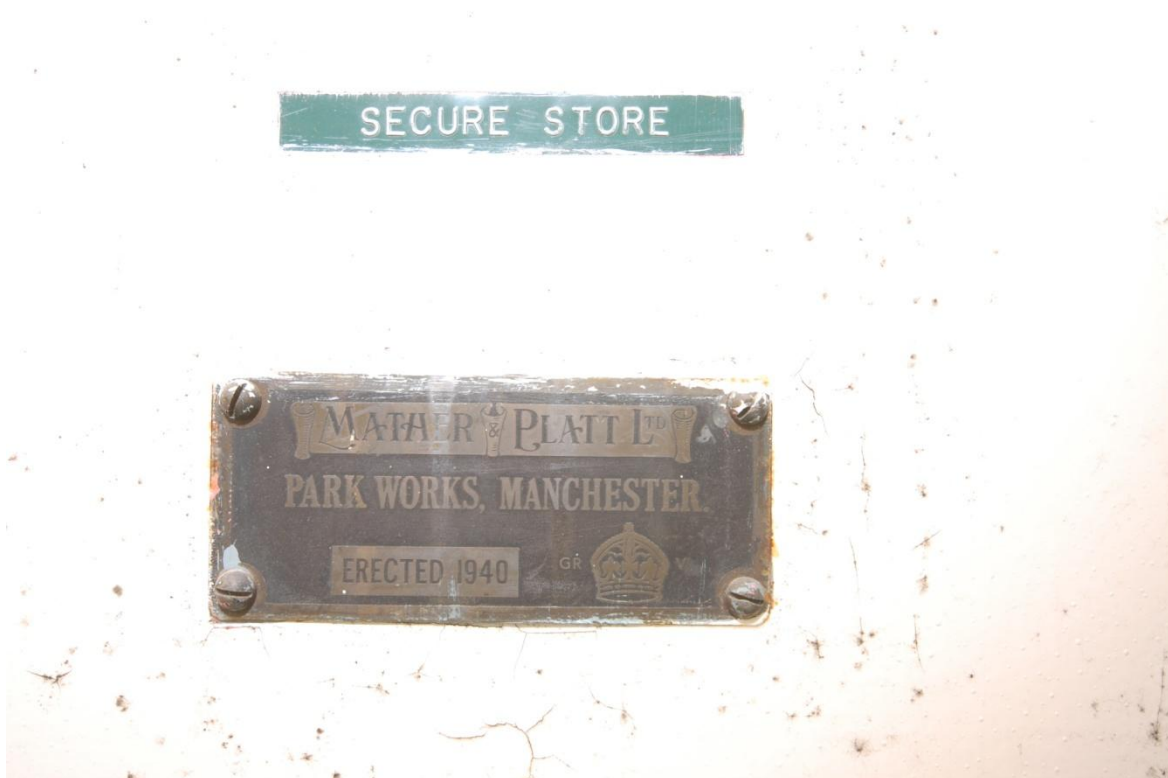
Fig 12

Building 2; plate on secure door room B2/6

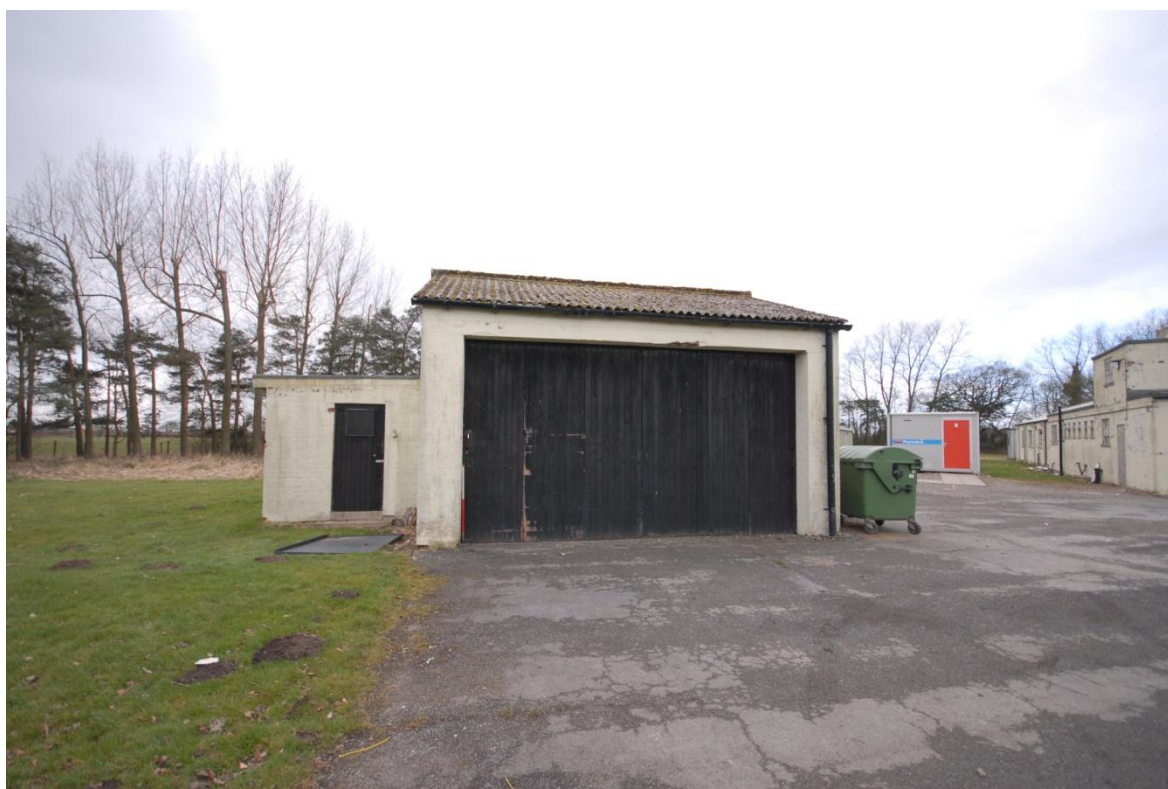
Fig 13

This building was originally a shed for 4-tonne lorries (Fig 13) It is of brick and has a pitched roof with corrugated asbestos. There is a large concertina door in the east elevation which opens to the full length and height of the building. A smaller ancillary room east of the main structure could not be accessed. At the time of this survey this building was being used for general storage.

Building 4; 4 ton lorries shed east elevation

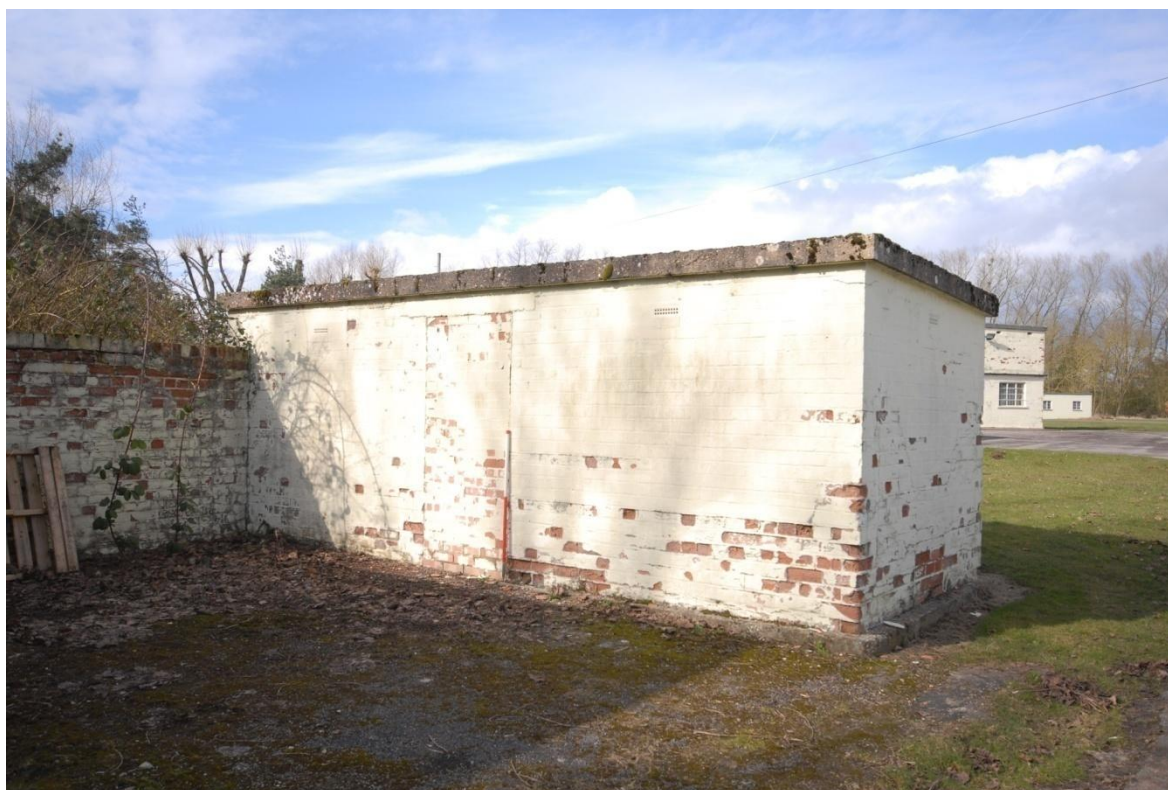
Fig 14

These four buildings are of a uniform size and shape (Fig 14) they are brick with flat concrete roofs. Access to these structures was not possible. Their function is unknown.

Building 7; an example of the inaccessible buildings

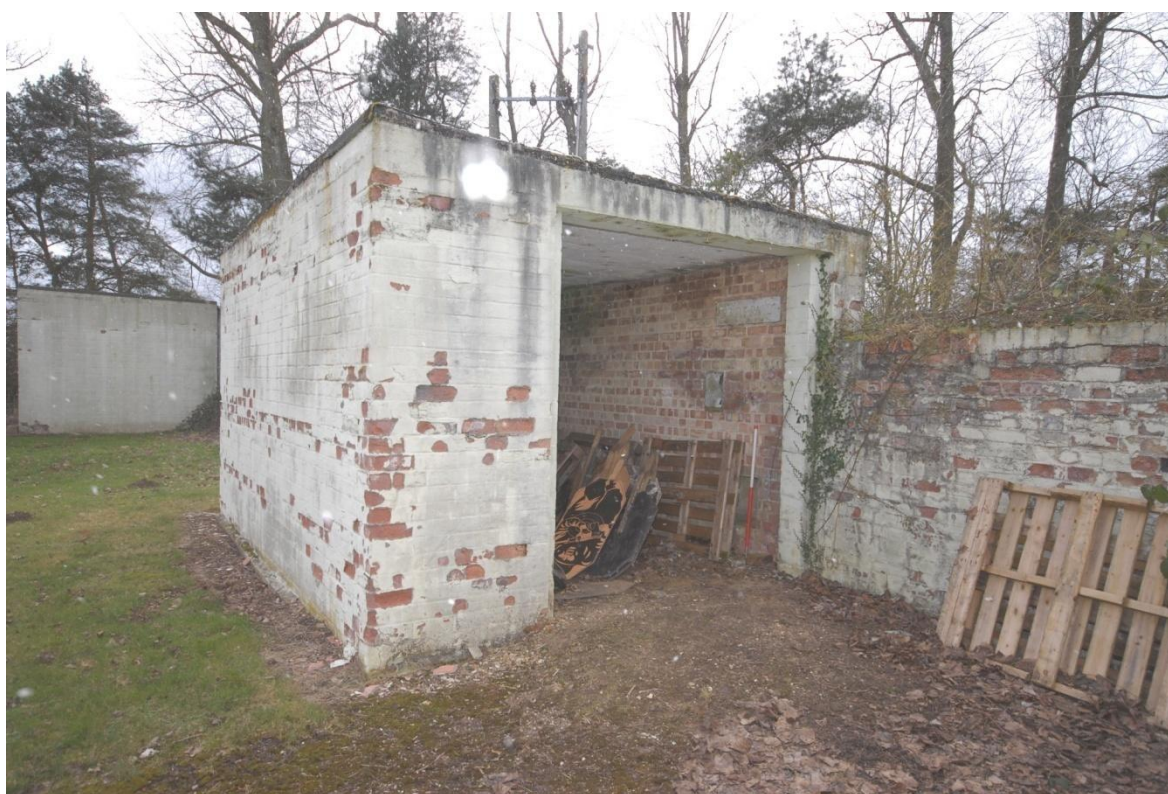
Fig 15

This building is the same type as Buildings 5, 6, 7 & 8, however, the north wall has been removed and has been used for air rifle practice (Fig 15).

Building 9; air rifle practice building

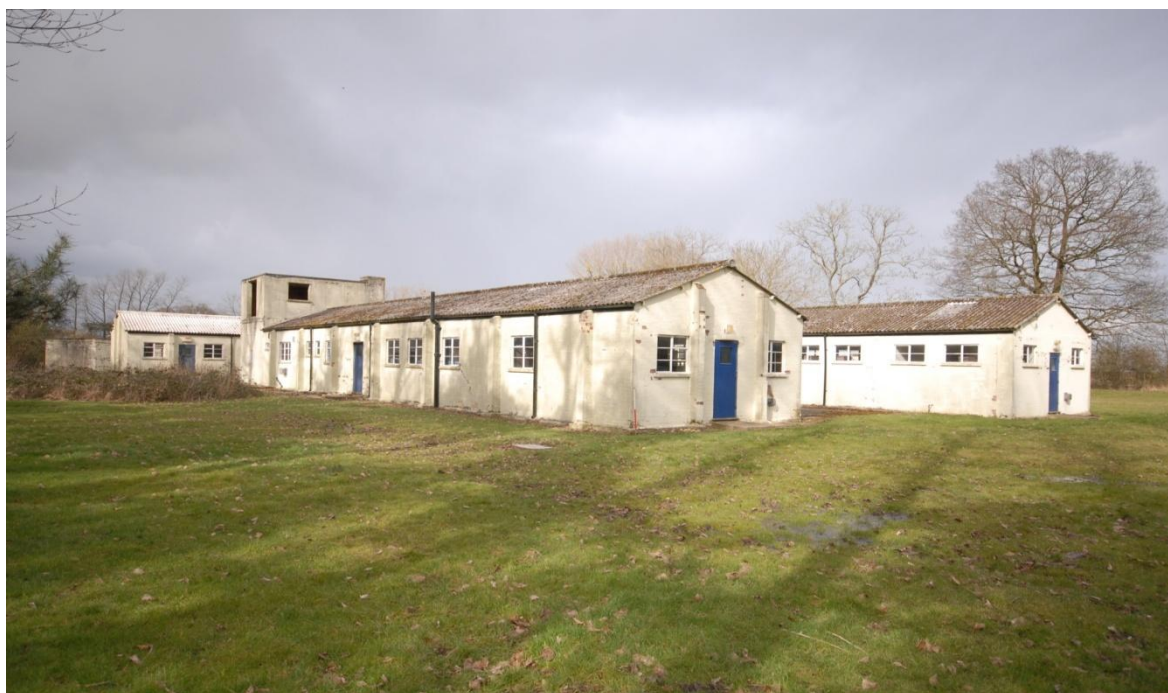
Fig 16

Building 10; the kennels, north elevation

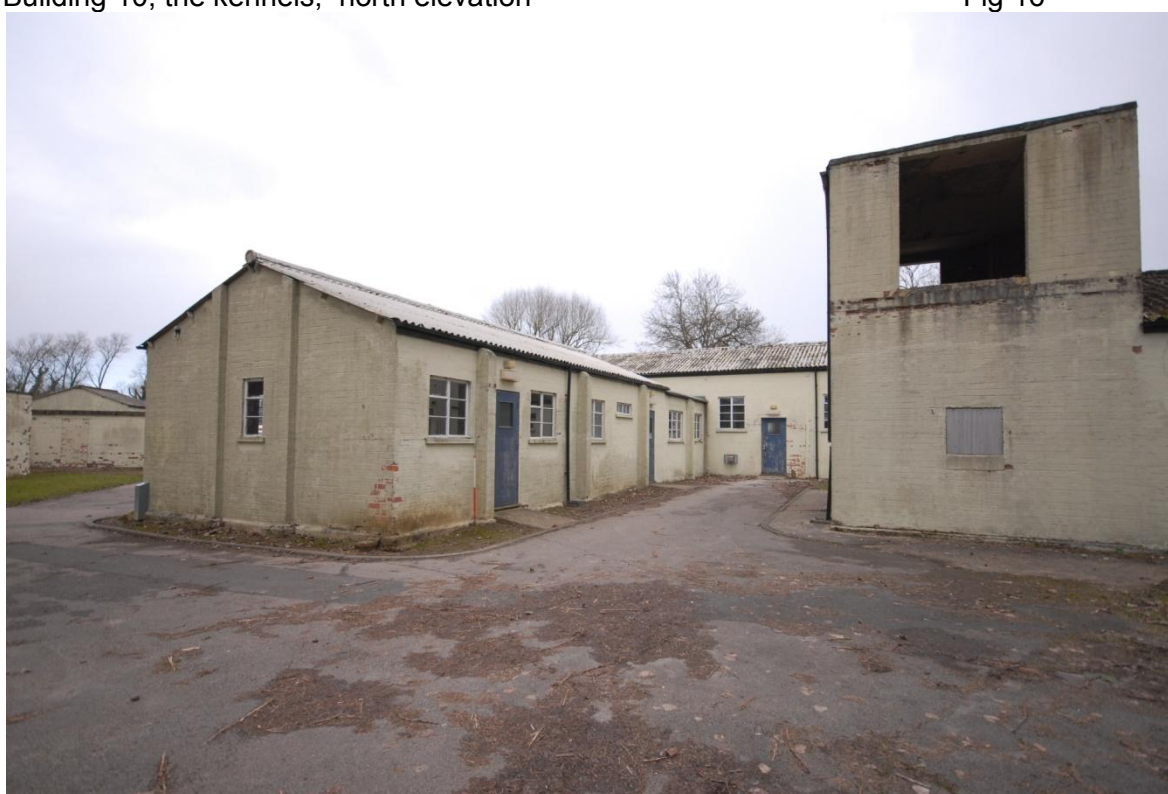
Fig 17

The buildings were of a cast iron framework with brick infill. Two different roof types were present; flat concrete, present on some of the smaller buildings, and gabled with corrugated asbestos roofing supported by king posts of cast iron (Fig 17). All the floors are concrete.

Building 10; the kennels cast iron structure

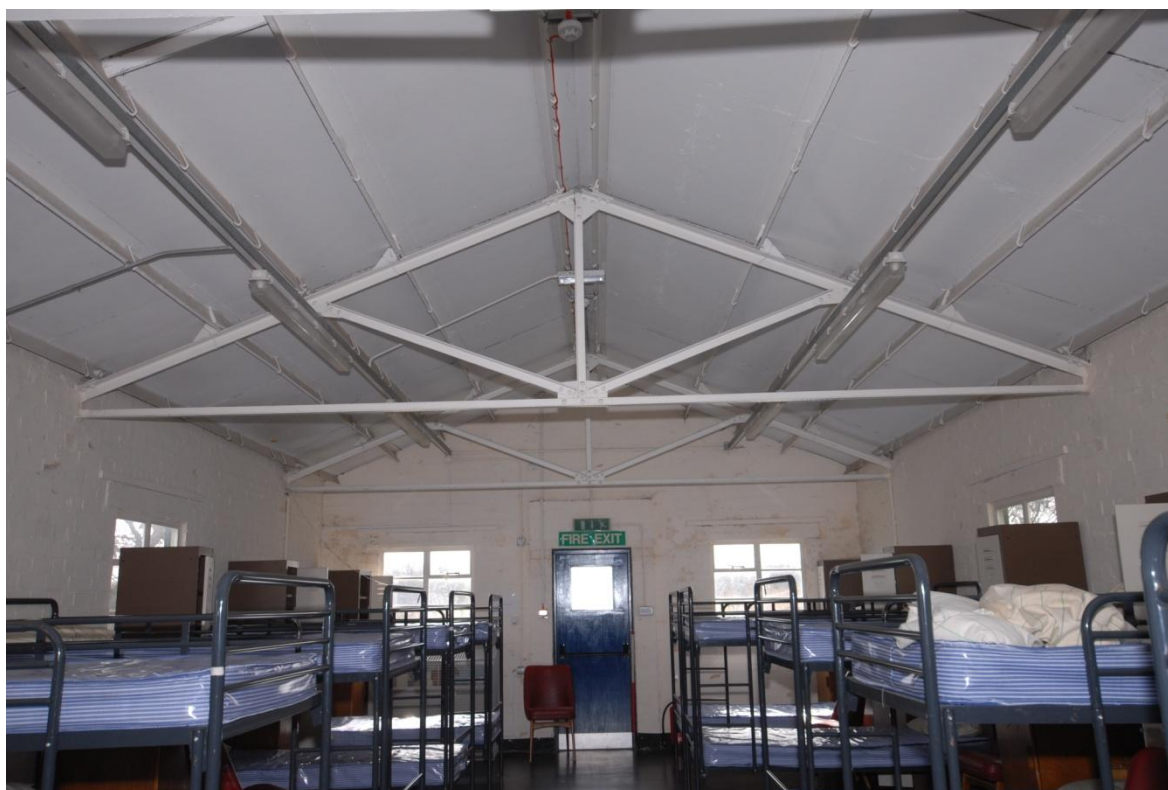
Fig 18

This building was one of two in use by the Cadets. This building is known as the kennel block; however, there is no evidence to suggest the building was ever used for this purpose. The building has both flat concrete and gabled asbestos roof types present, good examples of which can be seen in the dorm (Fig 18).

Building 10; dorm room with pitch roof structure B10/5

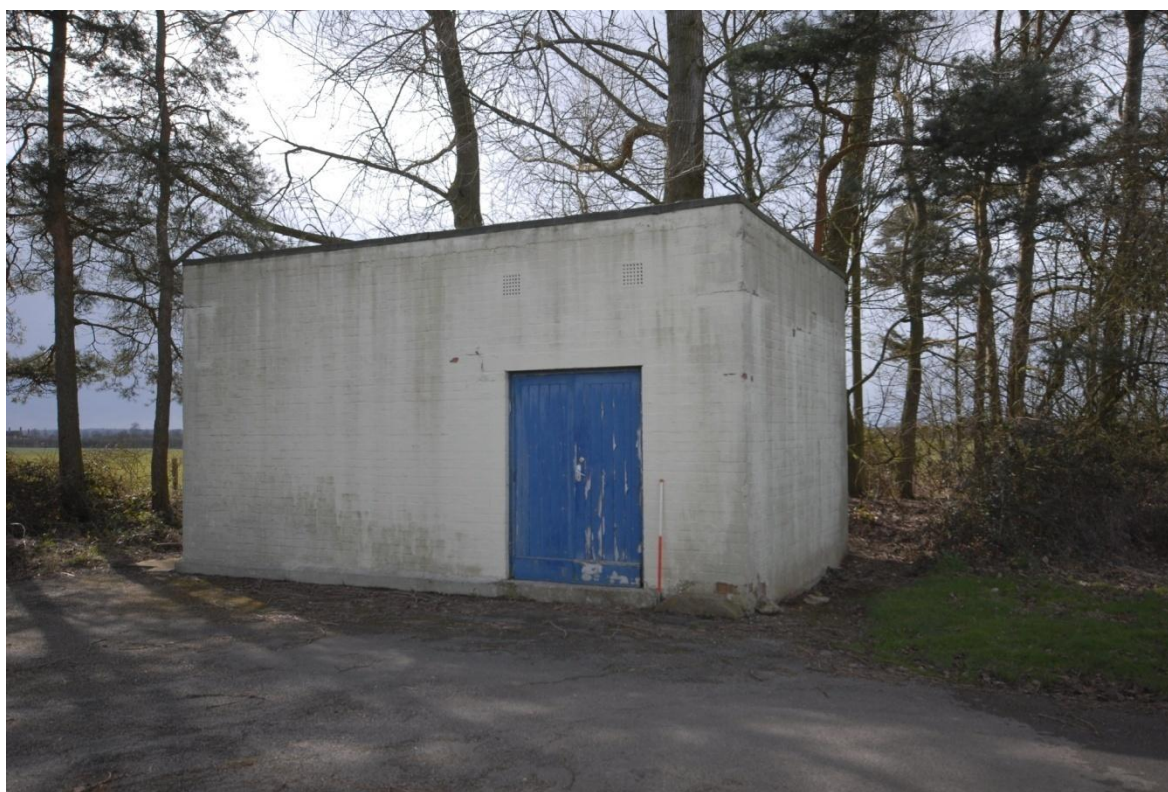
Fig 19

This building was the generator building. It is a simple brick build with a flat concrete roof, there is only one door in the north corner of the building and four small high level vents (Fig19). The original generator is still present within the building though it was no longer in use, the building now houses a newer generator (Fig 20).

Building 11; the generator

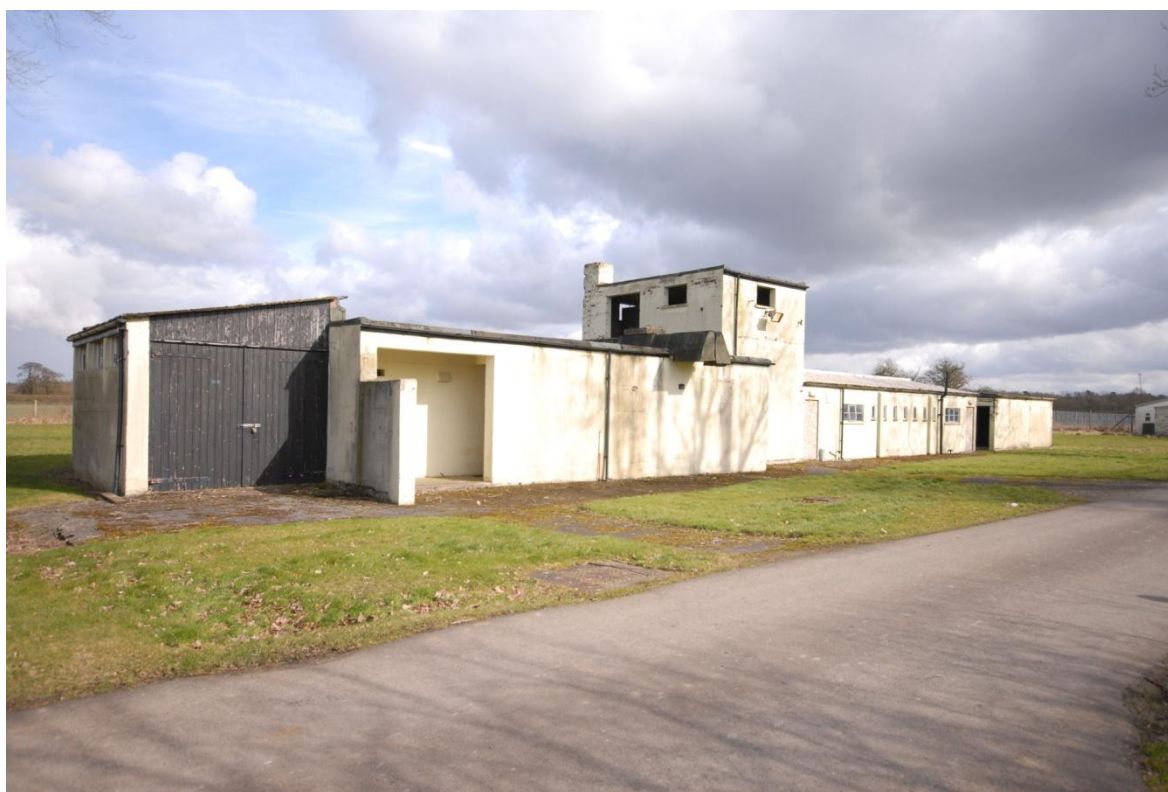
Fig 21

The north-west end of the structure is the fire station (Fig 21) area and comprises two rooms; B12/1 was a large storage area with double doors and originally housed the fire engine. B12/2 is the main station however there is no access to this room due to asbestos.

Building 12; the fire station

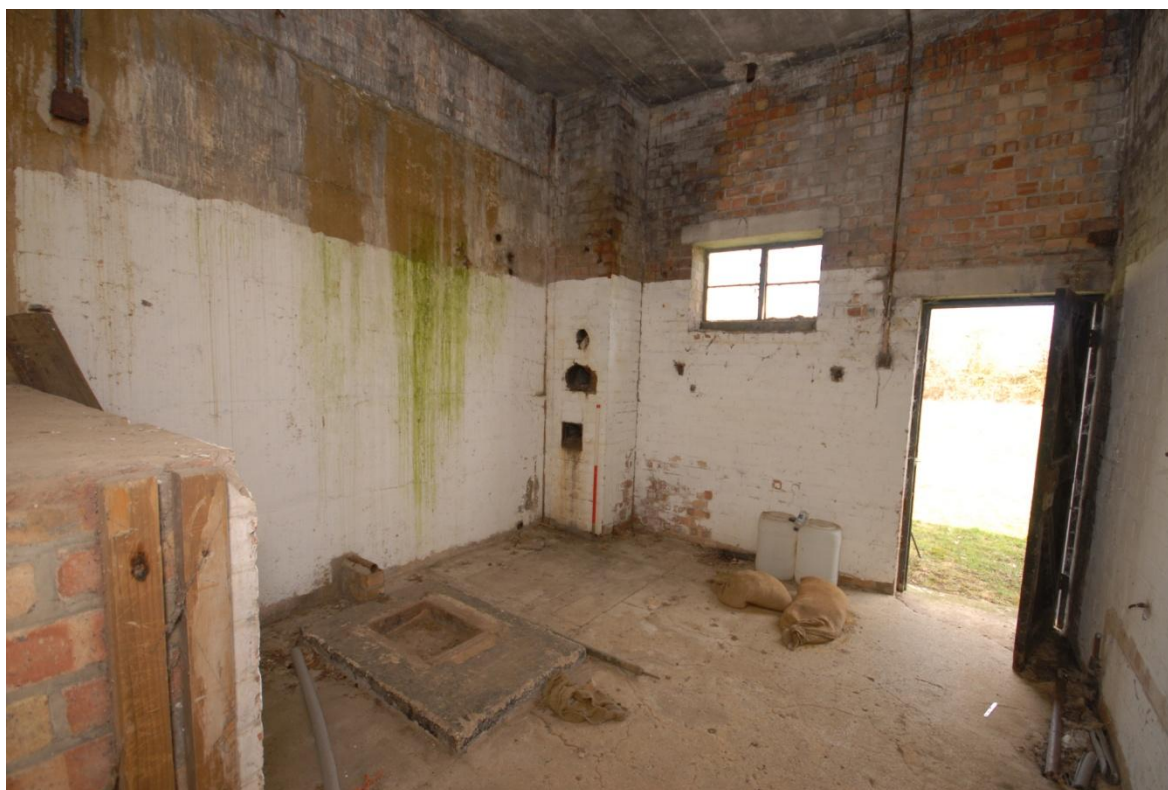
Fig 22

The boiler room B12/3 has access through the north-west facing wall and the chimney is still present in the corner of the room on the same side. The footings for the boiler are still set in the concrete floor. A single window and vent are present on the south-west wall. There is also a small dividing wall aligned north-west measuring 1.36m in height and also features an opening for access (Fig 22).

Building 12, the boiler room

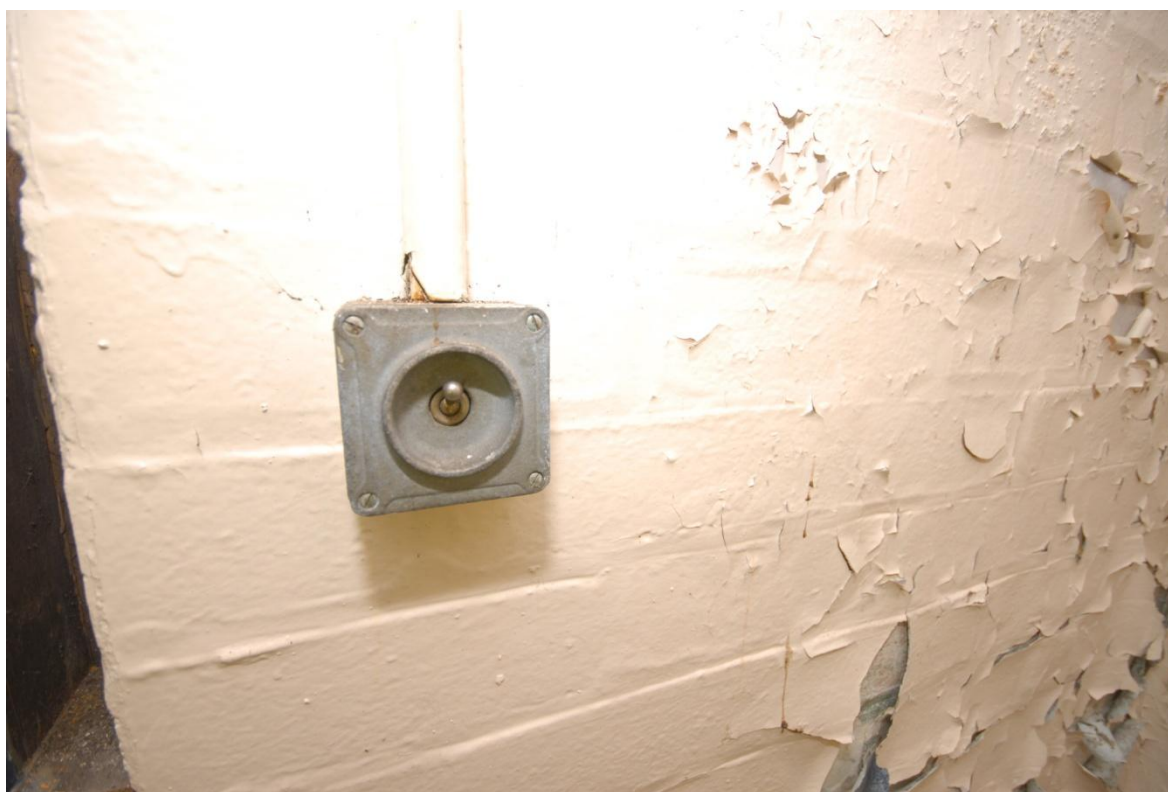
Fig 23

This building has a flat concrete roof and one doorway on the north-west elevation. Three bricked up windows are present in the south-west wall. It was divided into two rooms B13/1 and B13/2. Room B13/1 had an original door (Fig 24), while B13/2 retained original light fitting and Bakelite switch (Fig 23)

Building 13; original Bakelite switch

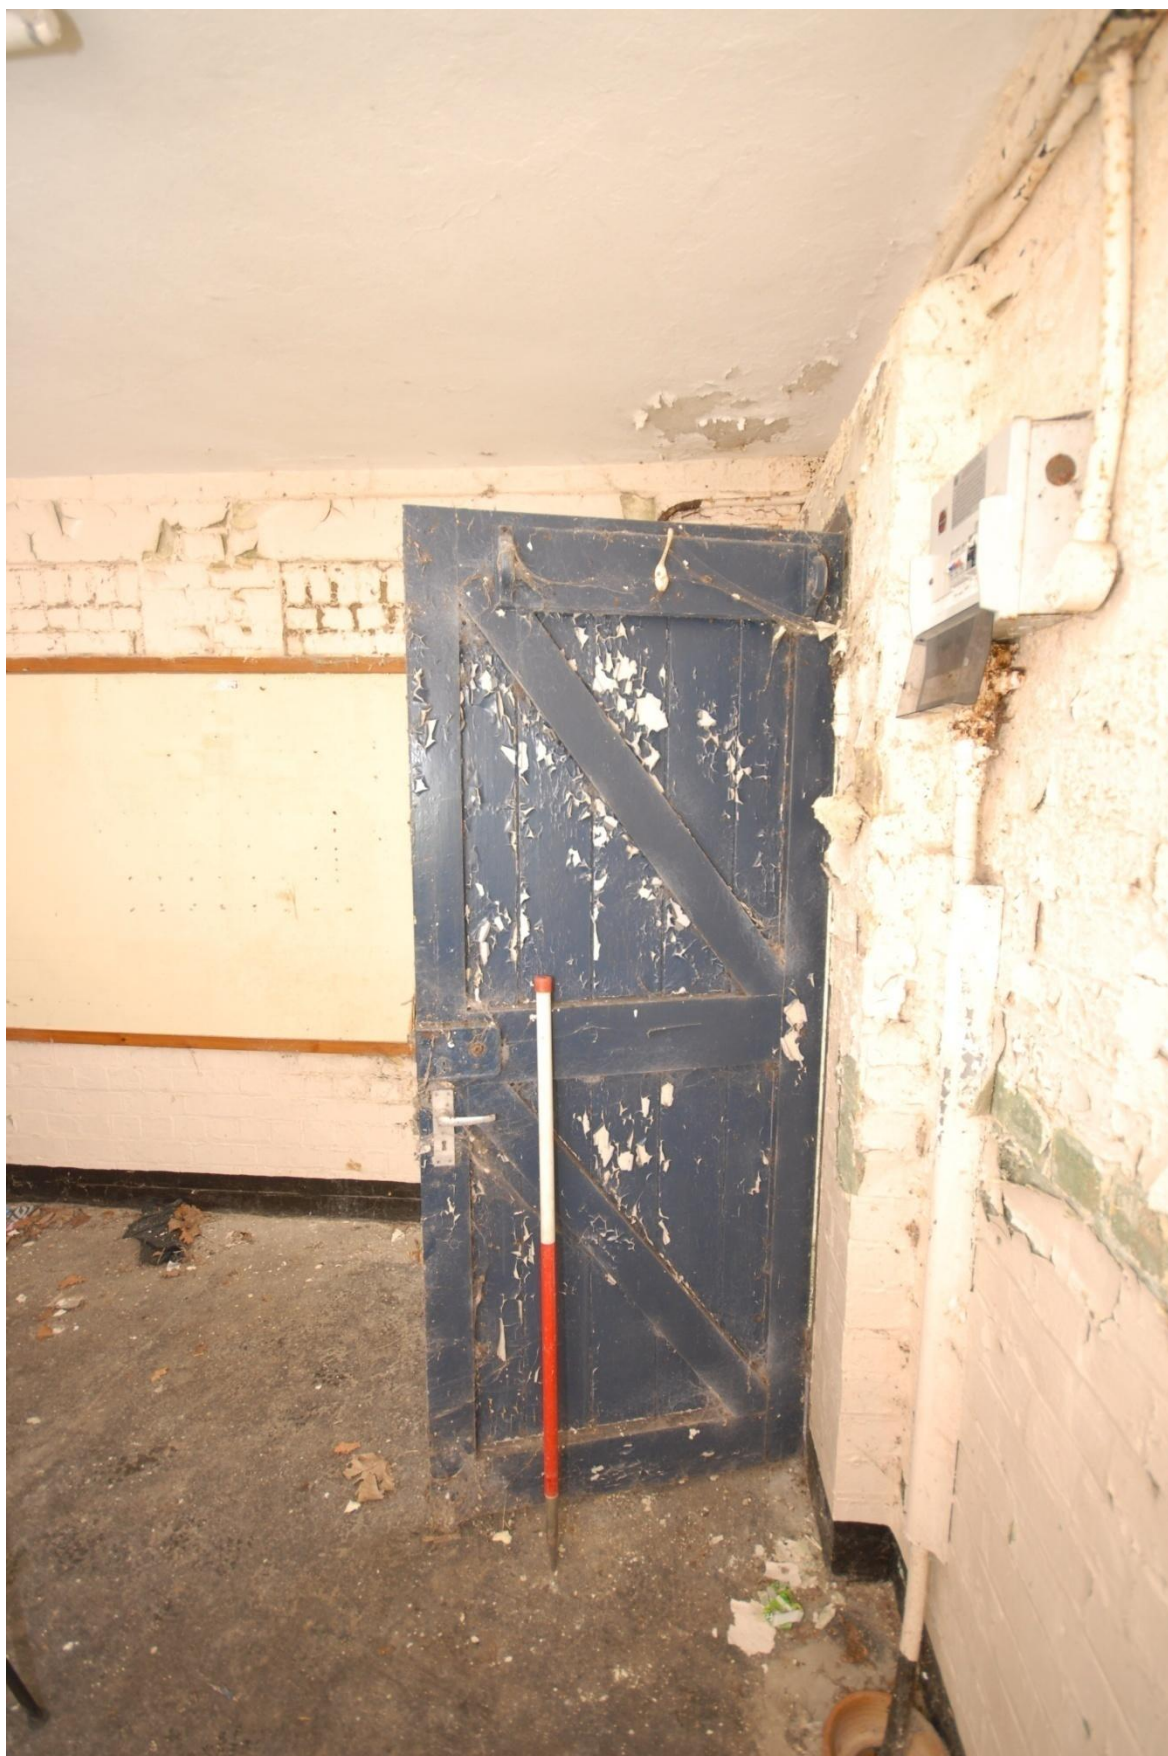
Fig 24

Building 13; original door
