An assessment of
three dormer windows
at Barton Seagrave Hall,
Northamptonshire

28 November 2005

AN ASSESSMENT OF THREE DORMER WINDOWS AT BARTON SEAGRAVE HALL, NORTHAMPTONSHIRE

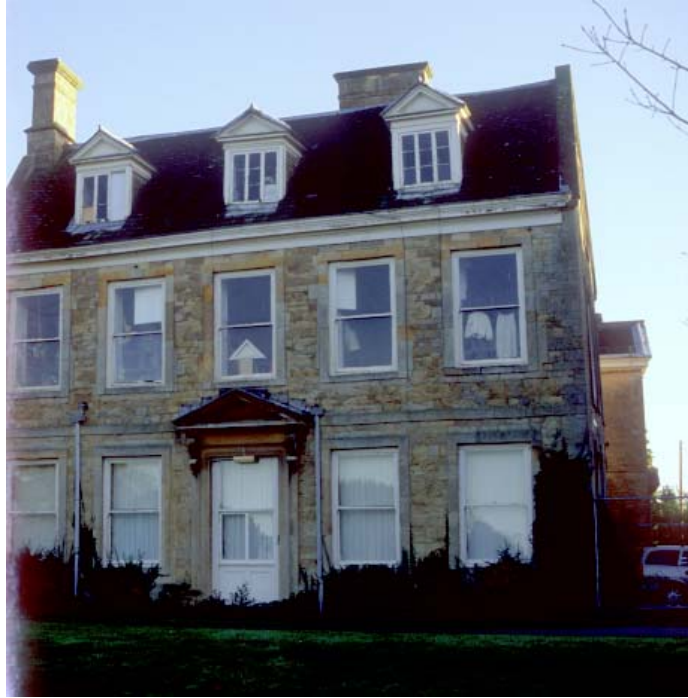
Plate 1 The west wing from the west

- 2.1 The Hall is a fine building comprising various phases of construction; the west wing which contains the three dormer windows is Georgian according to Pevsner (Pevsner and Cherry 1973). The dormers sit within the attic storey of the five bay west front of the house overlooking the garden on that side (Plate 1). Each dormer is of the same configuration, is pedimented and contains nine lights set in two casement windows, one of three lights, the other of six (Plates 2 and 3). Only the casements are in need of repair, the structure of the dormers is sound and will not be replaced. Since the dormers are set within the roof they could only be viewed from the ground externally, but each was examined from inside the attic rooms which they light.

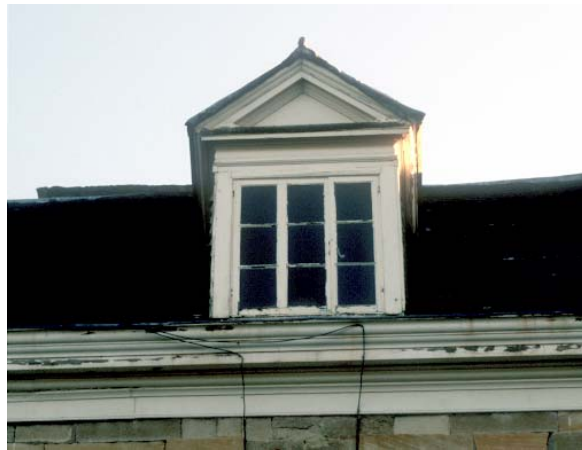
Plate 2 The southernmost dormer

- 2.2 The southern windows two light a single room; the casements are made of pine painted white, the moulding size and profile suggests a late nineteenth/early twentieth century date. Each is fitted with sliding iron bolts at top and bottom, these have monkey tail terminals but are modern (i.e. late nineteenth/early twentieth century). In the centre of the edge of the frames that open outwards are swivel catches, these are cast metal and stylistically suggest an early twentieth century date, most probably 1920s/30s. The casement stays are cast in the same style and are of the same date. Some glass has fallen from the windows due to the fragility of the frames, some of which have had attempts to repair them using narrow iron plates. However, due to the rotten nature of the wood these plates have been unsuccessful.

- 3.2 It is the opinion of the author of this report that they have no historic value in themselves as they are secondary fixtures and are now beyond repair. Wicksteed Trust carpenters are understood to have already made measured drawings of the casements and are ready to make new ones; the existing window glass and fittings are to be re-used on the new frames. This seems the most sensible and logical option and will prevent further deterioration of the roof structure.

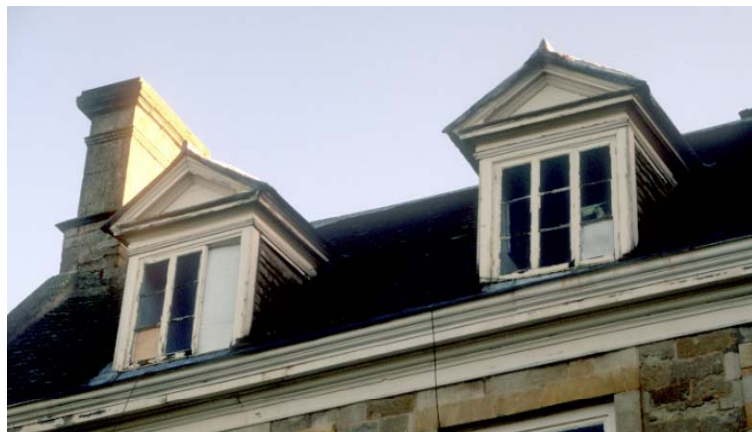
Plate 3 The central and northern dormers

- 2.3 The third dormer which lights a smaller room at the northern end of this wing is in the worst condition (Plate 3, left hand window). The three light casement has fallen out completely and is presently stored on a landing, in the six light casement some glass has fallen out and has been replaced with plywood sheet. Both casement frames are very rotten. The windows furniture is the same as in the southern room, i.e. all late nineteenth or early twentieth century.
