Archaeological observation, investigation, recording
and analysis on the Barford Road mains
replacement at Wilden, Bedford Borough

Report 13/85

May 2013

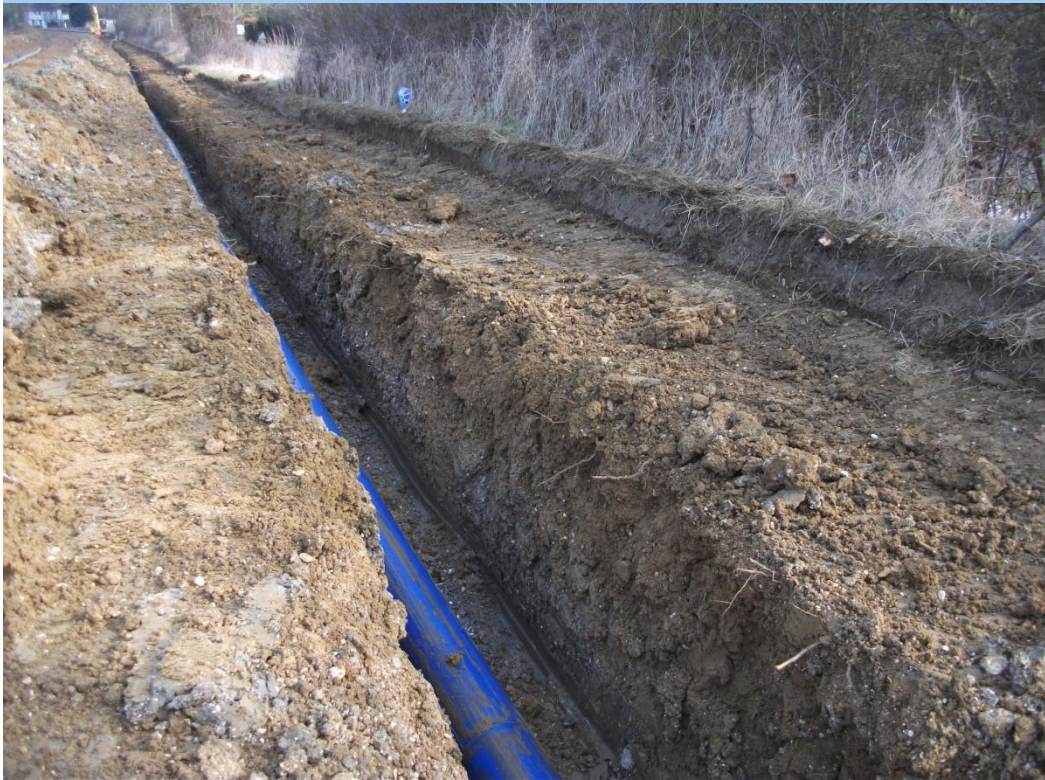
Front cover:	Pipe trench at chainage 1800-1900m, looking north-west
Fig 1:	Site location and Historic Environment Record data
Fig 2:	Sections through ditches and gullies
Back cover:	Pipe trench at chainage 200-300m, looking north-west

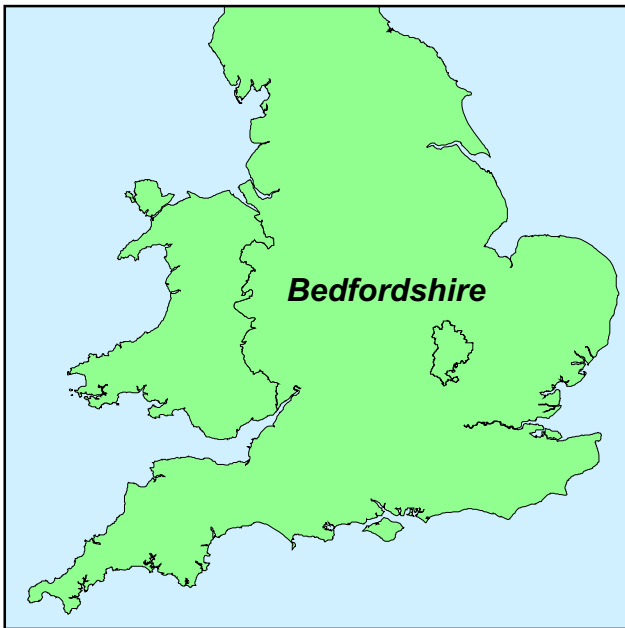
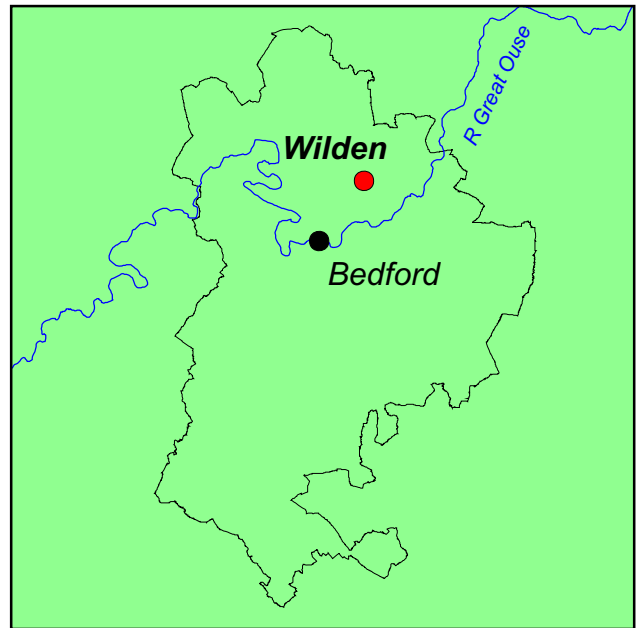
Site location and Historic Environment Record data Fig 1

A search of data held in the Historic Environment Record, detailing known sites, find spots and events within 500m of the pipeline, was requested and the results used to inform the watching brief fieldwork. The location of these heritage assets are shown on Figure 1 and Table 1. The list specifically excludes standing buildings, which are concentrated within the village of Wilden and relate to post-medieval settlement. Some of the older village buildings may have 16th-century origins, and are built upon timber frames, but most have received significant alterations during the intervening years and are likely to be of the 18th-19th centuries.

An area of cropmarks where Romano-British pottery has previously been recovered (HER1630) is located on the east side of Barford Road to the north of Northfield Farm. There are further areas of undated cropmarks showing linear features and a possible rectilinear enclosure on aerial photographs taken in 1971 and 1996, which also lie on or close to the route (HER589; 591; 1632).

Seven ditches were observed crossing the pipe trench during mechanical excavation, all of which were in the southern extent of the site on the west side of Barford Road (Figs 1-2). All of the ditches exhibited very similar fill constituents which may be an indication that their origins were of a similar source, given their close proximity. The majority of features were located within the area of chainage 700-800m. Ditch 115 was located near chainage 500m and ditch 117 was located near chainage 350m. None of the features produced finds or correspond with mapped post-medieval boundaries, and they are therefore undated.
