Archaeological Watching Brief at

Harvey Reeves Road/ Sixfields

Northampton

Report 05/93

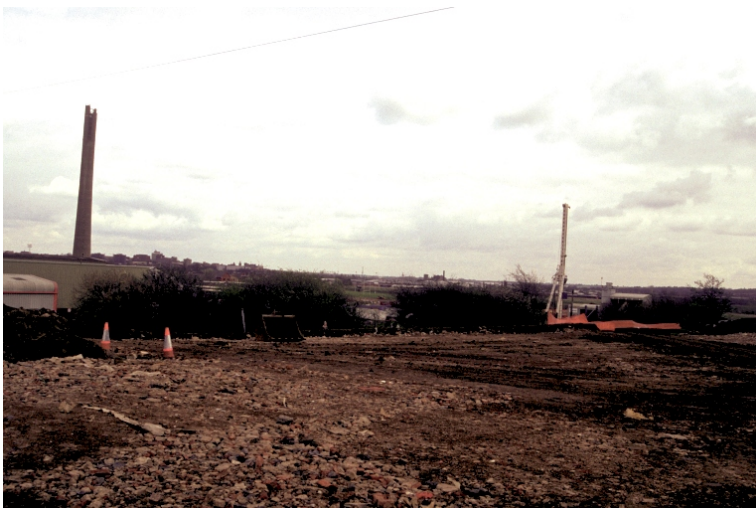
Plate 1: General site shot
looking towards Harvey
Reeves part of site.
Looking east

The area, comprising about 24 hectares, is sited to the south-west of Northampton, north of the River Nene. Most of the site falls within the 60-70m contour, with some within the 50-60m region. The northern third of the site is currently occupied by several sports pitches, which are to be retained. This is divided from the southern two-thirds, an area of un-used grass land, by a small watercourse. An embankment at the southern edge of the site divides it from the Duston Mill Reservoir (Plate 1).

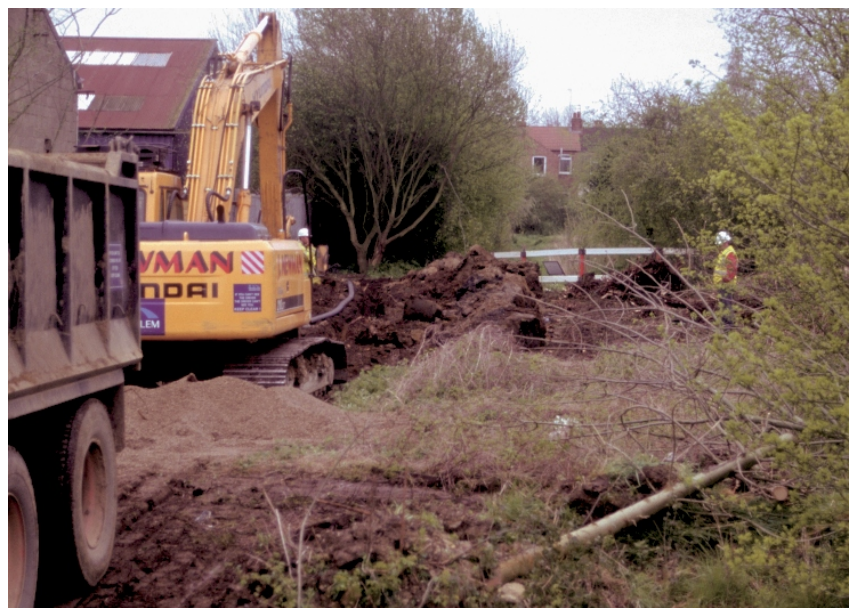
Plate 2: Working shot
in area of Trench 6

Trench 6 was 42m long and was located within the Halcrow easement area N to N1. It averaged a depth of 1.50m. It was aligned south-east to north-west to the north of man-made Sharman Road Lake. At the top of the trench there was a topsoil to the depth of *circa* 0.10m. Below this was a re-deposited brown sandy clay. No landfill or archaeological features were observed.

Continuous archaeological observation was maintained during the removal of all deposits overlying the natural geology, i.e. topsoil, subsoil, made ground. The strategy employed by Halcrow's contractors was to first excavate a set of five test pits, followed by a series of 0.70m wide trenches with two teams of JCBs. They averaged a depth of 2.50m, although occasionally they extended down to a depth of 4m. The total trench length was *circa* 730m (Fig 3 and Plate 2).

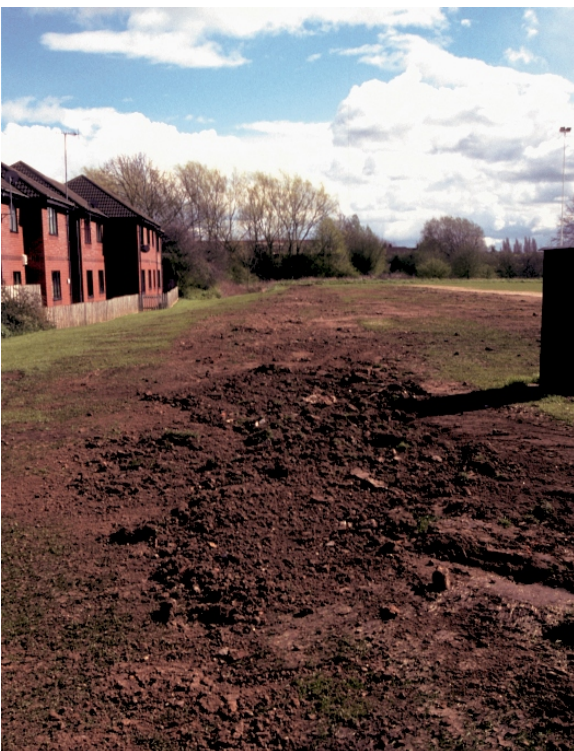
Plate 3: Trench 3 re-instated
Looking south-east

A photographic record was maintained of the works, including pre- and post-excavation shots, views of representative stratigraphical sequences and details of individual and groups of archaeological remains. Photographs were taken in both colour slide and monochrome 35mm film formats. Each shot included a title with the relevant contexts and site code, the direction of north and a photographic scale where practicable. Record shots were also taken of the site in general and re-instated trenches (Plate 3).
