**An archaeological watching brief  
at the Church of St Catherine, Burbage**

**Leicestershire**

**April - May 2005**

Report 05/142

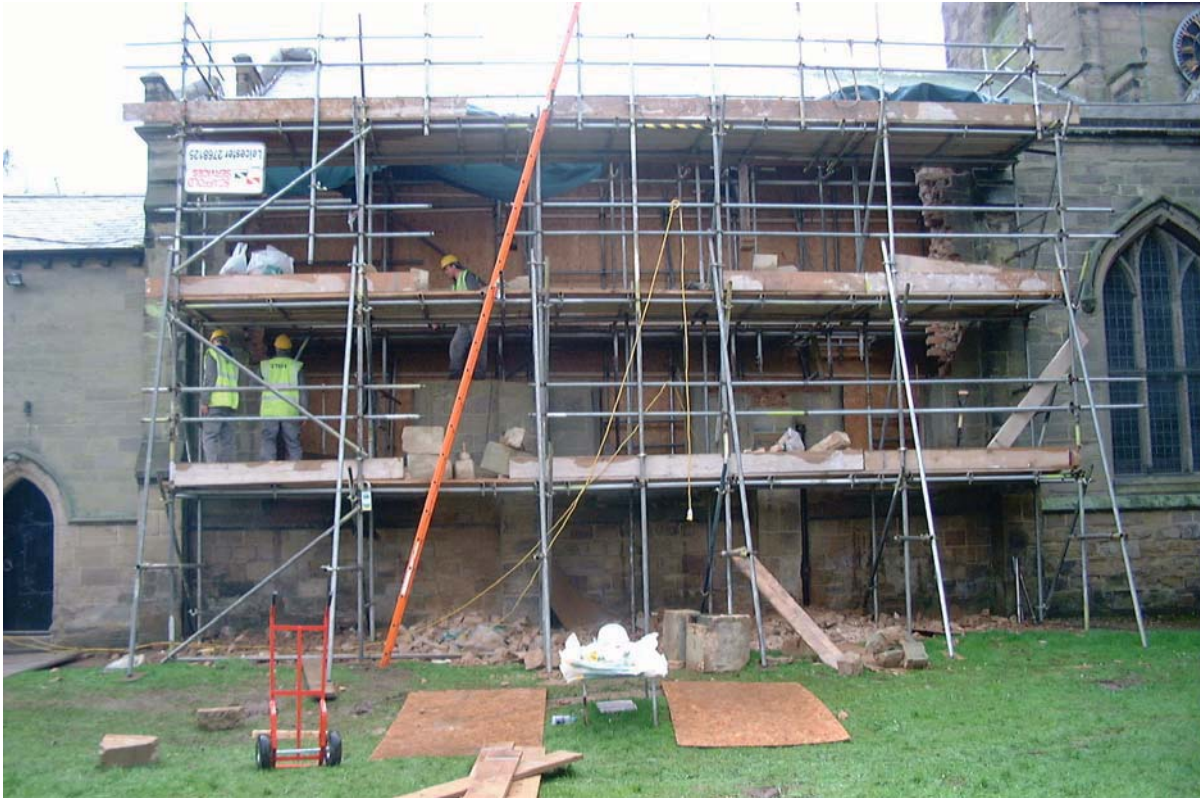
Plate 2: The north wall during dismantling

The north wall of the church was dismantled using a combination of hand tools and power-chisels (Plate 2). The existing windows and tracery were carefully removed and marked in order to allow re-assembly within the wall of the new extension (Plate 3). A photographic record was made of the wall prior to the start of work and during dismantling.

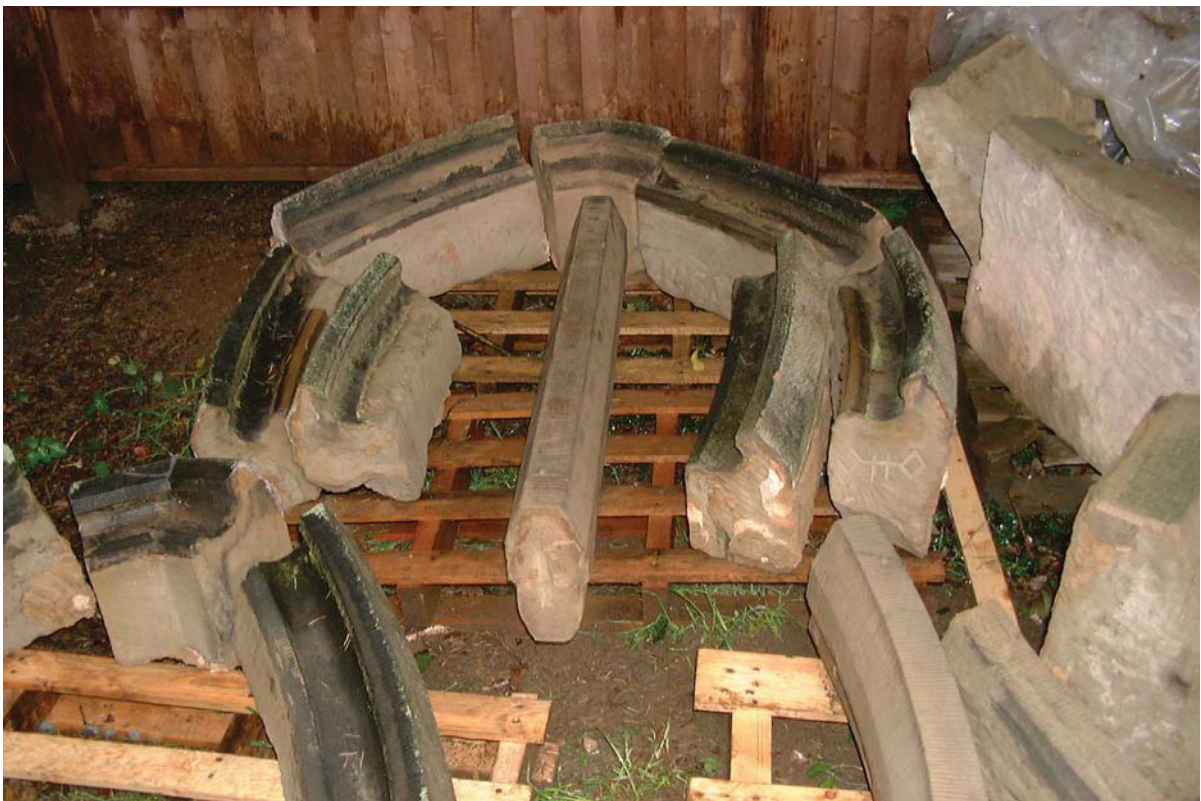
Plate 3: The windows and tracery after removal

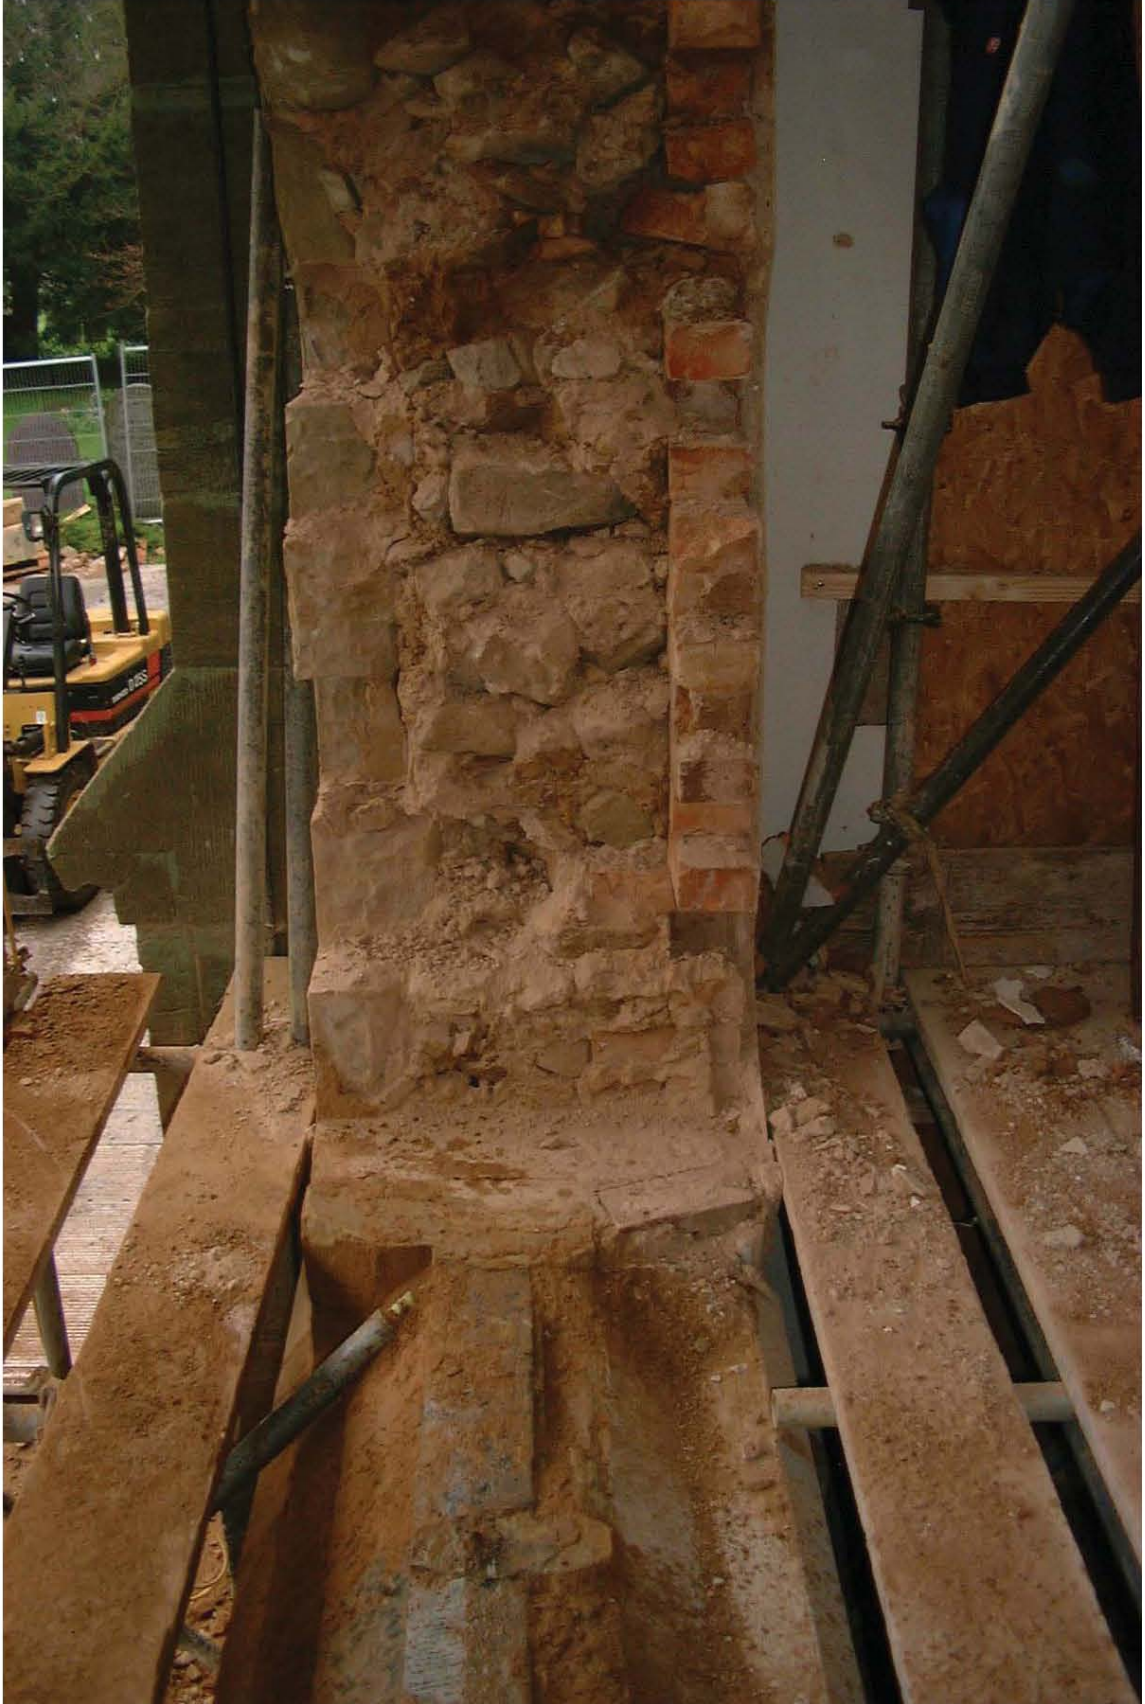
The wall construction comprised an inner face of red brick of 19<sup>th</sup>-century date, bonded with a compact, grey white mortar. The outer face comprised saw-cut limestone blocks bonded with mortar similar to that used in the inner brick face. The cavity between the inner and outer faces was filled with a loose rubble and pink/red mortar mix. The overall thickness of the wall was 1.1m (Plate 4). To provide additional stability to the wall the original builders had tied both wall faces together by means of bridging stones, these comprised both un-worked stones and architectural fragments. The architectural fragments showed no evidence of wear or weathering and would appear to be unused fragments from the 1842 re-build; a fragment was retained for the archive.

The north wall was dismantled down to 0.75m below present ground level, and the wall foundations continued below this depth. No evidence of masonry connected with the pre-1842 church, or any earlier archaeological deposits were revealed either within the foundations or within the fabric of the wall.

Plate 4: Section through north wall

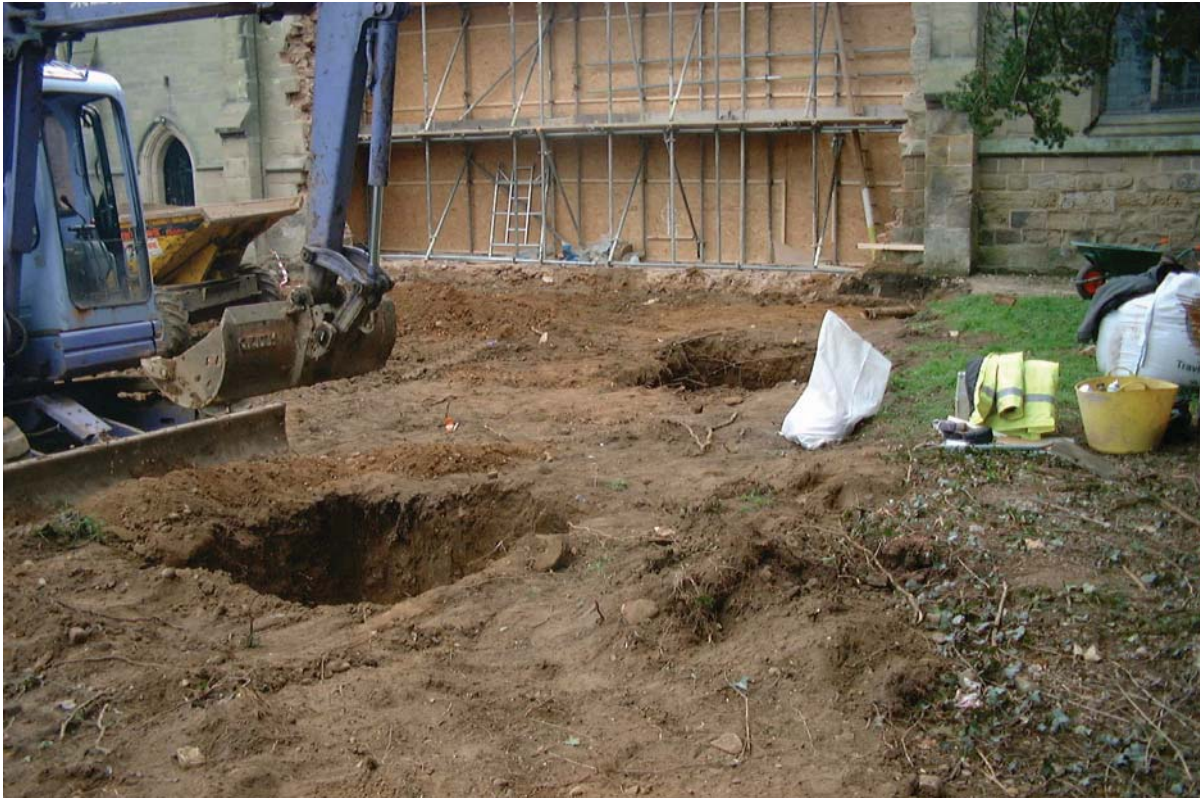
Groundworks for the foundations of the new extension began with the excavation of ten pits for load-bearing pillars (Fig 2 & plate 5). These measured 1m x 1m and were mechanically excavated to a depth of 0.9m below present ground level when the level of burials identified during the evaluation was reached. Hand digging was thereafter employed to excavate the remainder of the pits to a maximum depth of 1.50m, the level at which the lowest burials were encountered. Further mechanical excavation took place after the removal of the burials to increase the depth to formation level.

A similar stratigraphic sequence was common to all the pits. This comprised clean orange/red sand substratum, overlain by grey/brown demolition/levelling material up to 0.75m thick containing numerous fragments of 19<sup>th</sup> century and later ceramic building material. This in turn was sealed by grey/brown topsoil, up to 0.15m thick.

Plate 5: The excavation of the foundation pits

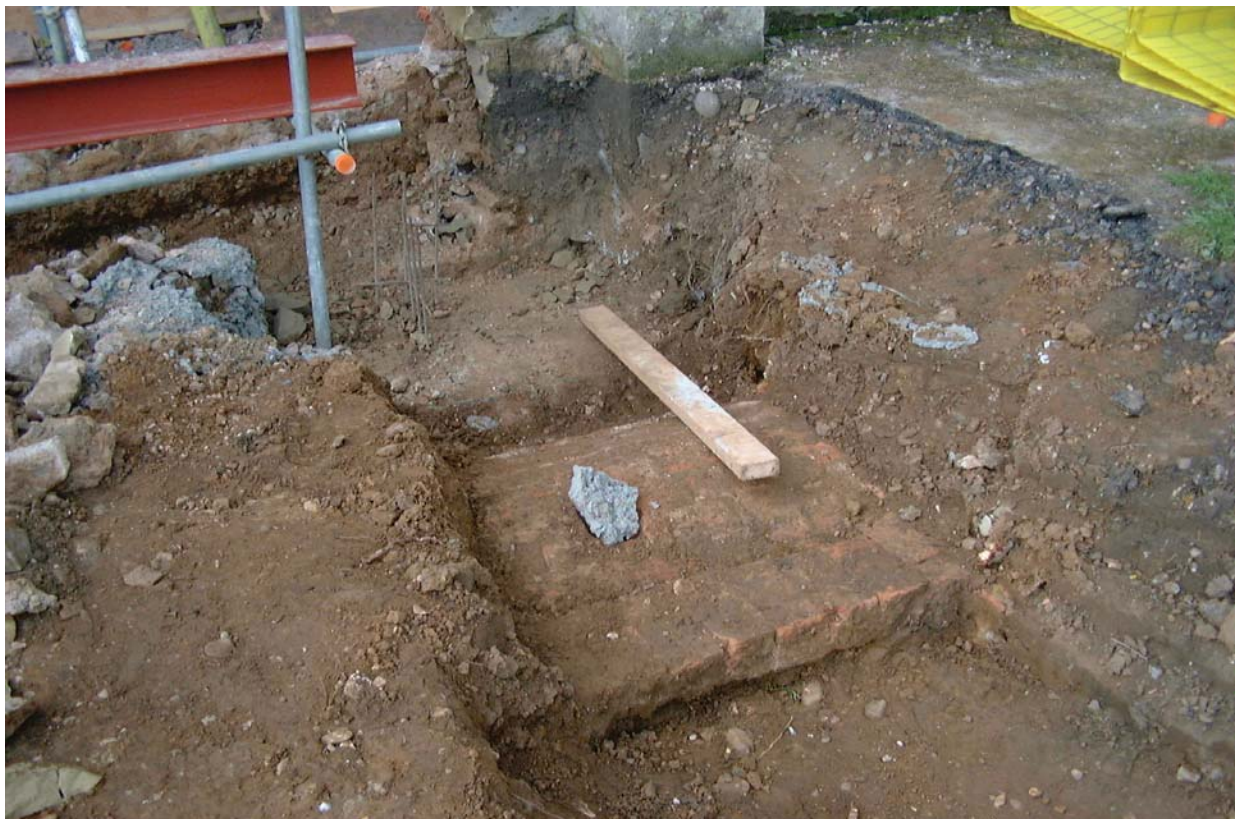
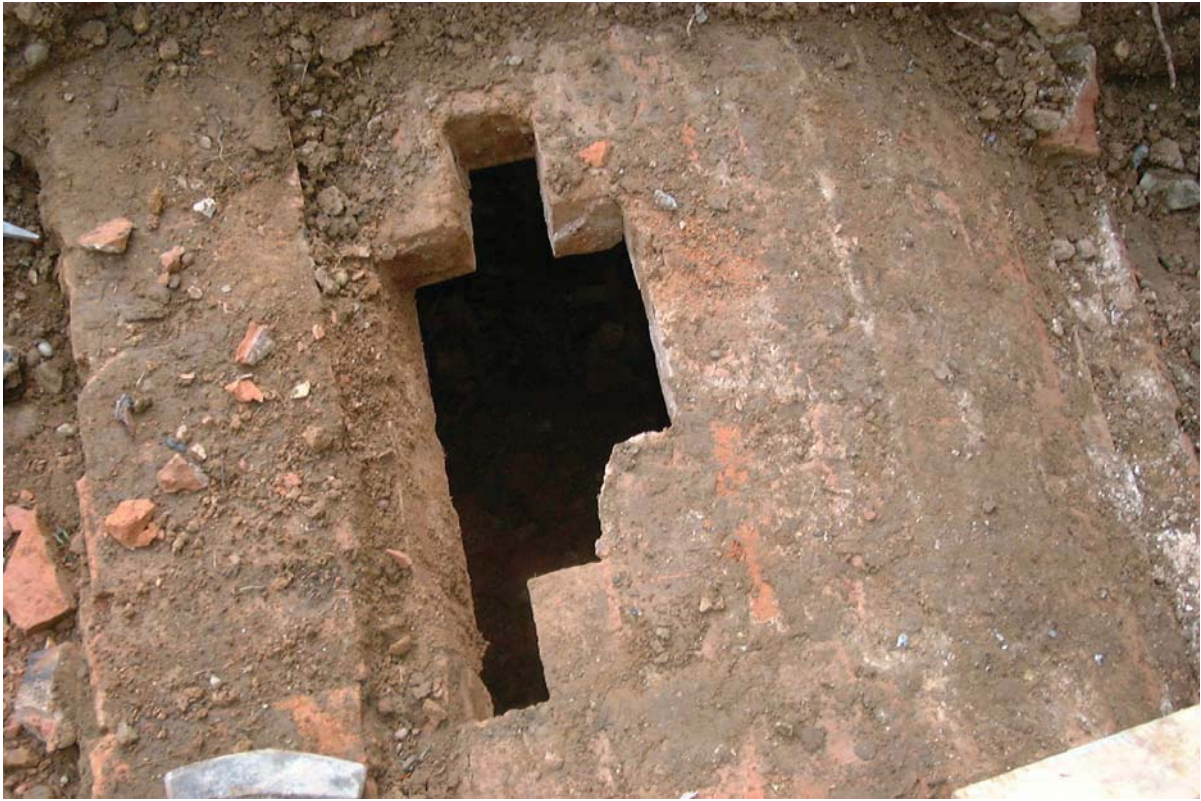
This was constructed of red brick bonded with hard grey/white mortar. It measured 2.20m in length with an outside width of 1.73m. The walls were of double brick thickness with a vaulted roof, again in red brick. Within the grave an adult male skeleton lay within the remains of a wooden coffin, with coffin furniture of typically 19<sup>th</sup> century date. It was not possible to ascertain whether further burials were interred below that exposed. Once recording was complete the grave was filled with clean dry sand in order to allow the concrete ring beam foundation to be bridged over.

Plate 6: Brick lined grave 1, as revealed

Plate 7: Brick lined grave 1, opening in progress

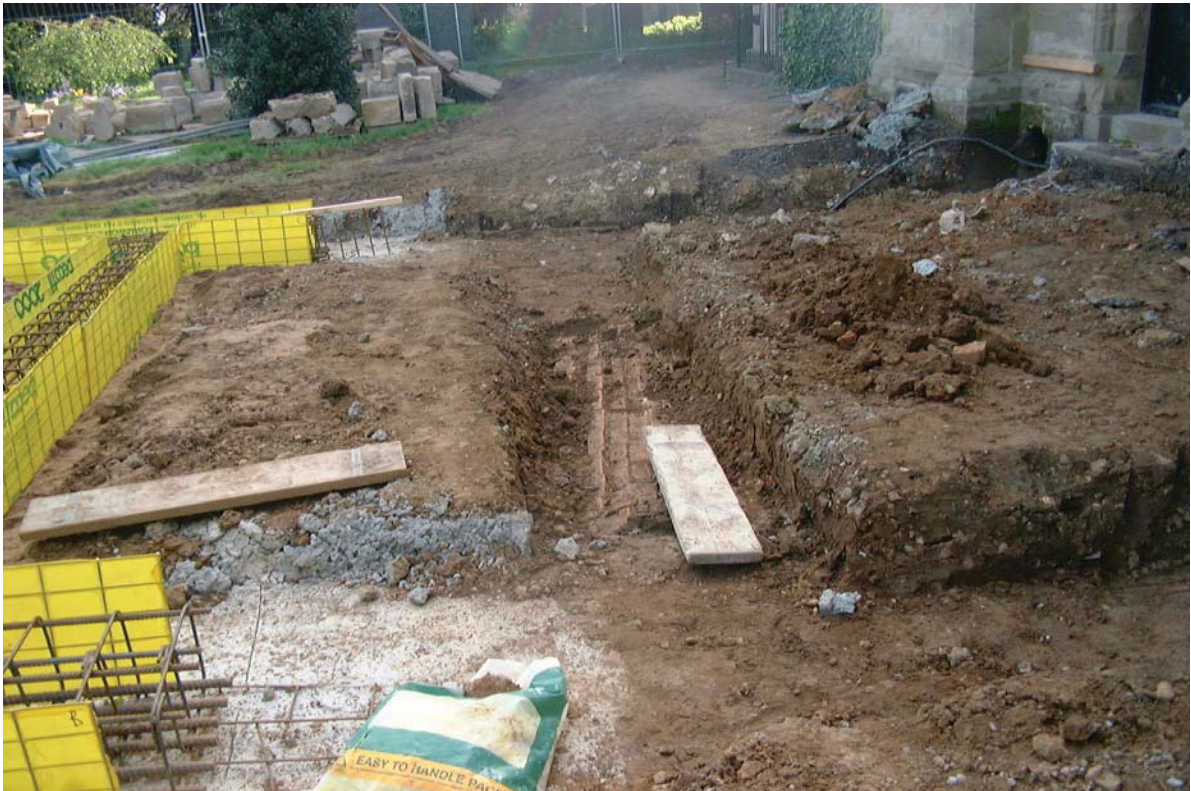
Grave 2 was of identical construction to grave 1. Within the grave were degraded remains of human bone and fragments of a wooden coffin. As with grave 1, the grave was filled with clean dry sand and bridged by the concrete ring beam foundation.

Plate 8: Brick lined grave 2
