Archaeological Watching Brief on the

Compound for the Anglian Water Sewage Scheme

Tansor and Cotterstock S101A

Report no. 05/38

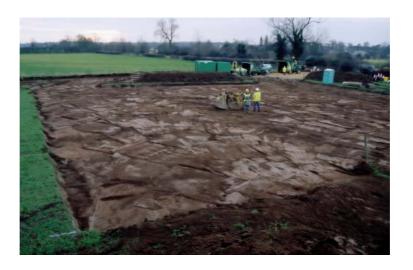
1	INTRODUCTION
2	BACKGROUND AND OBJECTIVES
3	METHODOLOGY FOR THE WATCHING BRIEF
4	WATCHING BRIEF ON THE COMPOUND
5	THE FINDS
6	CONCLUSIONS
	BIBLIOGRAPHY
	TABLES
	Table 1: Pottery occurrence by number and weight (in g) of sherds by fabric type
	FIGURES
	Fig 1 Site Location, scale 1:12,500
	Fig 2 Watching brief results overlaid on the geophysical survey plot, scale 1: 500
	PLATES
	Frontispiece View of compound after the removal of topsoil, looking south-west, 2 nd February 2005

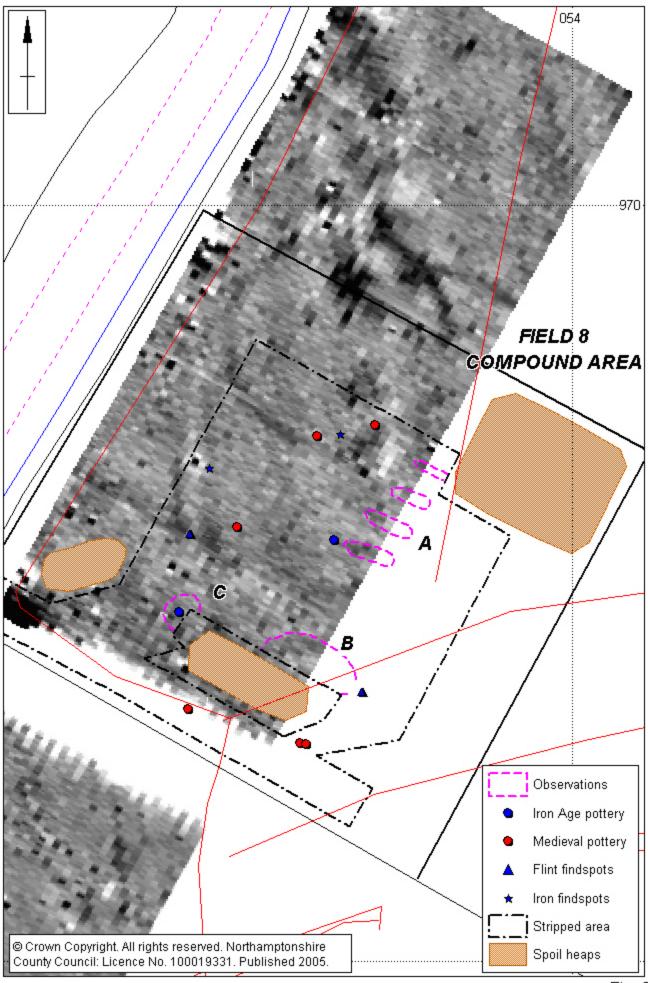
Fig. 2

A watching brief was carried out on the 31st January and 1st February 2005. Topsoil was removed in the imprint of the compound and from the verge at a new entrance through the hedge in the south-west corner of field 8 (Fig 2) by a 360° tracked machine fitted with a 2m wide toothless ditching bucket. At the entrance, a section of circular concrete pipe was added in the stream channel after the removal of some of the surrounding silty clay. The clay contained occasional large pieces of pantile. Topsoil at the entrance was 450mm deep.

Topsoil varying from 250mm to 500mm across the compound area, was removed to achieve a uniform, flat surface. The underlying subsoil was a brown silty clay with occasional gravel, possibly alluvial in origin. The natural ground surface was not exposed. Remnants of four parallel linear features comprising up to 20mm of remnant topsoil were present within the surface of the subsoil towards the north-east side of the compound area (Fig 2: A). These features probably represent the base of medieval/post-medieval furrows, and correspond with faint geophysical anomalies. A larger and irregular spread of silt at the south-east corner of the compound probably represents a slight natural hollow in the subsoil (Fig 2: B). Part of a semi-circular spread of clay was present at the south-east side of the compound, possibly a superficial dump which originated from the clearing of the nearby stream channel alongside the field (Fig 2: C).

There was no indication of the large circular, possible ring ditch feature nor the adjacent parallel features identified by the geophysical survey in the subsoil, which suggests that they are sealed by the subsoil. Several sherds of medieval pottery and an iron object were recovered from inside the circuit of the enclosure. Several other finds of pottery – two Iron Age, and the remainder medieval, as well as worked flints and iron were made from the remainder of the area and from spoil. None of the objects confirms the date of the ring ditch, which is presumed to be prehistoric.
