Northamptonshire Archaeology

An archaeological watching brief in the north-
western compartment of the Tiltyard Garden
Hampton Court Palace
February 2013

Report 13/159

September 2013

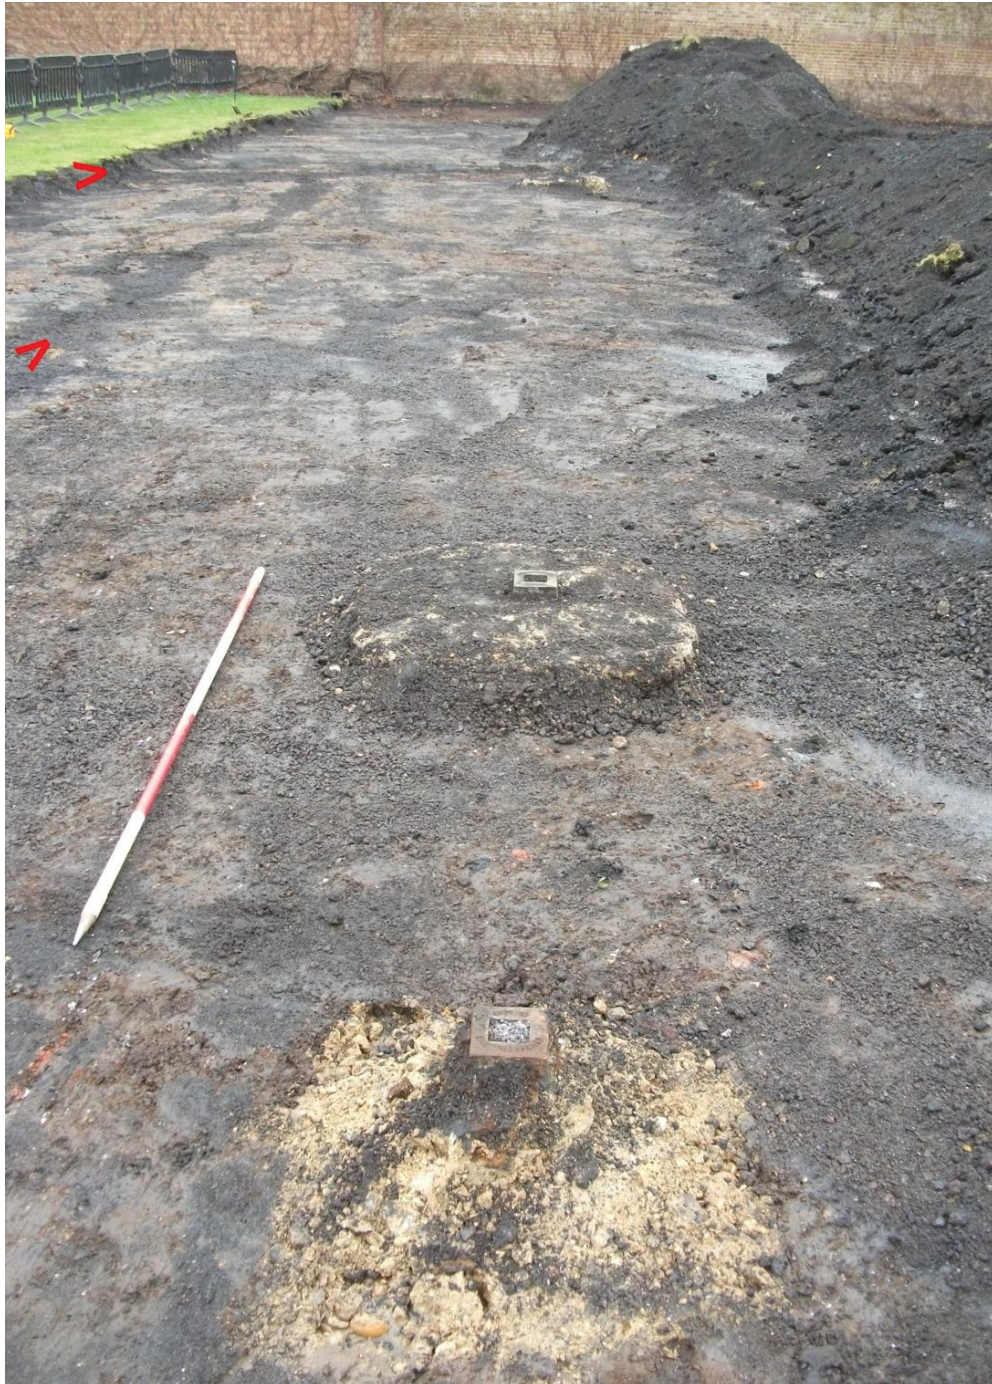
A series of cast-iron sockets were present for containing the posts that formerly held up the individual tennis nets. Five were set into square pits cut through levelling layer (121), and a sixth was in a pit cutting path surface (120). Each socket was square-sectioned, 0.12m wide, and was marked SLAZENGERS L^{TD} LONDON on its upper face (Figs 3 & 4). They were arranged in an east-west line, with regular spacings of 12.8m for net length (14 yards) and a c 2m gap between adjacent nets (Figs 2 & 3). Five of the socket-pits, [102], [104], [106], [108] and [112] were concrete-filled and had dimensions of c 0.8m across and 0.35m deep. The other [110] was filled with a softer deposit of mortar, and was only 0.6m across.

When the concrete pad was removed from socket-pit [104], a ceramic field drain was found to be adhering to its base. The drain (115) was tubular with a ribbed outer surface, and occupied a cut [114] which could be traced as a line of slight subsidence in the surface of (121). A similar line of subsidence indicated that another drain cut [116] approached [114] from the east (Figs 2 & 3).

Cast-iron sockets [110] and [108] formerly containing the posts that held up the tennis nets and field drain cuts [114] and [116] (arrowed), looking west Fig 3

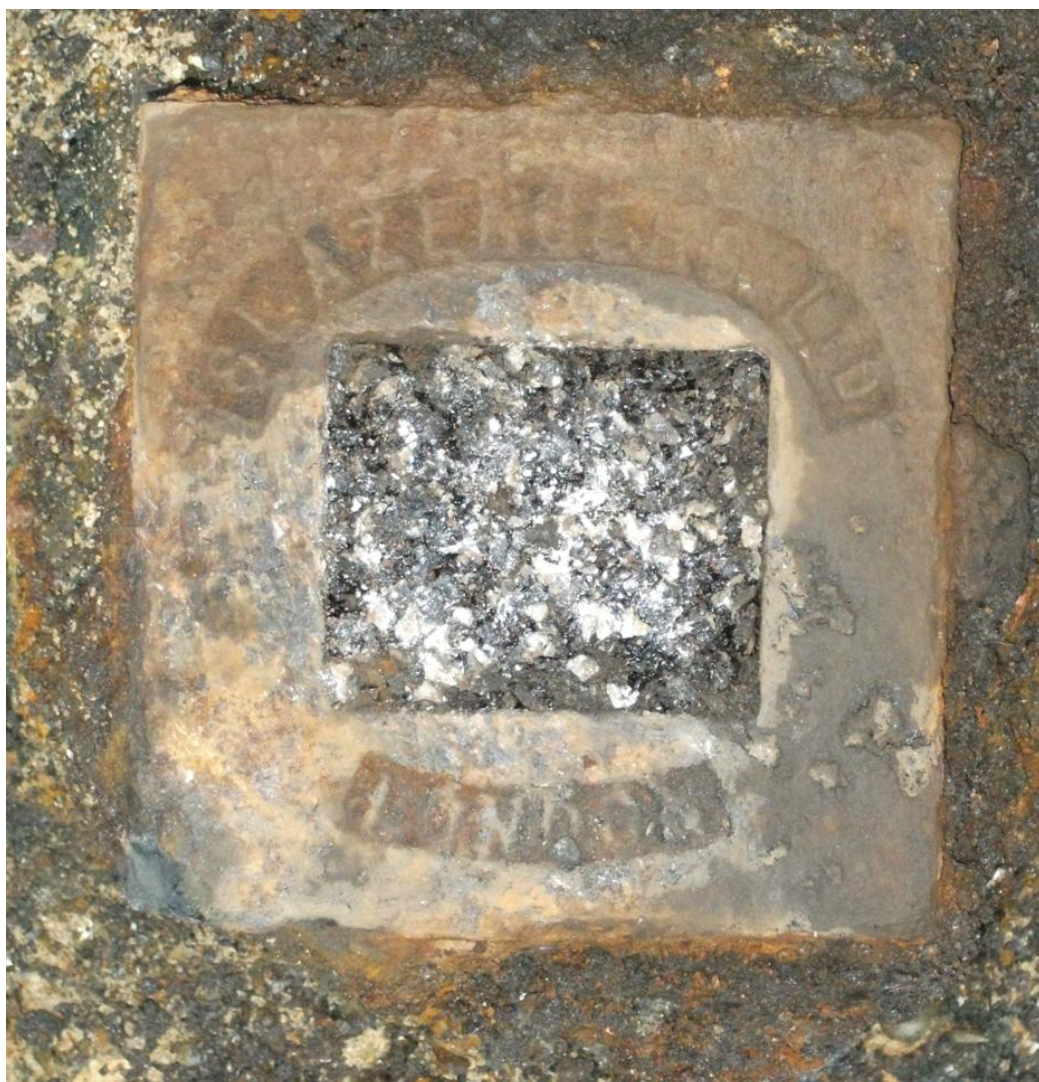
Cast-iron socket formerly containing a post that held up a tennis net
(dimensions 120mm x 120mm) Fig 4

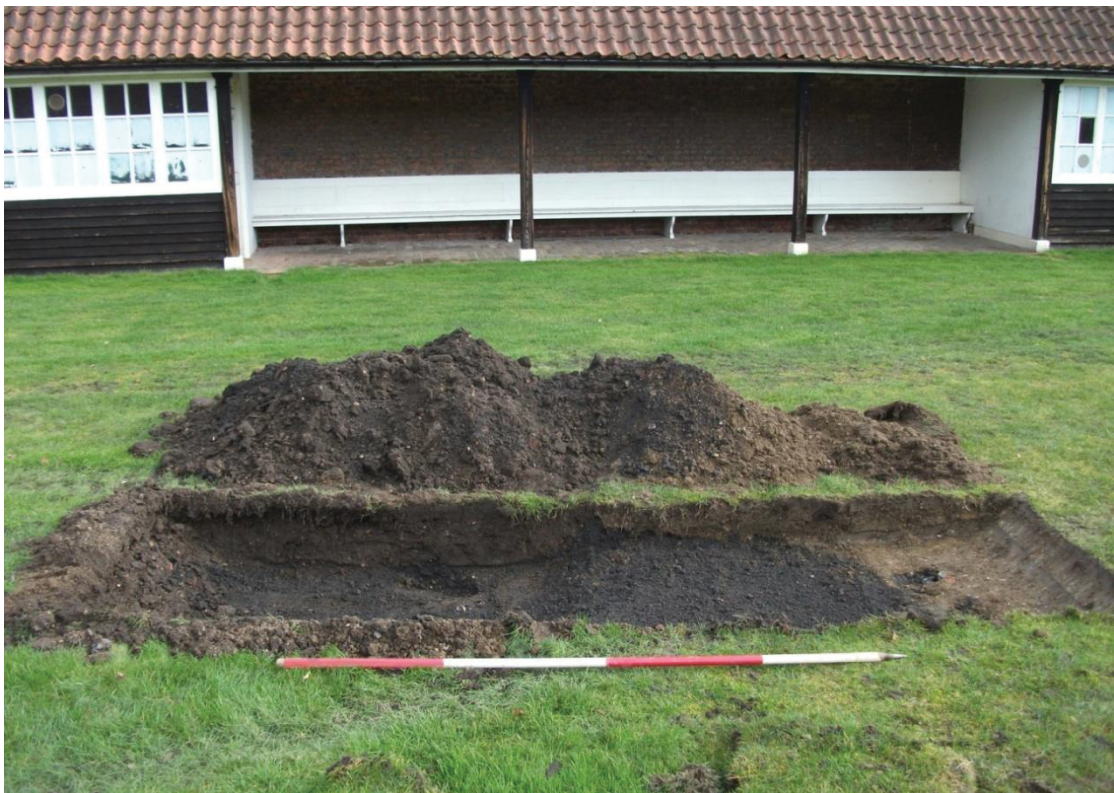
A small test pit was machine-excavated to the south of the main watching brief area to investigate the quality of the previous lawn re-instatement works (Fig 2). Particular aims were to confirm the presence of residual hardcore beneath the turf and to determine the cause of two zones of differential parching in the lawn.

The test pit was dug across the junction of the two zones, and showed that each was underlain by a layer of clinker and slag hardcore which represented the basal make-up of the former tennis court. There was a distinct contrast between the northern half of the trench, where the hardcore lay 0.35m below the turf and was overlain by a dark brown loamy topsoil, and the southern half, where it lay only 0.2m below the turf and was overlain by a sandy silt with abundant brick and mortar fragments. The transition from one zone to another was moderately sharp.

Test pit, looking east towards pavilion Fig 5

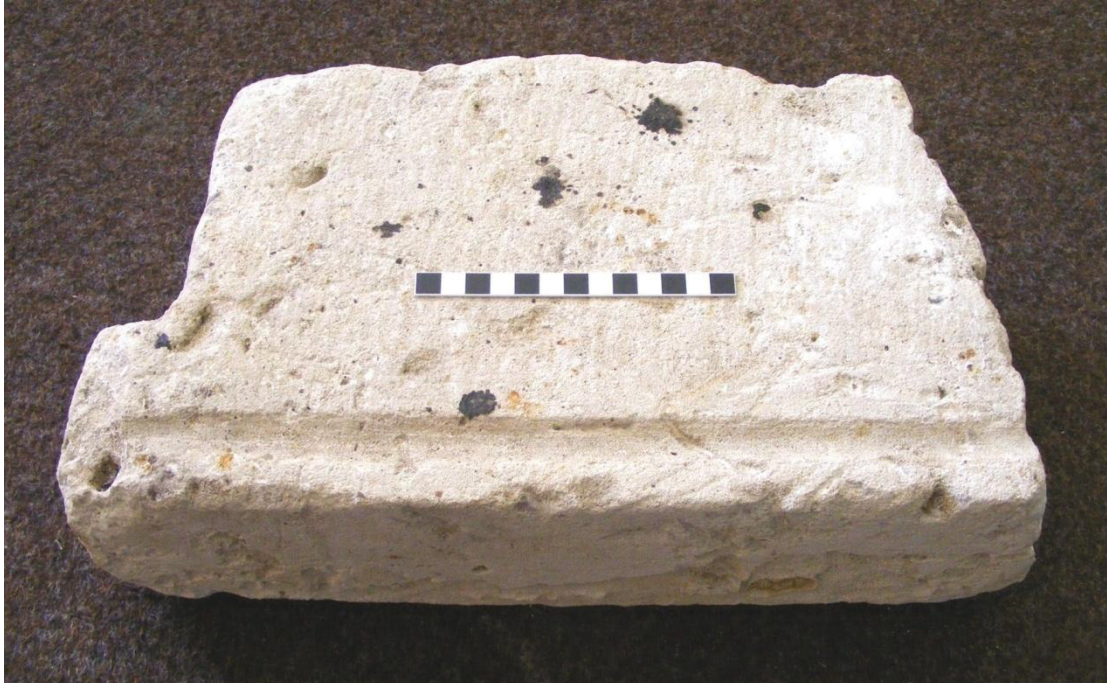
In the area where garden soil (118) and levelling deposit (121) merged, there was a localised spread of brick rubble and other debris (119), including a fragment of dressed limestone masonry (Fig 6). Although the rubble itself was not very modern, other finds from the same context, including fragments of glass bottles and a highly corroded sheet of zinc alloy, were evidently of 20th century date.

An architectural fragment was recovered from context (119). The fragment is broadly rectangular although it is incomplete in length (Fig 6). It is cut from fine grained

limestone and measures 220mm wide by 130mm deep and 400mm long. On the unbroken end of the stone there is a socket for joining the piece to another. On the underside of the piece there is a narrow channel running the length of the stone, which is likely to be a drip gully suggesting that the fragment may have been part of a window sill. There is no indication of date for the piece.

The architectural fragment (scale interval 10mm) Fig 6
