Archaeological evaluation  
on the site of the former church,  
Hartwell, Buckinghamshire  
May 2007

Report 07/143

**ARCHAEOLOGICAL EVALUATION ON THE SITE OF THE FORMER  
CHURCH,  
HARTWELL, BUCKINGHAMSHIRE**

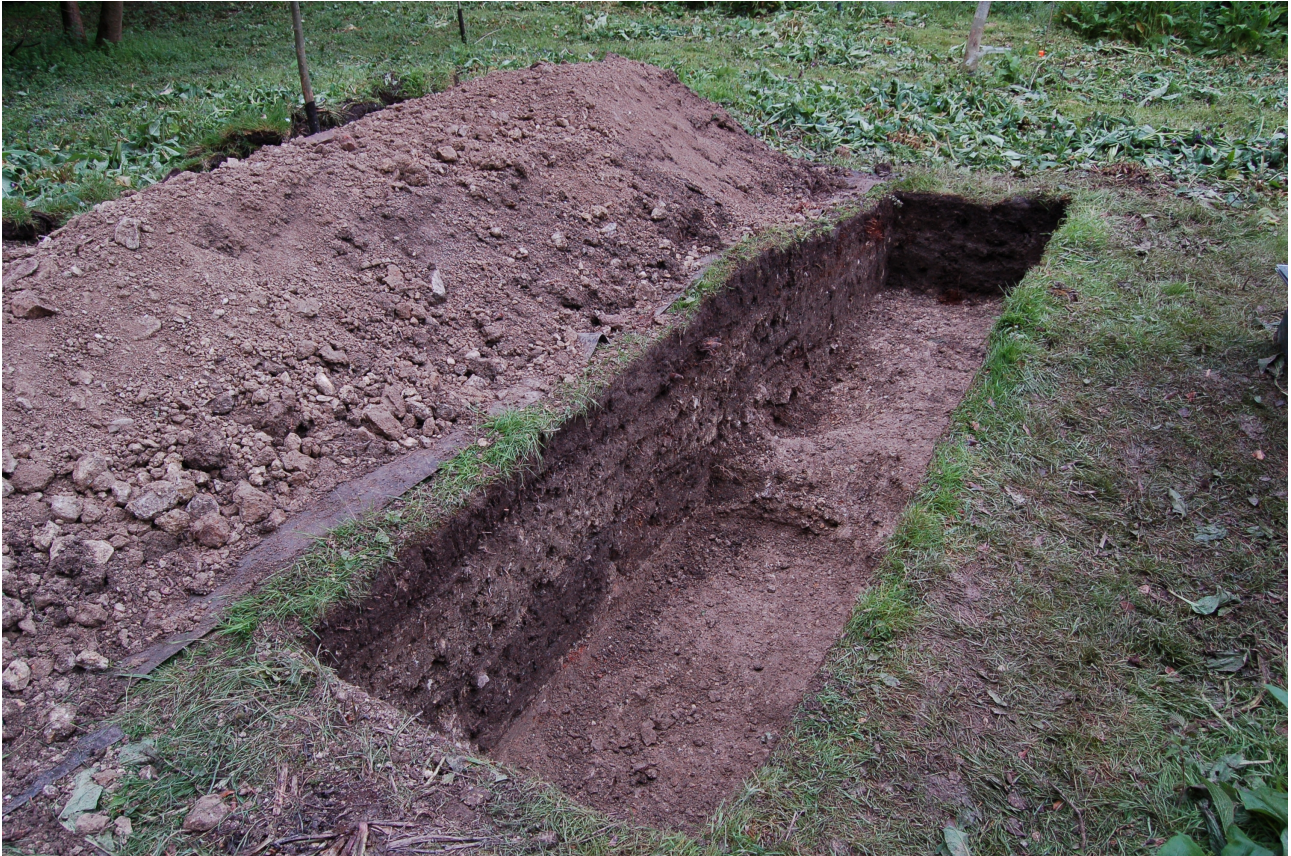
Plate 1: The trench looking north-west.

- 5.1 The trench found no direct evidence of the former church. However, the depth of the rubble and re-deposited natural show clear evidence of a large amount of disturbance which is difficult to explain other than being part of an extensive programme of destruction followed by landscaping. The documentary research carried out by Mr Throssell based on historic map evidence clearly places the former church in the area and though geophysical survey has been carried out the evidence is equivocal due to the level of disturbance. Though disappointing that no walls, floors or other tangible features remain of the church building, such thorough destruction is not uncommon.

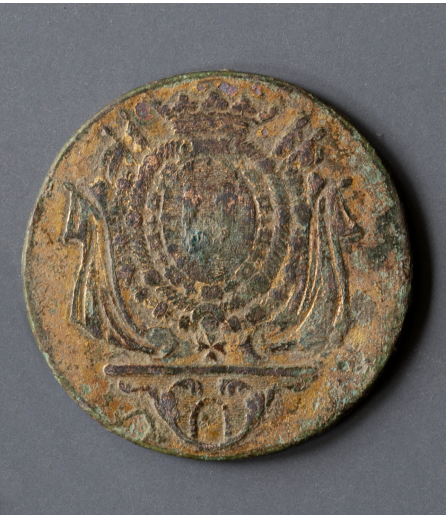
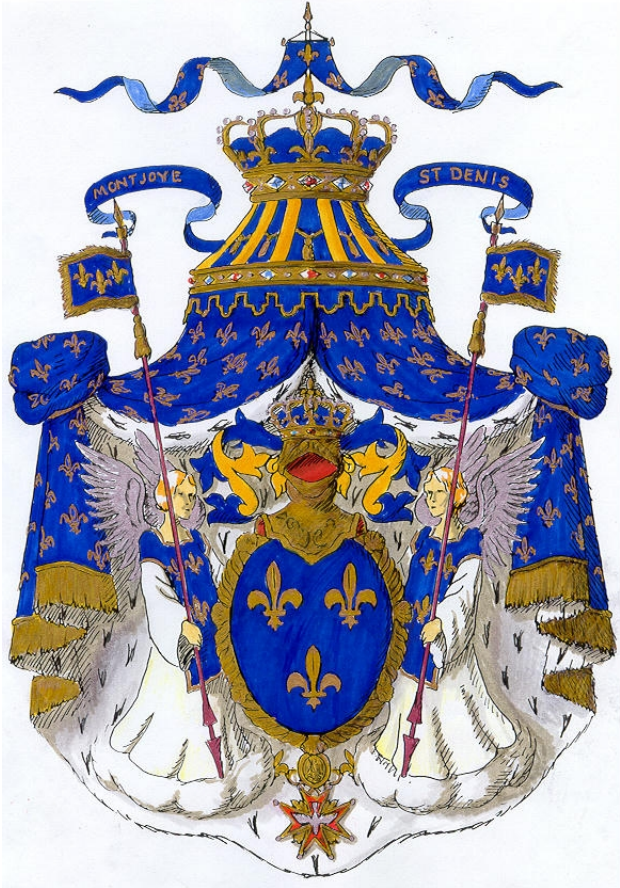
Plate 2: Gilded copper alloy button with Bourbon emblem and the Bourbon Coat of Arms

- 4.3 Other finds. These included two small fragments of glass, one from a window, the other from a vessel. Both are so small as to un-dateable. Two undiagnostic pieces of copper alloy sheet are similarly un-dateable. A gilded copper alloy disc is almost certainly a button (Plate 2). The front is decorated with a stamped image comprising a central oval cartouche within which are three fleur-de-lis. The cartouche is surmounted by a coronet and to either side are swags and flags. Below the cartouche is a Maltese cross above a horizontal bar beneath which is an arch flanked by foliate fronds. The reverse is plain apart from the faint scar of a central stub, presumably the remains of the loop with which the button was sewn onto fabric. It almost certainly dates to the period 1809-1814 when the French Court in exile was resident at Hartwell as it corresponds to the Bourbon coat-of-arms (<http://en.wikipedia.org>). It most likely comes from the livery of an attendant.

- 5.4 A gilded copper disc, almost certainly originally a button, may have been from the livery of an attendant to the French Court in exile, having as it does the emblem of the Bourbon coat of arms of the period. If this is the case it must date between 1809 and 1814 and presumably is the result of casual loss.
