Archaeological evaluation and watching brief
at
Stoke Park School and Community College
Dane Road, Coventry
Warwickshire
May – June 2007

Report 07/173

**ARCHAEOLOGICAL EVALUATION
AND WATCHING BRIEF
AT
STOKE PARK SCHOOL AND COMMUNITY COLLEGE
DANE ROAD, COVENTRY**

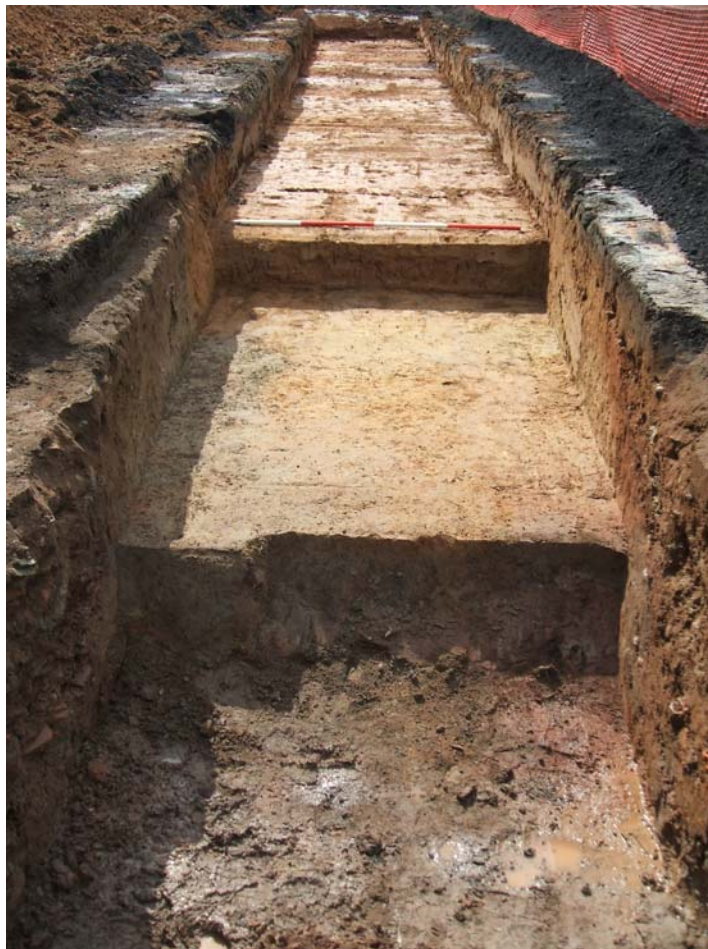
Plate 1: General view of Trench1, looking west

One 23.5m long trial trench was excavated using a mechanical digger fitted with a 1.8m wide toothless ditching bucket under continuous archaeological supervision (Figs 5 and 6, Plate 1). Mechanical excavation proceeded as far as the surface of the natural geology, hereabouts a pale sand and pink/brown clay.

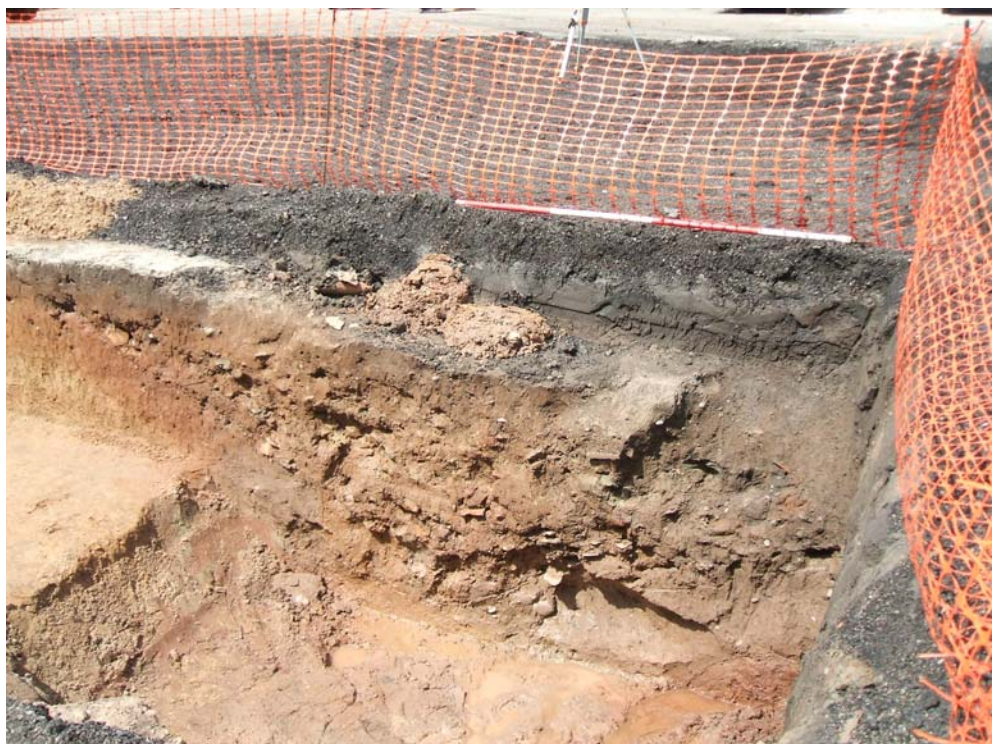
Plate 2: Trench 1, Section 1, ditch [116], foundation cut [109], pit [107], looking north

Cut into the natural red clay was a possible ditch [116], aligned north-south, with a wide, 'U' shaped profile and a narrow and shallow gully at the base (Figs 6 – 7, Section 1, Plate 2). It measured 3.10m wide to the limit of the trench and 0.90m deep and was filled with soft, light grey/reddish brown, silty clay (110), with inclusions of sandstone fragments.

A possible foundation trench [109] cut into the ditch fill (110). It was aligned north-south, with a wide 'U'-shaped profile and a stepped cut left over from a robbed out wall (Figs 6-7, Section 1, Plate 2). It measured 3.20m wide and 1.32m deep. Its fill (108) consisted of light red/brown sandy clay and contained 17th-century pottery, frequent tile fragments, fragments of green sandstone and Swithland roofing slate. Larger pieces of green sandstone fragments were present in the top 0.20m of the fill and a large squared block of red sandstone measuring 0.35m by 0.35m square by 0.20m deep may be the remains from the robbed out wall (Plate 4).

A third pit [107] was situated on the north-east corner of the trench and cut the robber trench (Figs 6-7, Section 1, Plate 2). It measured at least 1.60m wide and 1.12m deep, and had a 'U'-shaped profile. Its fill (106) was red/brown sandy clay which contained residual 13th-century pottery and fragments of green sandstone and ceramic roof tile.

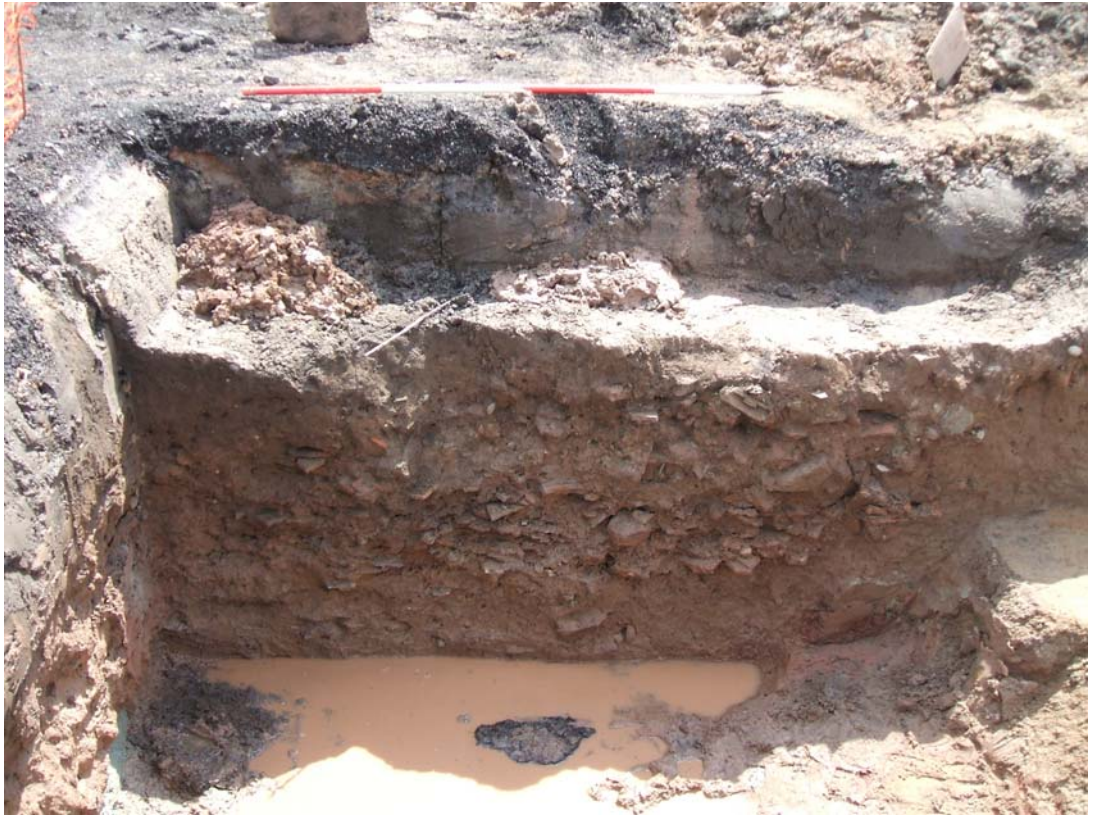
Plate 3: Trench 1, Section 2, ditch [116], pit [105], looking south

A large pit [105], cut the robber trench. It was situated on the south-east corner of the trench and was sub-circular in plan (Figs 6-7, Section 2, Plate 3). It measured more than 3.40m wide and 1.21m deep with steep sides and a flat base. Its fill (104) was mid brown/grey sandy clay which contained 19th-century pottery, fragments of red and green sandstone and a considerable amount of broken ceramic roof tile.

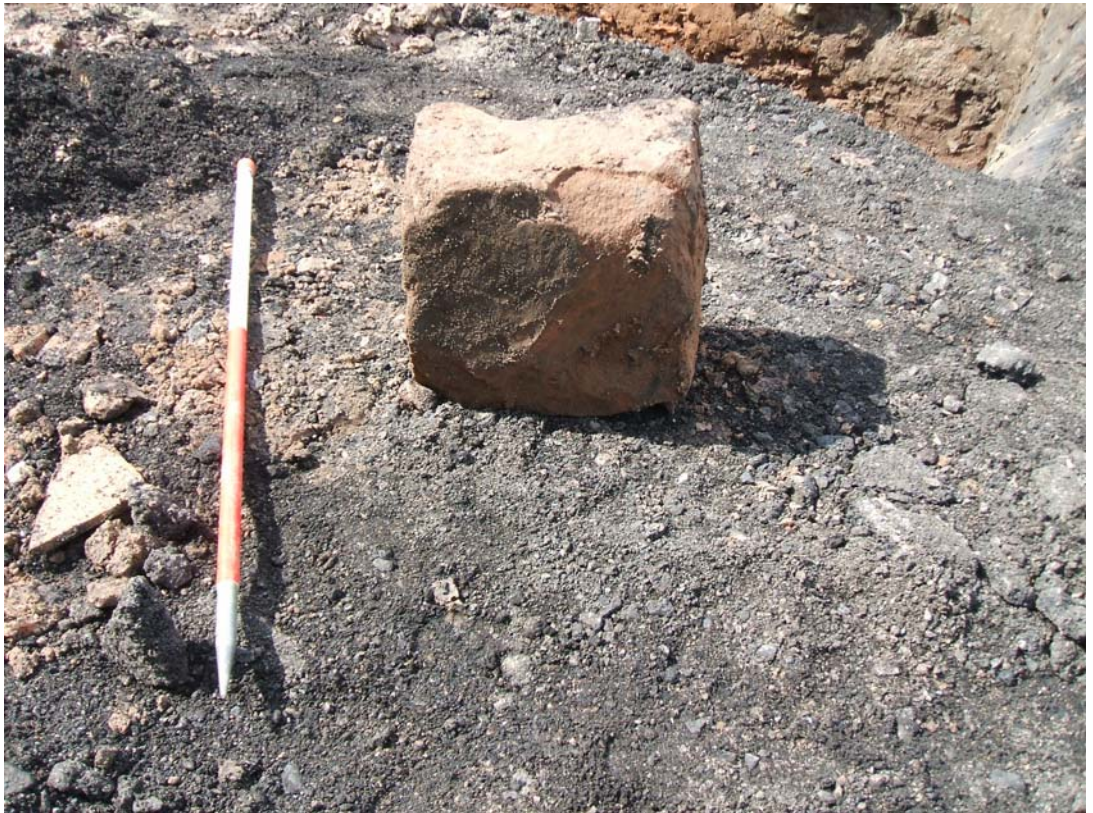
Plate 4: Red sandstone block from Trench 1

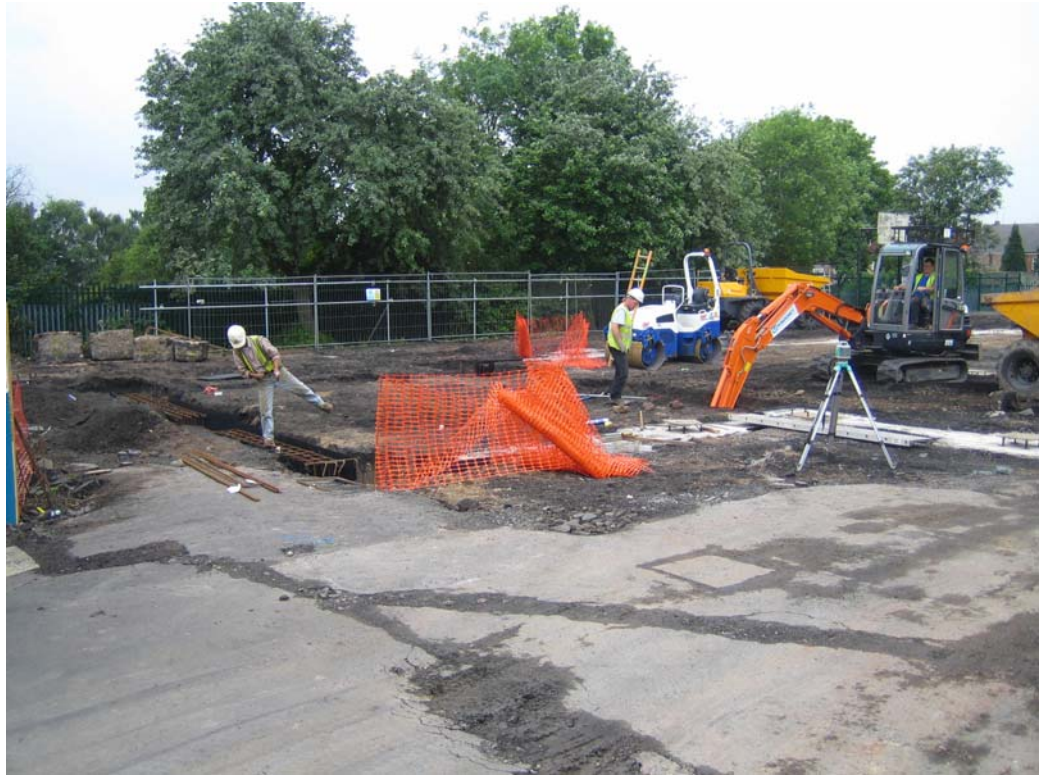
Plate 5: General view of watching brief area, note the square concrete base for temporary buildings centre right of photo, looking south-west

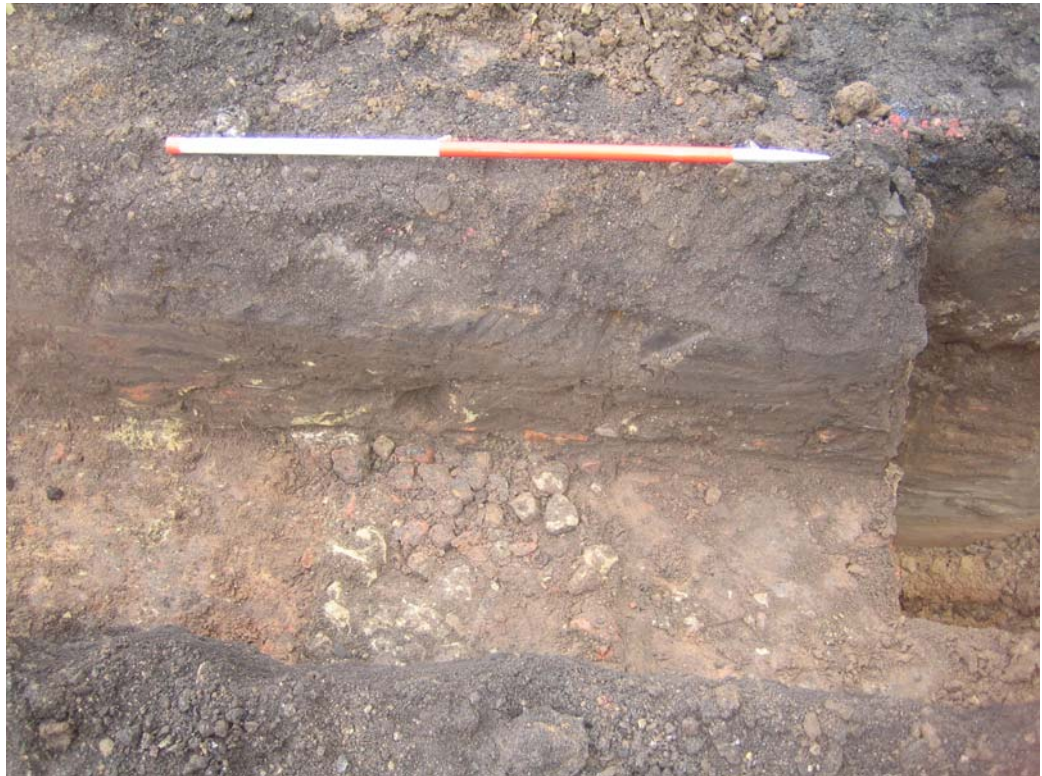
Plate 6: Watching brief, Section 3, wall (205), looking east

About 2.10m south, a construction trench [203] cut into the green/grey sandstone natural (208) and aligned roughly east-west (Figs 6, 7 and 8, Section 3, Plate 6). The trench had vertical sides but was not bottomed. It was 1.20m wide and was filled with dark brown, sandy clay-loam (204) containing a sandstone wall (205). The wall was 1.00m wide and built of roughly coursed irregular sandstone blocks up to 0.30m long, 0.20m wide and 0.20m deep and bonded with stiff red clay. Pottery from the construction trench fill was dated to the 15th –16th centuries.

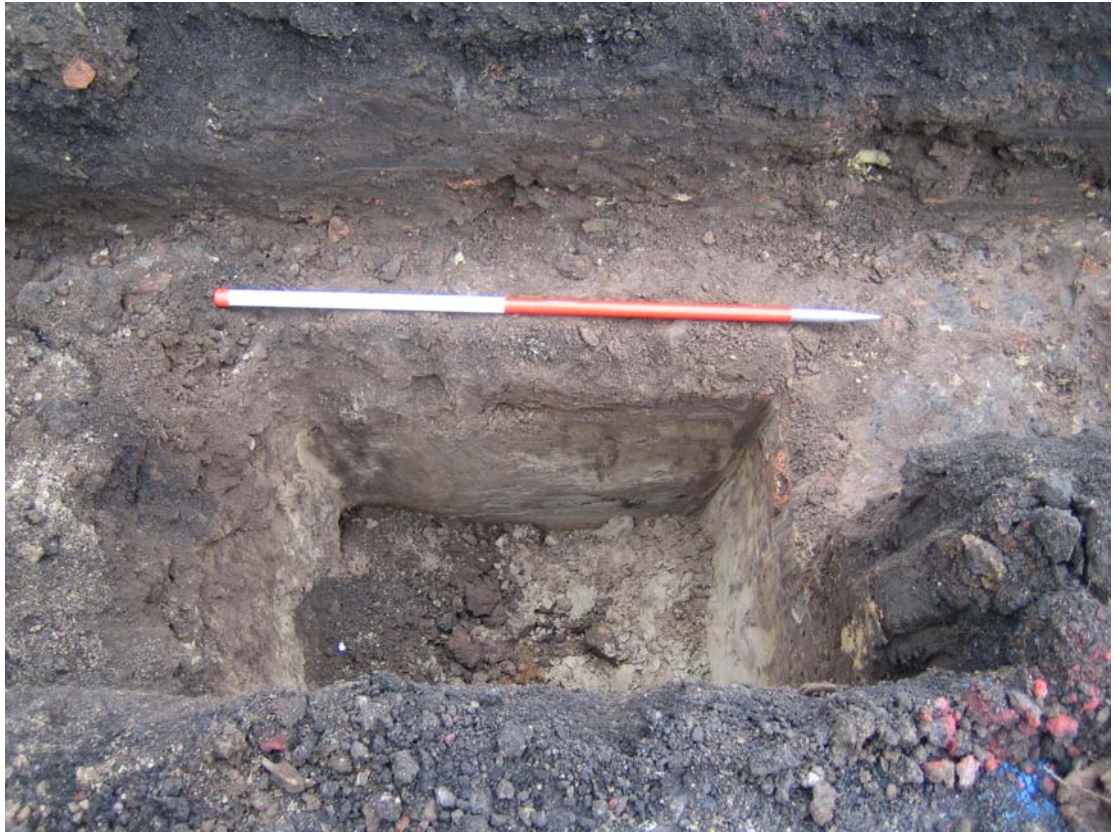
Plate 7: Watching brief, Section 5, pit [209], looking north

About 1.00m further south, the cut for the next stanchion base revealed circular pit [209] which was 1.00m in diameter and 0.60m deep (Figs 6, 7 and 8, Section 5, Plate 7). The pit was filled with dark brown sandy clay loam containing small fragments of red and green sandstone and broken roof tiles (210).

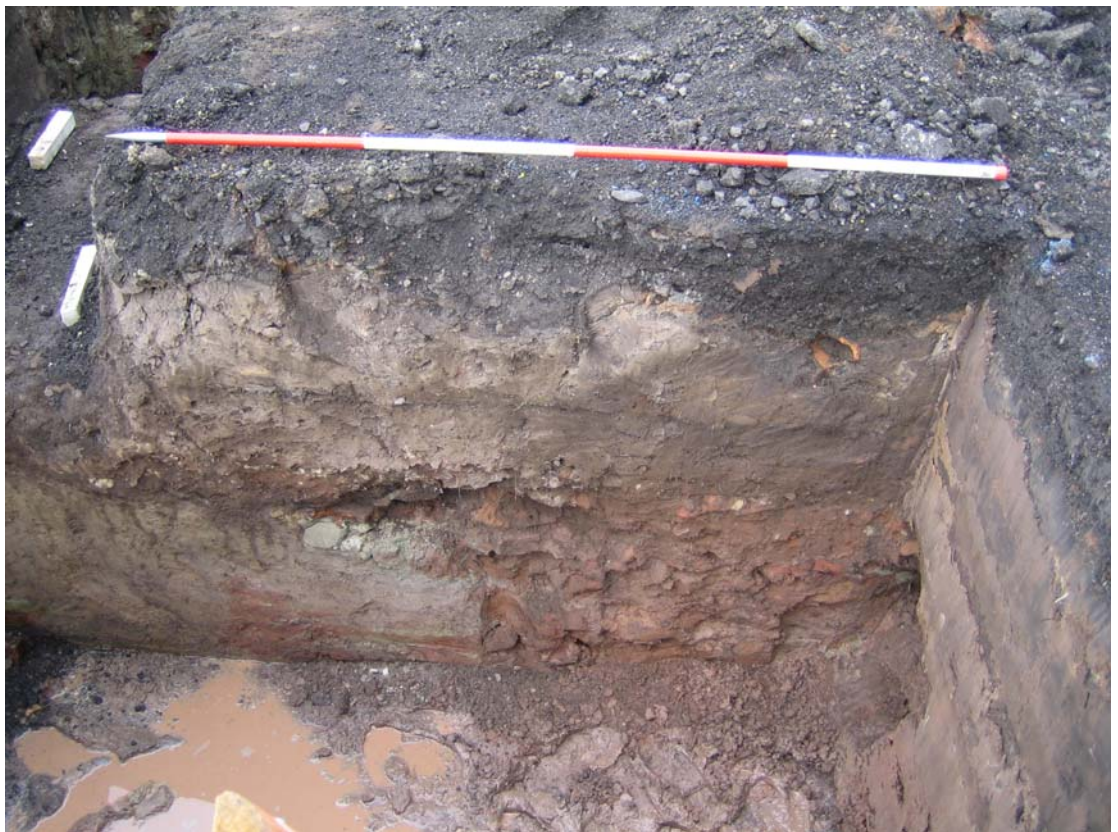
Plate 8: Watching brief, Section 6, wall (214), looking north

The two closely-spaced stanchion bases at the south-west corner of the watching brief area revealed a construction trench [213] aligned roughly east -west, with vertical sides and a flat base, cutting the natural green sandstone (Figs 6, 7 and 8, Section 6, Plate 8). It was 0.60m deep and 1.00m wide, and contained a sandstone wall (214) built of irregular and roughly coursed sandstone blocks up to 0.30m long, 0.20m wide and 0.20m deep which were bonded with stiff red clay. Overlying the wall was a mixed debris layer of broken red sandstone, red clay (215) and fragments of red roof tile. It was up to 0.30m deep and extended 0.50m to the north of wall (214). It appears to be a dump of broken stone, roof tile and clay bonding from the demolition and robbing of the upper part of the sandstone wall. The wall was truncated by the cut of a robber trench [211] at least 3.00m wide (probably 4.50m) with shallow sloping sides and a slightly dished base.
