A Programme of Archaeological Observation,
Investigation and Recording on land at
Bury Farm, Tilsworth Road, Stanbridge, Bedfordshire
December 2010 – May 2011
Accession No: LUTNM: 2010.99

Report 13/160

August 2013

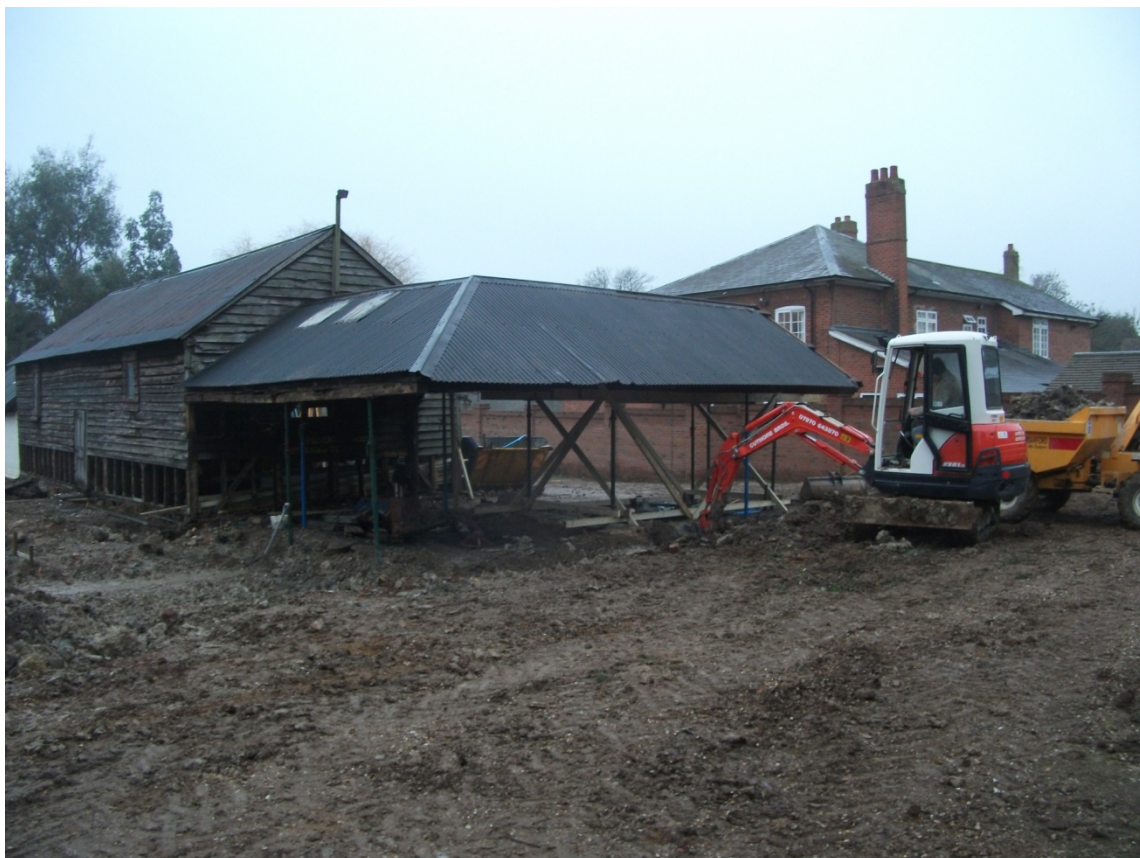
The existing barn and outbuildings, looking south-west Fig 3

The fieldwork was undertaken between December 2010 and May 2011 during groundworks for the construction of a new extension and the redevelopment of an existing barn and associated outbuildings (Figs 3 and 4) to residential and commercial use, along with a re-designed access and the construction of a new rainwater harvesting pond.

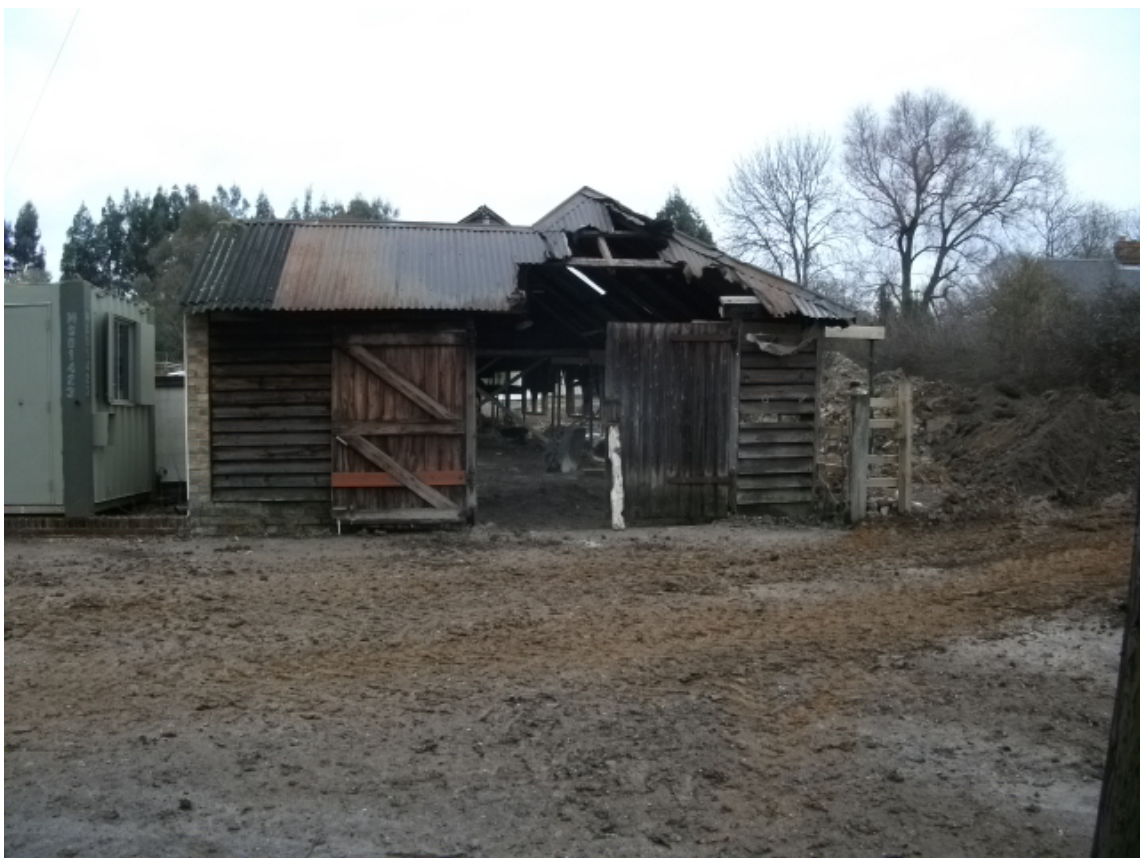
The existing barn and outbuildings, looking east Fig 4

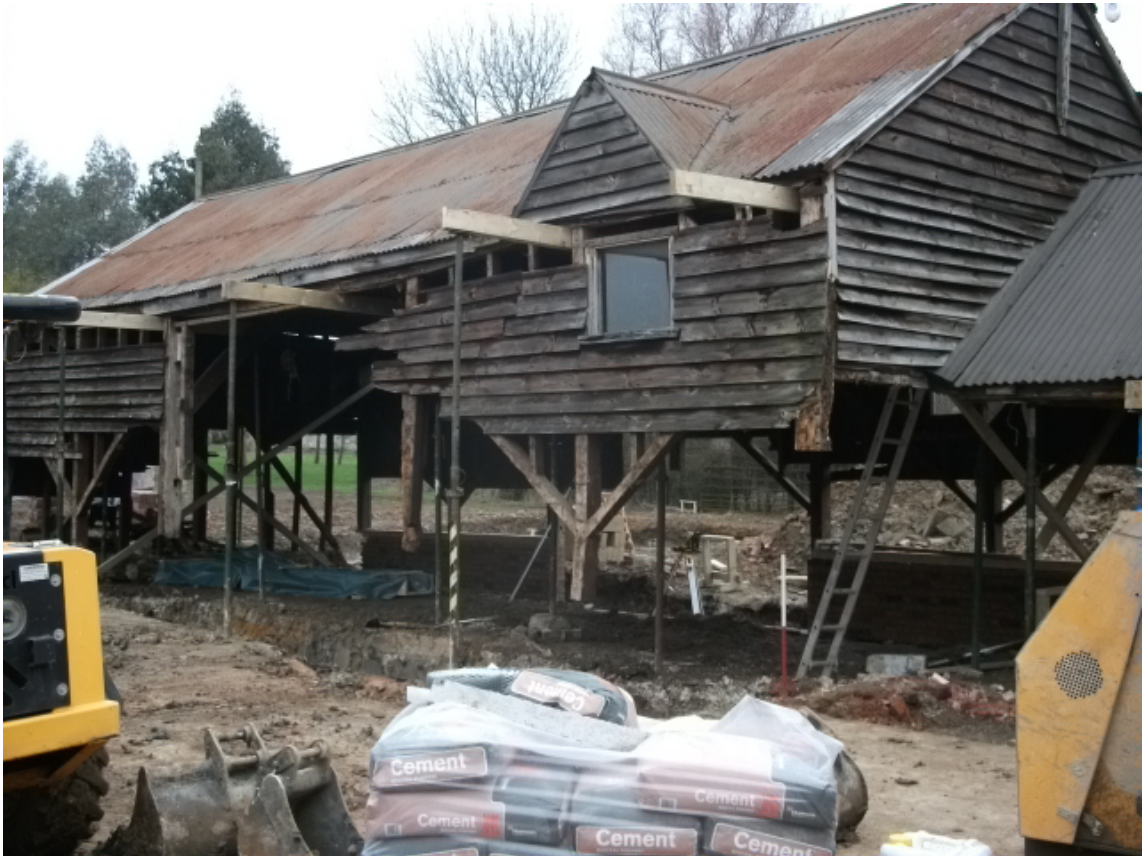
The barn after removal of the walls, looking south Fig 5

In order to adhere to the requirements of the planning condition the demolition of the existing barn and outbuildings was carried out in two stages. Initial demolition comprised the removal of the walls (Figs 5 and 6) and the supporting of the roofs on screw jacks. Once construction of the new supporting walls was underway the existing roofs were removed.

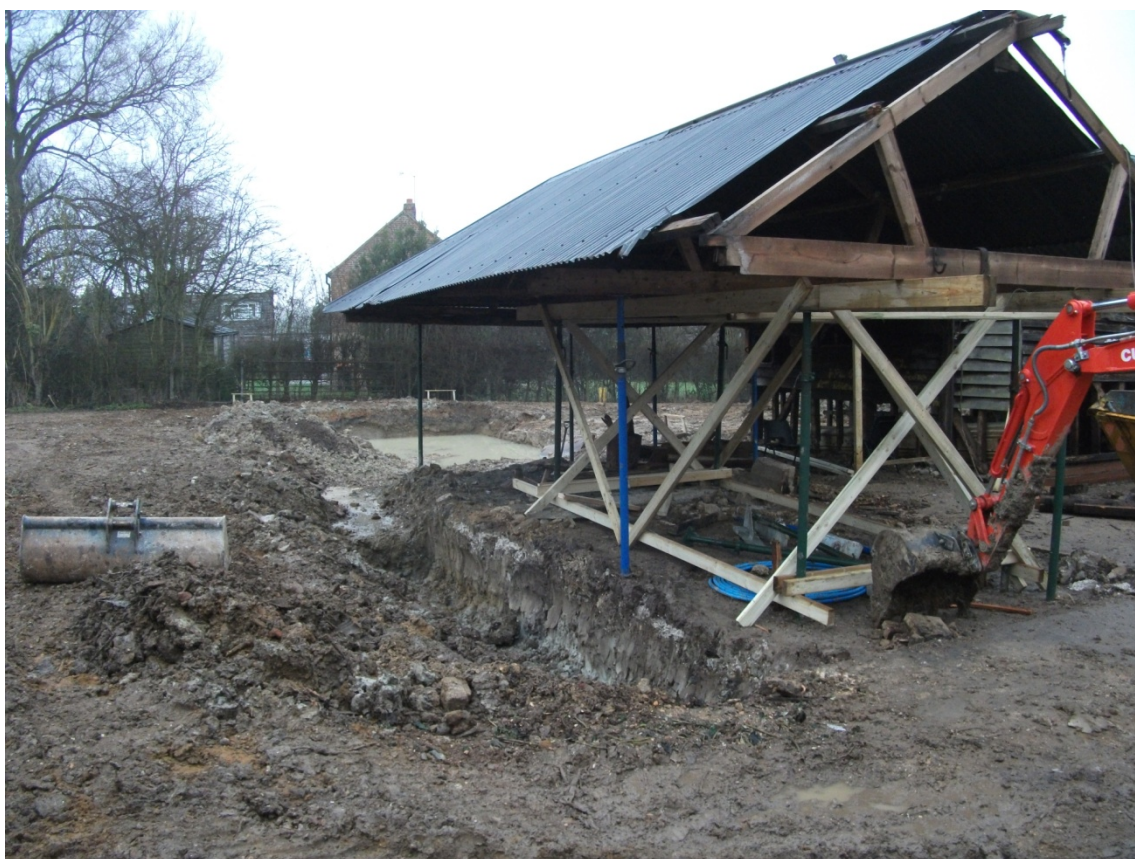
The barn after removal of the walls, looking east Fig 6

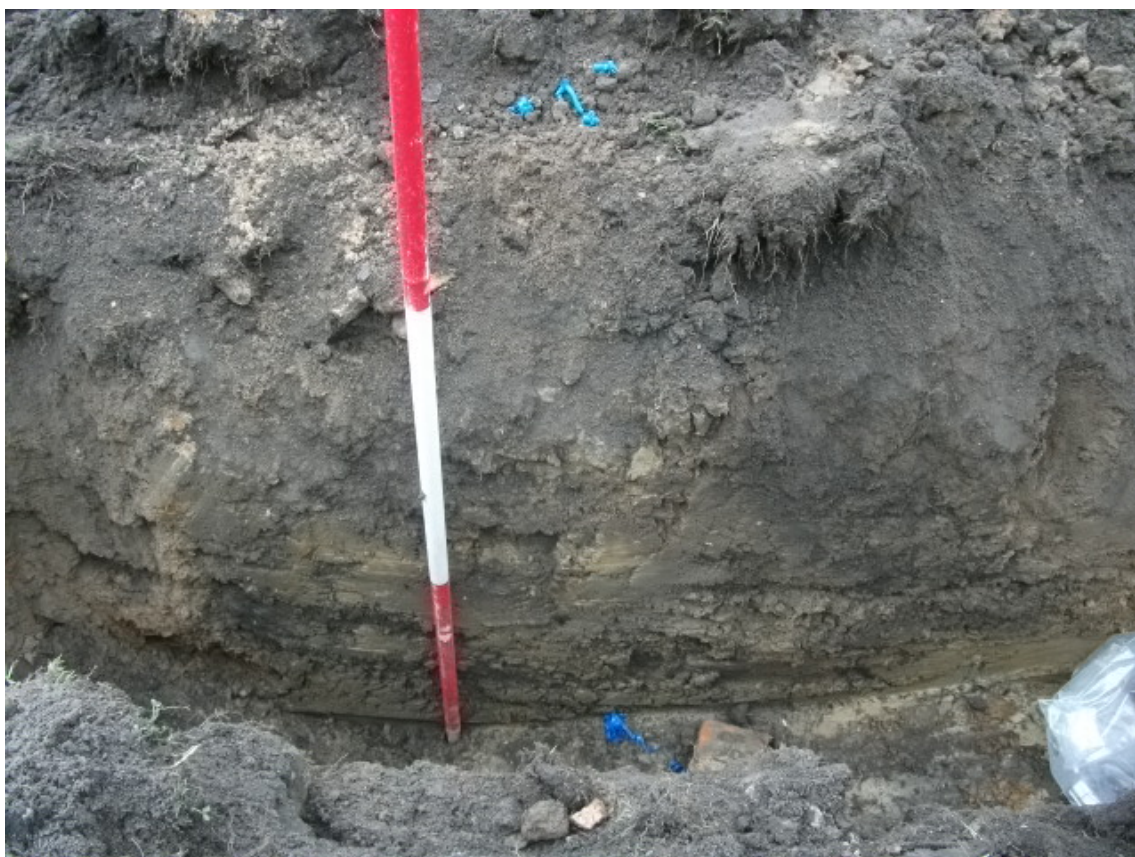
Within the area of the barn, outbuildings and the new extension the natural substratum was encountered at a minimum depth of approximately 0.20m below present ground level and comprised grey-blue compact clay with occasional chalk inclusions (Fig 7). Sealing this was grey-brown sandy loam, up to 0.35m thick, containing occasional irregular stones and numerous small fragments of modern ceramic building material.

No pre-modern archaeological deposits or artefacts were present.

The stratigraphic sequence in the area of the barn and outbuildings Fig 7

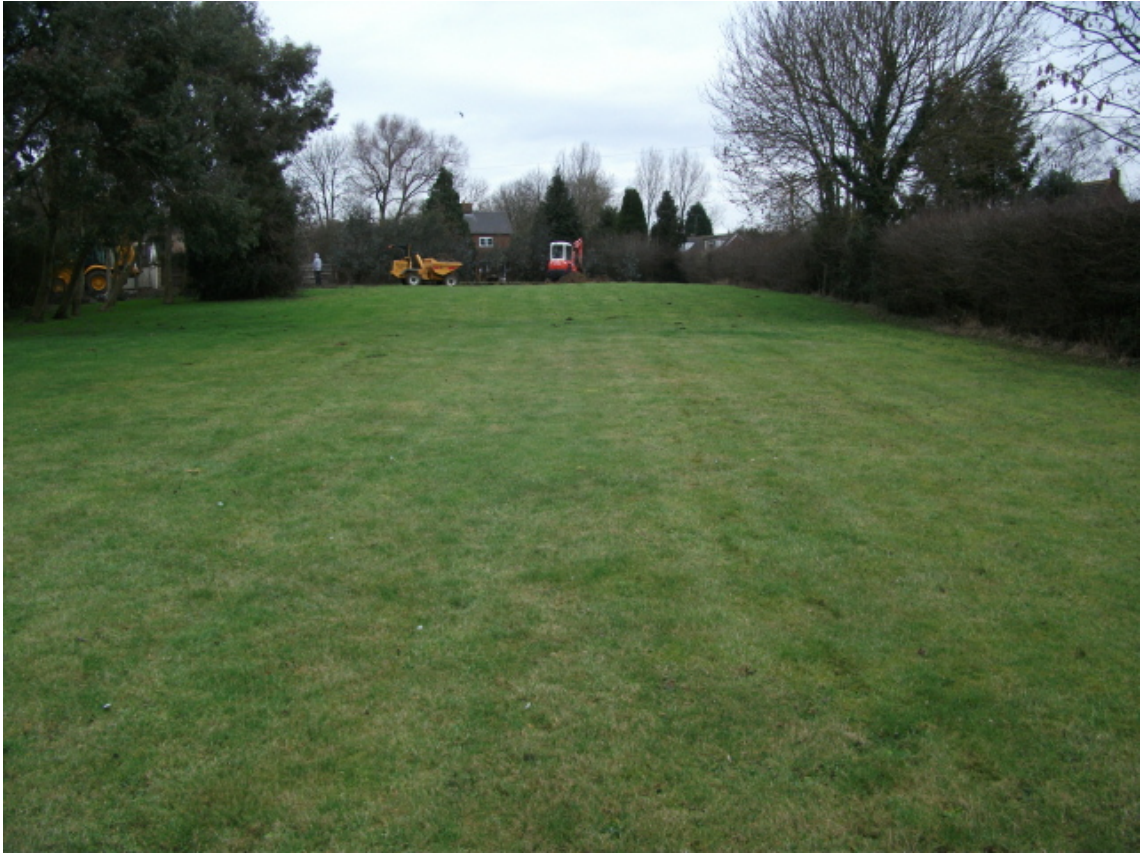
The rainwater pond was excavated to the south of the barn within an area of maintained lawn (Figs 2, 8 and 10).

The area of the new rainwater pond prior to excavation Fig 8

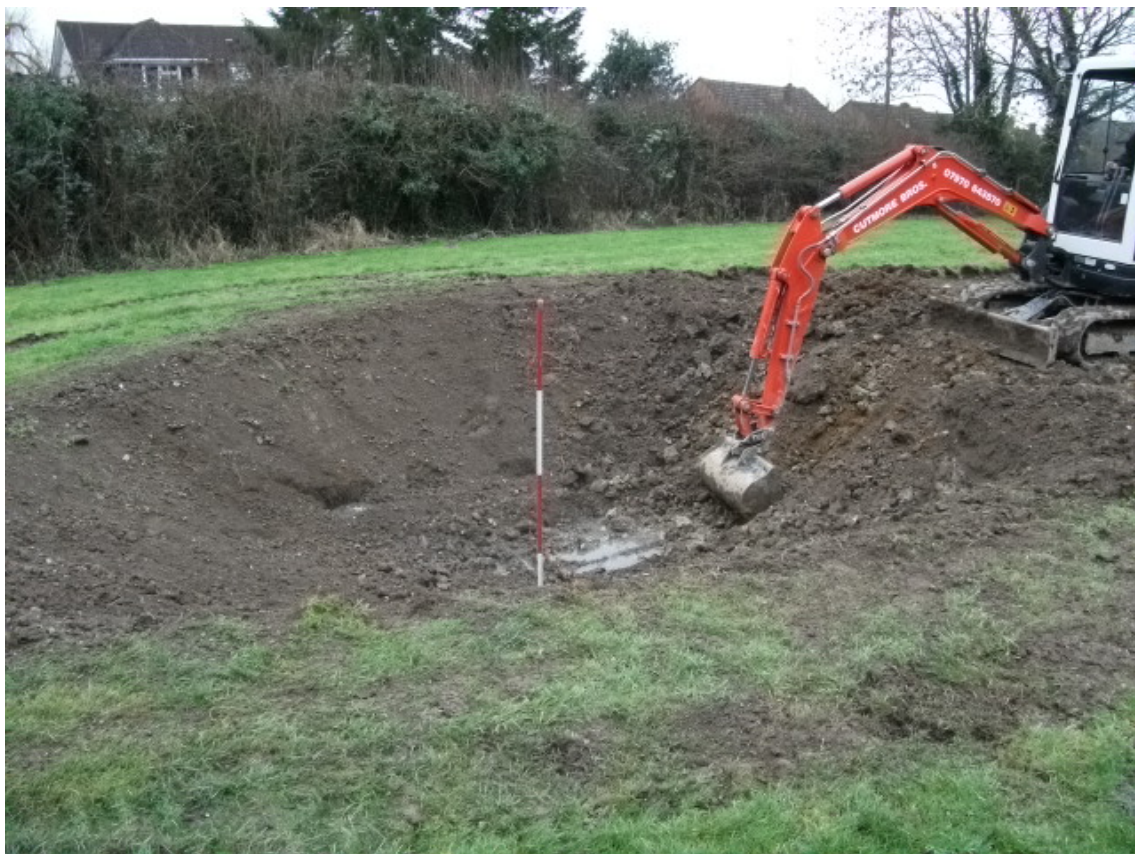
The stratigraphic sequence (Fig 9) comprised, natural grey-blue clay encountered at a depth of approximately 1.30m below present ground level. This was sealed by grey-brown sandy loam, up to 1.15m thick, containing numerous fragments of modern ceramic building material, including fragments of London Brick and Thermalite blocks. This in turn was sealed by grey-brown topsoil/turf layer, up to 0.15m thick.

The stratigraphic sequence in the pond, looking south-east Fig 9

Modern disturbance was noted throughout the area of the barn, outbuildings and new extension. Evidence of modern ground make-up was noted within the area of the new rainwater pond, which may be associated with levelling up and landscaping activity in this area of domestic garden.

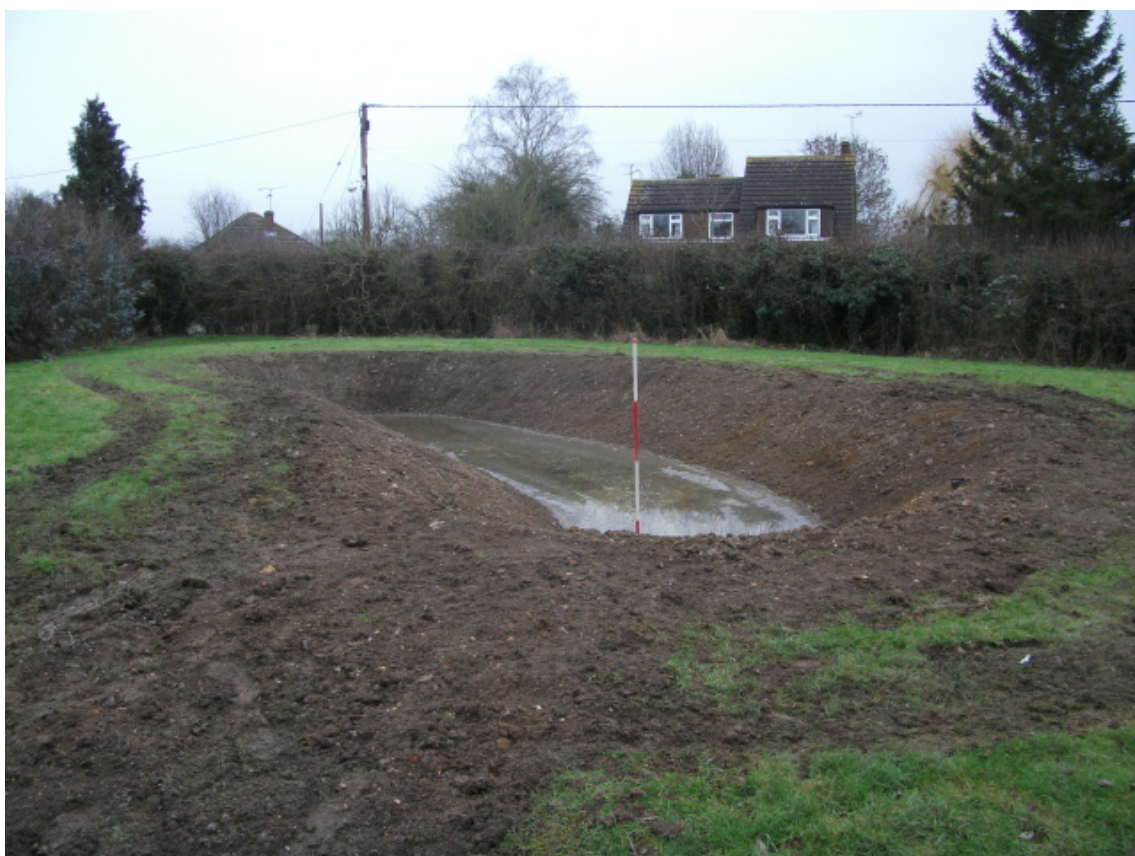
The pond after completion, looking north-east Fig 10
