Pendock Old Church, Worcestershire excavation of engineering test pits March 2010

Ian Meadows
Report 10/104
June 2010

PENDOCK OLD CHURCH
WORCESTERSHIRE
EXCAVATION OF ENGINEERING TEST PITS
MARCH 2010

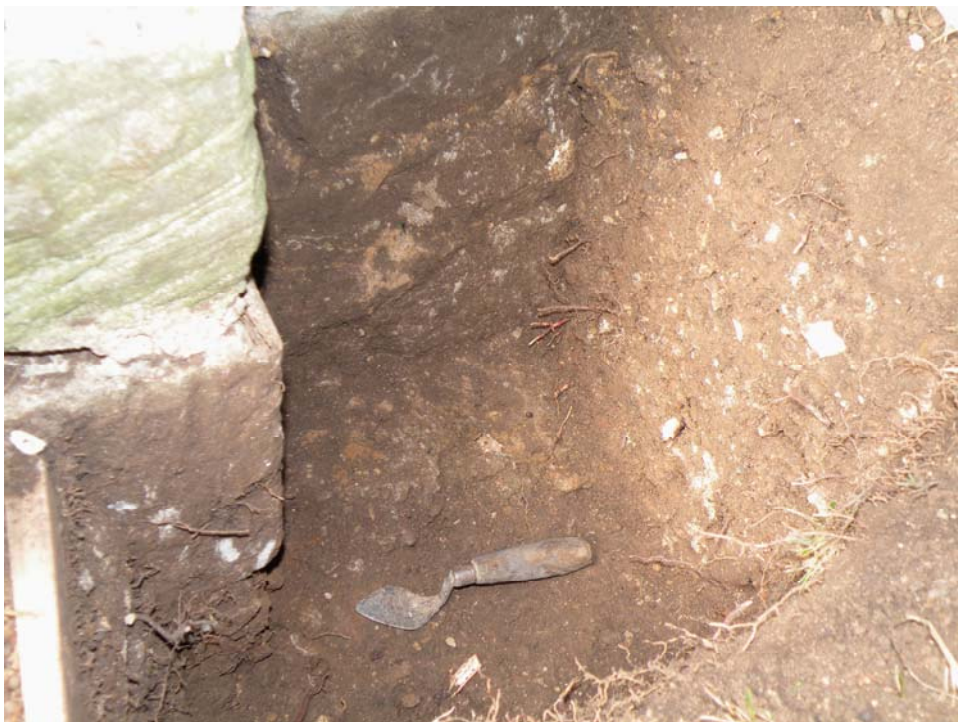
This pit was 0.35m wide and extended 0.20m along the east wall and 0.30m along the north wal. It was positioned to extend around the corner of the vestry between a small drain on the east and a buttress on the north. The thin (0.05m) topsoil was removed, this overlay a mixed deposit containing fragments of red clay roof tiles (identical to those currently on the roof) and mortar which extended to the base of the test pit (0.67m). This deposit was the infill of the foundation cut for the secondary buttress that rested against the north wall of the vestry (Fig 4).

Cut for buttress foundation Fig 4

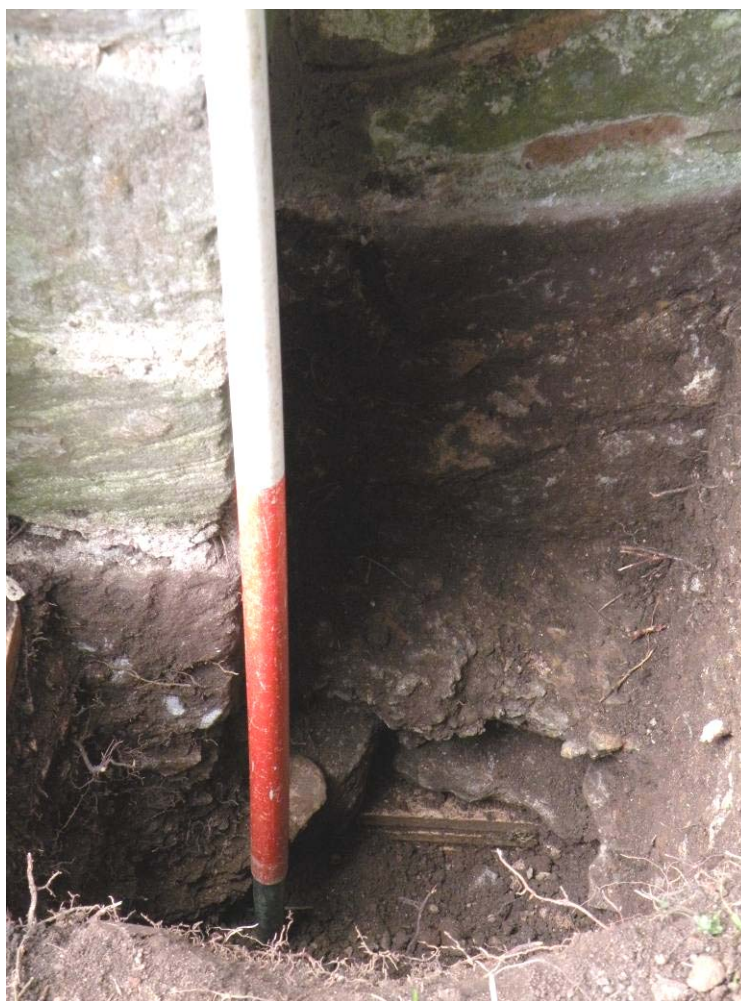
The corner of the vestry wall was exposed to its full depth, a single course (0.20m) below the present ground surface, which sat directly upon a gravelly soil containing isolated medium sized stones. The buttress extended 0.30m below the present surface to a bed of concrete 0.10m thick which in turn overlay a rubble horizon of loosely deposited material, at least 0.15m thick, including fragments of roof tiles similar to those on the vestry roof and a cream colour glazed engineering brick/tile with distinctive 'reeding' on one face (Fig 5) other than the clay roof tiles (none of which were retained) the only other find was a short length of clay pipe stem (not retained).

Base of buttress foundation showing glazed brick/tile Fig 5

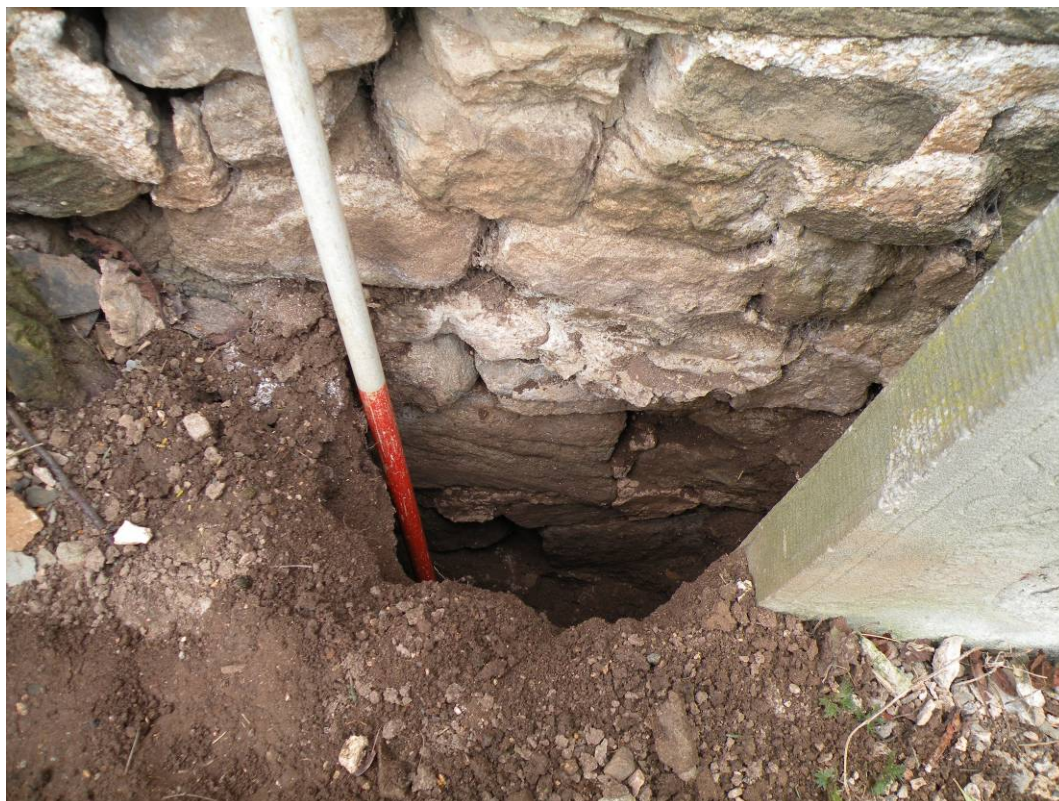
Fig 6

In the centre of the east wall a substantial amount of rabbit disturbance was evident, In order to expose the depth of the main churches foundations it was decided to formalise part of this disturbance to expose the face of the wall to its maximum depth. The test pit was located between two large grave slabs (Fig 6). Excavation of the loose rabbit disturbed soil exposed the face of the east wall to 0.60m, most of which comprised good masonry with the lowest 0.15m being less regular 'foundation' type material. The full depth of masonry could not be reached.

Test pit 2 showing character of the east wall of the church

Both pits were entirely excavated within graveyard soils and, as their purpose was to explore the footings of the building, did not extend to the underlying natural. In such small exposures, one of which was severely disturbed by rabbit burrowing activity, it is not possible to comment meaningfully about the deposits encountered. The pits did, however, demonstrate the foundation for the main body of the church extended to more than 0.60m below the present ground level whilst the vestry only reached 0.20m depth.
