The excavation of test pits within the Church of
St Peter, Barrowden, Rutland
October 2013

Report 13/205

October 2013

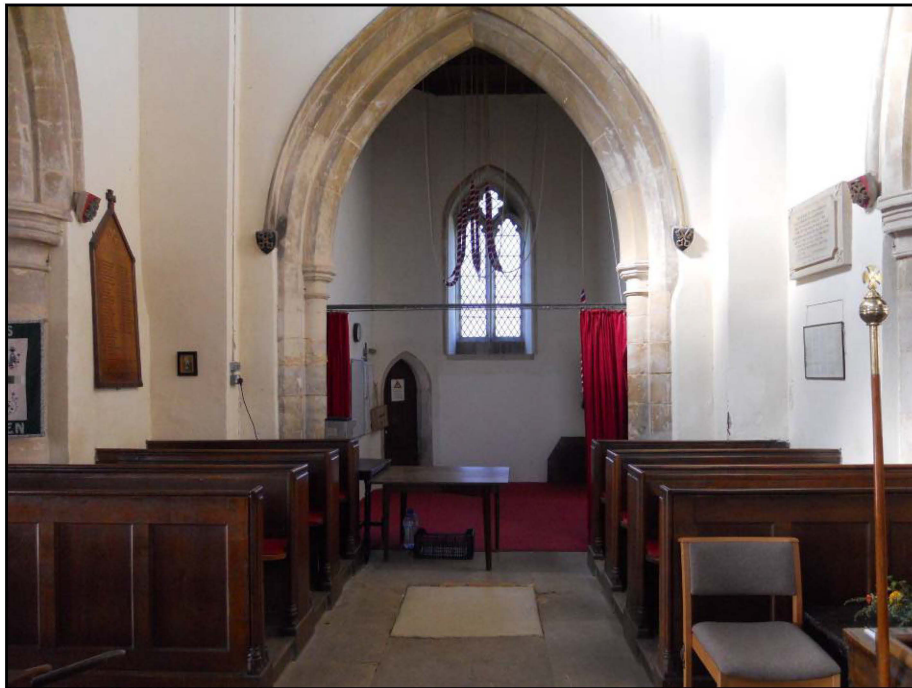
Test Pit 1 in the central aisle, looking south-west Fig 3

Test Pit 1 was located in the central aisle of the Nave, at the south-western end by the tower, due to the constraints of the slabs the test pit measured 0.90m by 1.0m and was 500mm deep (Fig 3). At a depth of 370mm below the current stone slabs a firm, mixed sandy loam with moderate amount of limestone inclusions was recorded. This possible grave fill was truncated during the construction of the flooring and contained human bone fragments and nails, which were left *in situ*, pins and stained glass. This was overlain by 100mm of make-up layer of loose mid-brown sandy loam and limestone rubble, also containing small fragments of human bone (Figs 4 and 5). The stone slabs sat on three parallel rows of bricks aligned roughly east to west. The two outer rows were two courses of stretcher bricks sitting on one course of header bricks resting on the ground; the central row was two courses high resting on a lime mortar/limestone rubble mixture. The void varied in depth of between 100mm and 200mm.

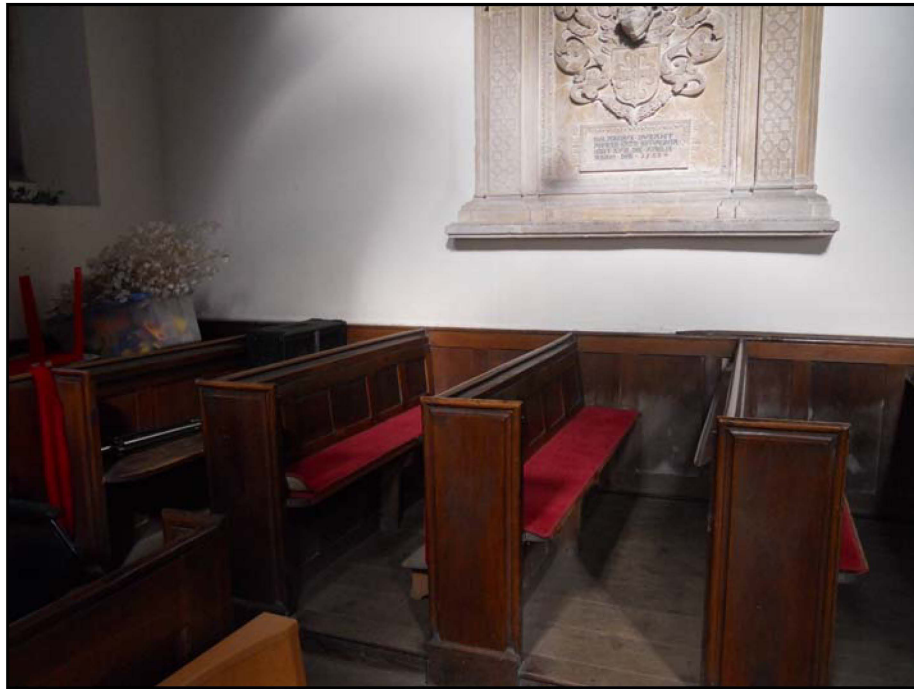
Location of Test Pit 2, looking north-west Fig 6

Test Pit 2 was located in the south-western corner of northern aisle (Fig 6). Due to the constraints of the wooden flooring the test pit measured 0.80m by 1.0m and was 500mm deep. The natural stratum lay 450mm below the current floor level and comprised ironstone rubble, which had been probably truncated during the construction of the new flooring. At the north-western edge two shallow graves containing human bone, orientated north-south, were partially visible as cutting the natural. The edge of the third,

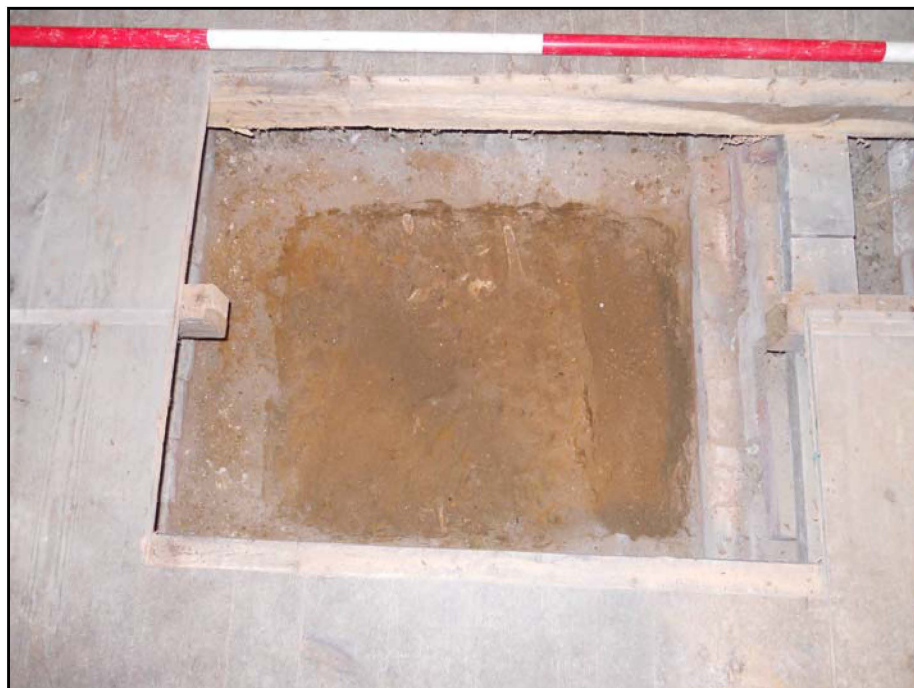
The excavated Test Pit 2 showing all three graves, looking north-east Fig 7

deeper grave was visible parallel with the south-eastern boundary of the test pit (Fig 7). A copper alloy lace chape fragment was recovered. The graves and natural stratum were overlain by a 20mm trample layer.

Test Pit 2 revealed the presence of two graves possibly predating the construction of the northern aisle, which dates to the 13th century. A third later grave was also recorded, the interment probably having taken place when the aisle was in place. A copper alloy lace chape was recovered from the later grave suggesting it may date to the mid 16th-17th centuries. In Test Pit 1 the presence of grave soil was recorded from which drawn copper alloy wire pins were recovered, and these in use from the 18th century onwards. The stained window fragments came from an earlier phase of the church indicating leaded window lights.

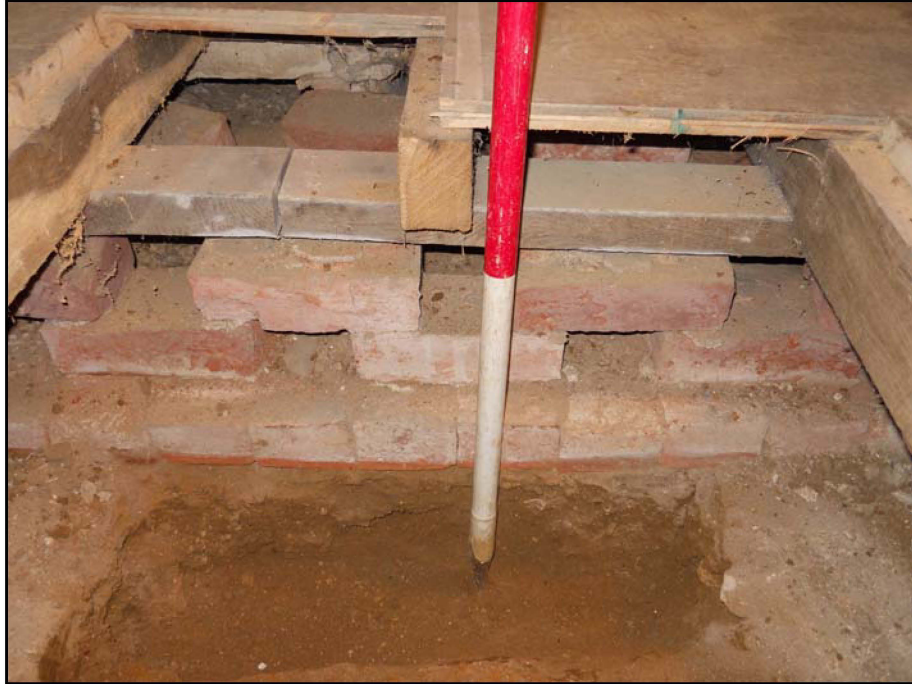
Section showing the floor construction in Test Pit 2, looking south-west Fig 8

The wooden flooring was supported on the same set-up as the stone slabs in Test Pit 1 with parallel rows of bricks, the stretcher courses of bricks were staggered to allow ventilation, upon which wooden beams supported wooden joists at right angles. The void between the soil and wooden floor planks were c 300mm (Fig 8).
