Assessment report and Updated Project Design
An archaeological investigation of the historical development
of Cathedral Square, Peterborough
November 2008 to August 2011

Stephen Morris and
Adam Yates
Report 12/48
March 2012

**ASSESSMENT REPORT AND UPDATED PROJECT DESIGN
AN ARCHAEOLOGICAL INVESTIGATION
OF THE HISTORICAL DEVELOPMENT OF
CATHEDRAL SQUARE, PETERBOROUGH
NOVEMBER 2008 TO AUGUST 2011**

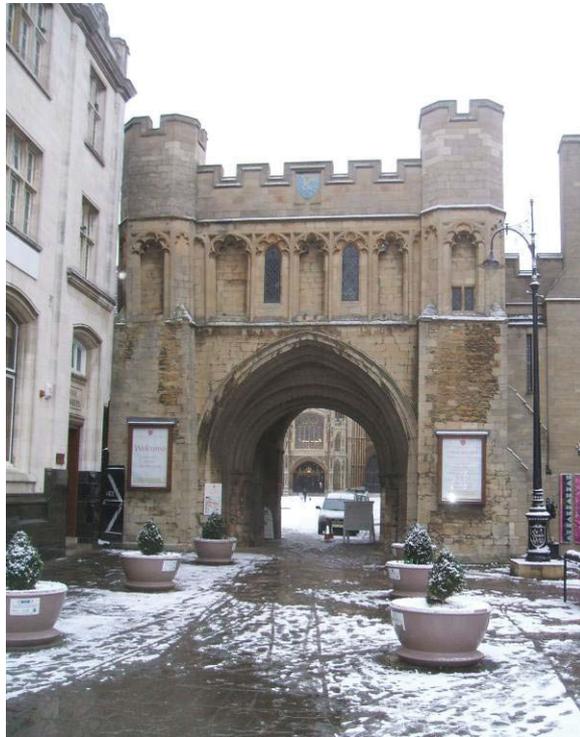
Pre-development photograph, 2009; Cathedral Gateway (Great Gateway), facing east
Fig 3

The Great Gateway is situated on the western side of the precincts and gives access to Cathedral Square (Fig 3). The Norman gateway was constructed between 1177-94, during the time of Abbot Benedict. The gateway was remodelled in the 14th century with the addition of the pointed Gothic arch built in front of the semicircular Norman arch and the flanking turrets. The new arch enabled a portcullis to be incorporated, the slot for which can still be seen.

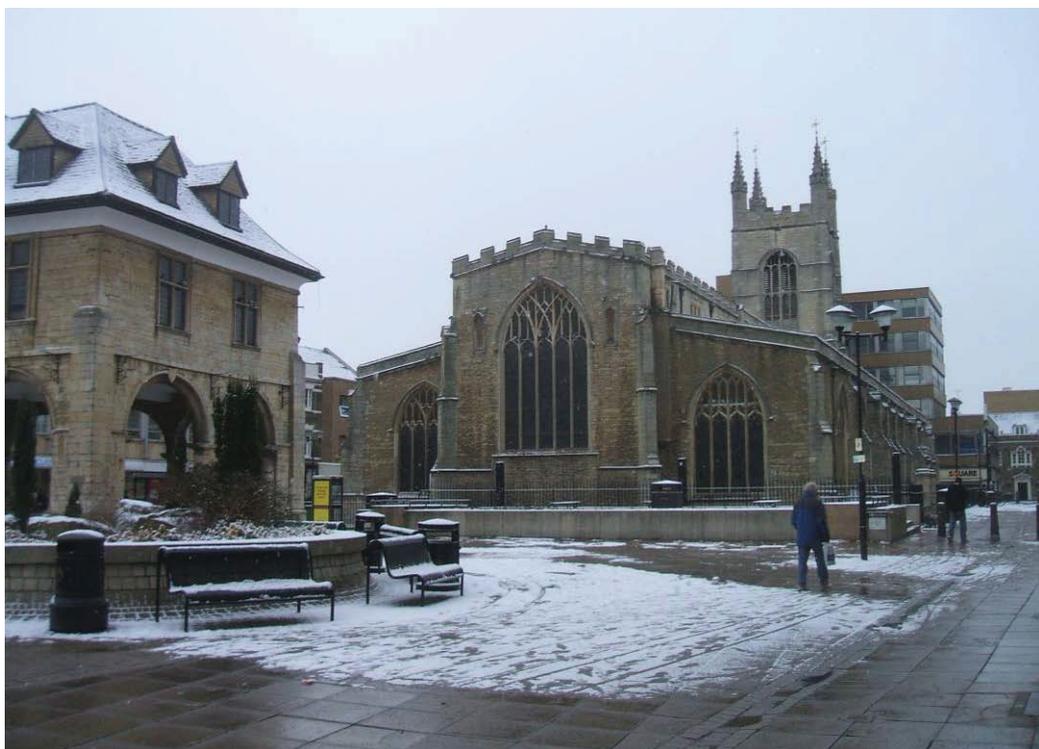
Pre-development photograph, 2009; The Parish Church of St John the Baptist (centre), Guildhall (left) and the Norwich Union Building (Corn Exchange, background), late 20th-century circular flowerbeds (left foreground) facing south-west
Fig 4

The construction of St John the Baptist's church in the market place was undertaken in the early 15th century to replace the former parish church which had been located to the east of the monastery, which was no longer at the centre of activity of Peterborough (Fig 4). This resulted in the demolition of the 'old' parish church and the Chapel of St Thomas the Martyr (Thomas Becket) to provide material for the construction of the new parish church. The site of St John's was a prominent one in the Marketstead, the place traditionally thought to be occupied by butchers' stalls, where the ground was considered

It was during the early 1960s that a new fountain was constructed, the location of which is shown on the 1967 Ordnance Survey map. The 1967 Ordnance Survey map also shows underground toilets and an electricity substation to the east of St John's church in the area formerly occupied by the 18th century buildings. The development of the Queensgate Shopping Centre in the late 1970s supplanted a large part of the street plan and commercial district from the north side of Cathedral Square and Cowgate across to Westgate (Queensgate Centre opened in 1982). More recently the fountain in Cathedral Square was replaced by a pair of circular flower beds (Figs 4 and 5).

In 1964 the Corn Exchange was demolished, with the construction of the Norwich Union Building replacing it and opening in 1966. Underground toilets and an electricity substation were located between the church of St John the Baptist and the Guildhall, in the area formerly occupied by the 18th to 19th-century buildings. In Cathedral Square a fountain was constructed in the early 1960s, which was in recent times replaced by a pair of circular flowerbeds (Figs 4 and 5).

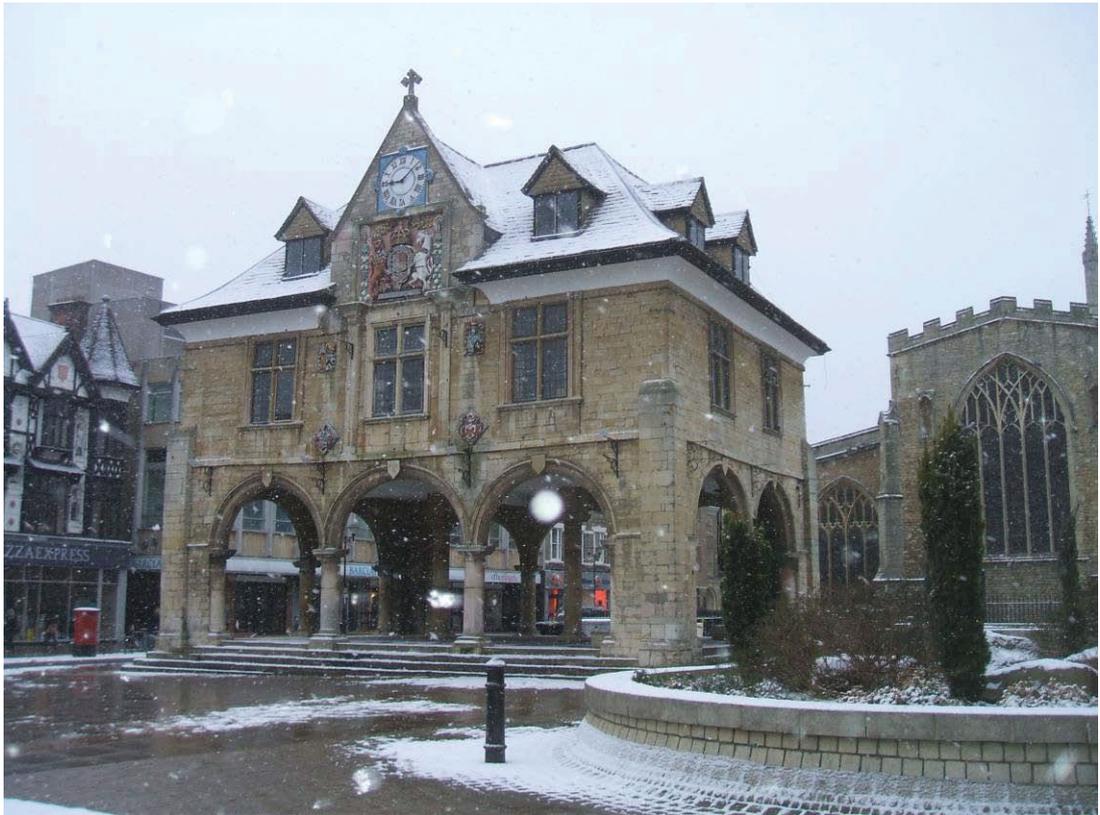
Pre-development photograph, 2009; the Guildhall built in 1671, late 20th-century circular flowerbeds (right, foreground) facing south-west Fig 5

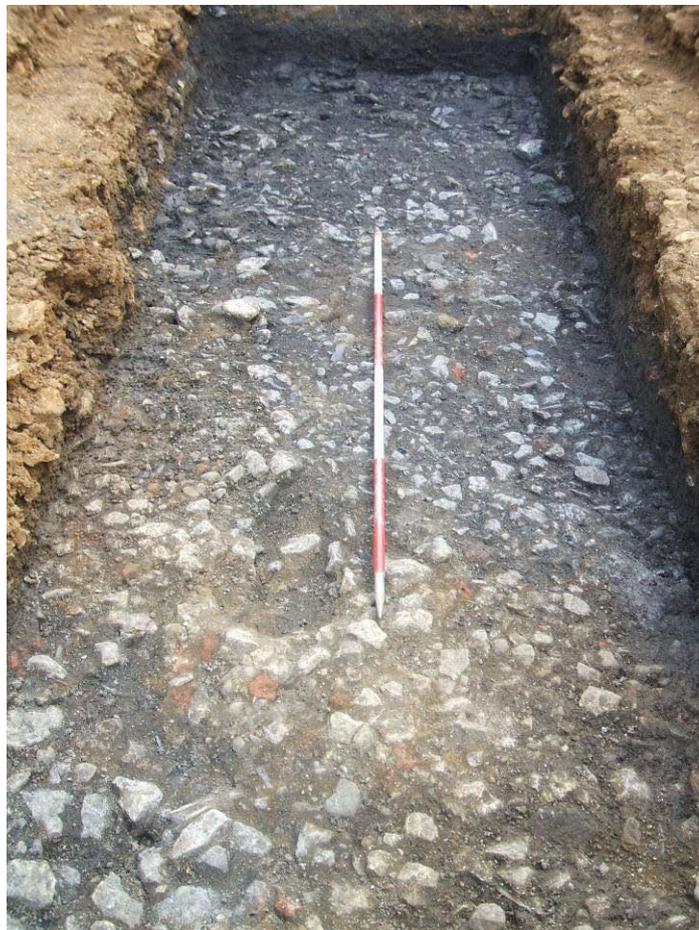
De Bec's market square surface, sealed by dark silt, 12th to 17th centuries.
Cathedral Square, east of the toilet block, facing west Fig 12

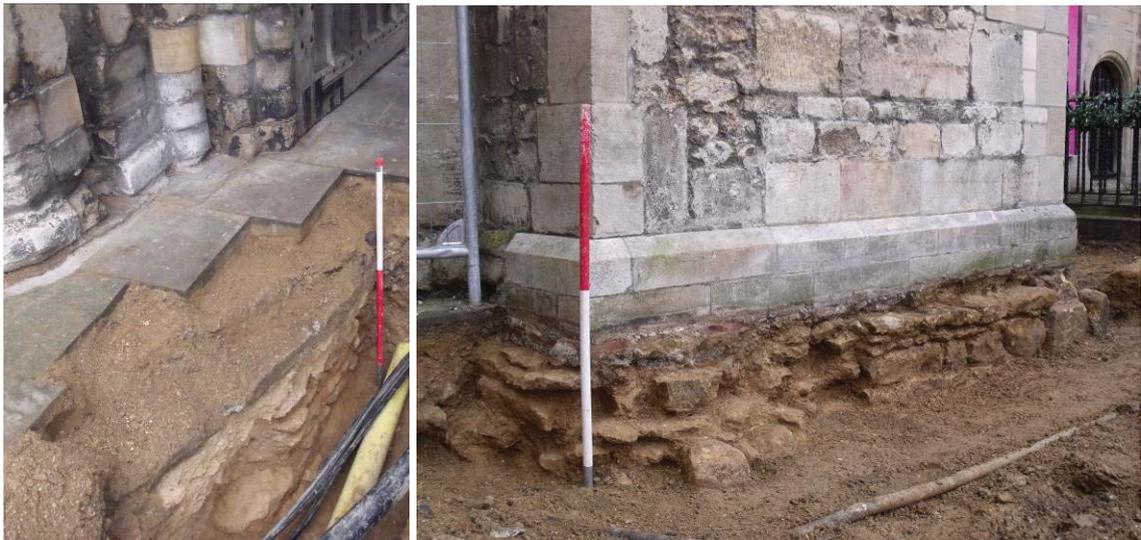
Gas trench at Cathedral Gateway, showing stone foundations (12th to 14th centuries), facing north-east Fig 13

The stone foundations of the 12th and 14th-century gateways were exposed during reopening of the 1m deep gas main trench that passed through the gateway into the Cathedral precincts (Fig 13). The foundations for the supporting 14th-century turrets were exposed during the groundworks, the north side foundations were partly replaced with recent concrete, probably in the 1930s, during widening and construction of new Bridge Street (Fig 14).

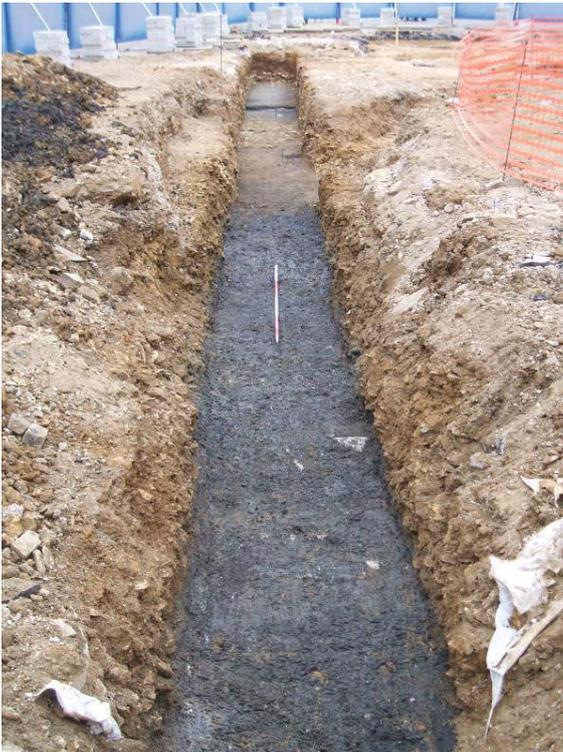
Dark silt over de Bec's market square surface, north side of Cathedral Square Fig 15

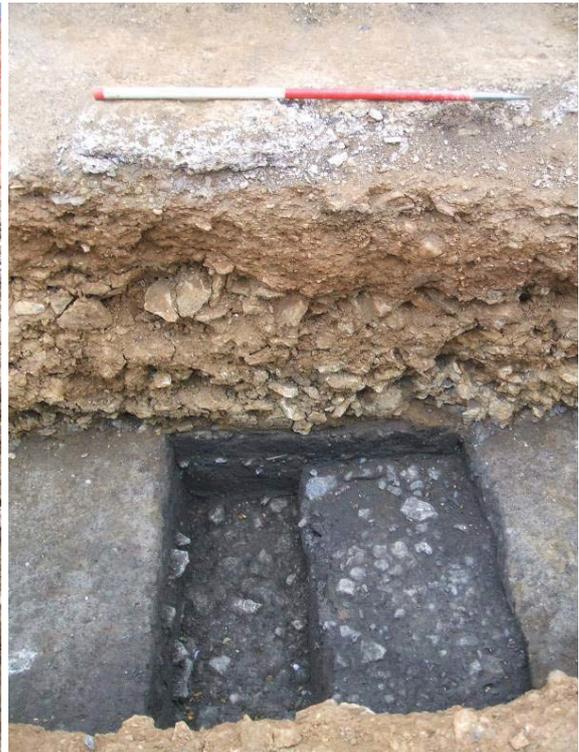
De Bec's market square surface, with overlying dark silt, showing resurfacing. Sealed by limestone rubble/clay make-up Fig 16

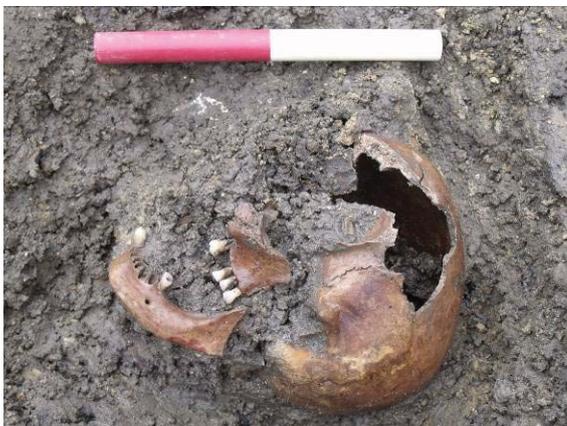
Burials in cemetery to the north side of St John the Baptist Church. Burial1, facing north Fig 17

To the west side of the churchyard wall a remnant of cemetery survived below a north south path, where at least 14 grave cuts aligned east-west were exposed, seven of which had human bone visible, from which pottery dating from the 13th to 17th centuries was recovered (Figs 17 and 18). The ground to the west of this had been heavily truncated by 19th-century and more recent building development removing the western extent of the cemetery. Just as the blood contaminated ground had been removed for the construction of the church so was the area of the cemetery, formerly the market square surface, overlaid by an introduced soil similar to the churchyard. The records suggest that the church of St John the Baptist never had a burial ground and the burials of the townsfolk had been placed in the grounds to the north side of the abbey, post-dissolution. These burials represent a previously unknown cemetery, probably created at the same time the church came into service and may have ceased functioning as a burial ground about the time of the Dissolution.

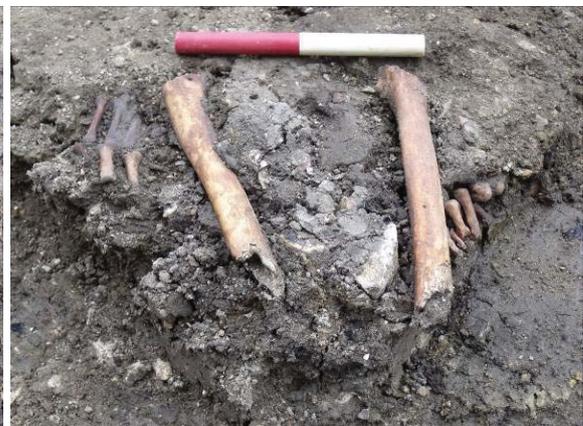
Burials 6 and 7, facing west Fig 18

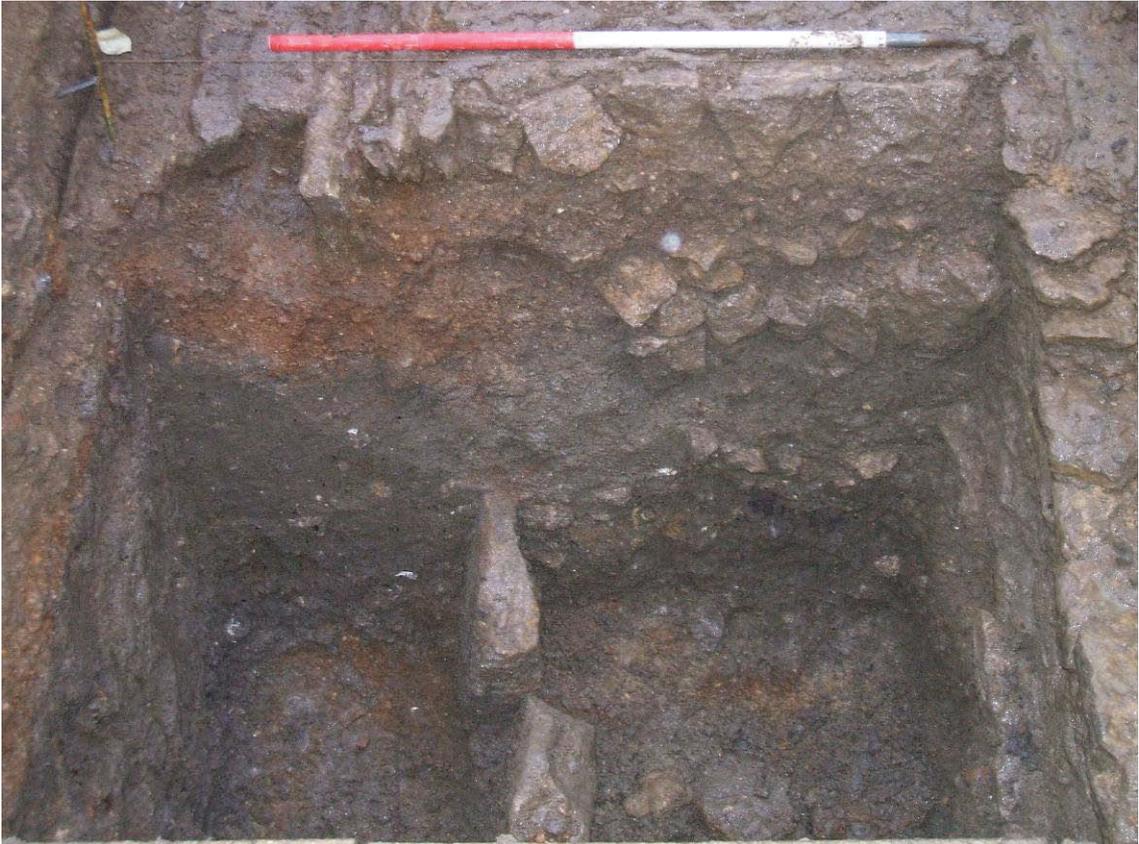
Trial trench in Church Street, adjacent to the churchyard wall of St John the Baptist, The base of the trench was the de Bec's 12th-century market surface.

A trench adjacent to the south side of the church of St John the Baptist, revealed a street level that was probably contemporary with the construction of the church. It was composed of a roughly metalled road and path separated by large stone slabs that formed a kerb, adjacent to the south churchyard wall. A single sherd of 13th to 15th-century Bourne B ware pottery was recovered from the path (Fig 19).

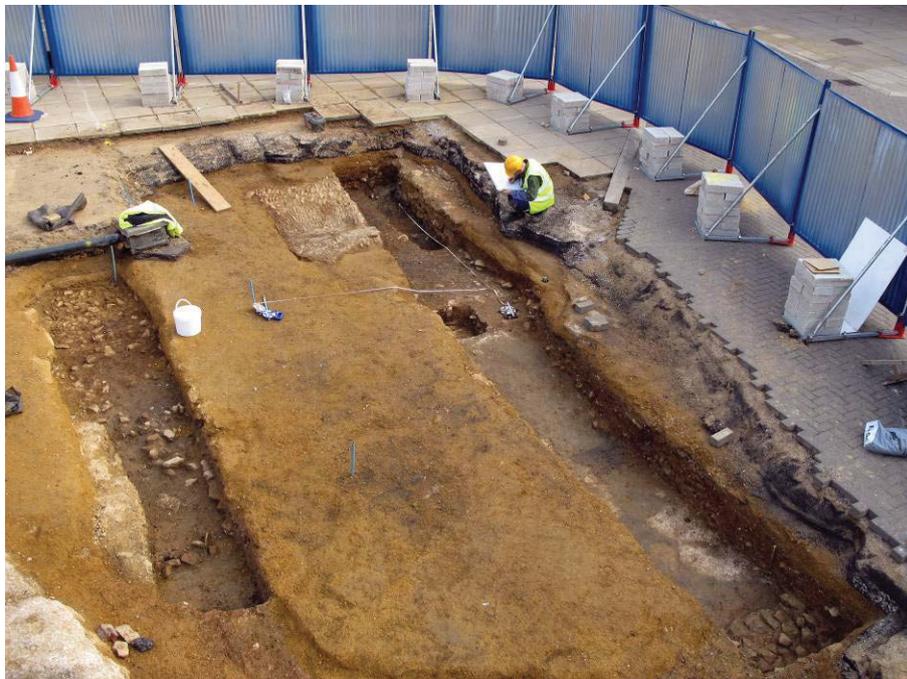
Fountain array trenches, containing walls and surfaces of the tenement building block in the south-east corner of Cathedral Square, facing north-east Fig 20

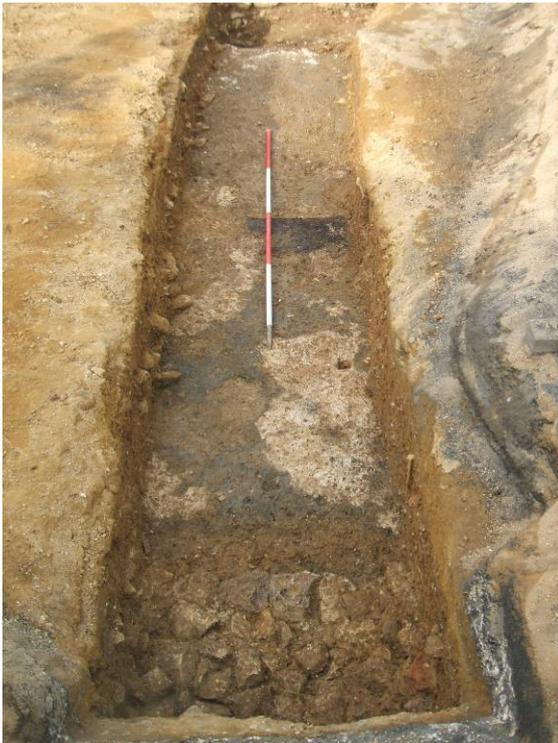
Fountain array trench, building wall (foreground) robbed wall (background), internal floors of tenement block in the south-east corner of Cathedral Square, facing north Fig 21

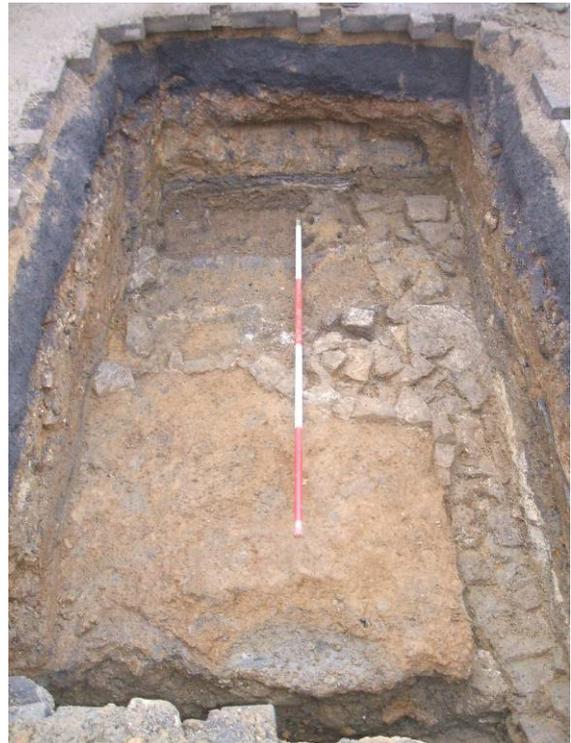
Trial trench containing building wall, with internal floors of tenement block in the south-east corner of Cathedral Square, facing west Fig 22

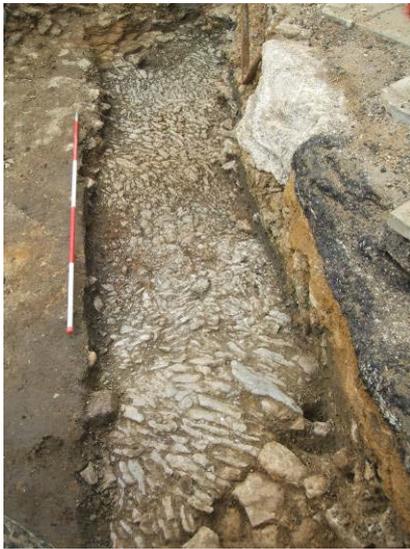
Pavement and street surface on west side of the tenement building in the south-west corner of Cathedral Square, building wall (foreground) and street monument mound (background), facing north-west
Fig 23

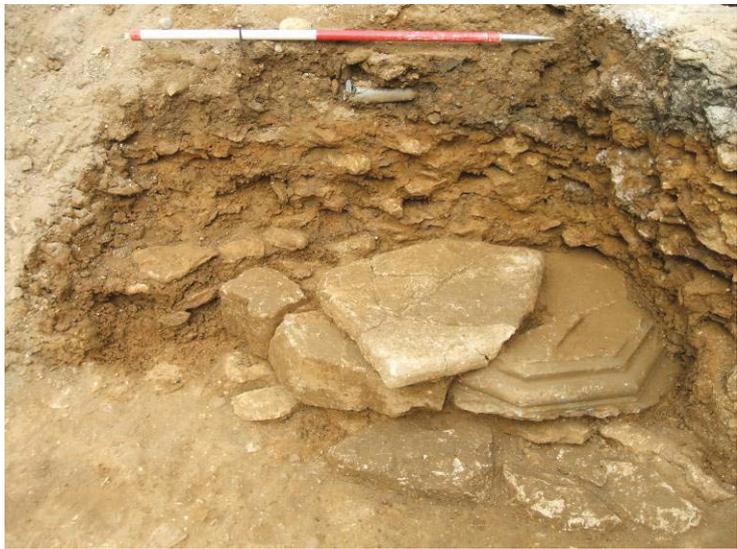
Street monument mound containing ashlar and ornamental stone, facing west
Fig 24

The structural remains may have been elements of a street cross or some other street furniture, but its removal may have occurred before the construction of the neighbouring building, however, the soil mound appears to have remained as a feature in the square since the street silting was allowed to abut and partially overlay it.

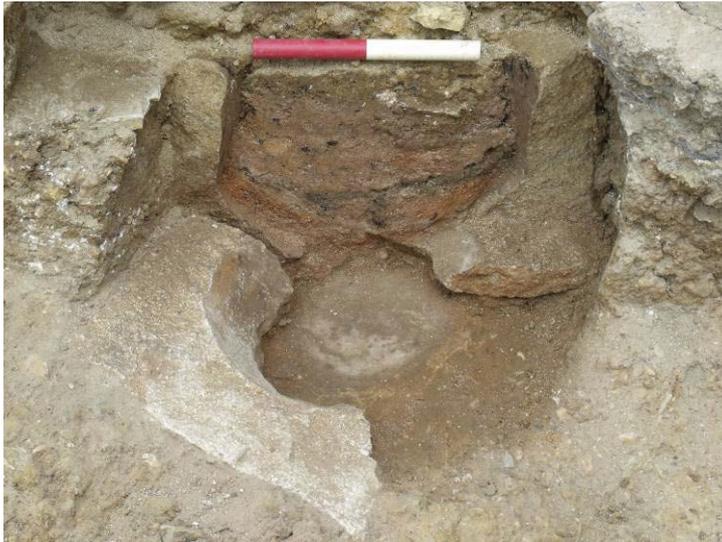
Stone mortar in the floor of building in Butchers Row facing north
Fig 25

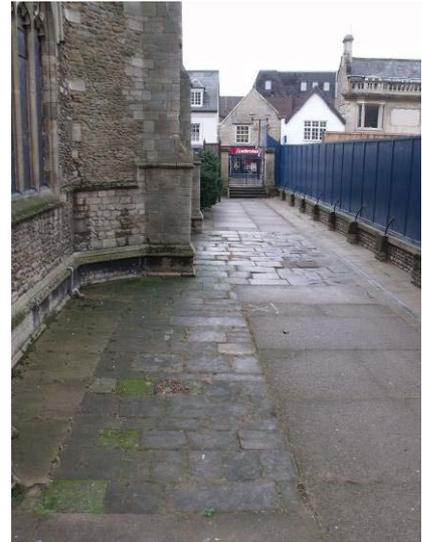
Flagstones at west end of churchyard may outline the location of the Sexton's house at the north end of Butchers Row, facing south
Fig 26

The outline of the sextons building in the churchyard may have been defined by the remains of a flagstone path in the churchyard, but no remains of the building had survived (Fig 26).

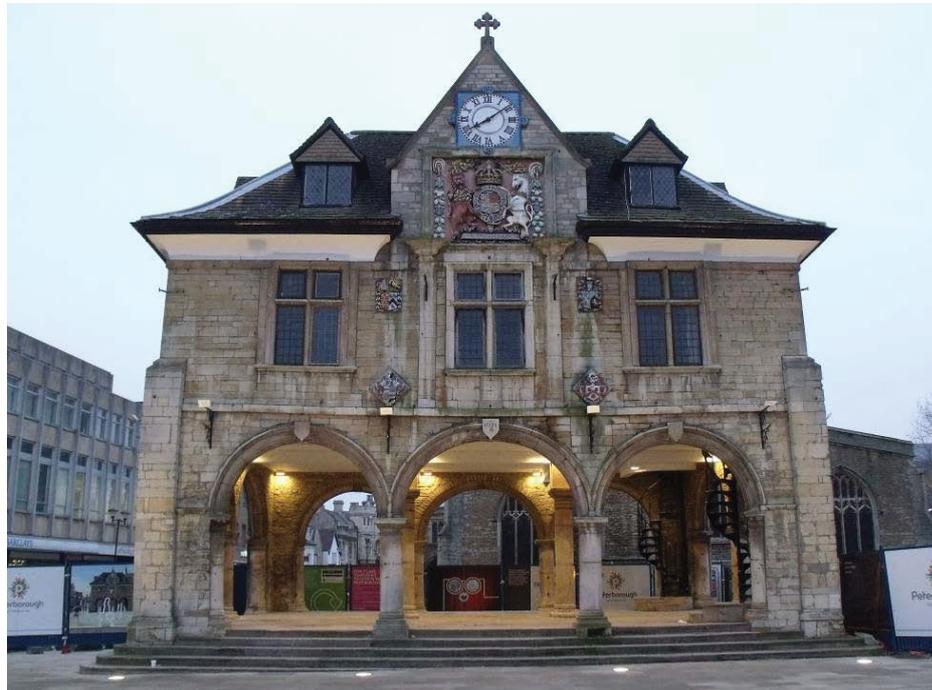
East facing facade of the Guildhall Fig 27

This development created a marked change in the look of the square, with the construction of the 'Guildhall' forming the centre piece, a public building consisting of a large chamber supported on open arches, forming a covered market space. A public subscription was started in 1669, with the completion of the structure in 1671, which in its formative years was known as the Chamber over the Cross. It was located in the market square to the east side of the church (Fig 27). A trench adjacent to the east side

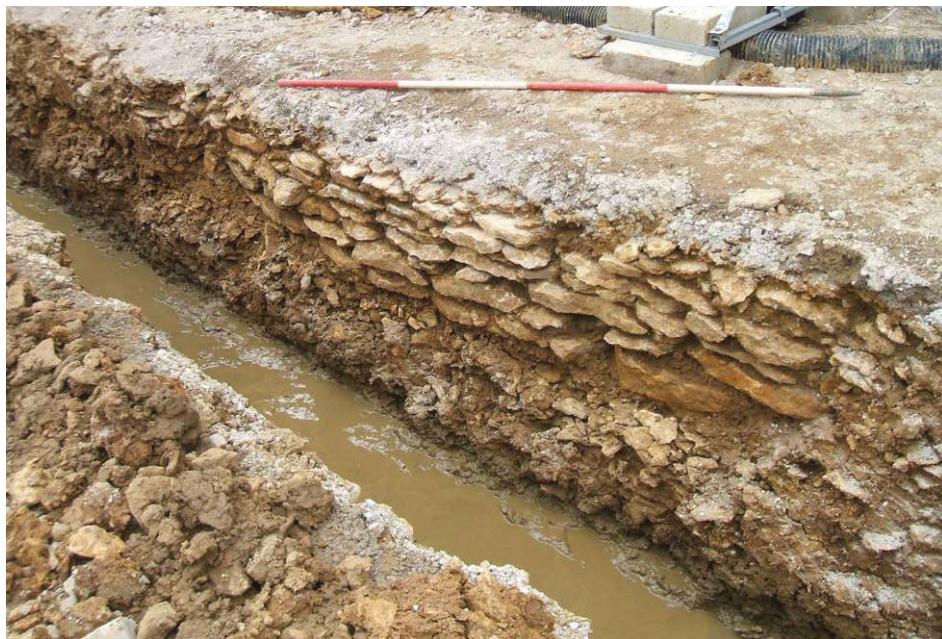
Guildhall stone foundations in fountain drain trench on the east side of the building, facing south-west Fig 28

of the Guildhall revealed a 3m length of curving stone foundation, probably part of an estimated 17m circular structure on which the building is probably supported. The foundations were approximately 0.5m deep, constructed on a similar depth of clay and cornbrash rubble make-up overlying the dark silt deposit (Fig 28).

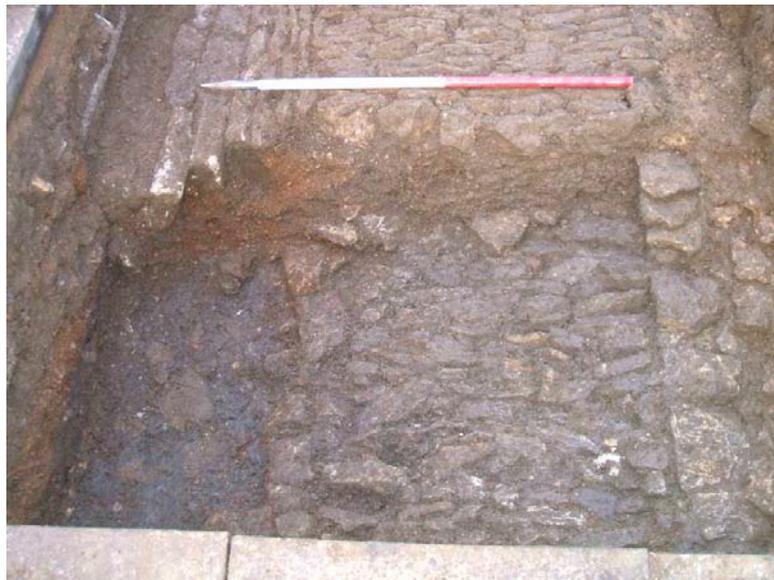
17th-century pitched stone path (foreground), overlaid by a late 18th-early 19th-century pitched stone pavement (background), both abutting churchyard stone wall (right), facing west Fig 29

A pitched stone path c 1m wide was located along the length of the churchyard wall on the north side of Church Street (Fig 29). The path had a slight incline into the street that had lost its stone surface exposing the dark silt deposit beneath. It is possible the churchyard wall may have been reconstructed at the same time or at some stage post-dating the laying pitched surfaces, as the wall appears to be slightly offset to the south at the new ground level.

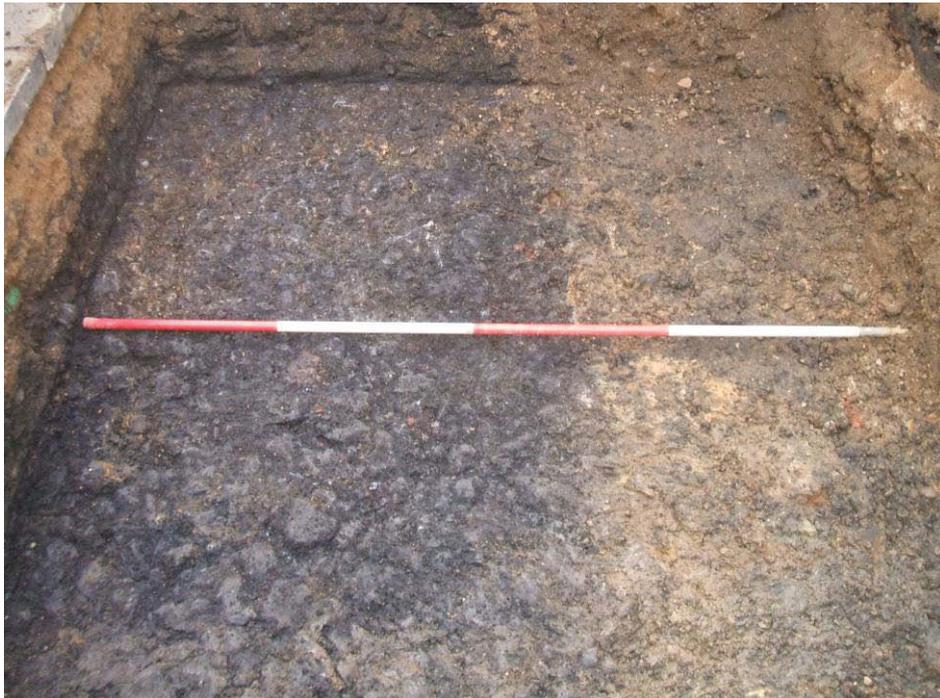
Trial trench in Queen Street; showing 17th-century street surface overlaid by the dark silt (right), modern service pipe trench fill (right), facing south Fig 30

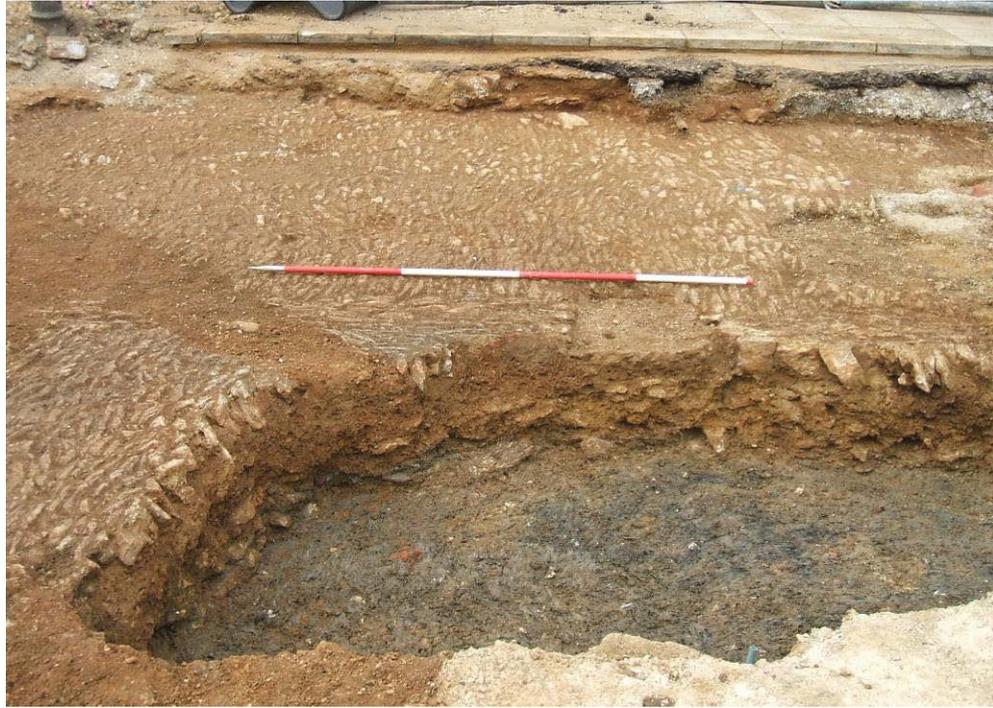
Late 18th-early 19th-century pitched stone surface, with underlying make-up layers, sealing the dark silt, area of fountain array north side of Cathedral Square, facing north, Fig 31

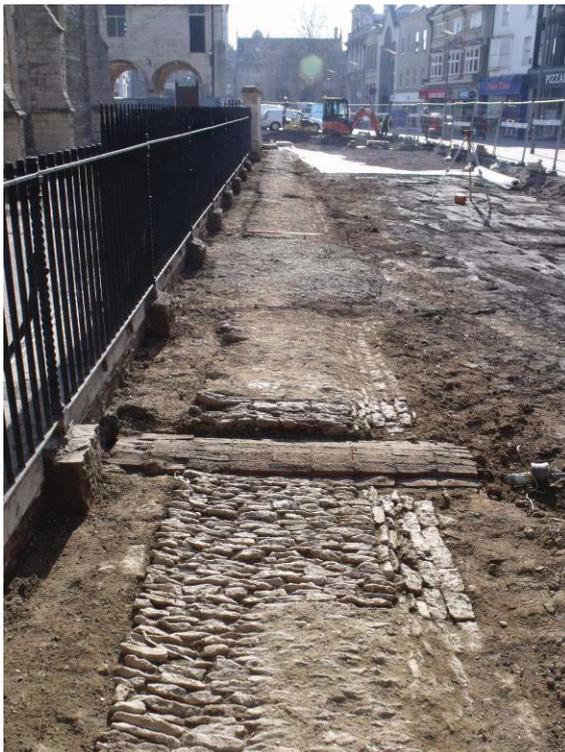
Stripped area on the south side of Church Street adjacent to the churchyard wall. Pitched stone pavement, with linear open pitched stone drain lying square to the outer edge of the path. Shows pavement from the east side of the church porch entrance, a Victorian brick culvert is seen cutting across the path (foreground), facing east Fig 32

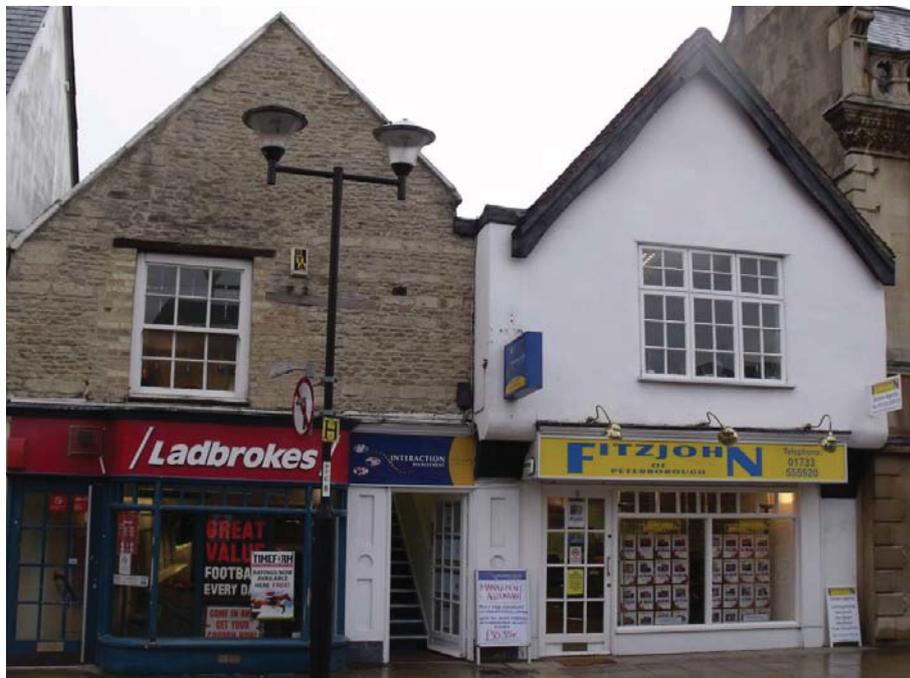
Surviving 17th-century buildings on the south side of Cathedral Square (Church Street), facing south Fig 34

By the 19th century probably little remained of the early burgage tenement blocks, as the new larger commercial and public premises were now dominating the street frontages, although two 17th-century buildings still exist on the south side of the square (Fig 34).

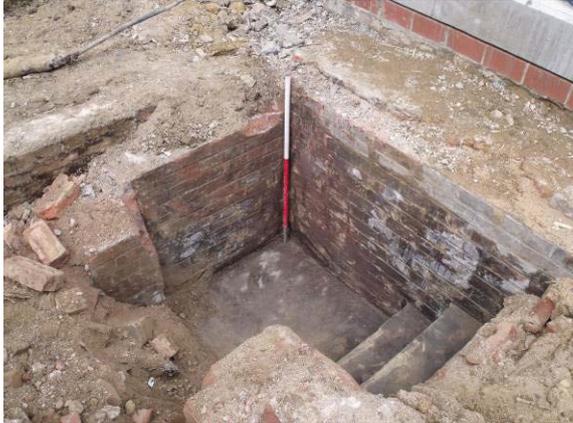
Buildings between the church of St John the Baptist and the Guildhall
Steps leading to cellar,
south side of toilet block,
facing north-west Fig 35

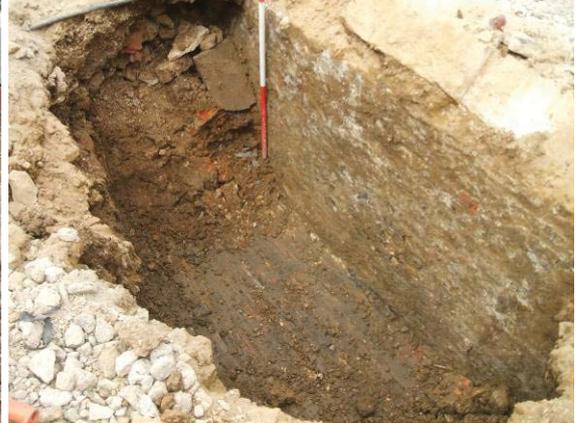
Stone cellar wall and brick floor,
east side of toilet block,
facing north-west Fig 36

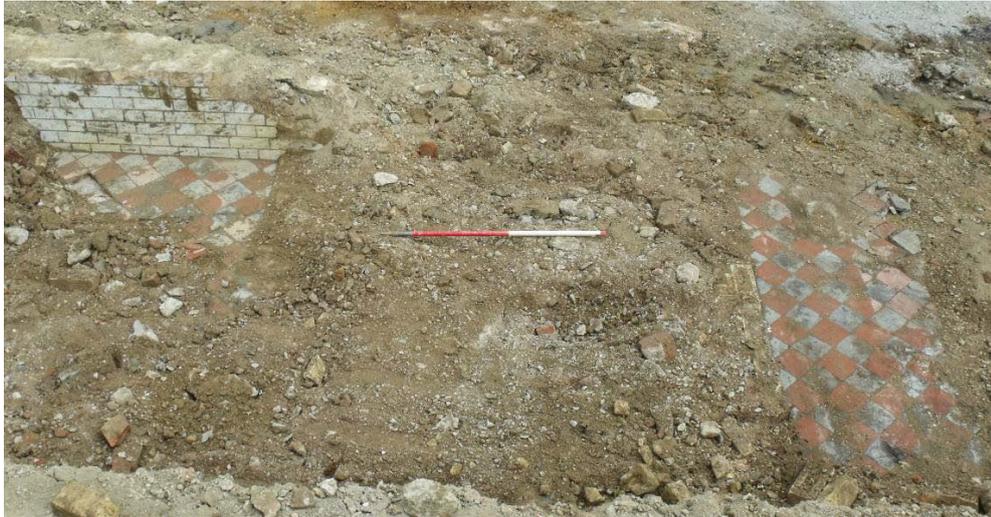
Corn Exchange; Remains of wall and floor of the subterranean toilet facing east Fig 37

With the demolition of the Norwich Union Building and the landscaping of the area for the new St John's Square, remnants of the Corn Exchange were uncovered. There were lengths of concrete and brick foundations, especially around the east corner, up to 1.5m deep, but the best preserved part of the building was in the north-east corner, where part of the white glazed brick walls and a diagonal chequer board tiled floor (red and black) of the subterranean toilet area was located, approximately 1.3m below the existing street level (Fig 37). The toilet area was probably part of the final 1893 extension of the building.

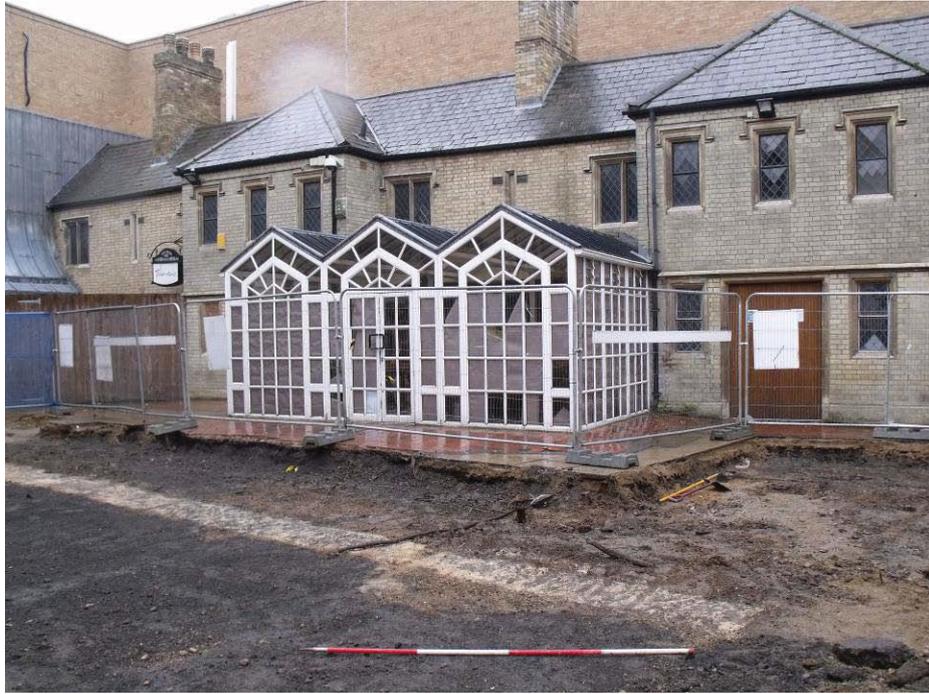
Cumbergate; Miss Pears Almshouses (background, now Harriet's tearooms), garden wall foundations (foreground), facing north-east Fig 38

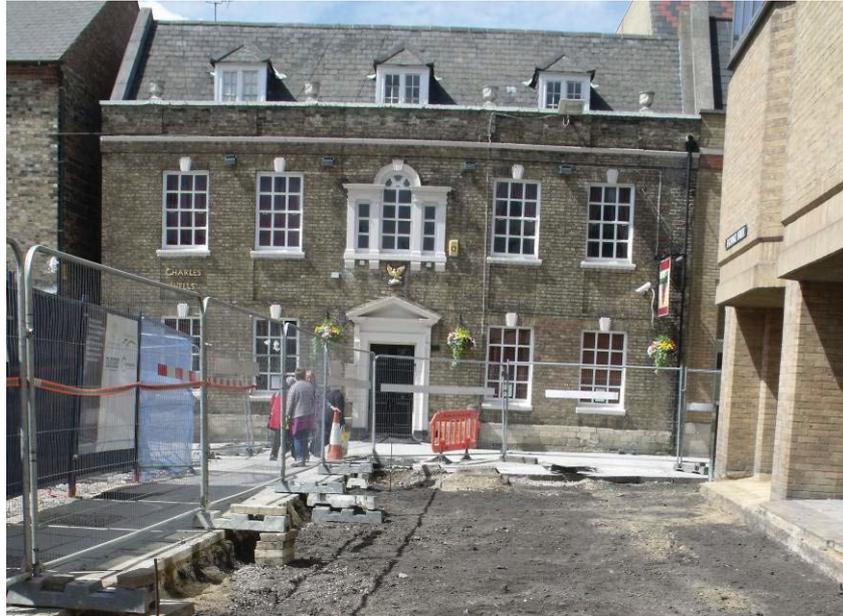
Former 18th-century town house on Queen Street, now known as The Grapevine (PH), facing east onto the square, facing west, from Exchange Street Fig 39

On the west side of Queen Street stands a mid-18th century brick town house of quality, with a central Venetian window and entrance. It is presently in use as a public house, called The Grapevine (Fig 39), though not the historical Grapevine public house which was on a different site, now gone. The reduction in the street level and the excavation of the service trenches prior to the new resurfacing gave opportunity to record the foundations of the building, and a partly obscured wall cavity for a boot scraper, adjacent to the north side of the entrance. The presence of a boot scraper in the 18th-century city centre appears to be a clear indictment to the conditions of the pavements at this late date, even after all the previous street improvements.

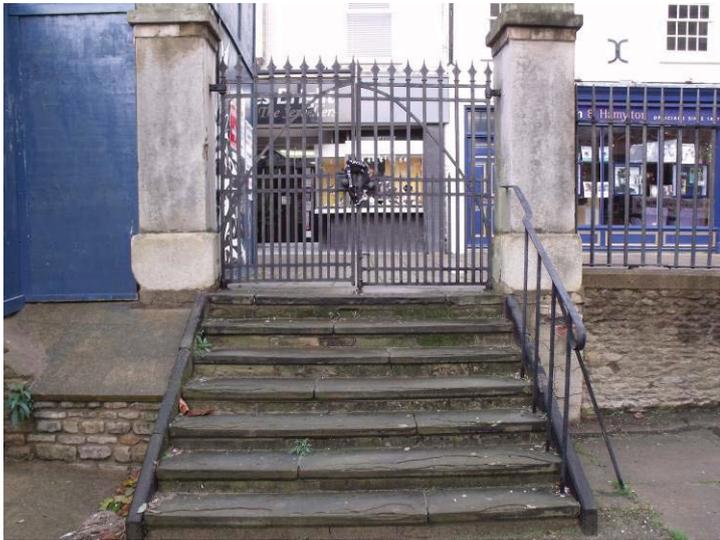
Church gateway, north-west corner of the churchyard, facing north onto Exchange Street Fig 40

In the later part of the century the medieval stone churchyard wall was demolished and replaced, with a 'new' low wall, with wrought iron railings, opening up the lower part of the church to street view. The 'new' wall and boundary extended around its entire length of the churchyard, with the exception of four new entrances of stone clad plinths and iron gateways at the two extremities of the churchyard facing Church Street and Exchange Street. Stone steps led from these entrances into the churchyard (Figs 40 and 41).

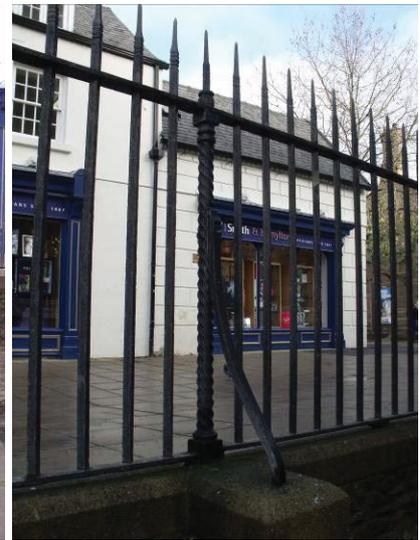
Churchyard railings on the north facing north-east onto Exchange Street Fig 41

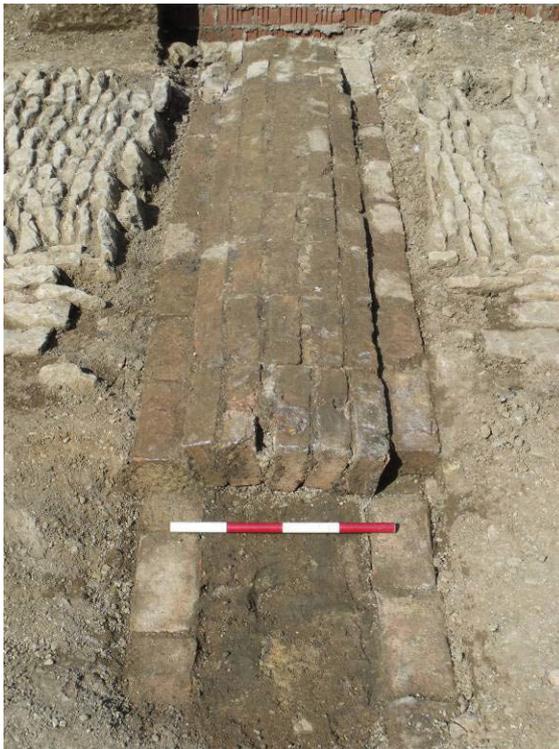
Victorian brick culvert cutting late 18th/early 19th-century pitched stone pavement, on the north side of Church Street, adjacent to the churchyard, facing north Fig 42

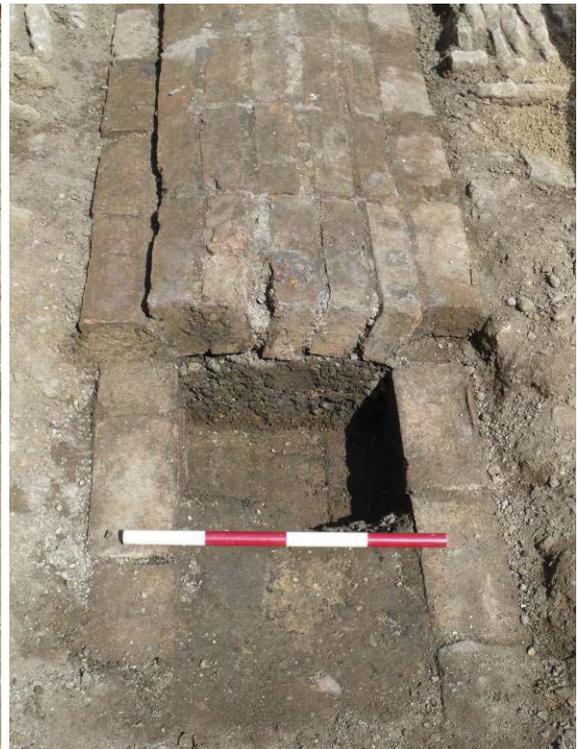
Excavated section through culvert facing north

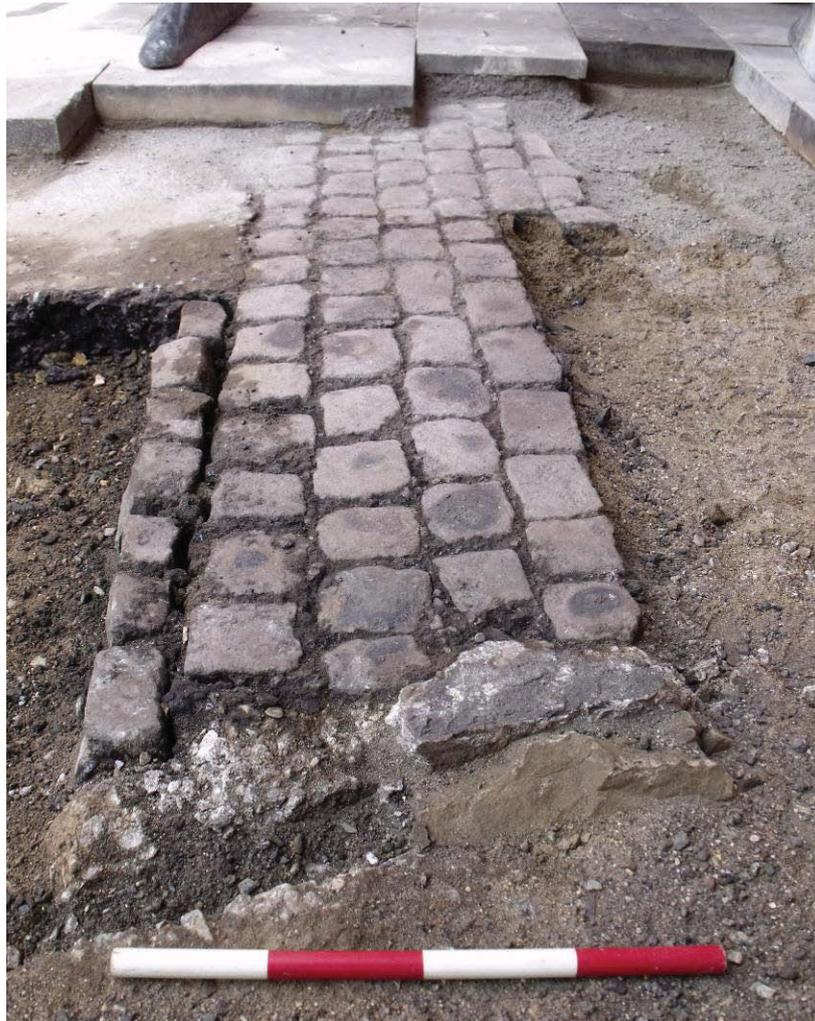
Remnant of late 19th-early 20th-century granite sett market square surface and stone kerb at the Cathedral Gateway, facing north Fig 44

From contemporary photographs this surface appears be extensive throughout the square and the neighbouring streets. The photographs also show an elaborate lamp-post in Cathedral Square, which was replaced by the Gates Memorial in 1897. The memorial was a fountain which honoured Henry Pearson Gates, the city’s first mayor. Although the monument was removed to Bishop’s Road gardens in 1963, the concrete foundations remained occupying an area of 5sqm and at least 0.7m thick, in the location of the northern array of fountains.
