An archaeological watching brief at  
Main Street, Thorpe-by-Water, Rutland  
November 2011-March 2012

Report 12/74

April 2012

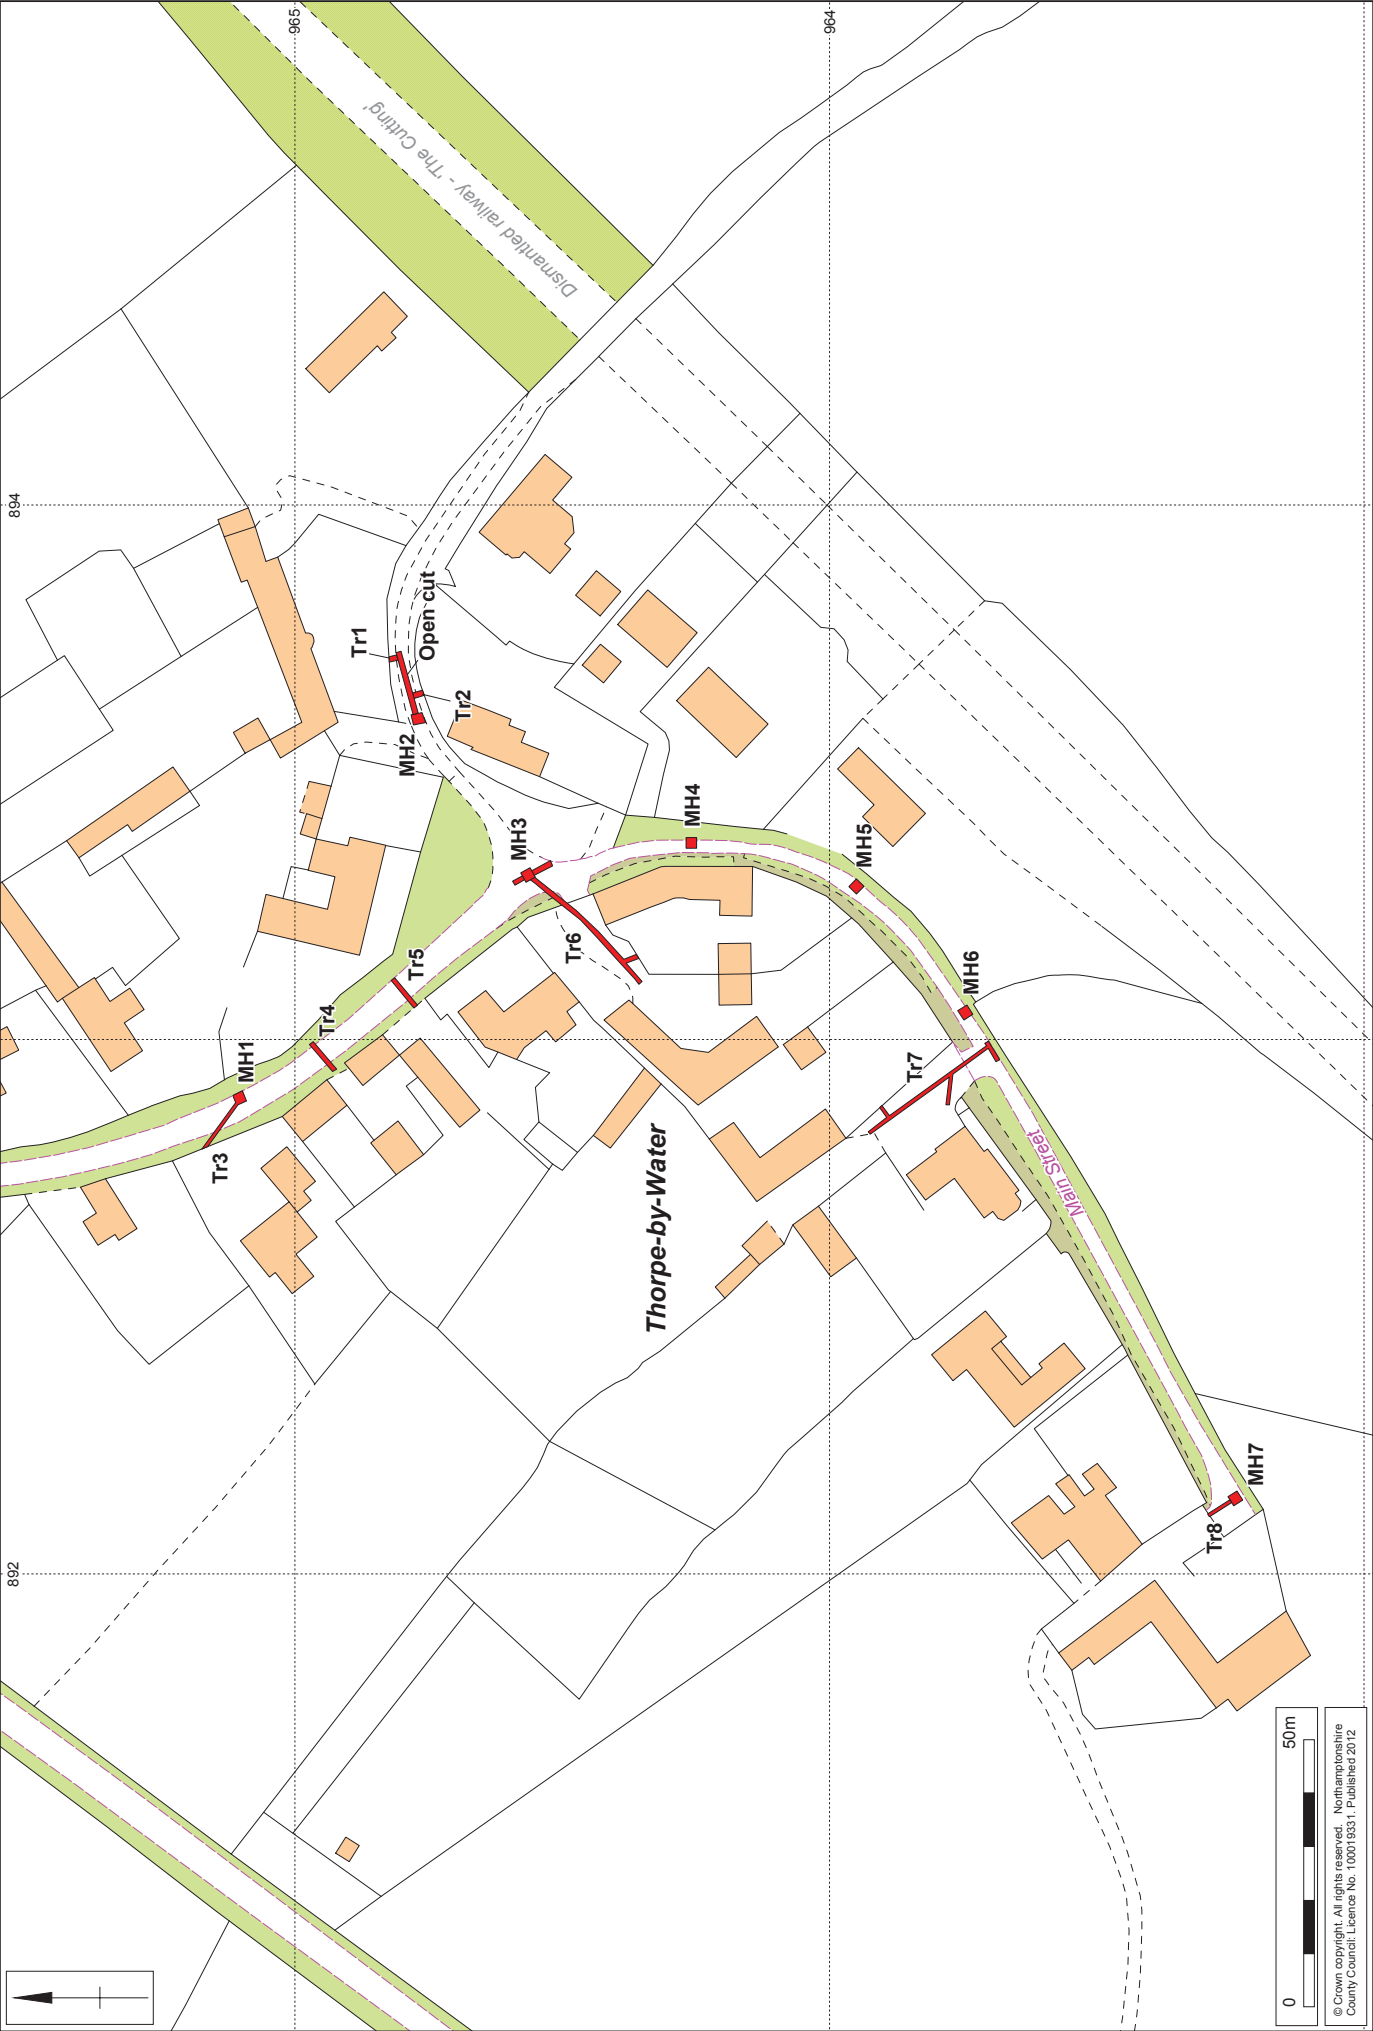
Scale 1:1000 (A3) Location of manholes and lateral connections Fig 2

Seven manholes were excavated with the majority of the new water main laid by drilling between these manholes. A 12m section of the water main was laid by open cut excavation to the east of manhole (MH) 2; this replaced the initially proposed MH1. In addition eight trench connections were also excavated from the new water main to property boundaries (Fig 2). All excavations were conducted using a mechanical excavator with a 0.40m, or 0.65m, wide toothless ditching bucket. The manholes were 2.0m long by 2.0m wide, excavated to an average depth of 4.0m. Trenches were, on average, 1.0m deep by 0.6m wide. Site visits were conducted at regular intervals whenever the site contractor gave notification of their intention to conduct mechanical excavation.

Trench 6 headed south-west from MH3 onto a small access road/driveway where it turned slightly westward and continued towards a property boundary (total length c29m). There was also a small 2.5m spur heading south-east to another property boundary near the end of the trench (Fig 2). Two other slots were excavated from MH3; these were to allow access for the pipe drilling machine. The south-eastern slot and the initial part of Trench 6 both revealed the same stratigraphy as the majority of the other manholes. Natural substrate was overlain by hardcore, 350mm thick, and tarmac, 110mm thick.

Trench 7 was excavated to the south-west of MH6 and consisted of a slot aligned south-west to north-east, 3.2m deep, and the mains connection which stepped up to 2.0m deep and headed north-west from this slot. The trench crossed Main Street and headed up a driveway/access road which had quite a steep incline, 0.9m deep at the north-west end. There were also two spurs to different property boundaries (Fig 2).

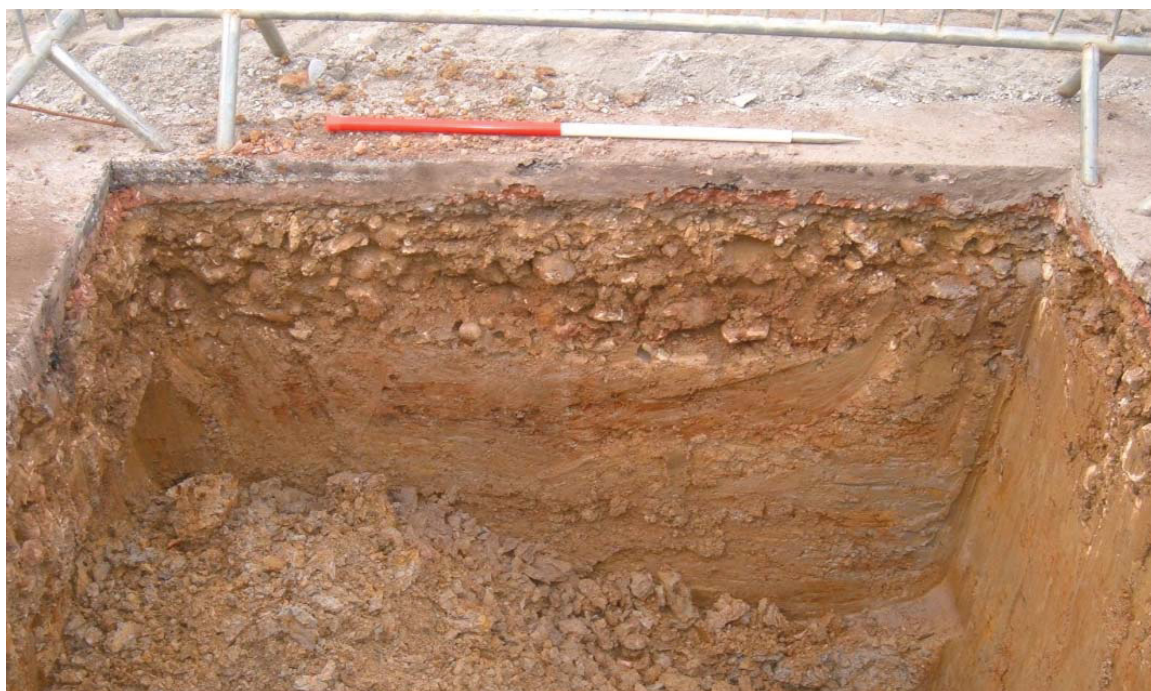
Manhole 5 section, looking north-west Fig 3

Manholes 1, 2, 4, 5, and the open cut from MH2 all revealed similar sections (Fig 3). The natural substrate was mixed mid brownish-orange and mid greyish-blue clay with some bands of orange sandy clay and ironstone. These bands tended to become more frequent at greater depths. This was overlain by a compacted hardcore layer of sub-

angular stone (<0.2m in length), 200-400mm thick, mixed with mid orangey-brown sandy clay, which contained occasional brick fragments. The tarmac road surface was laid directly over this and was 100mm thick.

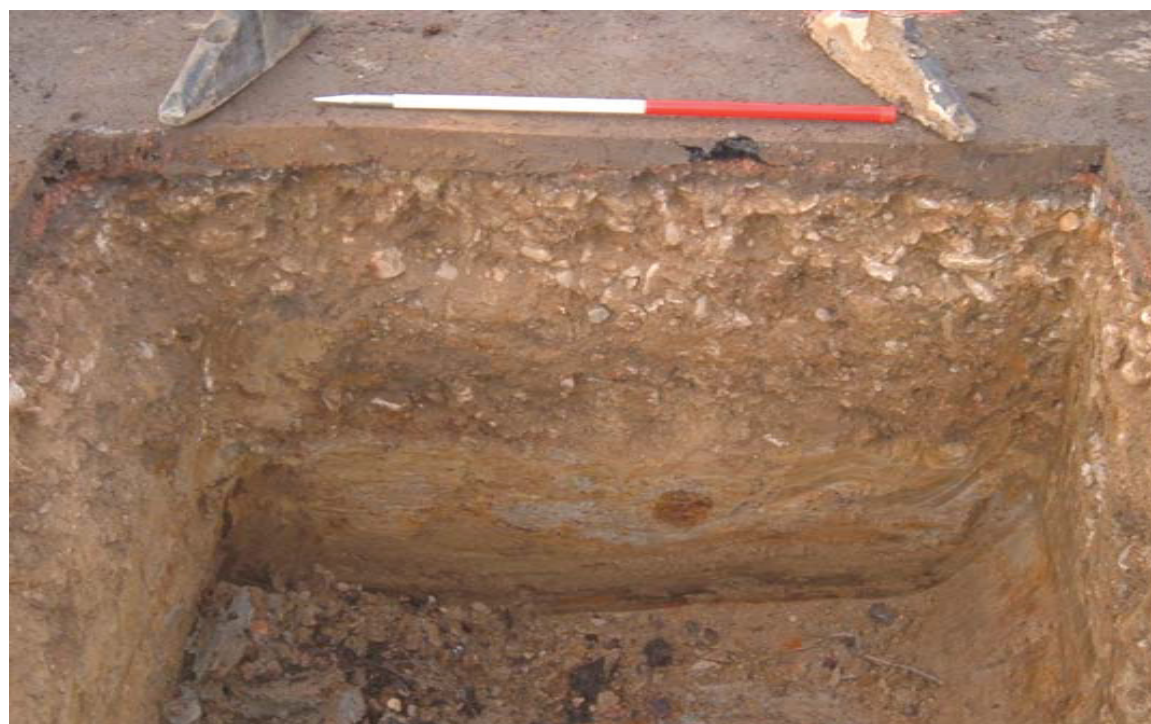
Manhole 6 section, looking north-west Fig 4

MH6 revealed a slightly different stratigraphy. The natural substrate was overlain by a make-up layer of mid greyish-brown sandy clay mixed with patches of redeposited natural clay and frequent stone inclusions, 400-500mm thick. The same road surface (hardcore under tarmac) overlaid this (Fig 4). MH6 was located towards the base of a gentle incline in the road and this make-up layer may have been deposited to decrease the incline when the road was laid.

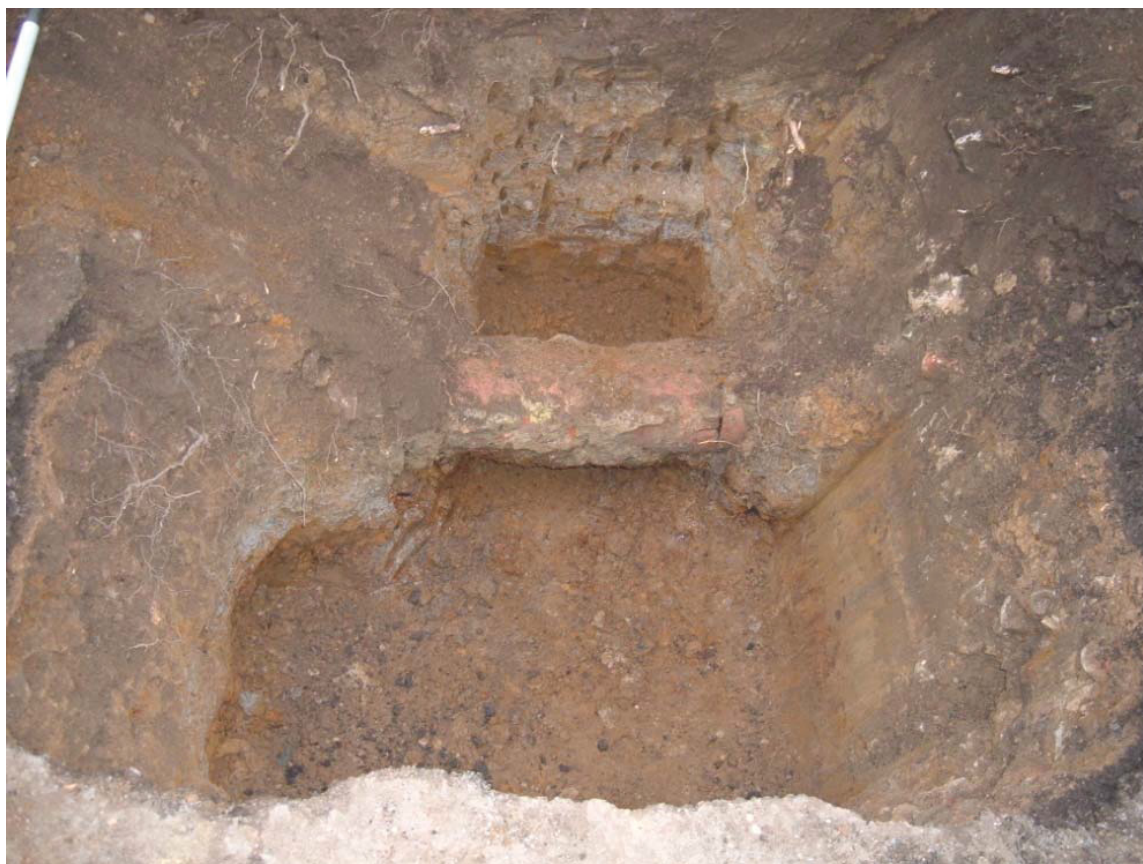
Trench 1, looking north Fig 5

Trenches 1 and 2 connected the open cut water main trench to the surrounding property boundaries. Trench 1 was 1.5m wide and Trench 2 was 1.0m wide, both were 1.0m deep. Within the road corridor the stratigraphy was the same as that of the open cut but on the verge it changed slightly. The natural was overlain by a make-up layer of mid greyish-brown silty clay, 300mm thick, with frequent sub-angular stones and brick fragments. In both trenches this was cut by existing service lines, the backfill of which was similar to that of the make-up layer. The surface was overlain by 0.1m of dark brownish-grey silty clay topsoil (Fig 5).

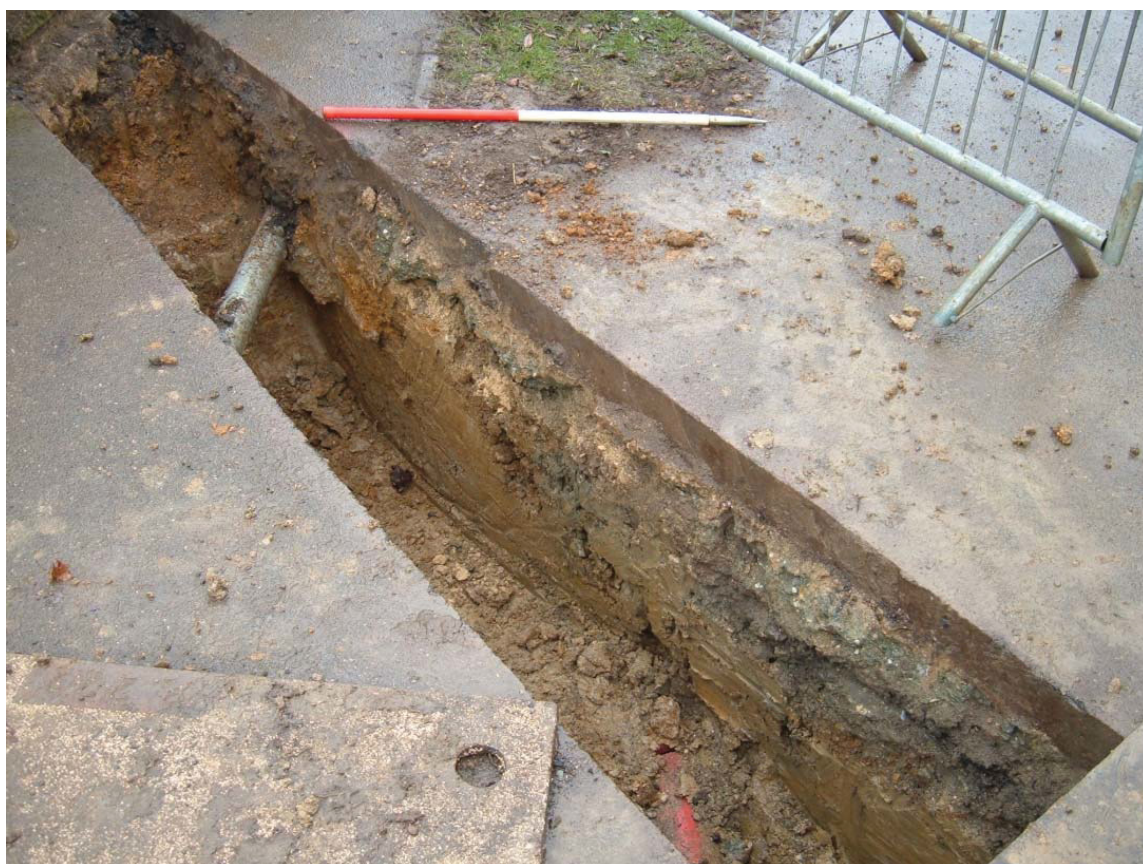
North-west end of Trench 3, looking north Fig 6

Trench 3 headed north-west from MH1 to a property boundary. It was 0.6m wide and sloped up from 1.4m deep at MH1 to 1.0m deep at the boundary wall. The road make-up is the same as that of MH1. However, when the trench crossed the edge of the property driveway there was a thin lens of yellow sand and gravel over which a slab of concrete 1.5-2.2m wide by 150mm thick, was laid. According to the homeowner the concrete was laid during the building of the property and extends all the way up the drive. This is abutted to the north-west by a layer of orangey-brown sand and gravel, 250mm thick, which deepens at the boundary wall and appears to have been used as both a hardcore layer for the pavement and backfill for the 0.4m deep concrete foundation of the boundary wall. This layer was cut by a BT cable trench. There was also a storm drain, 0.8m deep, and a water pipe, 0.9m deep, the backfill of which was sealed by the concrete and road hardcore respectively. Road tarmac covered the concrete and pavement hardcore (Fig 6).

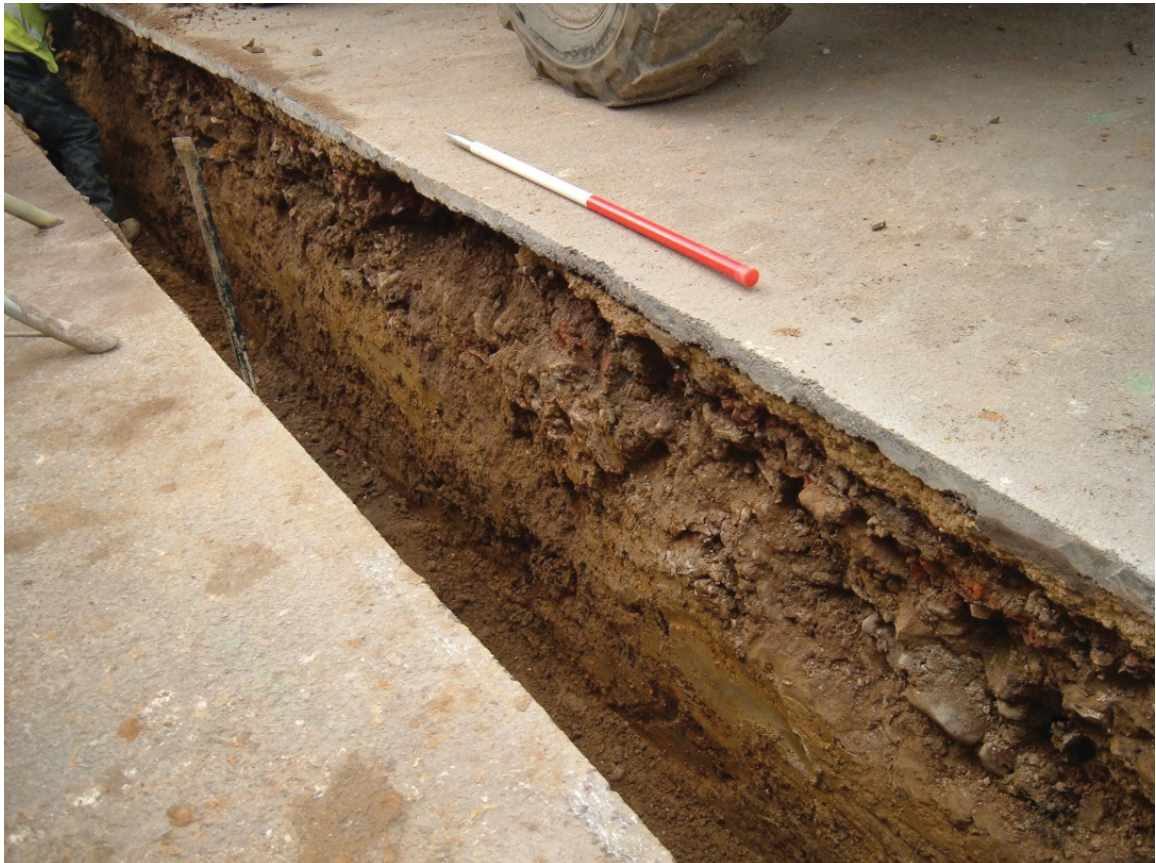
Trench 6 within the access road, looking west Fig 7

Trench 6 was 1.35m deep at MH3 and sloped gently to 0.90m at the south-west end. As the trench passed from the road to the pavement, and the start of the access road, the hardcore layer thinned to 200mm thick and the storm drain and water pipe from Trenches 3-5 were observed. Once on the access road the trench was crossed by numerous services at a slight angle to the trench for c12m. There were no distinct cuts for the majority of these services which had been cut through disturbed ground and backfilled with their own upcast. This heavily disturbed layer overlaid natural and was similar to the road hardcore layer, comprising mid greyish-brown sandy clay with frequent large stones and cobbles, 300-350mm thick. This was overlain by small brick and tile fragments mixed with red sandy clay, 70mm thick, across the extent of the

access road. Light yellowish sand and gravel, 60mm thick, lay above the brick, onto which 70mm of tarmac was laid (Fig 7).

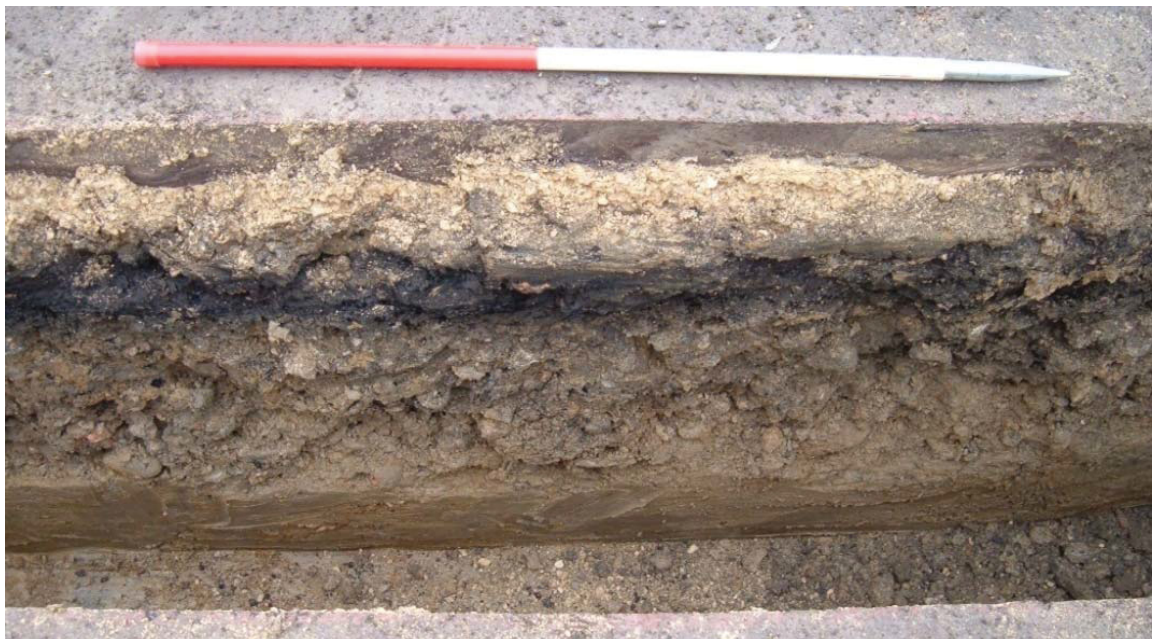
Section within the access road of trench 7, looking south-west Fig 8

Trench 7 largely consisted of two make-up layers, the earlier of which overlay the natural substrate and was the same greyish-brown sandy clay as seen in MH6. This extended for the length of the trench and undulated between 160-300mm thick. The upper make-up layer was found only within the access road. This was mid greyish-black sandy clay with some patches of greyish-brown sandy clay and contained frequent brick fragments, stone and charcoal lenses. There were also a number of quite large concrete, and reinforced concrete slabs, one of which was over 1.0m long by 0.3m thick. The layer also contained modern pottery, glass and plastic coated wire which were not retained. The layer undulated between 200-500mm thick and was probably related to the building of the house to the south-east of the trench in 1985. The layer thinned out towards the boundary wall of the north-eastern spur and towards the house in the western spur; therefore, it may have been deposited to build up the access road to a similar level of that of the surrounding properties. This layer was overlain by yellowish-orange sand and gravel and topped with tarmac (Fig 8). Within the road the make-up layer was overlain by hardcore and tarmac as seen in the manholes, which thinned out as it reached the access road. As with Trench 6 this deposit was disturbed by numerous services.

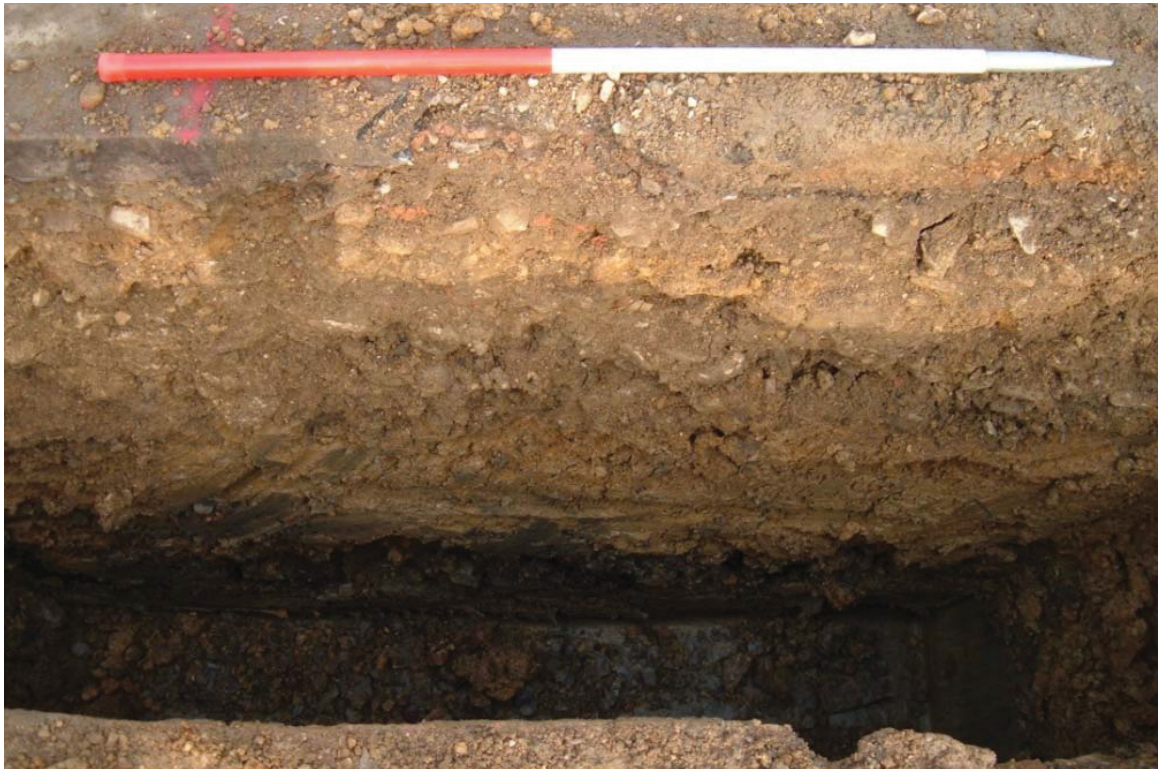
Section of Trench 8, looking north-east Fig 9

Trench 8 headed north-west from MH7 towards a property boundary and shallowed from 1.65m at MH7 to 1.30m at the north-west end. Natural substrate was not encountered within the trench, instead the base of the trench was within a layer of dark bluish-grey sandy clay with occasional charcoal lenses and stone, and very occasional brick fragments. This layer was at least 700mm thick and thickened to the north-west, overlain

by mid greyish orange-brown sandy clay which was redeposited natural clay. The clay was 150-400mm thick providing a leveling layer for upper deposits. Overlying this was hardcore, 330mm thick, similar to that found within the manholes and was slightly more yellow in colour. This was overlain by a 180mm thick layer of greyish-brown sandy clay with frequent stones and occasional charcoal flecks on to which the tarmac was laid (Fig 9). The property to the south-west of the trench was a converted barn and farmyard and this access has been redeveloped several times.
