Archaeological building recording at The Barn  
Potterspury Lodge School, Potterspury  
Northamptonshire  
October 2013

Report 13/255

*Northamptonshire Archaeology carried out a buildings recording action at The Barn, Potterspury Lodge School, Potterspury prior to its conversion to meeting room and workshop. The survey demonstrated that the buildings formed an integral part of a mid to late 19th-century farmstead, functioning as a cart shed.*

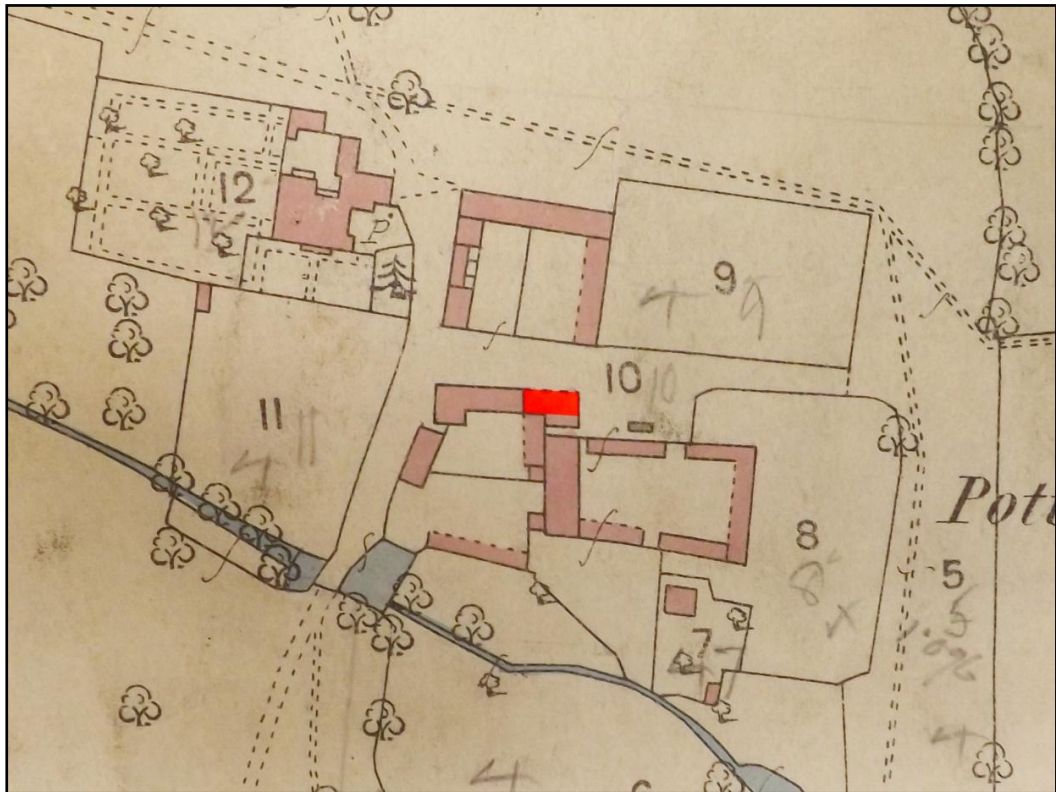
1st edition Ordnance Survey map of 1884 showing the layout of the Lodge and the Barn Fig 4

The 1st edition Ordnance Survey map of 1884 clearly shows the layout of the Lodge and outbuildings (Fig 4). The surveyed structure is present with north facing carriage arches clearly shown. A feature of the building, not surviving at the time of this survey, is a southern extension to the Barn. It is unclear from the map if this was a separate structure to the Barn or if there was access between the two. No evidence for a blocking was seen during this survey.

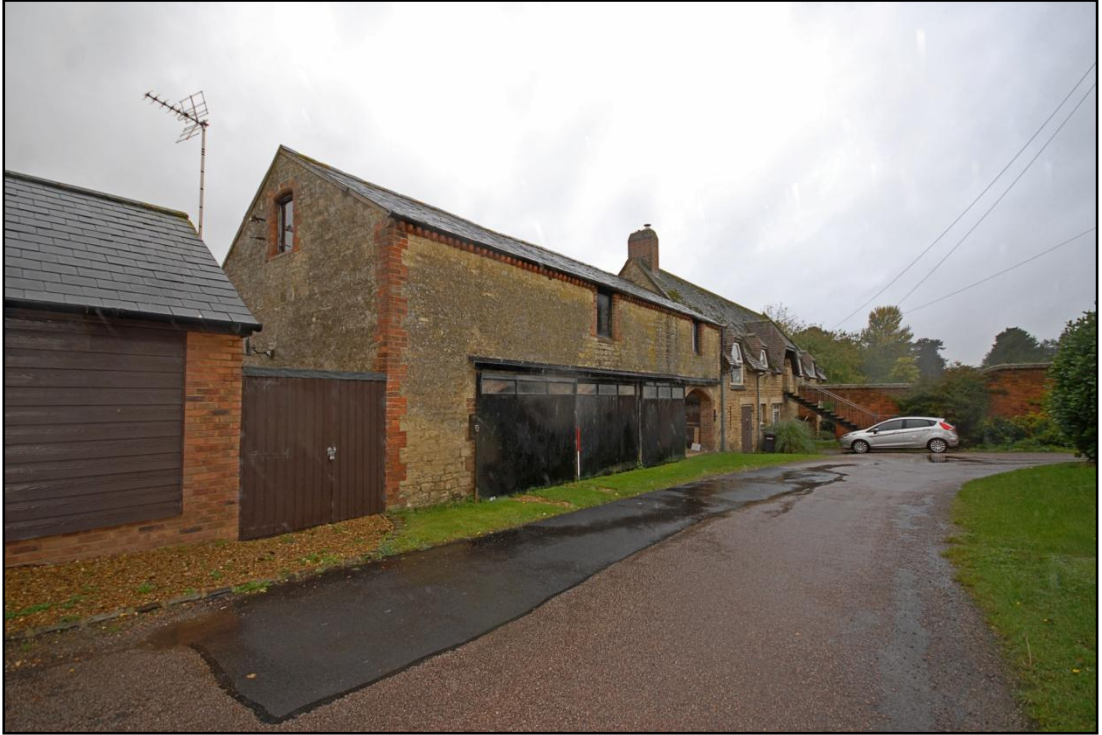
The north elevation of the Barn, looking west Fig 9

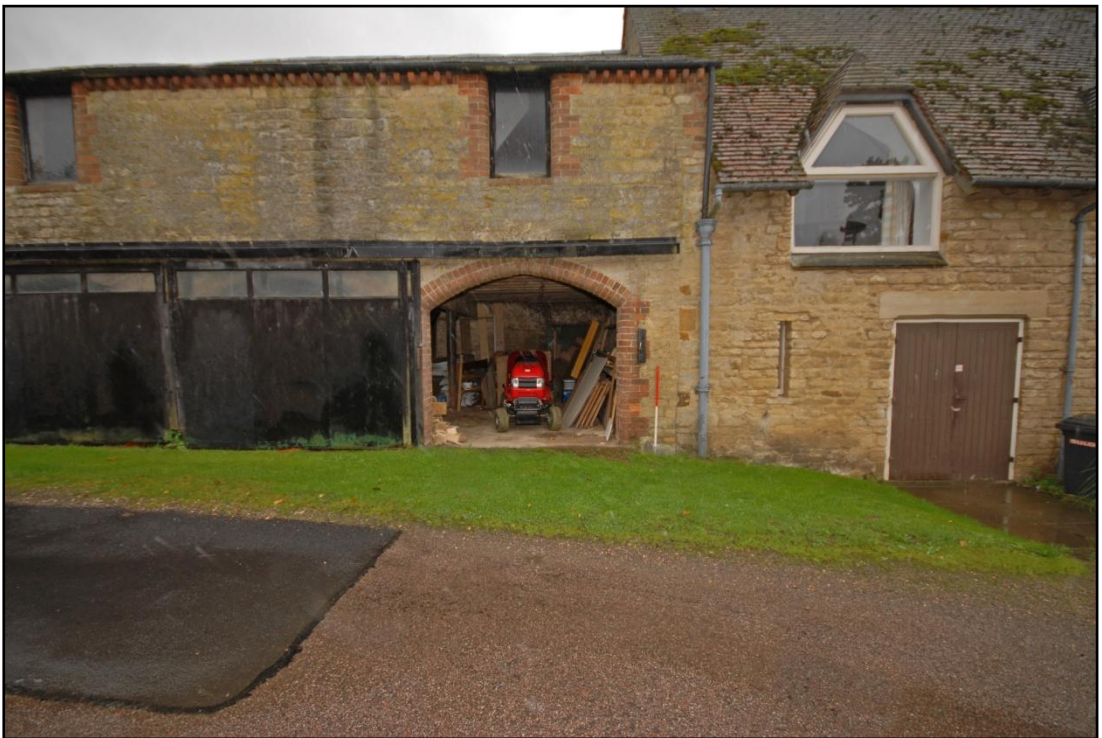
The building was originally open fronted with three carriage arches facing north. These were later covered over with timber, sliding garage-style doors (Fig 10). Two rectangular windows at first floor level look north with an opposing pair facing south and a single, high level window looks east through the gable wall. The windows are fixed, single panes in softwood frames throughout, inserted into the original openings in the mid-late 20th-century.

The north elevation of the barn, looking south Fig 10

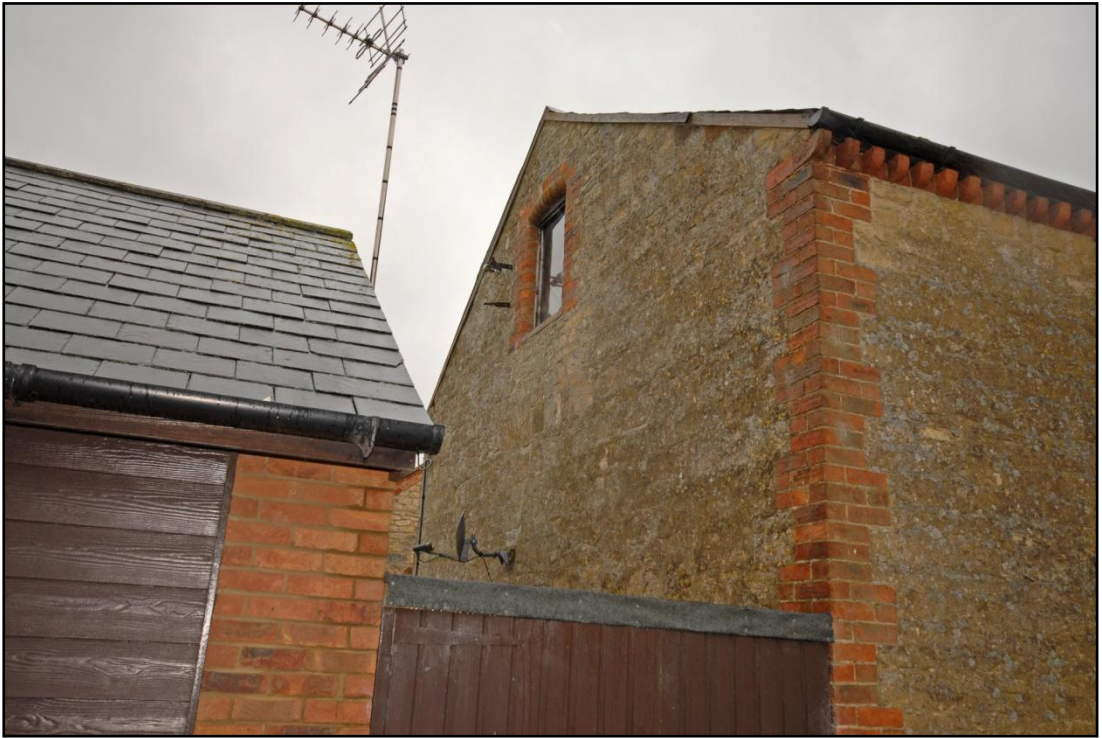
The roof is supported by simple, exposed, machine-cut pine trusses with central iron supporting rods and diagonal struts (Fig 18). A high level window in the eastern gable wall provides light to the top of the stair (Fig 11).

The eastern gable Fig 11

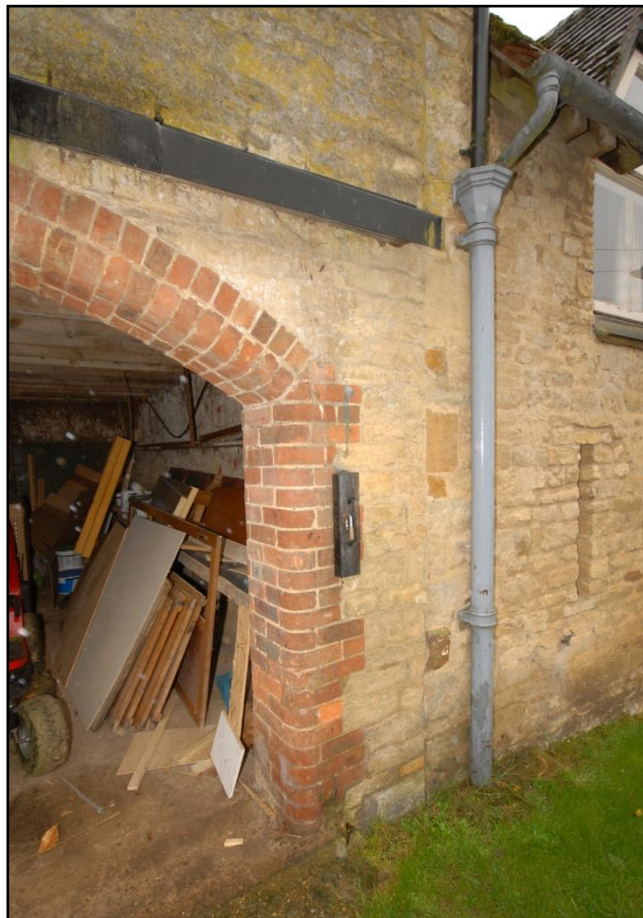
Map evidence in conjunction with the style and form of the building point to a date for construction in the latter half of the 19<sup>th</sup>-century. The bull-nosed bricks, which are an original part of the fabric, were not in use prior to 1840.

Bull-nosed brick detail around the carriage arches Fig 12

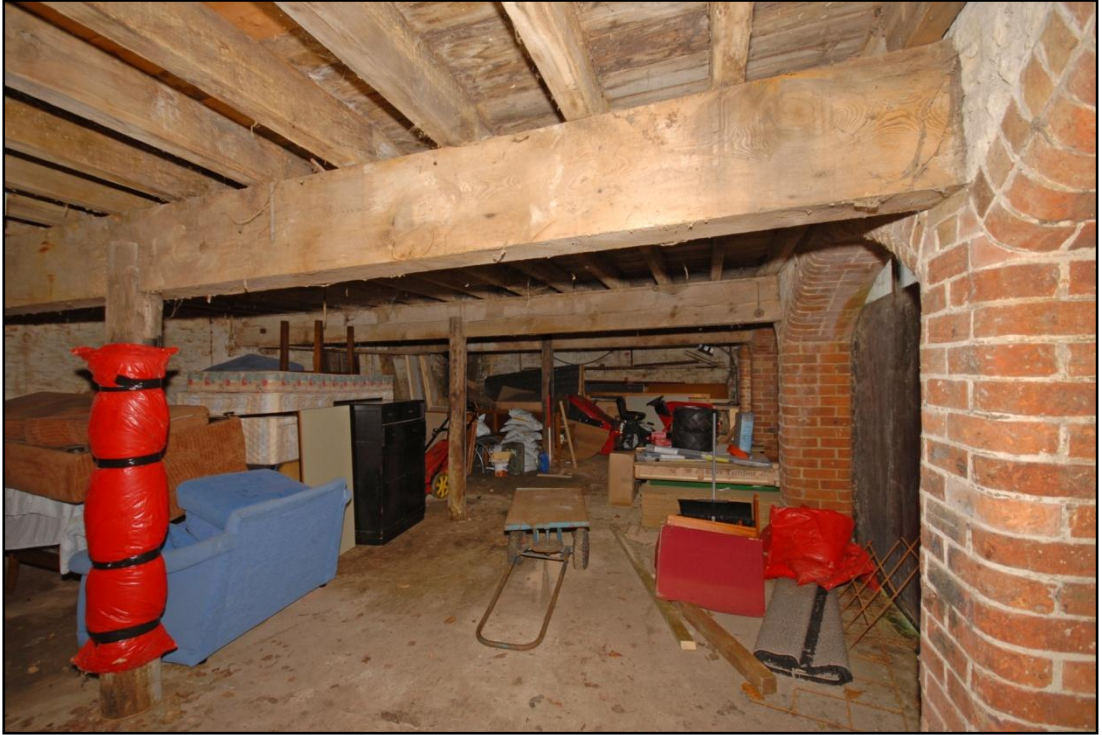
The walls are whitewashed internally and the room has a floor of beaten earth throughout. No original fixtures or fittings survive.

The ground floor, looking west Fig 13

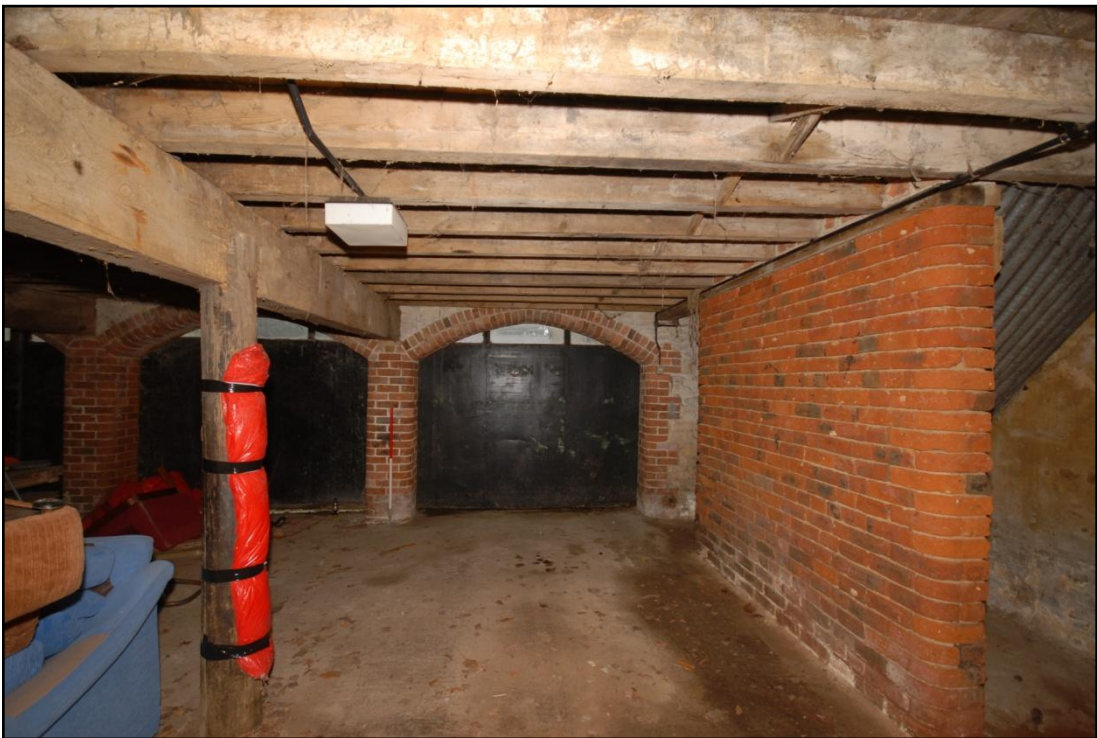
The ground floor is accessed from the north via the carriage arches. It is open plan on a plain rectangular layout with a stair leading to the first floor at the east end of the room (Fig 8). The stair is enclosed from the main room and supported by a red brick wall which also forms a small understairs area with corrugated sheeting over (Fig 14). A plank and batten door with diagonal slats separates the stair from the room (Fig 16).

Three north-south running beams support the floor joists over. These beams are supported on the brick arch dividers at the south, by the south wall and centrally by vertical timber posts (Fig 14). Crossed, diagonal slats ran between the joists, providing additional bracing and strengthening for the first floor (Fig 15).

The ground floor, looking north with stairs to the right Fig 14

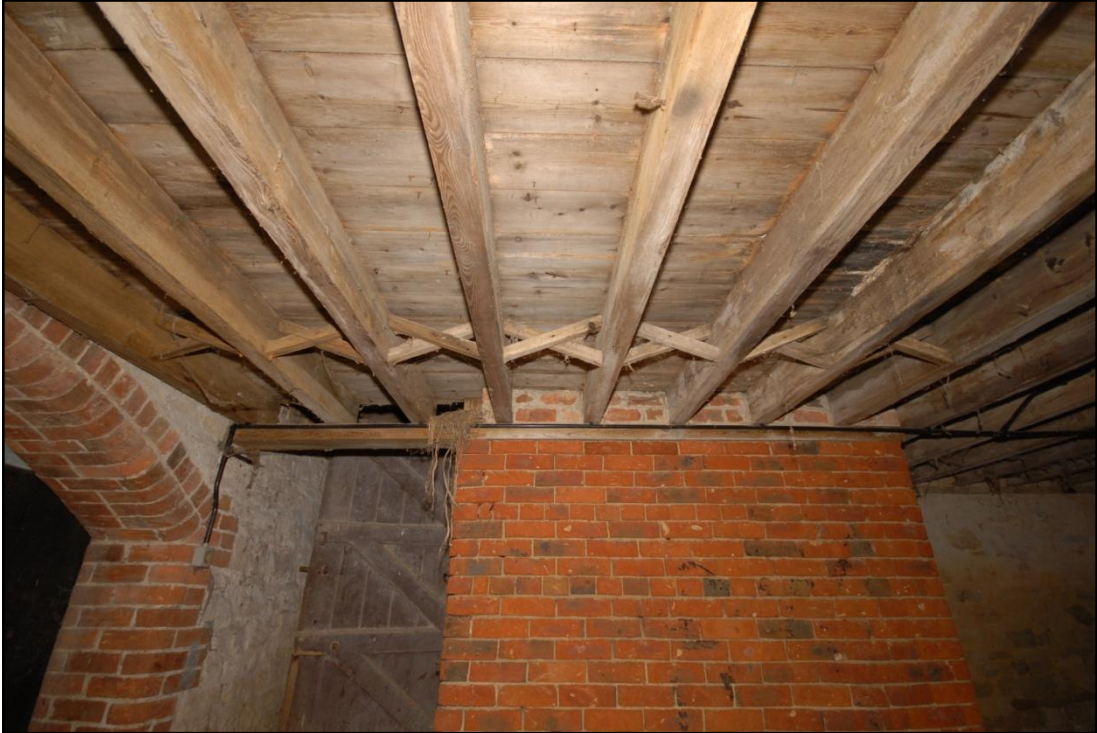
Detail of the roof structure with crossed bracing, looking east Fig 15

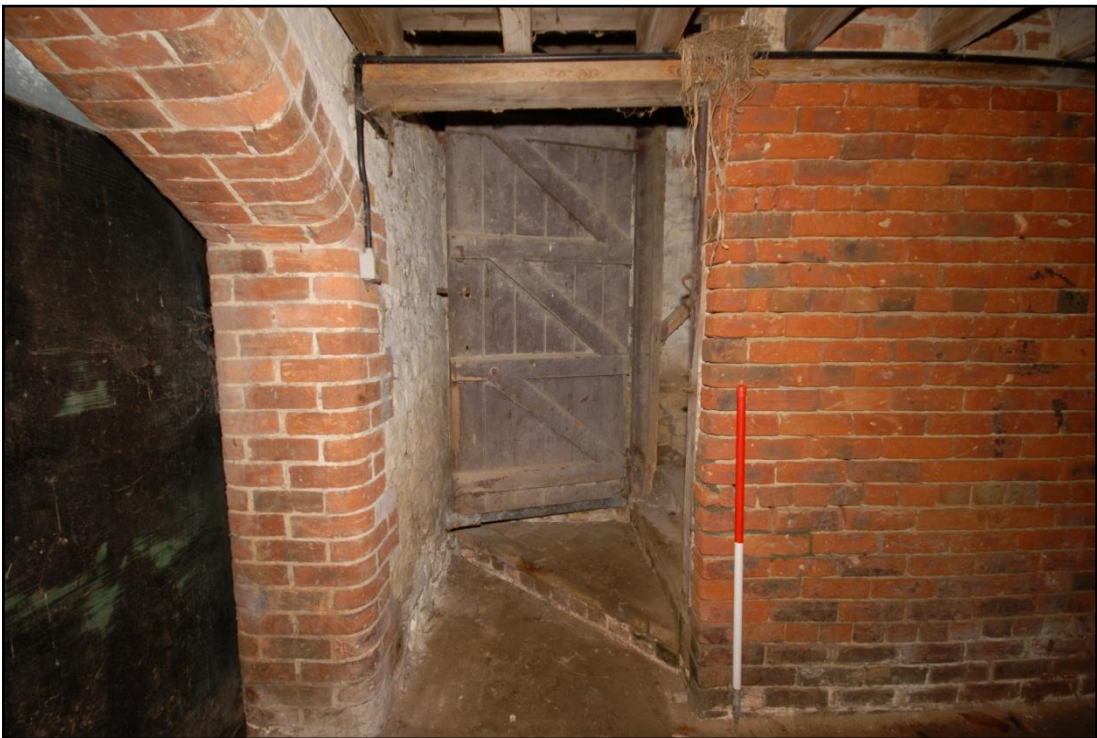
The stair door Fig 16

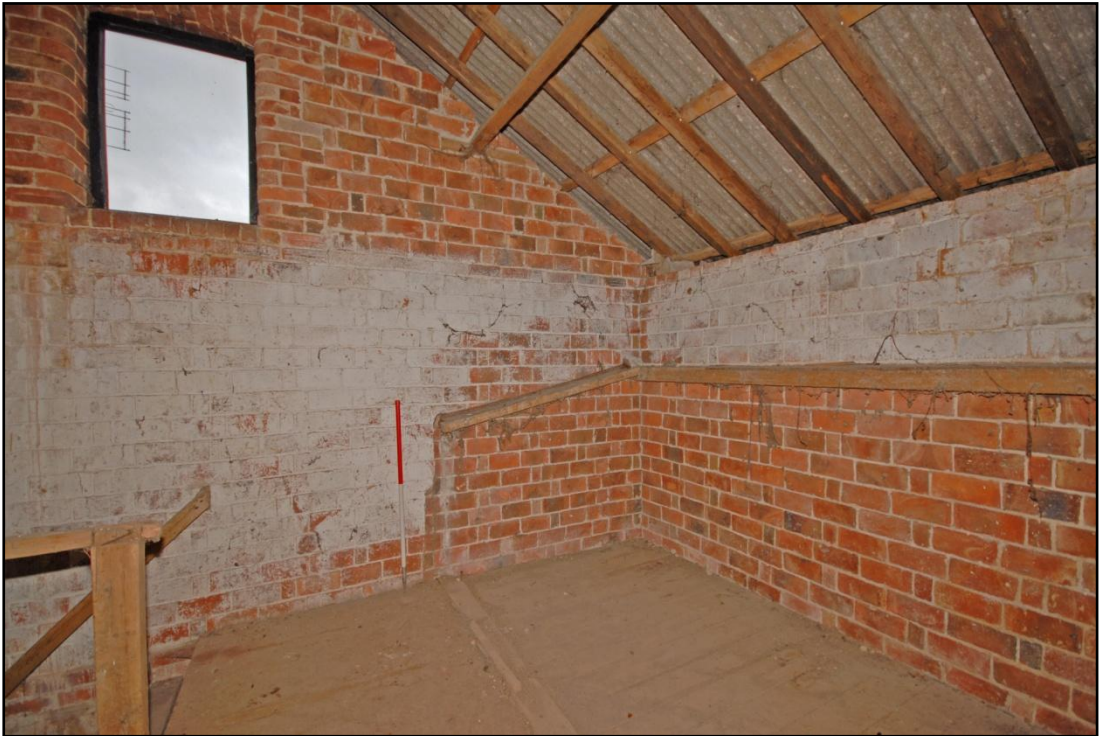
The first floor landing showing the scar of removed chicken coops to the right Fig 17

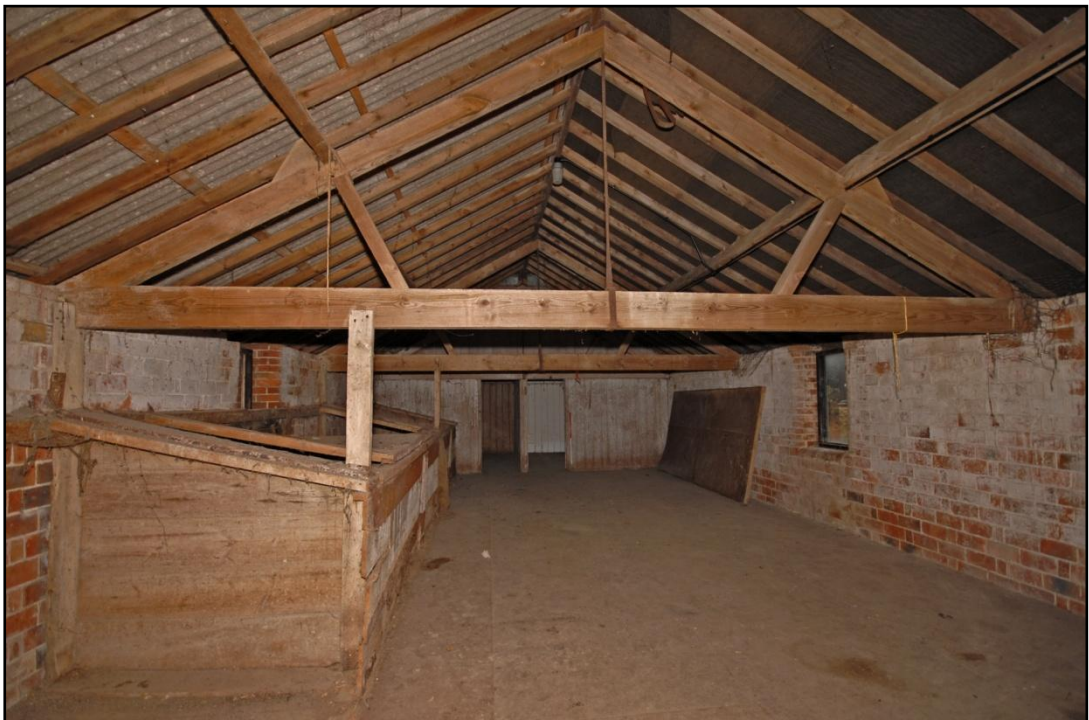
A row of raised, enclosed chicken coops run the full length of the south wall of the first floor. These are simple wooden structures with wooden roofs which could be raised and lowered (Fig 18).

The first floor, looking west, showing surviving chicken coops and roof structure Fig 18

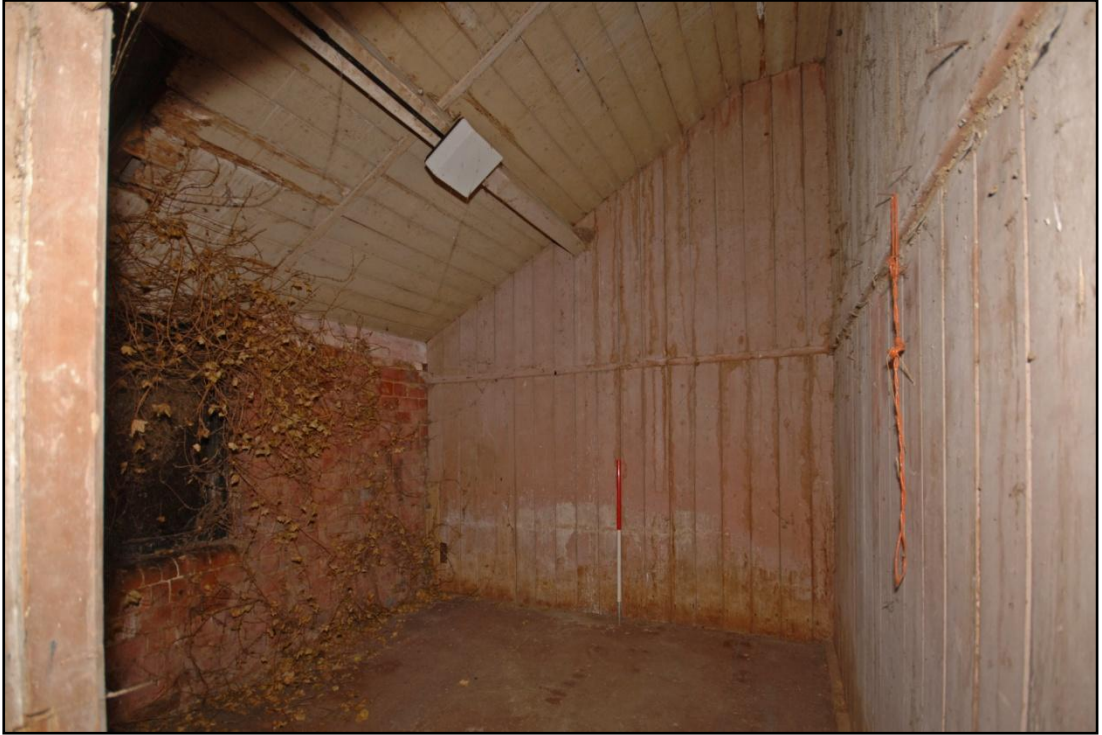
The tack rooms are small, square spaces, approximately 3 x 3.2m (Figs 19-20). No original fixtures were present in the rooms.

Tack Room 1, looking west Fig 19

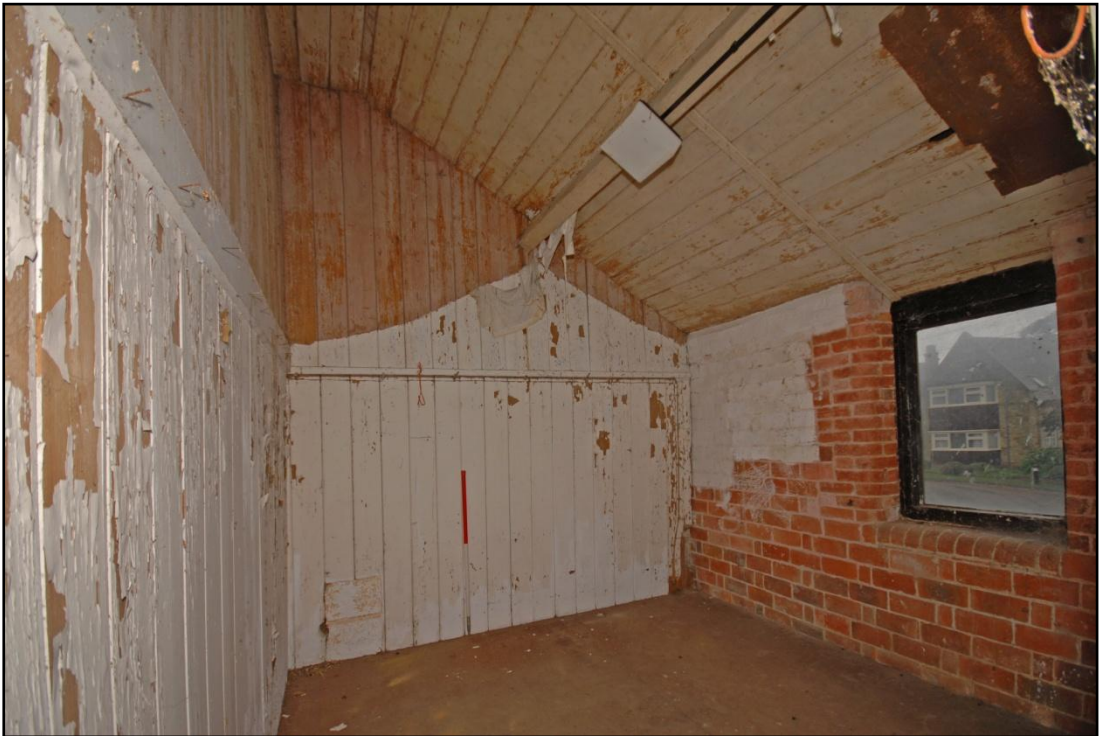
The first floor is an open plan space which had been subdivided into two smaller tack rooms at the western end (Tack Rooms 1 and 2, Fig 8). The walls are of red brick in English bond, whitewashed over. The partitions are constructed of vertical timber planks, which had been whitewashed (Fig 20).

Tack Room 2, looking west Fig 20
