A programme of archaeological work at The Grange, South Luffenham, Rutland, October 2010 – May 2011

David J Leigh Report 12/141 October 2012

A PROGRAMME OF ARCHAEOLOGICAL WORK AT THE GRANGE, SOUTH LUFFENHAM, RUTLAND OCTOBER 2010 – JUNE 2011

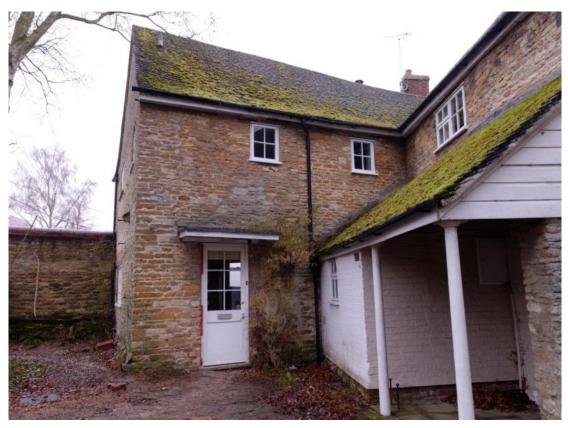
The porch, looking north-east Fig 10

The Grange comprises a stone-built two storey building with an attic room (Fig 23). The building is of predominantly 18th-century date with later additions. As part of the renovation works all the existing softwood window frames were replaced and the front porch, which was of relatively modern brick construction, was demolished (Figs 10 and 11). A new extension was constructed on the south-western corner of the building (Fig 3).

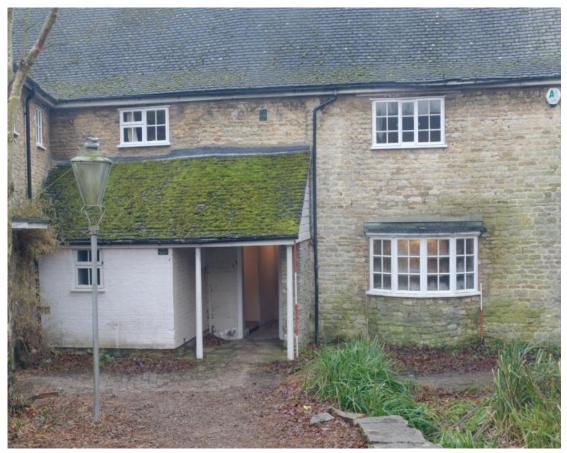
The porch, looking south-east Fig 11

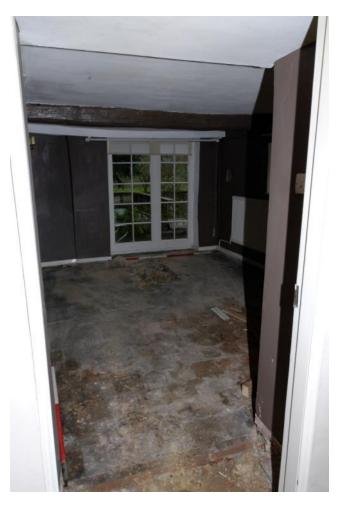
Room 1 Fig 12

In Room 1 a French window (Fig 12) exiting onto the back of the building was replaced along with the bay window of softwood construction in Room 2 (Fig 14). Two of the interior dividing walls had been demolished prior to commencement of the photographic survey (Figs 17, 18 and 22).

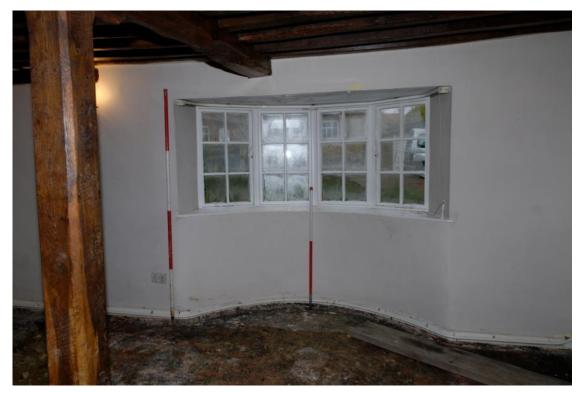
The bay window in room 2 Fig 14

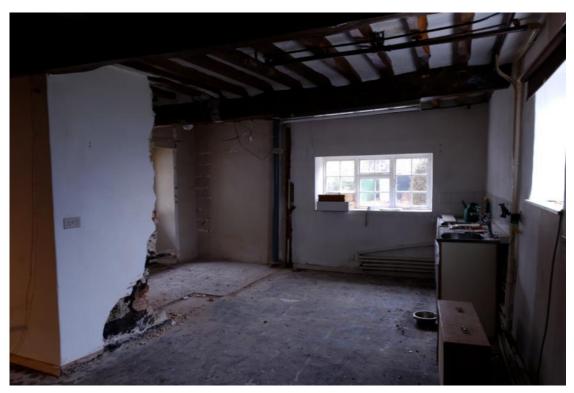
Room 5, the kitchen subsequent to demolition of a dividing wall Fig 17

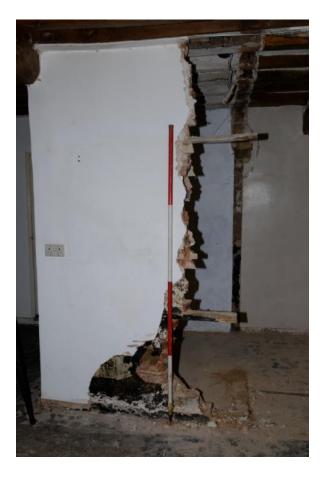
The remains of the dividing wall in Room 5 Fig 18

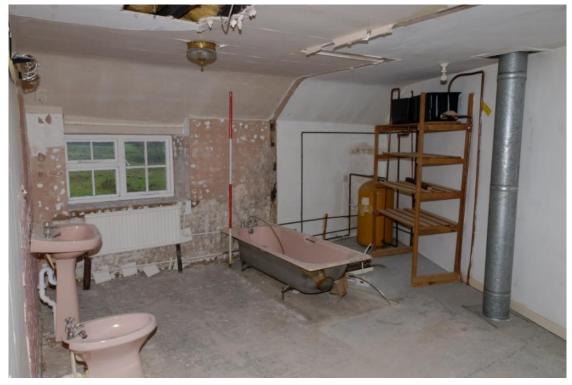
The floors in two upstairs rooms, 7 and 10 (Figs 19 and 22) were in an unstable condition and were replaced during the course of the renovation works.

Room 10, subsequent to the demolition of the dividing walls Fig 22

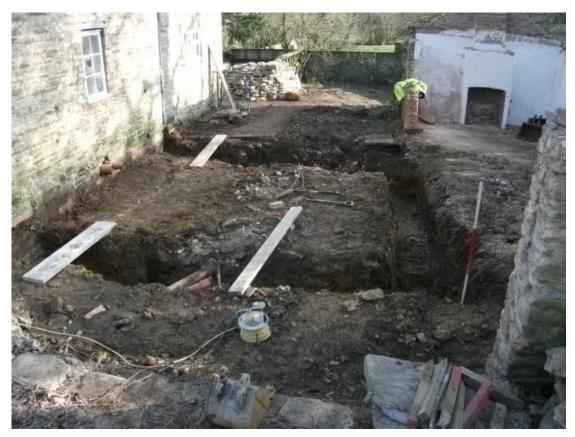
The foundations for the new extension were excavated to a maximum depth of 0.85m (Fig 24). The stratigraphic sequence (Fig 25) comprised a natural substratum of pale yellow-brown fragmented limestone, encountered at a depth of 0.35m below present ground level, this was overlain by mid-dark grey-black silt loam, up to 0.50m thick, containing numerous fragments of modern ceramic building material and small fragments of un-worked limestone and corroded metal gutter fittings.

General view of the foundation trenches, looking south-east Fig 24

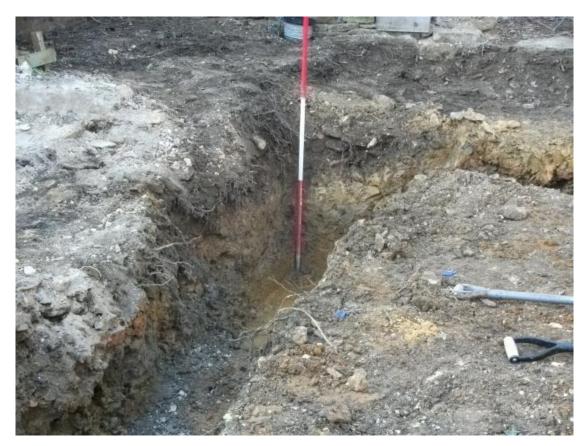
The stratigraphic sequence in the foundation trenches, looking north-west Fig 25

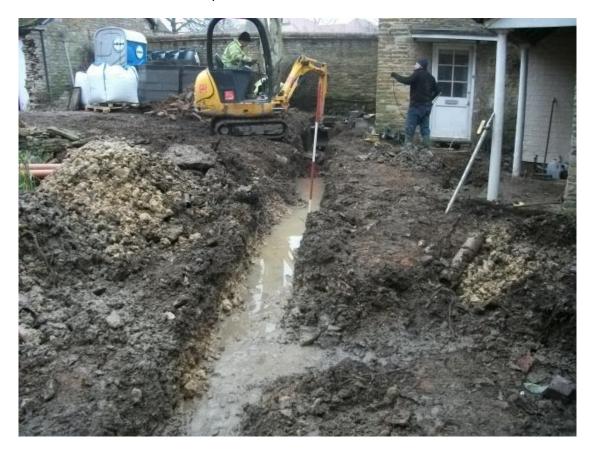
A new drainage trench was excavated across the frontage of the building (Fig 26) to a maximum depth of 0.30m below present ground level. Grey-black silt loam containing numerous fragments of modern ceramic building material and irregular fragments of limestone extended the full depth of the trench.

The excavation of the drainage trench Fig 26

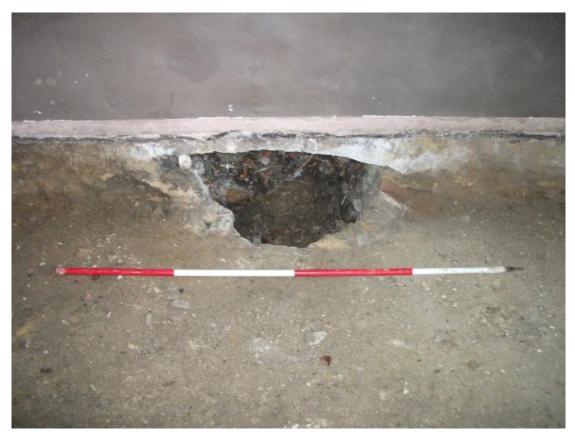
In Room 1 a single undated well was recorded lying directly the north-east wall of the room (Fig 27) and was sealed beneath the concrete bedding layer inside the building, although it was exposed on the exterior of the wall (Fig 28). It was of dry stone construction and measured approximately 1.0m in diameter, extending into the room 0.60m. Approximately 0.70m of grey-black silt loam, containing very occasional small fragments of modern ceramic building material was excavated from within the well to facilitate a concrete seal.

The well in the north-east wall of Room 1 Fig 27

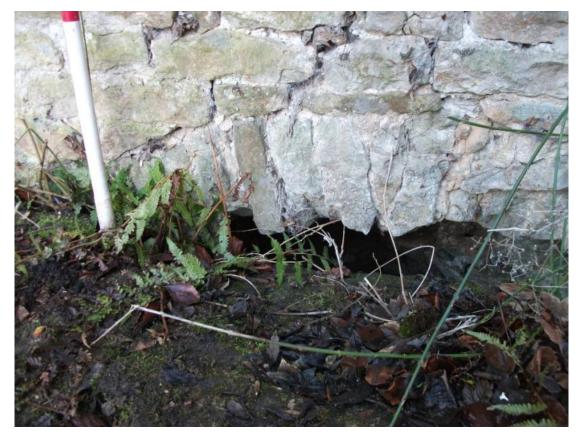
The well visible on the outside of the building Fig 28
