Archaeological watching brief at Ham House,  
Richmond, Greater London, (formerly Surrey)  
November 2011

Report 12/3

ENA6515

**ARCHAEOLOGICAL WATCHING BRIEF AT  
HAM HOUSE, RICHMOND, GREATER LONDON, (FORMERLY SURREY)  
NOVEMBER 2011  
National Trust event number ENA6515**

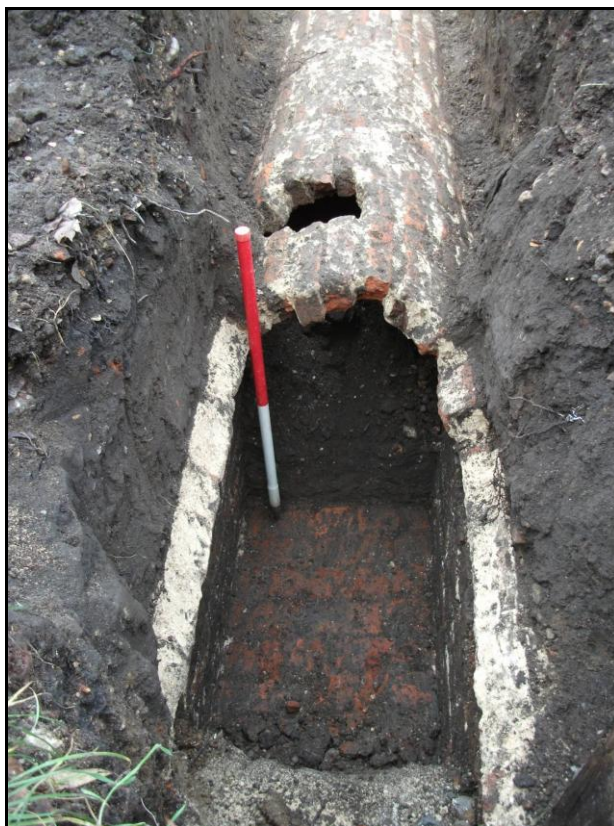
Fig 6

In the area of the new water treatment tank an 18th-century arched brick drain was exposed, aligned north-south (Figs 5 and 6). The exposed length of drain had been pierced by three postholes in relatively recent times. Where the drain crossed the boundary of the site to the south and under a trackway, the top of the arch had been knocked in and the drain filled. Going north into the walled garden area the drain was still open with only c0.10-0.15m of silting in its base. The drain was constructed from unfroged red bricks measuring 220mm by 98mm by 60mm (8 5/8" by 3 7/8" by 2 3/8"), bonded with a pale buff coloured lime mortar. The amount of mortar between the joints on the inside (intrados) of the arch would indicate that the drain arch was made from the outside by centering over a former, where it was not possible to tidy the inside joints (Fig 7). As the bricks forming the arch were plain, the mortar forms the wedge and acts as the voussoir. The side walls of the drain retain an internal lip and it is likely that the former for the arch sat upon this until the mortar hardened and it would then be moved along so that the next section of the arch could be constructed. The former would have been set on wedges which when the mortar had hardened would allow for it to drop so that it could be moved along with ease (Frost 1954).

The 18th-century drain, looking north

The watching brief demonstrated that there is at least c0.2m of made ground in the areas of the gardener's compound where excavations took place. The watching brief also revealed a previously unknown 18th-century brick drain, which may relate to the possible rectangular water feature in the western part of the walled garden shown on the Helmingham plan of c1730 (Fig 3). The fall of the drain was to the north and the River Thames.

The purpose of the feature remains unclear; it may have acted as a culvert taking water to the possible water feature shown on the 1730 plan, from ponds/water source to the south of the walled garden boundary. Whatever its purpose it is a major feat of construction and water engineering and opens the possibility of more targeted work to trace its route through the garden and to trace its origins south of the boundary.

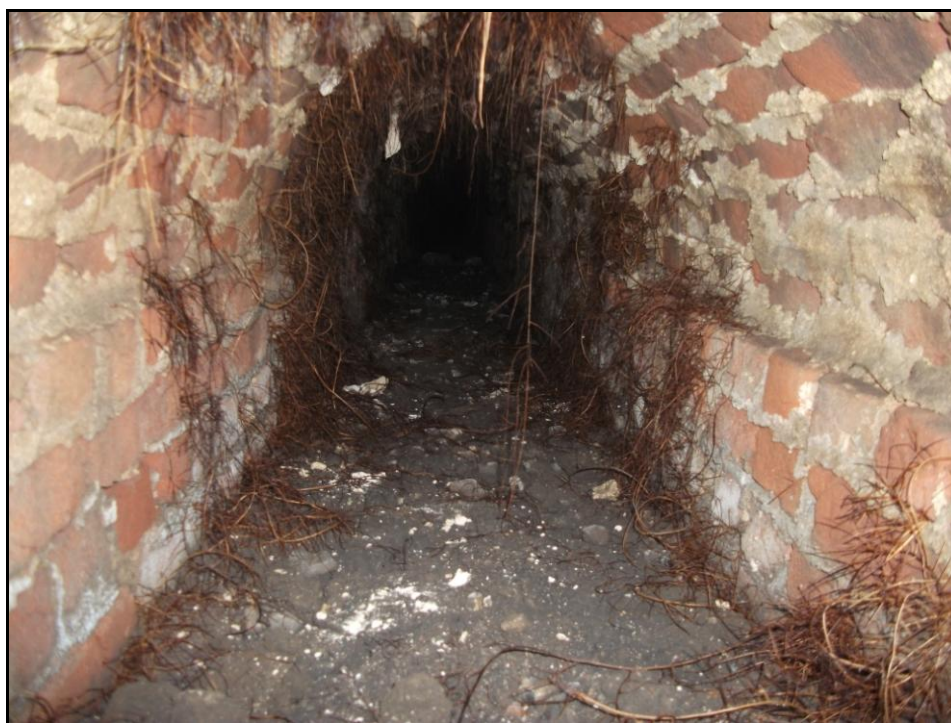
Fig 7

The inside of the drain, looking north
