*GEOPHYSICAL AND TOPOGRAPHIC SURVEYS
AND ARCHAEOLOGICAL EXCAVATION AT
EASTBURY MANOR HOUSE,
BARKING, ESSEX*

DECEMBER 2001

Detailed geophysical and topographic surveys followed by trial excavation were carried out in the west garden at Eastbury Manor, a National Trust property in Barking, Essex. This work formed part of Phase 1 of archaeological investigations at the property. The geophysical survey produced anomalies denoting the remains of possible garden features. The excavation was targeted at areas identified from the survey and by documentary research. This revealed that the whole of the west garden had been deeply cultivated during the 19th century. No earlier remains survive which may have indicated the layout of a contemporary garden.

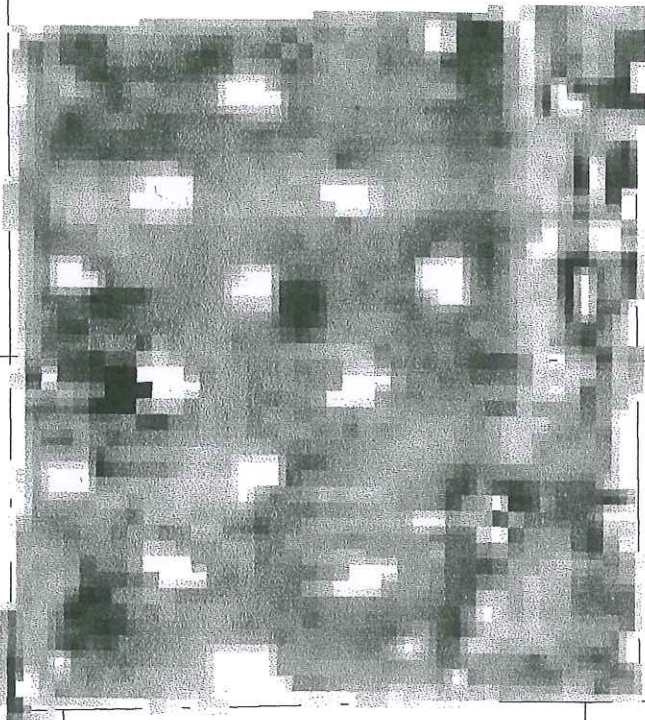
Fig. 2

The resistivity survey was carried out using a Geoscan RM15 Resistance Meter with a twin electrode configuration in a mobile probe spacing of 0.5m. Transects were spaced 0.5m apart and were walked from west to east in a 'zig-zag' fashion with readings logged at 0.5m intervals. White areas within the plot represent areas that could not be surveyed due to the presence of shrubs and trees.

The data was analysed using the Geoplot v3.0 (Geoscan 2000). In the resultant plots, low resistance is shown as white and high resistance as black. The plots are shown as raw and enhanced data. The data has been despiked, thereby reducing extreme readings as caused by uneven contact with the ground and with stones lying immediately beneath the surface.

A linear low resistance anomaly (A), approximately 1.5m wide and running in a west to east direction may denote the remains of the path indicated on the 1862 Ordnance Survey map, though the presence of a path would be expected to be indicated by a reading of high resistance. The low resistance reading may therefore indicate an earth-filled feature representing an area of introduced soil after the removal of the path. A square-shaped high resistance anomaly (B) located slightly off centre to the garden plot suggests an area of masonry or stonework. Anomaly (C) situated on the north side of the path has a slightly higher reading than the rest of this area and may indicate the presence of a structure though the lack of distinct form may simply be the result of uneven levelling of the underlying soil. Along the eastern side of the garden plot is a faint high resistance linear anomaly (D), which may denote remains of an enclosing wall or path edging interrupted by the cross path (A). High resistance anomalies (E) and (F) could indicate spreads of rubble, perhaps relating to the levelling of the area. A linear low resistance anomaly (G) lying roughly parallel to the west side of the house might be the result of a service trench, situated as it is close to four manhole covers. No other significant anomalies were detected.

This was placed near the centre of the garden to investigate an anomaly detected by the geophysical survey (Figs 2, 3 and 6). The same layer of black sandy loam was uncovered beneath the turf and cutting this was a roughly oval shaped deposit of brick rubble (Tr 5/3).

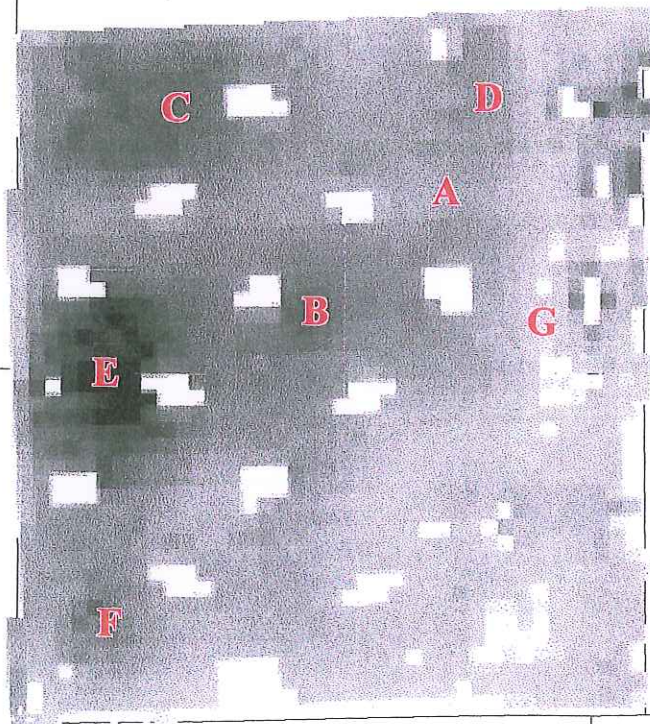
Fig. 3

The data has also been graphically smoothed and enhanced using a high pass filter (radius 5m gaussian) and a low pass filter (radius 1m gaussian).

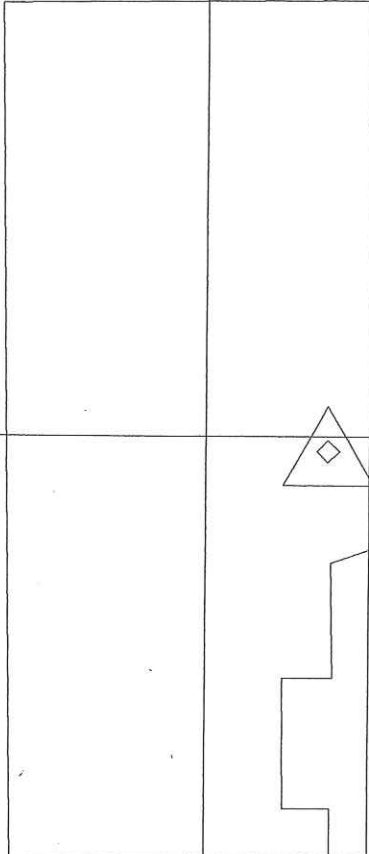
At the same time as the geophysical survey, a topographic survey was undertaken to record all the existing features in the garden and to determine if any variations in the topography of the site might indicate the presence of former features. The survey was made using a Topcon total station theodolite and processed using Intsurveyor and Mapinfo programmes. All of the cultivated areas around the present planting were recorded along with the edges of the grass area and any modern services (Fig 4). A series of levels were also taken in between the areas of planting, these were related to Ordnance Datum (Fig 5) and have been reproduced as contours.

While the garden appears essentially flat, it does slope gently to the south, and along the western perimeter wall is slightly banked. Across the main part of the garden there were no discernible earthwork remains, and this was confirmed by the creation of the contour survey which indicated no measurable features apart from the edges of the small beds around the planting.

Numbers represent height above OD

The area of investigation is located immediately to the west of the manor house and is essentially flat, though it does fall slightly to the south (Fig 5). The house is surrounded by a housing estate built in the 1930's which has impinged upon the original setting of the house but is not thought to have significantly changed the topography.

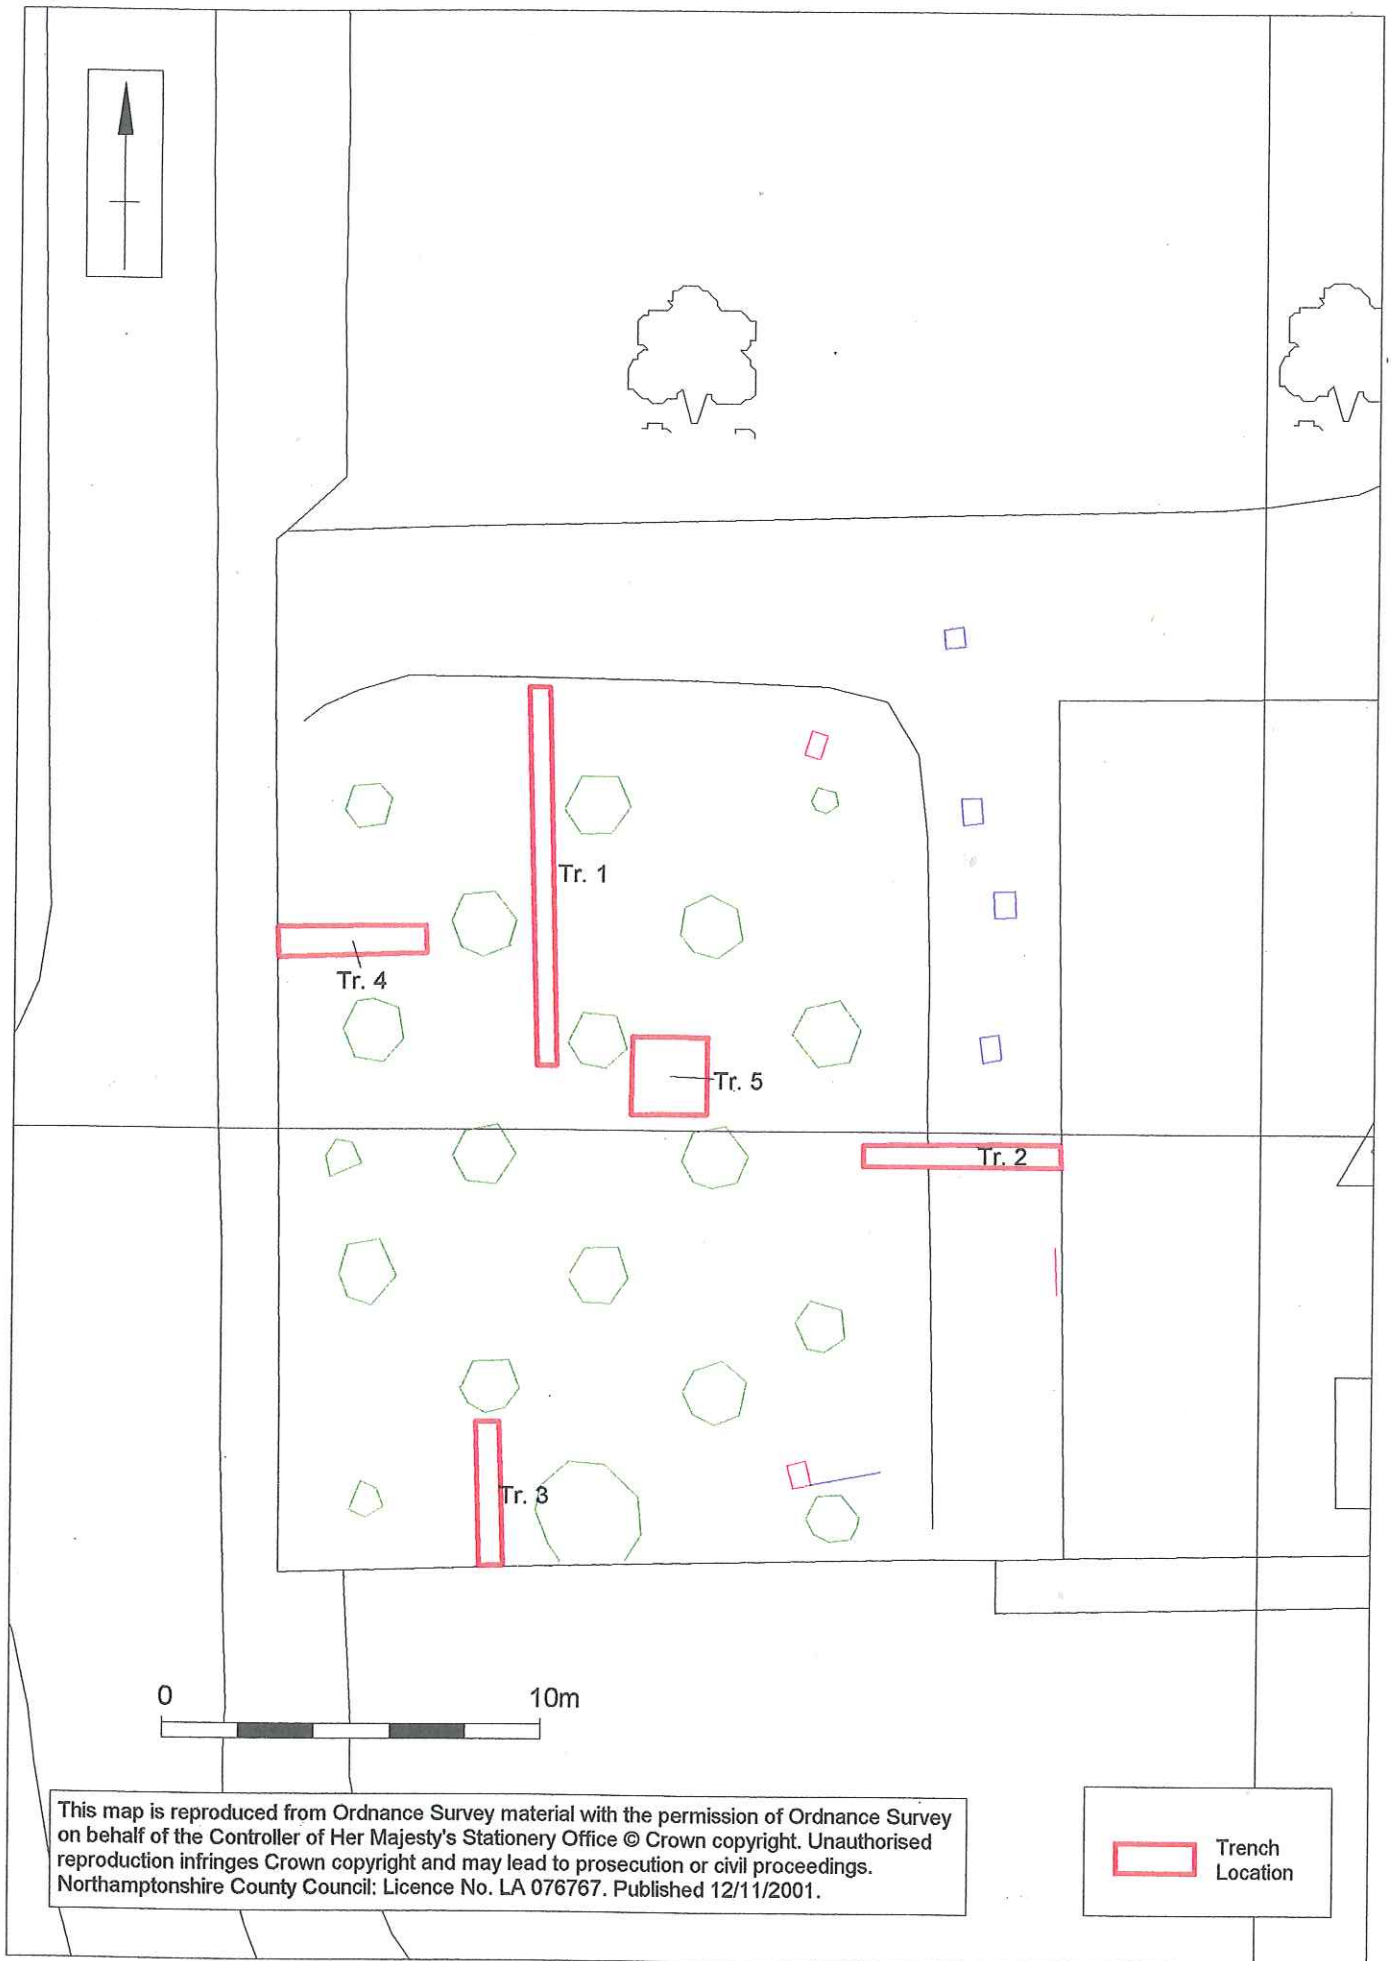
Fig 6

Following the surveys five trenches were excavated within the west garden to investigate the stratigraphy and anomalies identified by the surveys. The trenches had been provisionally located prior to the two surveys but some were moved following the results to obtain maximum information (Fig 6).

Trench Location

This trench lay on the eastern side of the garden and ran from the west wall of the house across the present path and into the lawn (Fig 6) to investigate the relationship of the garden and house. The trench was located here because to the north are four modern service inspection covers and to the south there was formerly a porch to the present door from the house. There are also drains from down pipes on the house, all of these features suggested prior to excavation that the whole of the path area was likely to be heavily disturbed. At the west end of the trench beneath the lawn, the stratigraphy was the same as in Trench 1 and comprised black sandy loam with gravel inclusions (Fig 7, Tr 2/1). Beneath the current loose gravel path surface was a hard compacted dirty orange gravel and hoggin path surface which was contained between an edging of edge set frogged brick. Though no dating was found from this surface the path must date from the 20th century due to the type of brick edging used. Between the path and the house was a narrow bed, presumably for planting against the wall of the house. This contained a black sandy loam with china and glass along with fragments of ironwork from drain covers and pieces of concrete. These fragments are most likely from the laying of, or alterations to, the present drains. Within the old path

This trench was located against the south wall of the garden (Fig 6). The same black sandy loam layer (Fig 8, Tr 3/1) containing 19th century china and glass was found and lay over an orange sand and gravel layer (Tr 3/2), the upper surface of the natural. This in turn was cut towards the south end of the trench by a construction trench for the wall (Tr 3/3) and was filled by a dark brown sandy loam (Tr 3/4). The construction trench was not excavated as this pre-dates any garden feature associated with the earliest phase of the garden and has been truncated by the 19th century layer which has removed any potential early garden layers. A modern iron pipe was found cut into the 19th century layer (Tr 3/5).

Placed against the west wall of the garden, this trench was positioned to investigate the possible blocked opening in this section of wall (Fig 6) and any remains of the perimeter bed indicated on the 1862 First Edition map. However, the stratigraphy was the same as in the other trenches with the upper layer of 19th century material (Tr 4/1) resting directly on the natural subsoil (Tr 4/2). There was no indication of any change in material close to the wall. The vertical joint in the brickwork of the wall continued below ground and three brick courses below ground level two courses of brick were missing horizontally across the space of the possible opening. This may indicate the former position of a sill to the opening. However, there is no indication of any blocking on the west face of this wall so the hypothesis that this was formerly an opening remains unresolved at present. A modern service trench for an electricity cable ran the length of the trench cutting into the subsoil layer.

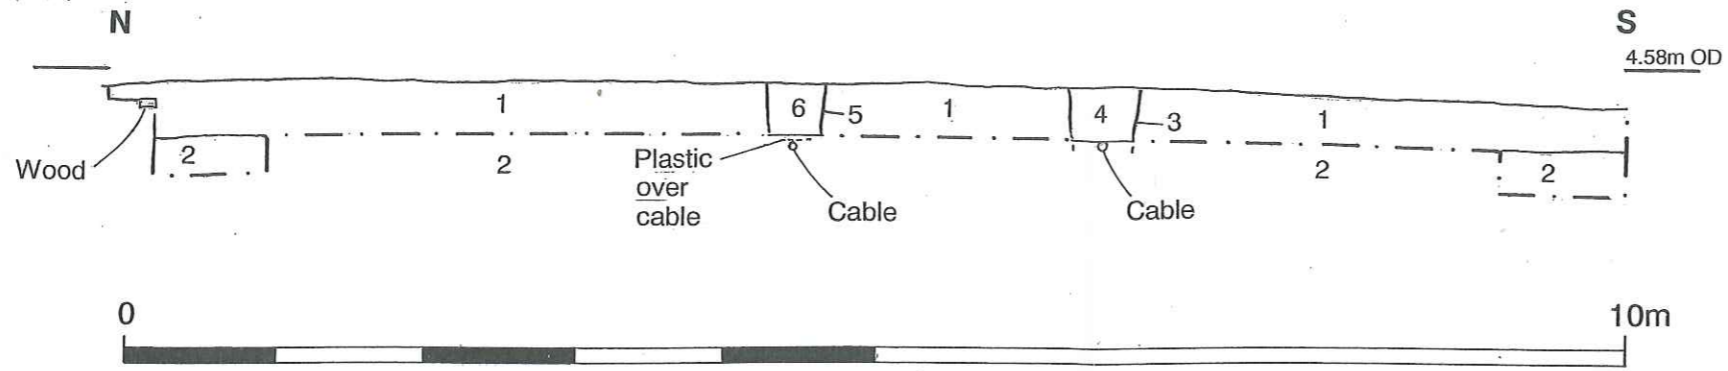
Trench 1 Section

This trench was placed to investigate the features identified from the First Edition Ordnance Survey map which shows the northern third of the garden as a bed with trees and shrubs, divided from the southern part by a path (Fig 9). Beneath the turf a layer of black sandy loam (Tr 1/1) with gravels up to 25mm was revealed (Fig 7). This contained 19th century china and glass and lay directly on a layer of orange/brown sand and gravel (Tr 1/2). This layer appeared to be the upper part of the natural subsoil and contained no finds. It was cut only by two modern service trenches (Tr 1/3 and 5). The 19th century layer had removed any former garden remains. No indication of the path was found or of any earth-filled feature that might have represented its removal. The anomaly (A) detected by the resistivity survey may be the two parallel trenches for the modern services.

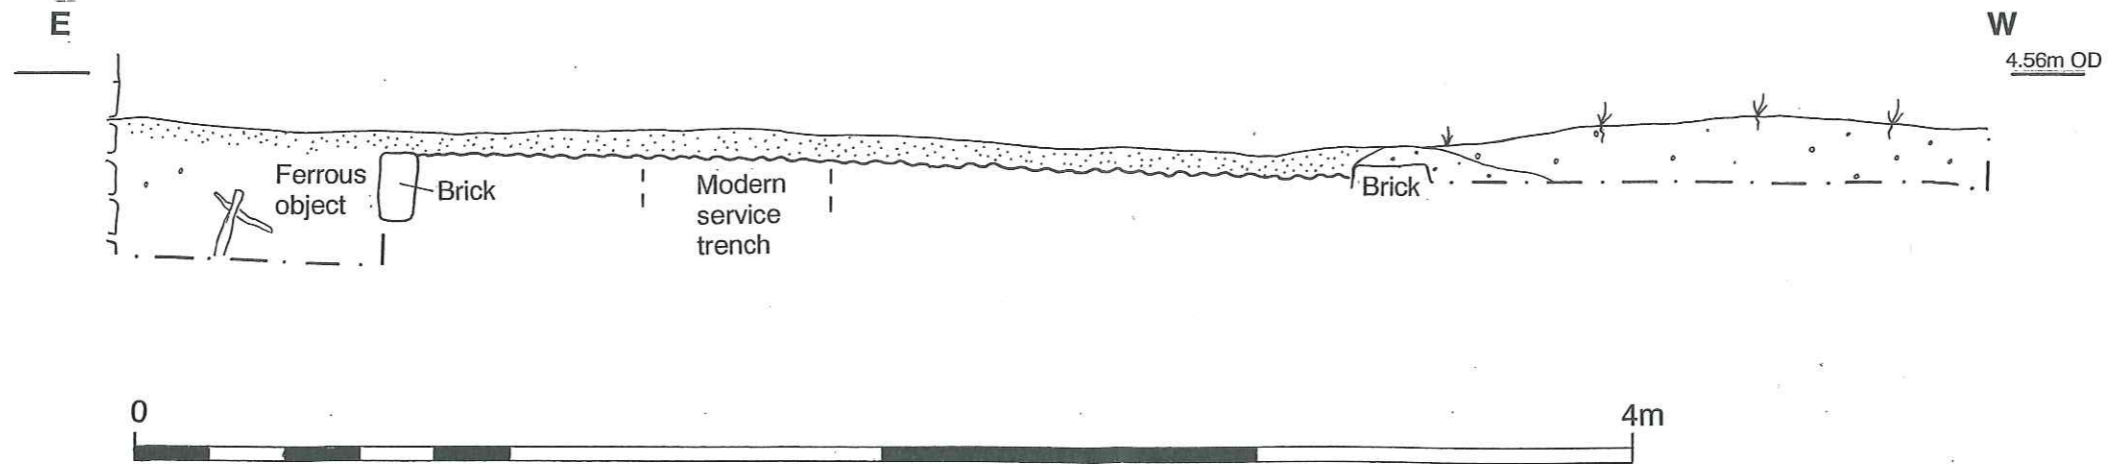
Fig 7

surface was a cut for another service trench which was not excavated and the CAT instrument detected a probable electricity cable immediately to the west of the brick path edging. This almost certainly runs to the flood light located at the south end of the garden and was not excavated.

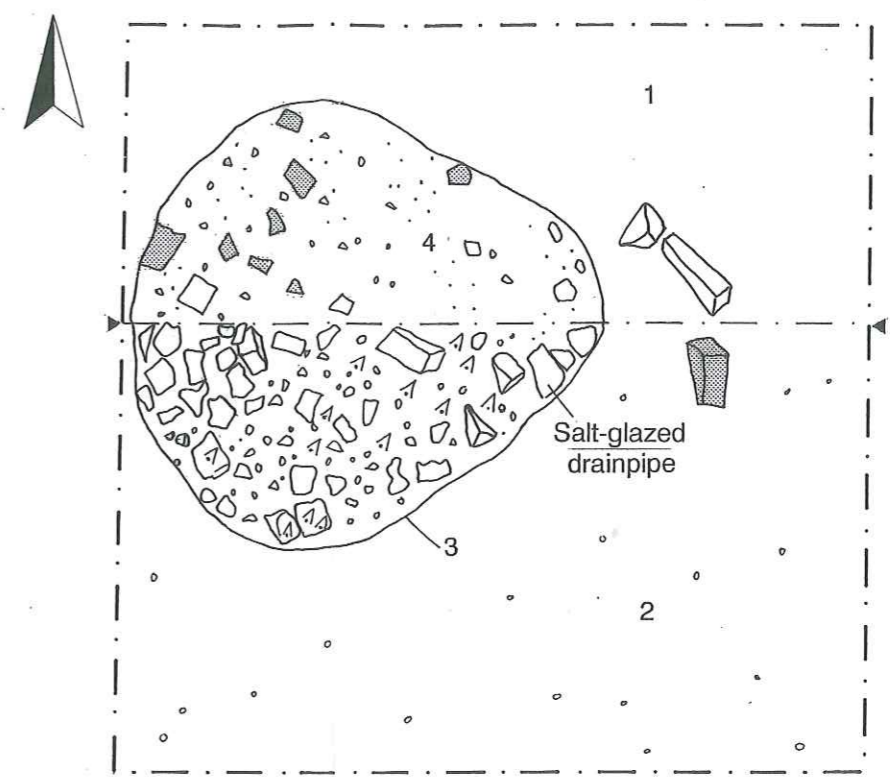
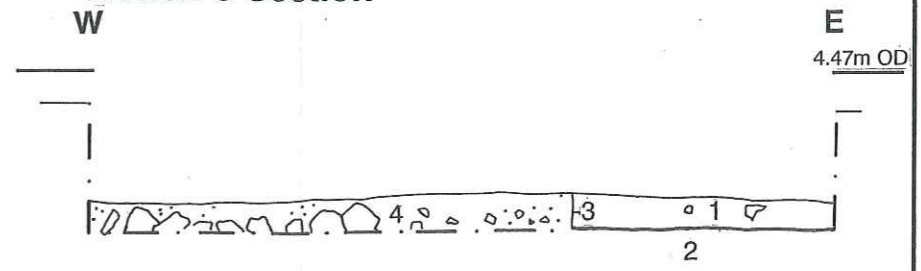
Trench 5 Plan

The rubble comprised fragments of early, probably 16th century brick with mortar adhering to it along with modern frogged brick and salt glazed drain pipe fragments. From amongst the rubble a 1923 half penny was recovered, which along with the later brick and drain fragments, and the fact that it is cut into the 19th century layer, indicate that this feature is of 20th century date. The feature's purpose is not clear but may simply represent a hole created by the removal of a tree or shrub backfilled with rubble.
