Archaeological Investigation at

Waddesdon Manor

Buckinghamshire

Report 05/68

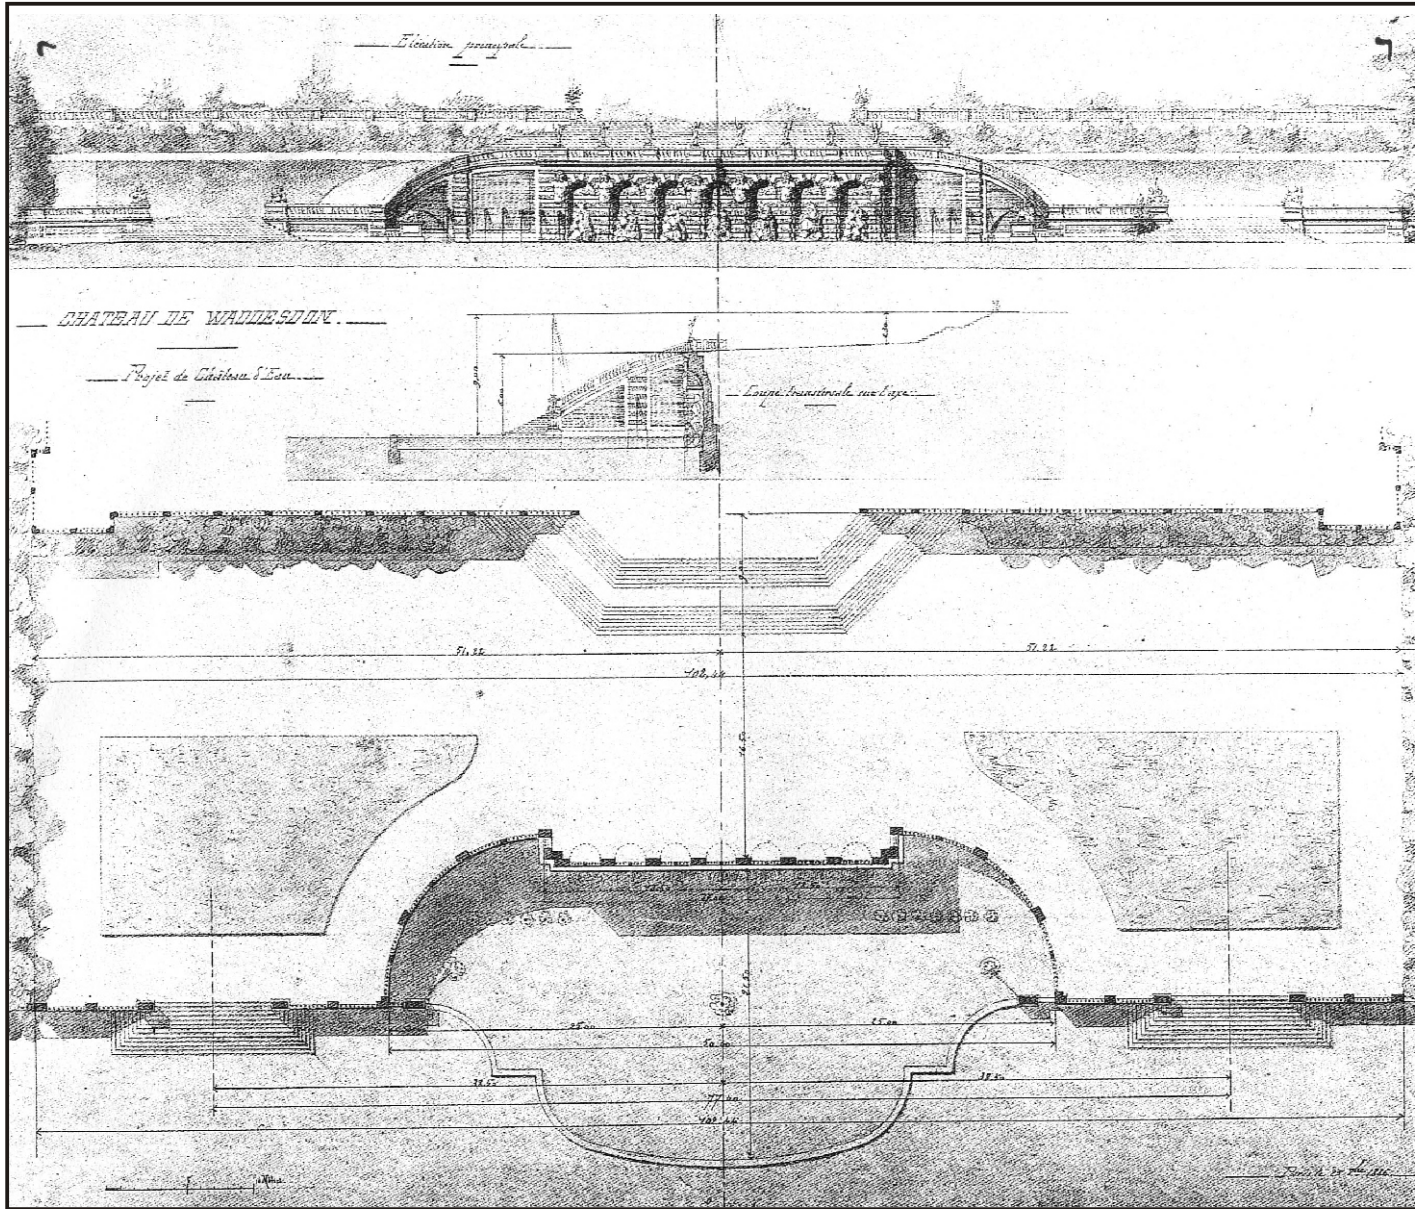
Fig 3

1886 Destailleur Plan

It is likely that Destailleur may have designed the original south front garden as he drew a plan, section and elevation, dated 1886, which depict a 'Grotto' style garden running the full length of the south front of the house (Fig 3). Based on the given measurements and relating the position of the semi-hexagonal steps with the modern steps leading down to the parterre garden, the proposed position of this feature relative to the existing garden is shown in Figure 4. The grandiose design comprises a large pool partly enclosed by a recessed bay, the rear wall of which contains seven rusticated arches. Within each archway is a small cascade fountain flowing over a pile of rocks and the columns are adorned with atlantes. Positioned either side of the bay are seven water spouts, with frog-like statues at either end of the bay, spouting water from their mouths. A central fountain completes the design. The 'grotto' is approached by flights of steps either side of the pool, descending from the southern edge of a sloping terrace. At the upper, northern end of the parterre garden there is an additional flight of semi-hexagonal steps leading to the broad terrace immediately in front of the house. It is not known whether this design was ever built, but the semi-hexagonal steps appear to be shown on the first edition Ordnance Survey map of 1885 (Fig 2); no further details of the south front gardens are given.

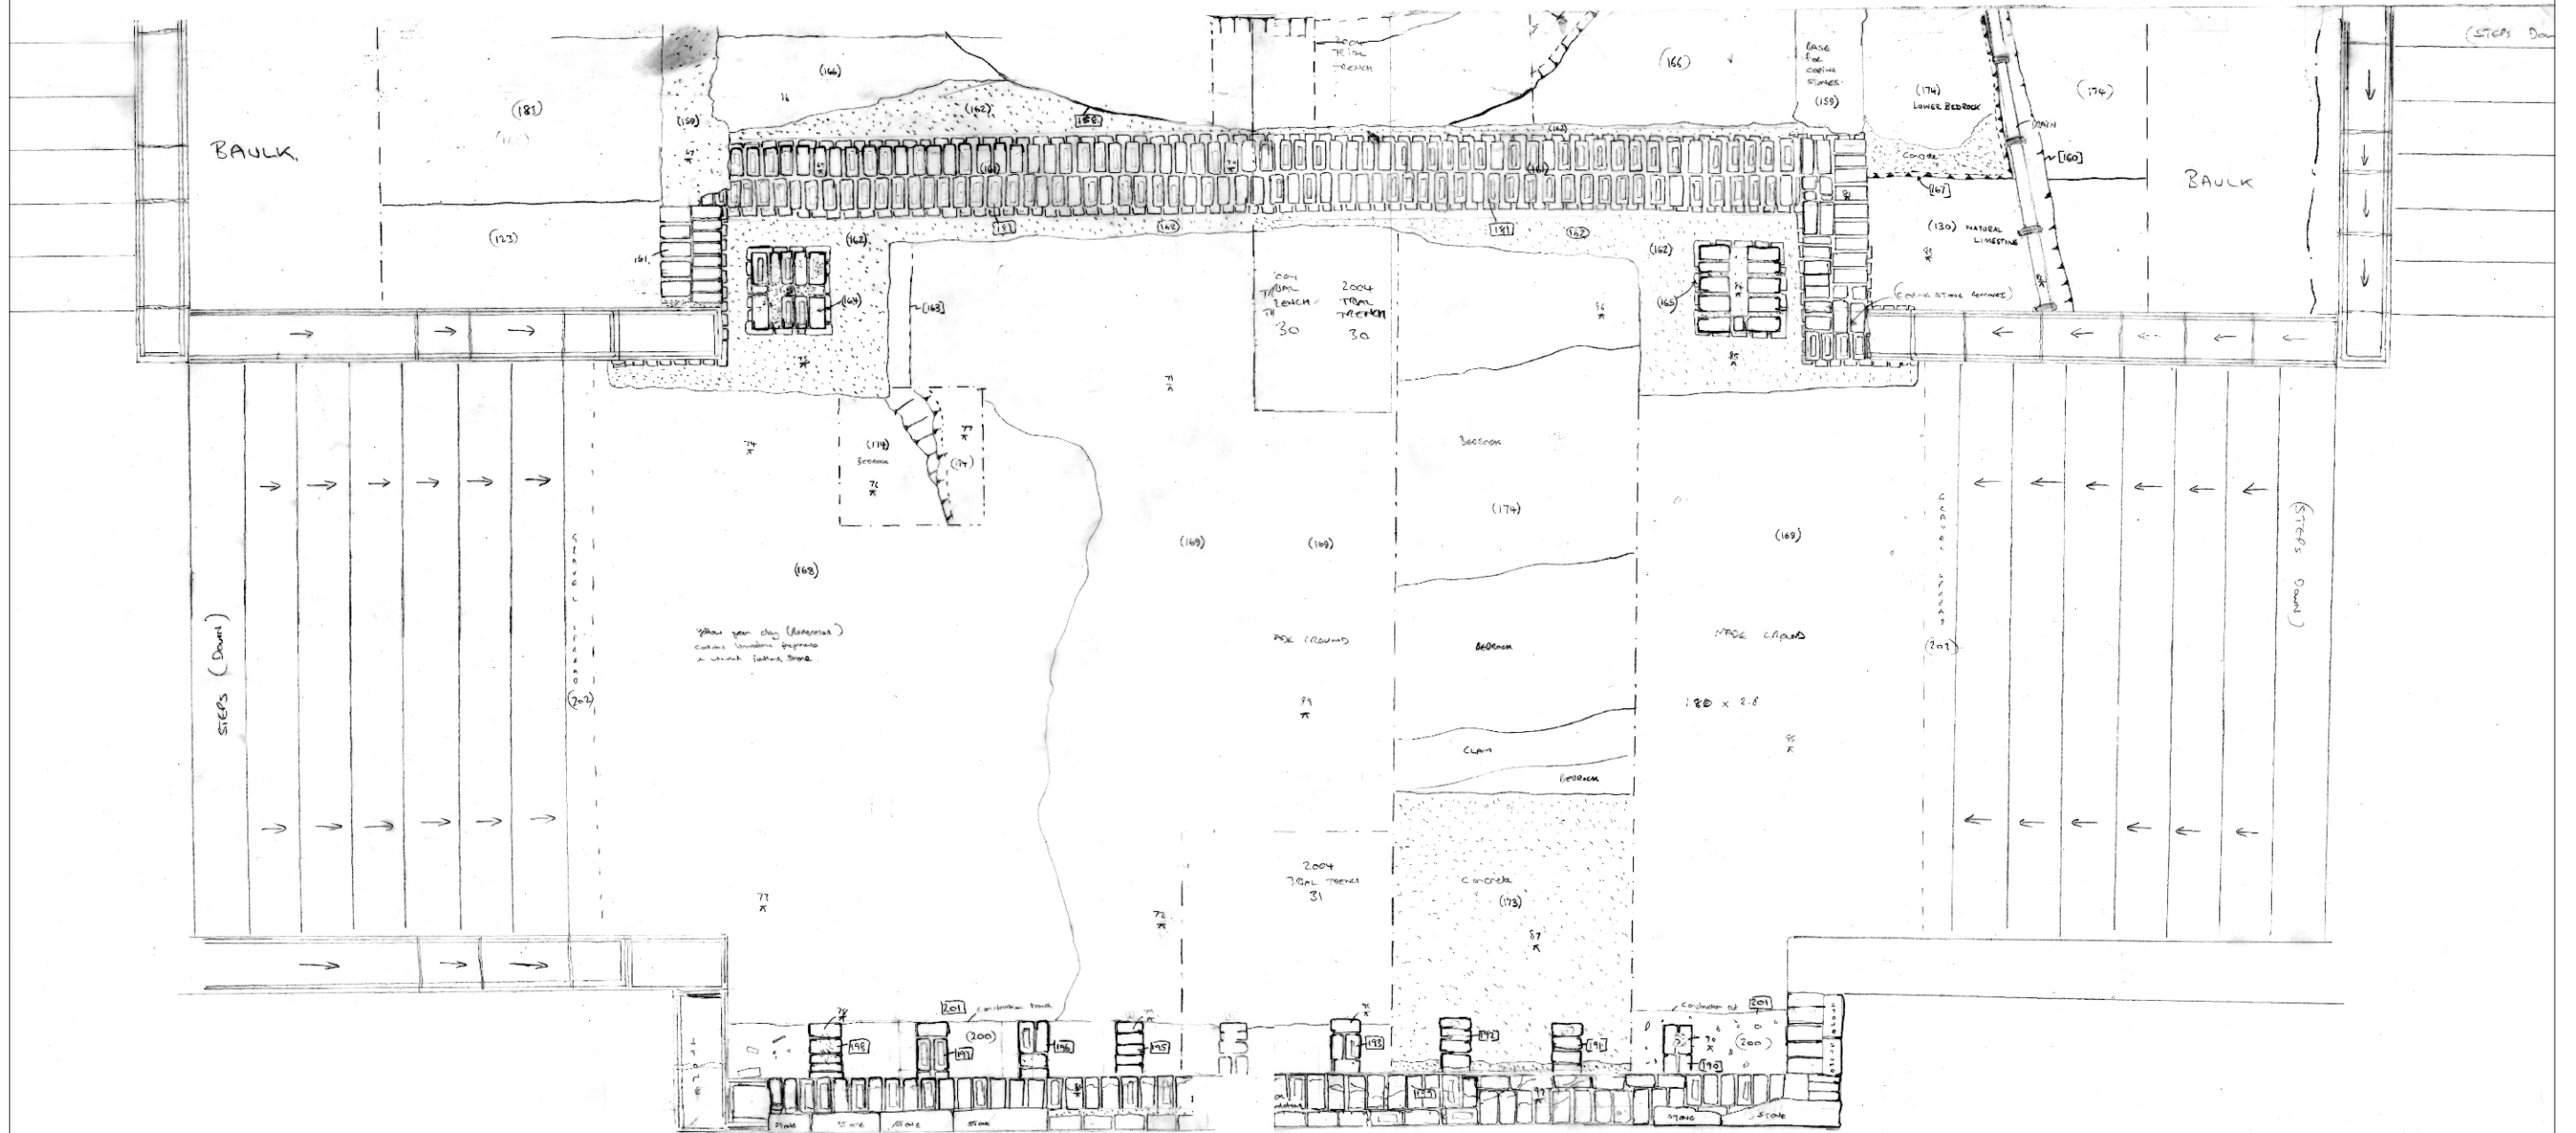
Fig 8

Waddesdon Manor - Phase Plan

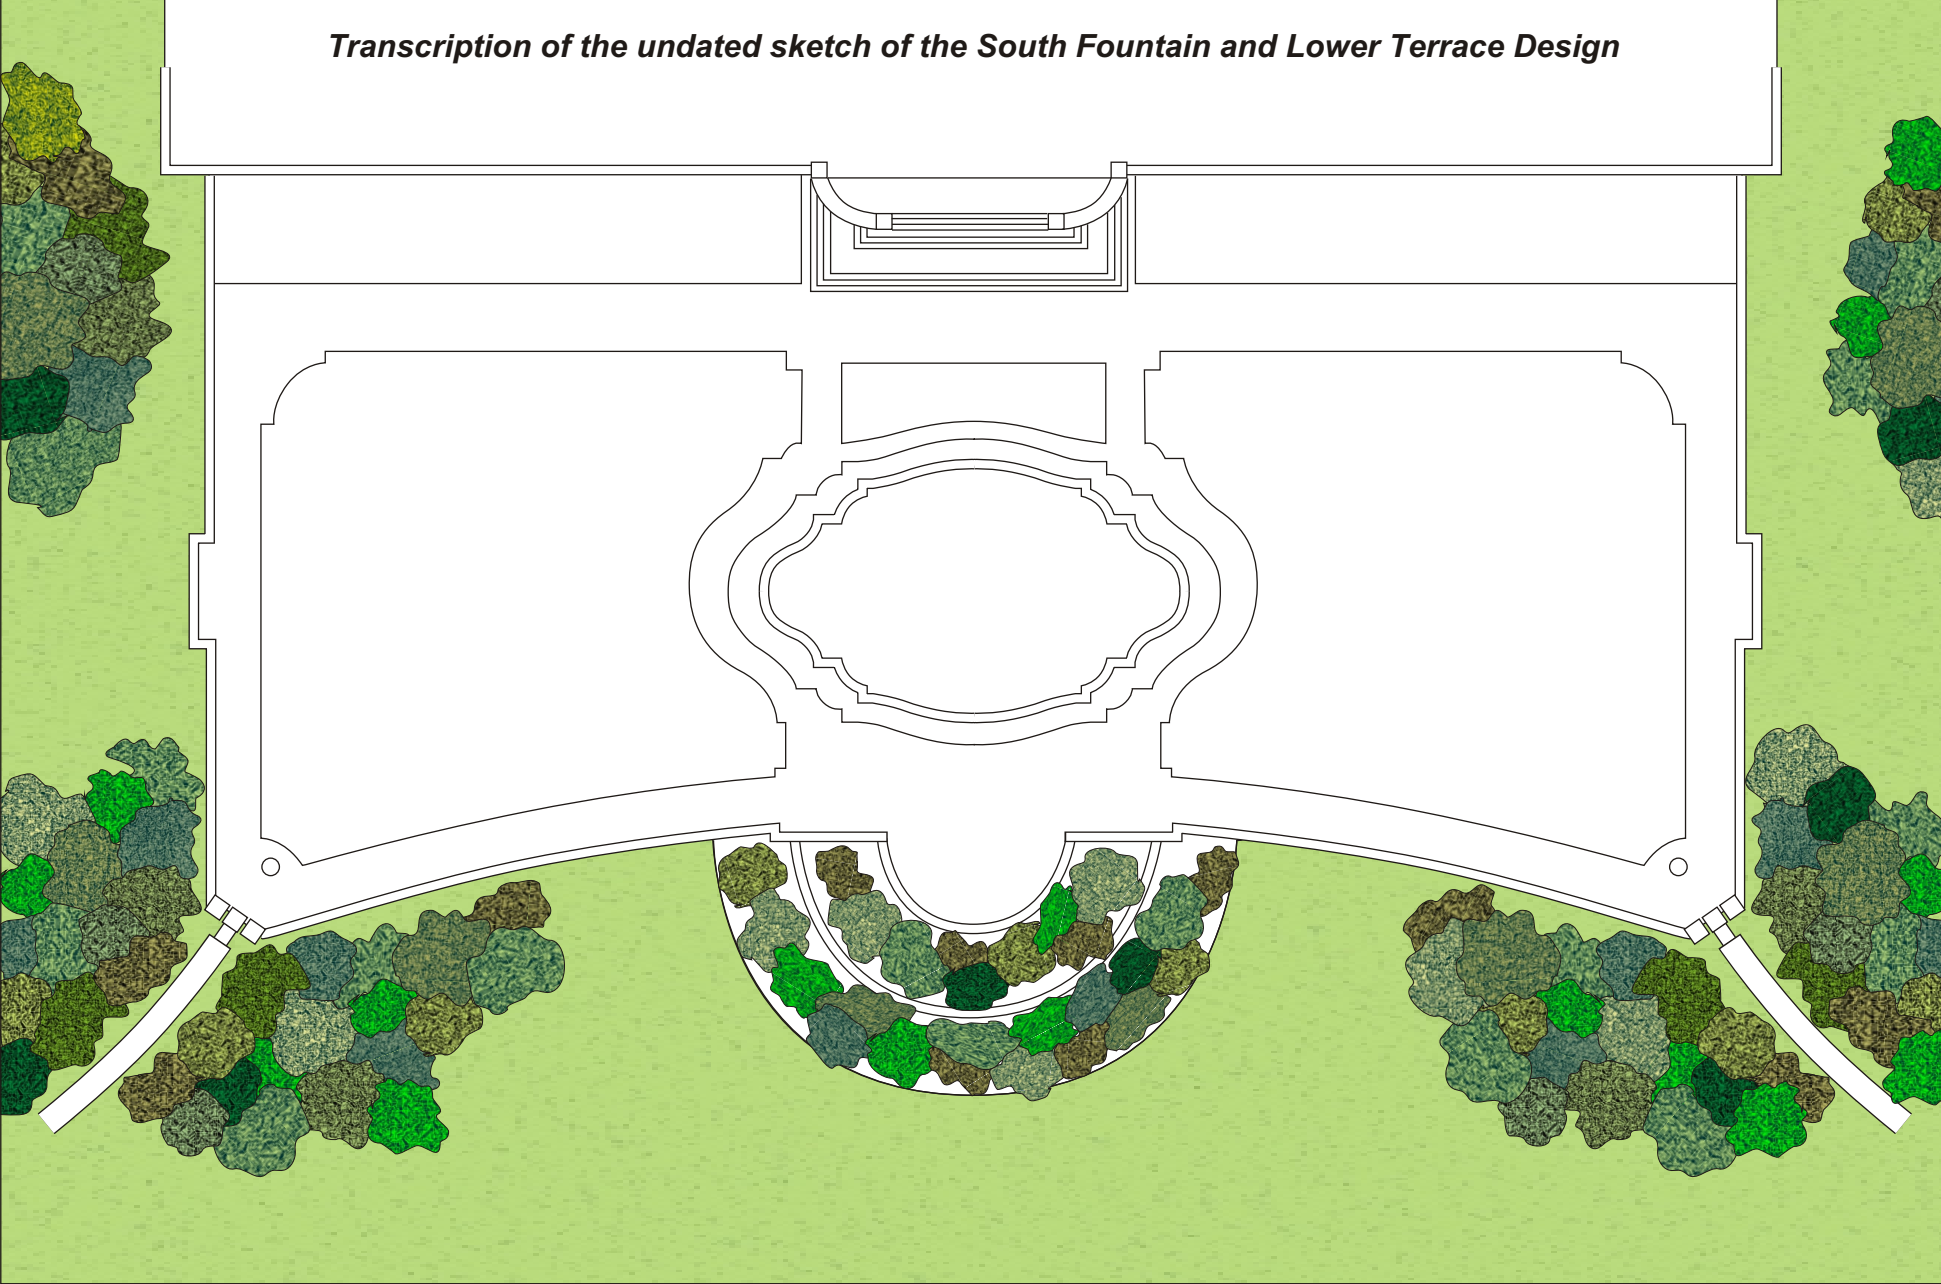
Fig 12

Transcription of the undated sketch of the South Fountain and Lower Terrace Design

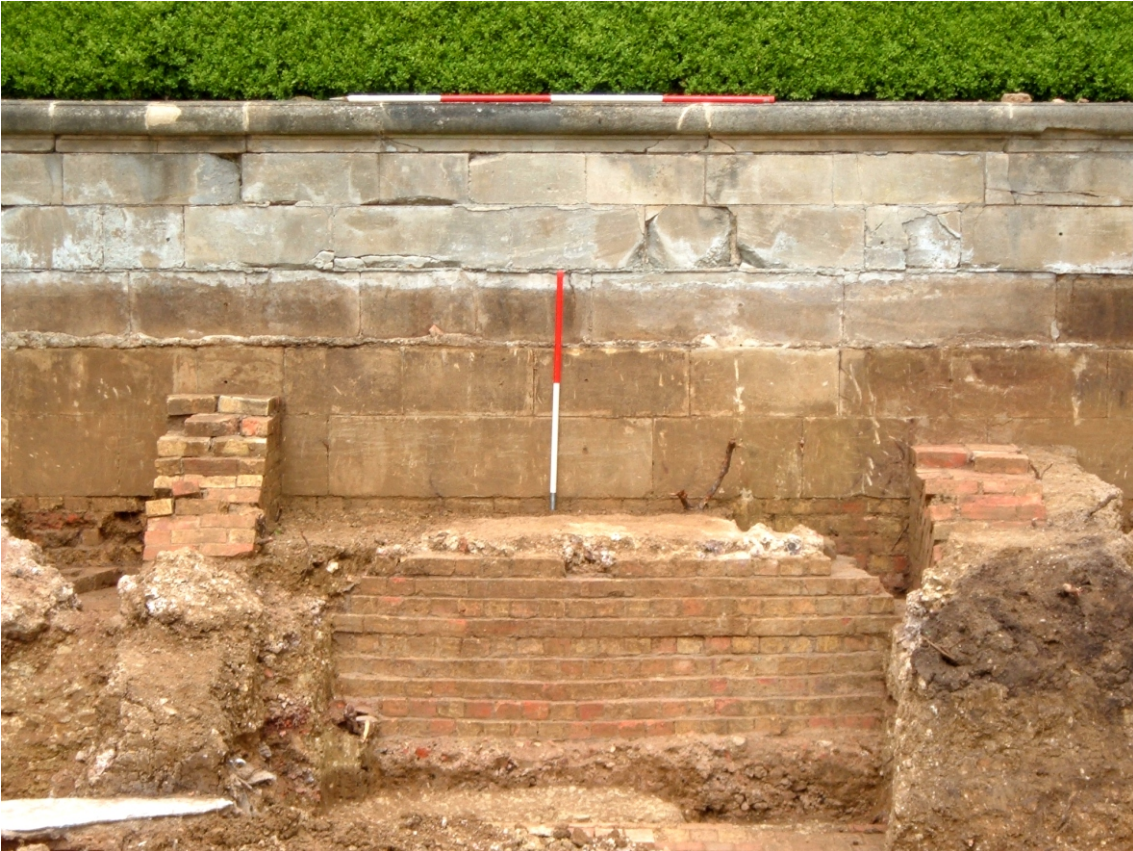
Plate 2

South wall of first fountain basin [118] during excavation

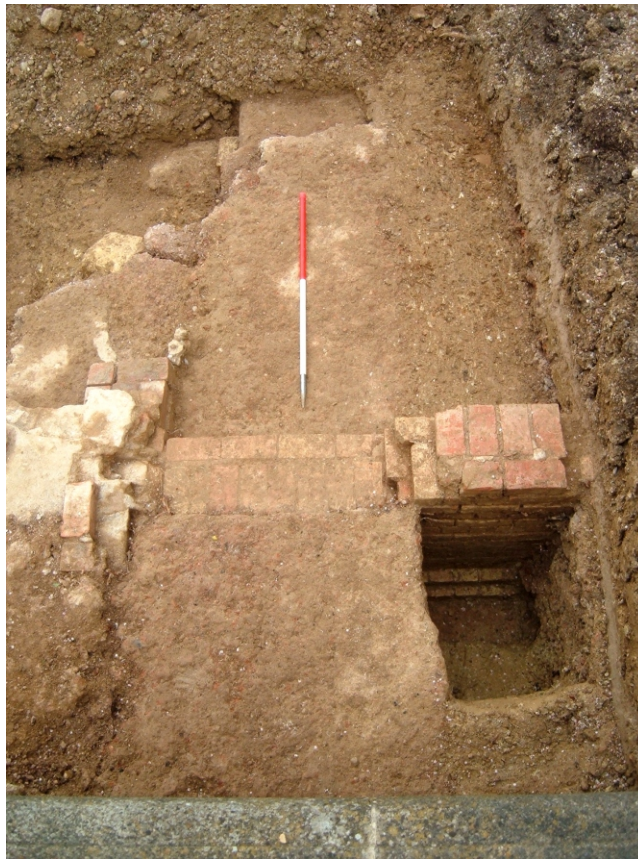
Plate 3

Wall [109] and concrete foundations

Flanking the southern edge of the fountain to the east and west were two brick walls, their foundations resting on a concrete raft (Plate 3). The two brick walls [109 and 137] were aligned from east to west and were constructed on a line tangential to the southern edge of the fountain. The opening between the ends of the two walls was approximately 8m wide, and provided access and an open vista to the parkland to the south.

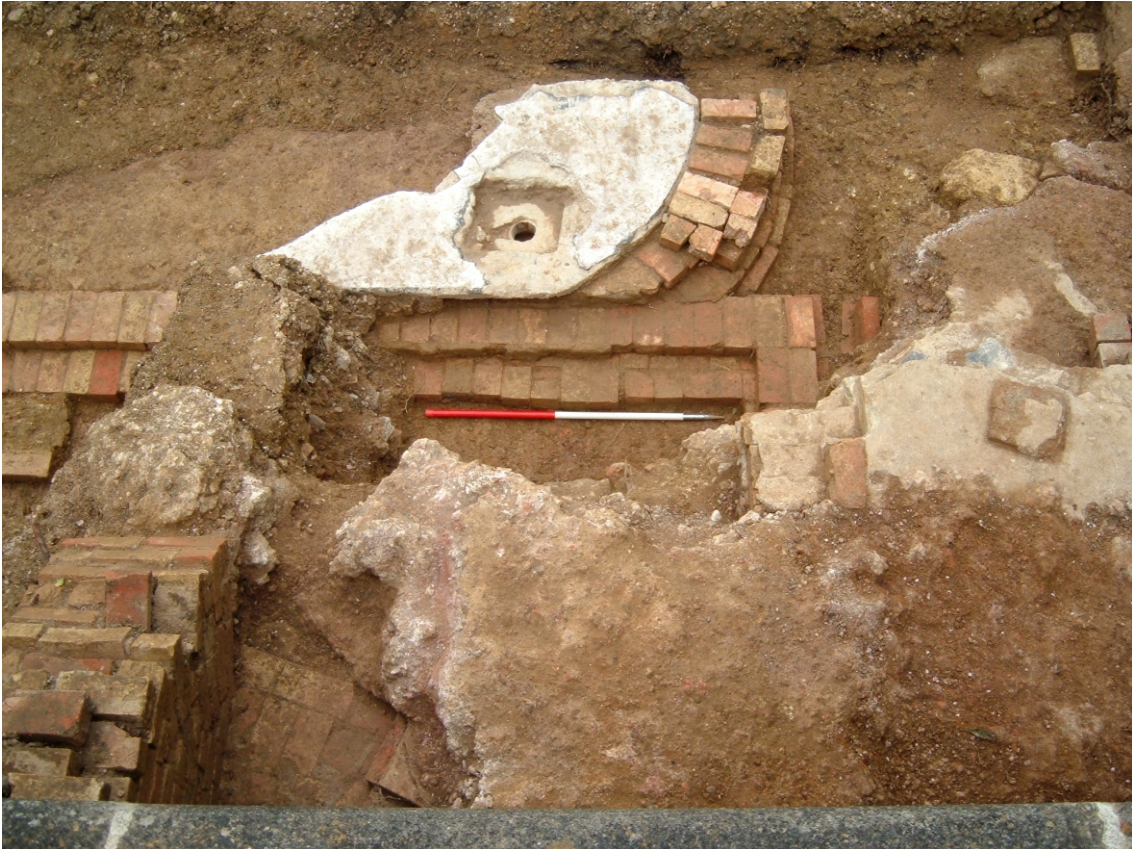
Plate 4

Drain and bitumen lining of second fountain basin [111 and 112]

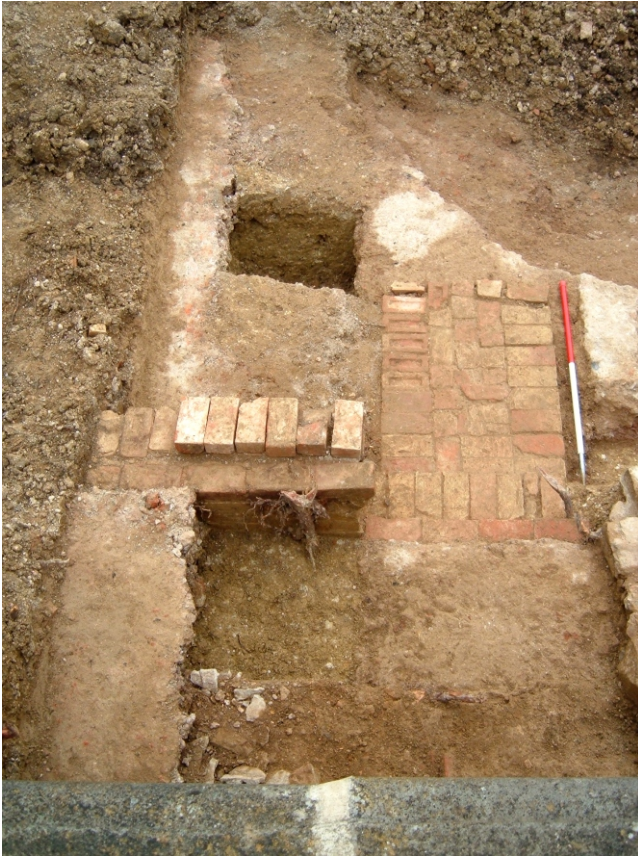
Plate 5

Brick surface [144]
of Phase 2 flight of steps

Descending from the parterre garden, opposing flights of dog-legged steps, *c* 0.8m wide, provided access to the fountains. The steps were constructed on thick concrete foundations cut into the Phase 1 made-ground and were surfaced with brick; a small area of the brick surface [144] survived on the eastern flight of steps (Plate 5). The steps cut through the Phase 1 wall on both sides of the fountains.

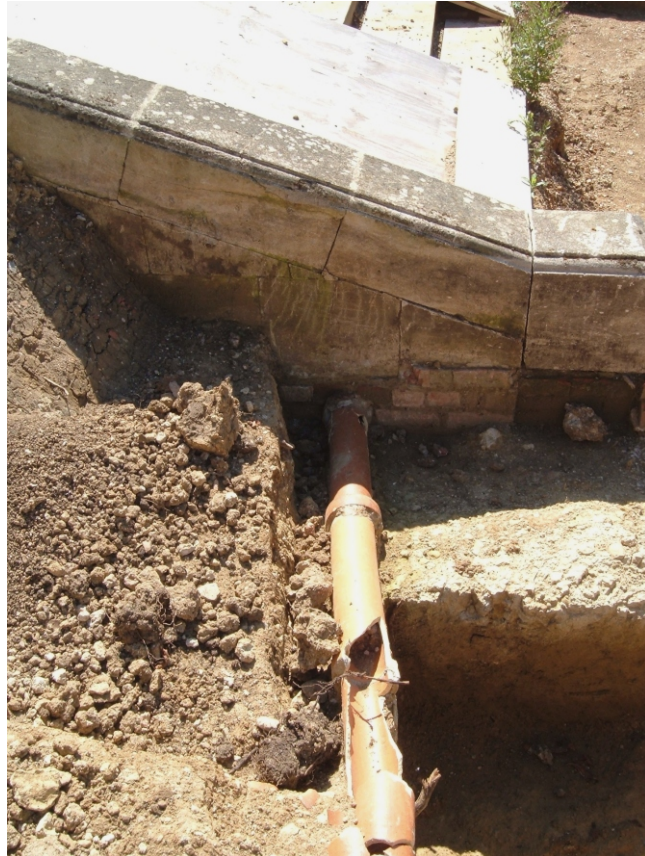
Plate 6

Drain [150] running under
Phase 3 flight of steps

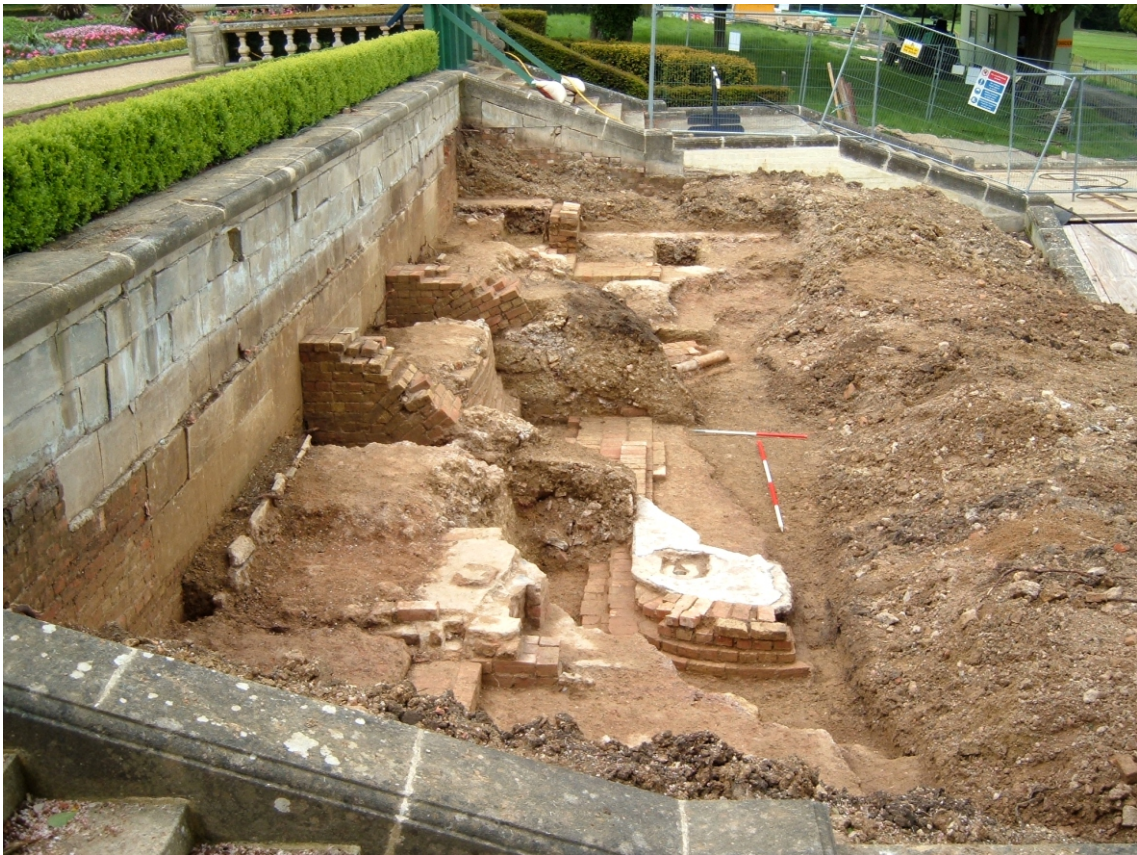
Plate 7

Butresses [136] and [140] cutting through first fountain basin

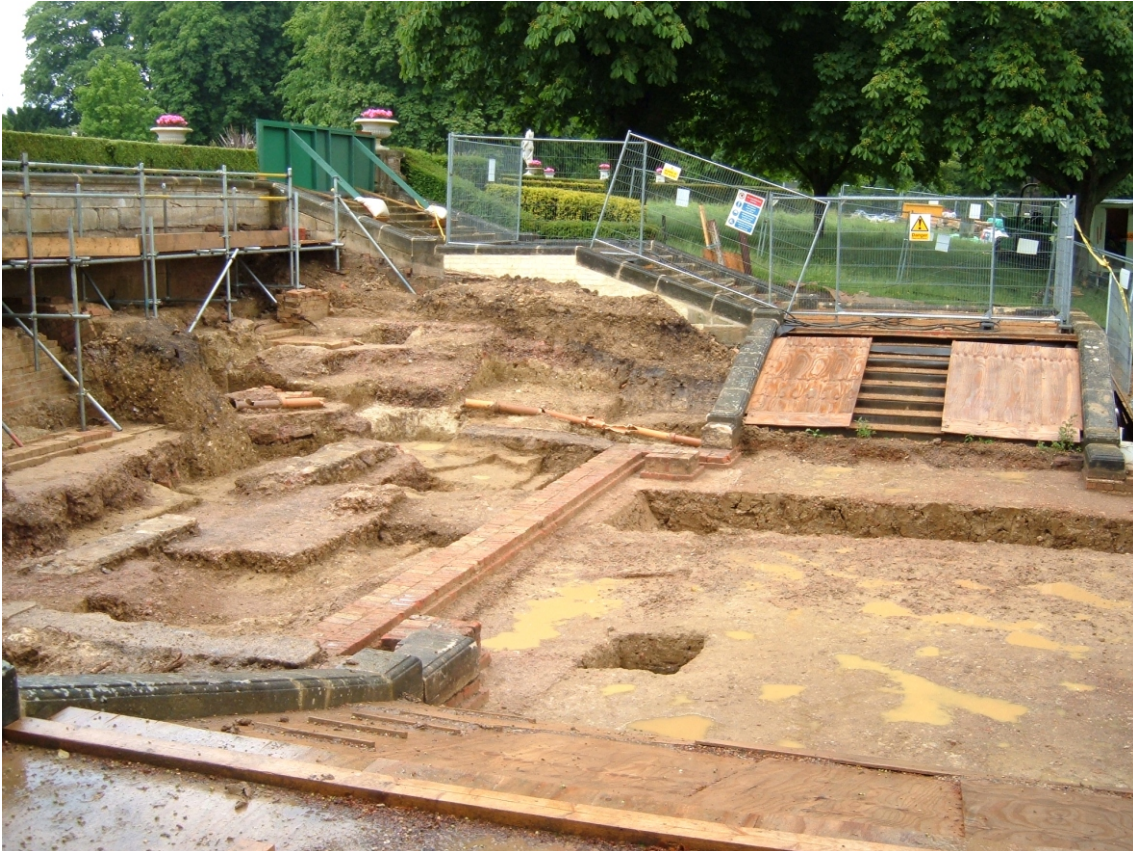
Plate 8

East flight of Phase 3 steps descending to Lower Terrace
