An archaeological watching brief at Main Street and The Green Allexton Leicestershire October 2006

Report 06/172 Accession Number XA 24.2006

AN ARCHAEOLOGICAL WATCHING BRIEF AT MAIN STREET AND THE GREEN, ALLEXTON

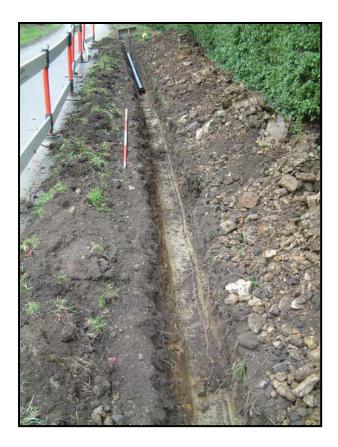
Plate 1 Main Street looking west

The trench was excavated along the southern edge of the field immediately adjacent to the entrance to Allexton Hall at the west of the village and extended 135m along the grass verge on the north side of Main Street to the entrance drive into The White House at the east of the village (Fig 1, Plate 1).

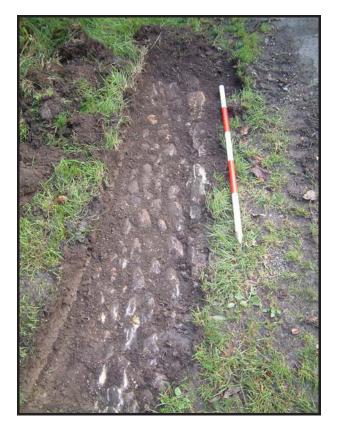
Plate 2 Cobbled surface, looking east

Immediately to the east of this field entrance, overlaying the sub soil was a layer of yellow/brown coarse gritty sand and gravel (16) up to 200mm deep supporting a compact and regular layer of large round river pebbles/cobbles (15) up to 300mm forming a level surface. Larger round cobbles had been laid on edge forming a clearly defined edge to the carriageway. On both sides of this 'edging' the surface was made of smaller rounded pebbles/cobbles forming a nicely coursed and level surface (Fig 1, Plate 2). The cobble surface extended to the hedgerow to the north of the road and extended below the modern tarmac of the modern road surface.

The cobbled surface exposed along the northern edge of Main Street appears to be an earlier road surface with large rounded river cobbles on edge forming a clear 'edge' to the carriageway with smaller cobbles extending to the hedgerow to the north. Although mainly destroyed by the insertion of modern service trenches along the road verge in recent years, the presence of substantial numbers of rounded river cobbles in the backfill of these trenches indicate the presence of the surface at least as far as the sharp bend in Main Street around the east end of The White House opposite the entrance to St Peter's Church.
