## Northamptonshire Archaeology

Walkover Archaeological Earthwork Survey at

Callan's Lane Wood

Lincolnshire

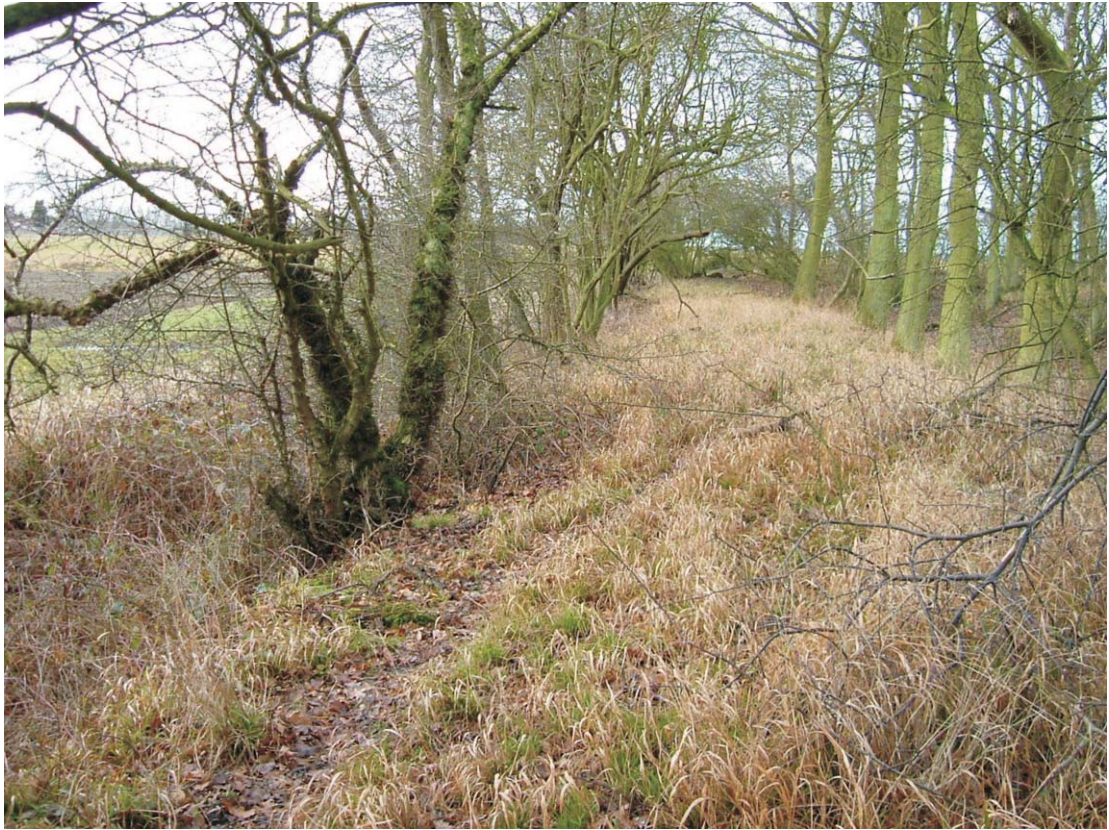
The boundary of Scullar Wood and Pasture Wood is defined by a ditch aligned east to west. At its western extremity it diverges from the line of the woodland management area, continuing straight to the western boundary.

Plate 1: Perimeter woodland boundary in Scullar Wood, looking west

The woodland boundaries, in particular the perimeter boundary, as well as the example defining Scullar Wood, vary in condition. In places the outer ditch had been re-cut and is presently used as a drain which the woodland ditches feed into. The bank therefore may have been altered to match this later activity indicating more than one phase of use. The outer woodland boundary would benefit from a basic recording of nature and size. Where applicable, a selection of trial archaeological trenches and environmental

sampling may be undertaken to clarify usage over time and any palaeo-environmental data.

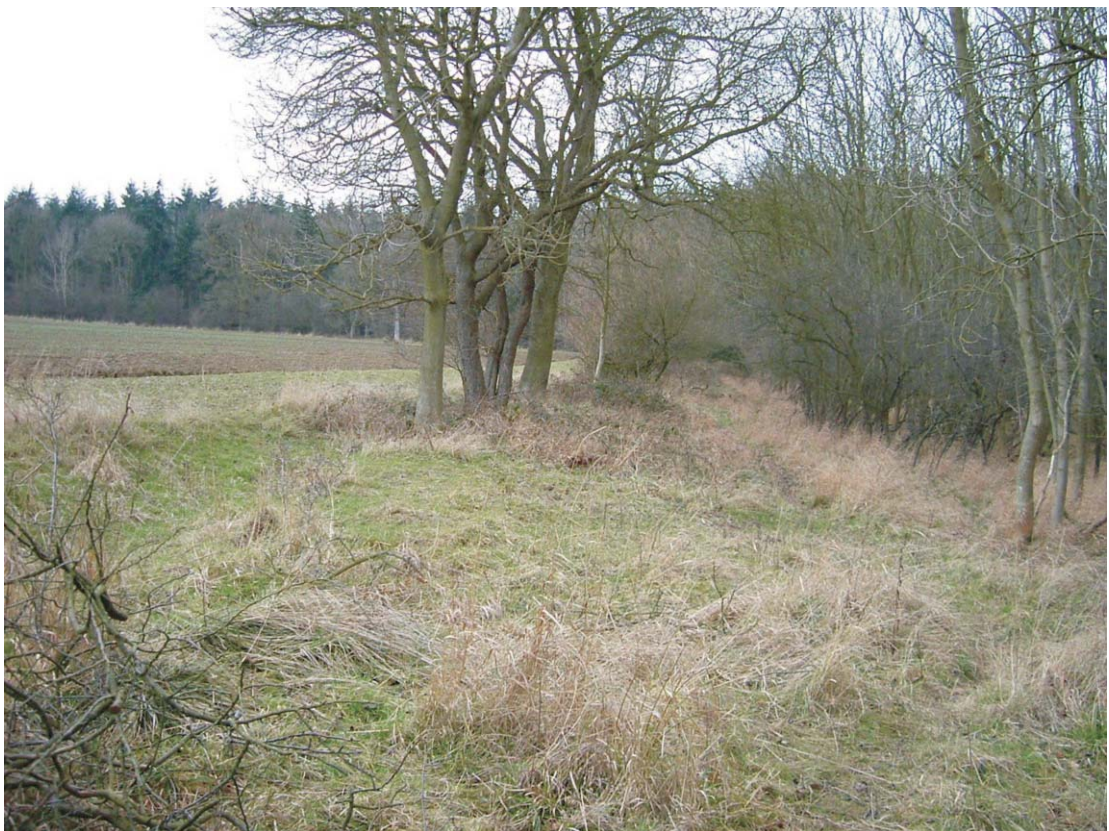
The Roman Road King Street which was aligned through Thorny Wood from the south-east and along the western perimeter of Callan's Lane Wood, was identified as a woodland track way flanked by avenues of trees (Fig 2, 5; plate2).

Plate 2: Roman Road, King Street, in Thorny Wood, looking north-west

The line of King Street is described in the SMR data as a partially upstanding feature and can be seen to have formed a major landscape element. It is currently used as a track or pathway along the edge of the woodland. However, it is of potentially national importance in the consideration of Britain's Roman Road network, and potential settlement and landscape usage in its vicinity. It can be recommended that a more detailed survey of this feature or excavation could be undertaken. Therefore any information that can be obtained regarding its nature would be beneficial.

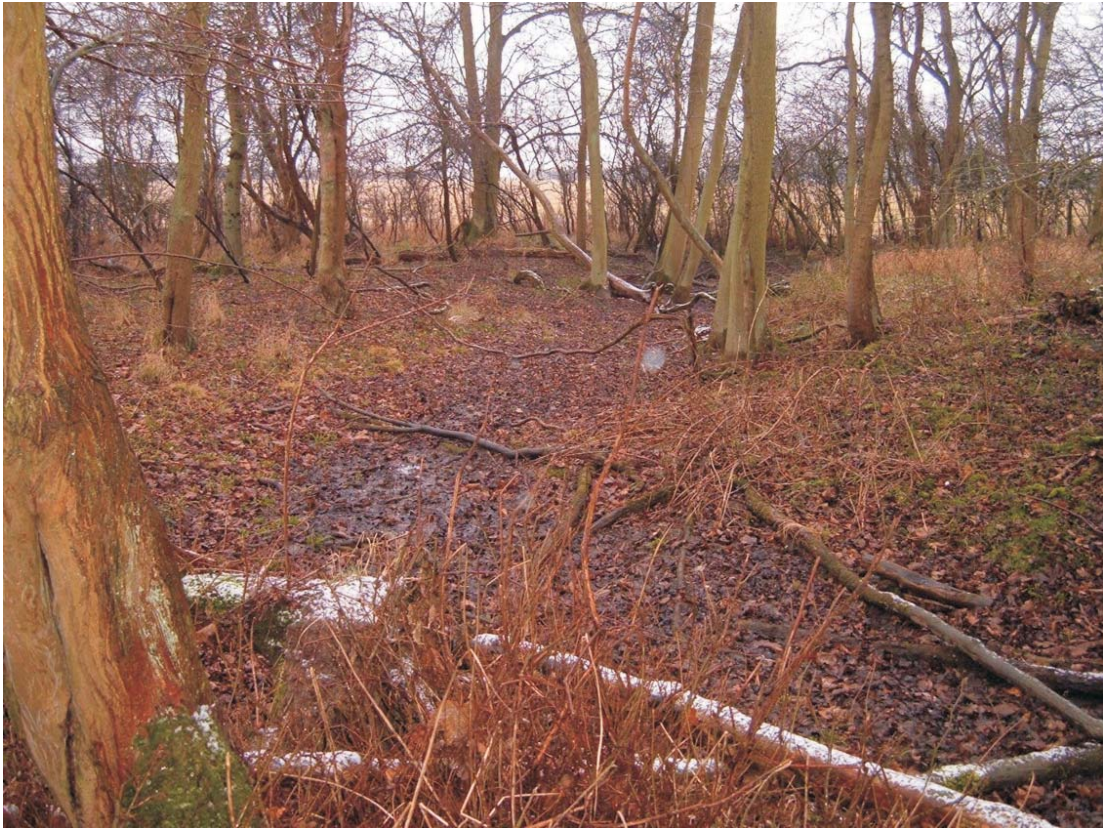
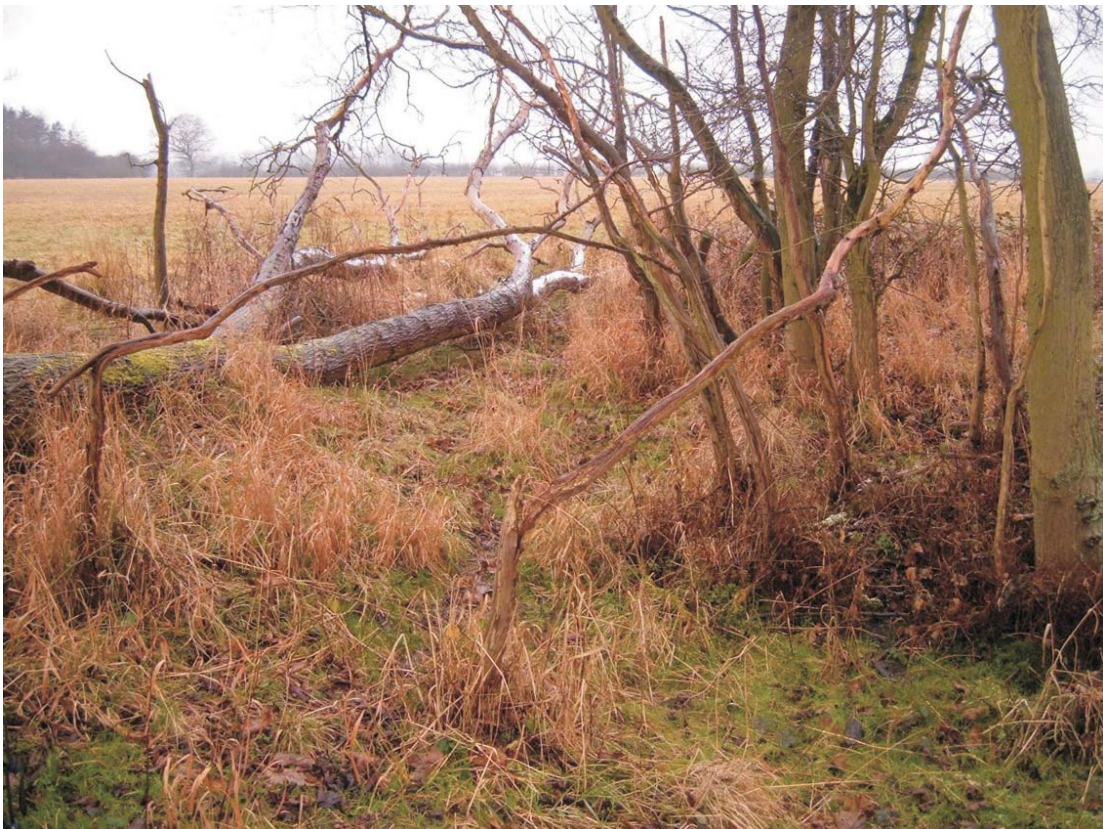
An enclosure was found consisting of a bank, ditch enclosing a rectangular area measuring approximately 35m by 35m extending the south into the adjacent field, in which no further earthworks were visible on the surface of the field (feature 7). Within the enclosure, a broad 15m by 5m ditch is aligned north-west to south-east, possibly an internal feature. There is no surface indication of date or of any other internal features (Plates 3 & 4).

Plate 3: Enclosure in Pasture Wood, looking south-west

Plate 4: Enclosure in Pasture Wood, northern ditch looking north-west into field

The newly identified enclosure in Pasture Wood is of unknown date and function. Much of it is well preserved and it would benefit from a full detailed earthwork survey. Aerial photography of an adjoining field to the west may, in the right conditions, reveal whether the earthwork continues as a potential negative feature. With regards to the date, and characterisation of this feature, it is possible further documentary research and archaeological excavation of the bank and ditch (depending on the recovery of datable artefacts) may be sufficient.

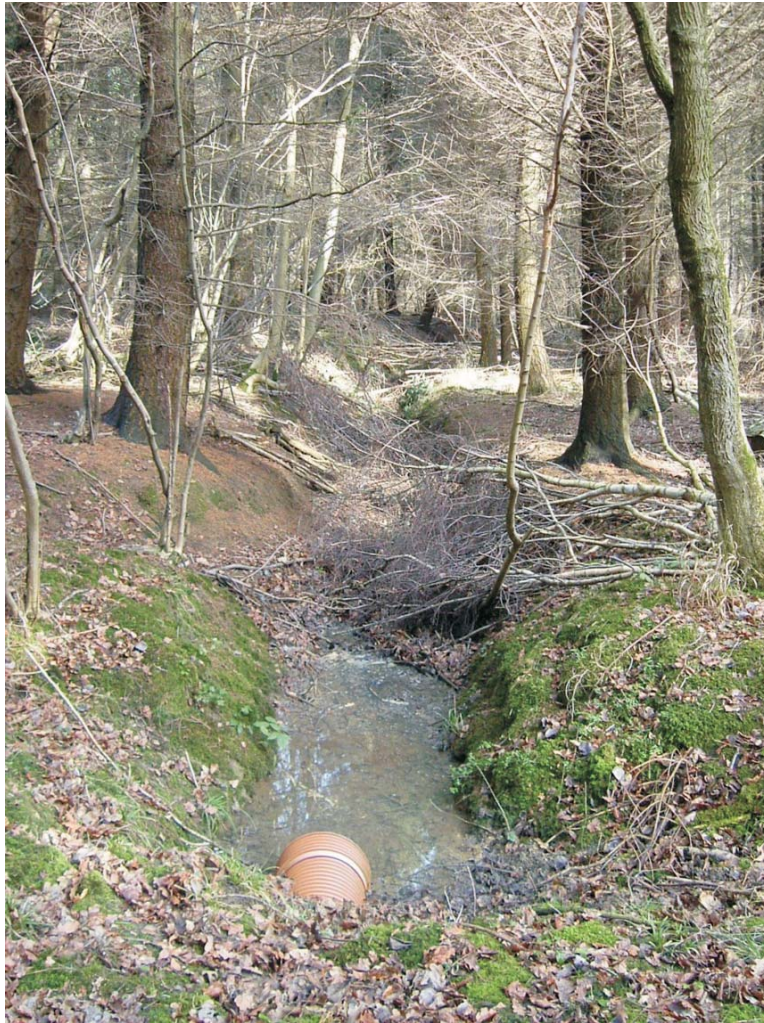
A series of drainage ditches associated with the roads and rides were plotted in addition to other woodland drainage ditches, some with plastic pipes to aid water flow. Some of the latter examples are sinuous and appear to reflect the tree planting line (Plate 5).

Plate 5: Drainage Ditch with plastic pipe in Pasture Wood

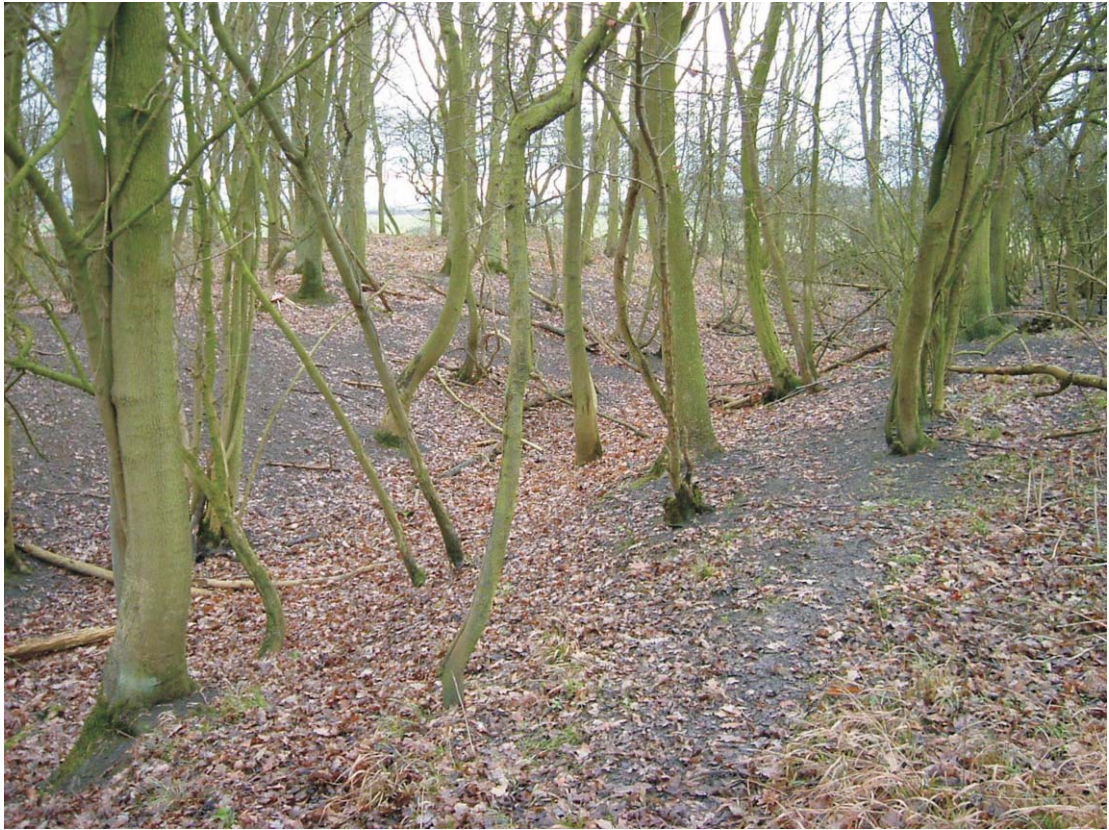
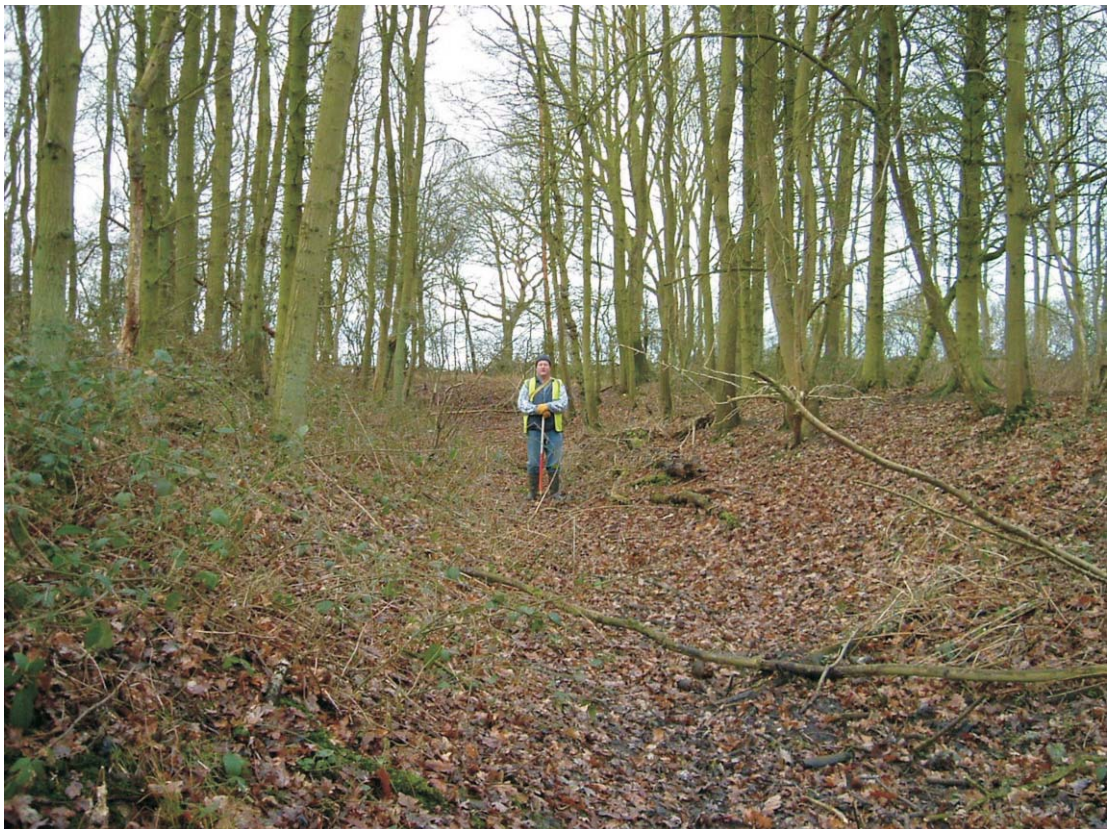
The moated enclosure had been identified in the survey undertaken by APS in 2001 and is recorded in the SMR database. It is located in the south-western corner of the wood and consists of a ditch and internal bank enclosing an area of 43.80m north to south by 47.50m east to west. No discernable internal earthworks or features were noted. In parts, the earthworks were disturbed by animal activity and there was evidence in the southern ditch of early to mid 20<sup>th</sup>-century waste disposal, including glass and ceramic bottles. The south eastern corner is truncated by a later drainage ditch feeding into the outer boundary.

Plate 6: Moated Enclosure in Scullar Wood, north western corner, looking south

Plate 7: Moated Enclosure in Scullar Wood, northern ditch, looking west

The presence of the moated site listed in the SMR was confirmed and its general preservation was excellent despite animal activity, tree root disturbance and modern dumping. It is recommended that a full detailed earthwork survey should be carried out. The additional features noted in the SMR also need to be investigated more completely, in particular the potential causeway, and the north to south aligned linear feature which could not be fully surveyed owing to heavy undergrowth. The date and characterisation of the earthwork could be ascertained through excavation, with the recovery of datable artefacts, or by its morphology. With regards to importance, if it is a medieval moated site it certainly of local and could be of regional importance. Further investigation could lead to an understanding of pre woodland or woodland land management. It could indicate the 12<sup>th</sup> and 13<sup>th</sup> century colonisation of the woodland landscape through assarting to create farmland (Maull & Chapman 2005, 120; Le Patourel & Roberts, 1978, 50). Its location in the south western corner of the woodland could indicate an association with Elsthorpe Grange.

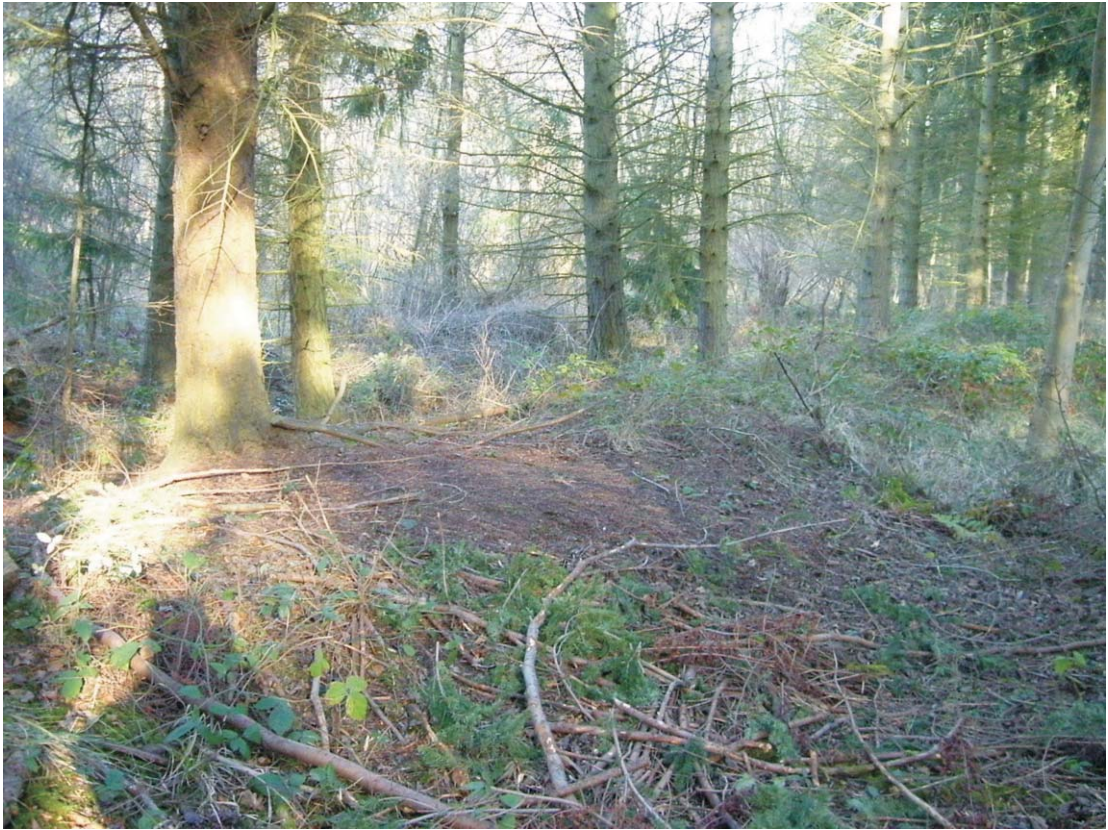
A coppice enclosure bank and ditch, orientated south-west to north-east was identified, with dimensions of 30m long by 11m wide. The ditch is shallow and indistinct, whereas the bank is rounded and more substantial (plate 8).

Plate 8: Probable coppice bank and ditch in Thorny Wood, looking east

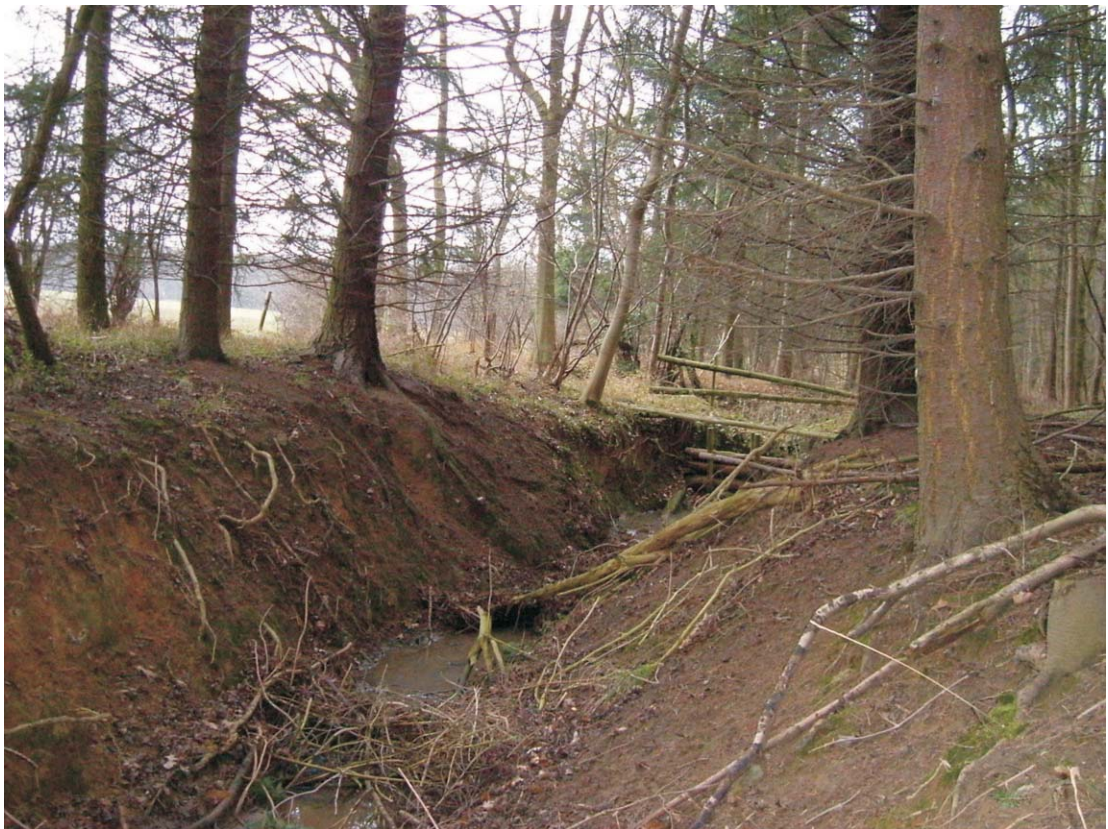
The drainage ditch network continued although it is not as extensive as in the western half of *b DF/MB*. A substantial water-filled ditch, aligned south-west to north-east, truncates the probable coppice and ditch for approximately 30m. It then separates from the coppice enclosure and appears to turn into the stream that demarks the boundary between *h RC/DF/MB* and *e RC/DF/AH* (plate 9).

Plate 9: Water bearing drainage ditch in Thorny Wood, looking south-west
