An Archaeological Watching Brief at
St Nicholas Church,
Cottesmore, Rutland

July 2006

Report 06/190

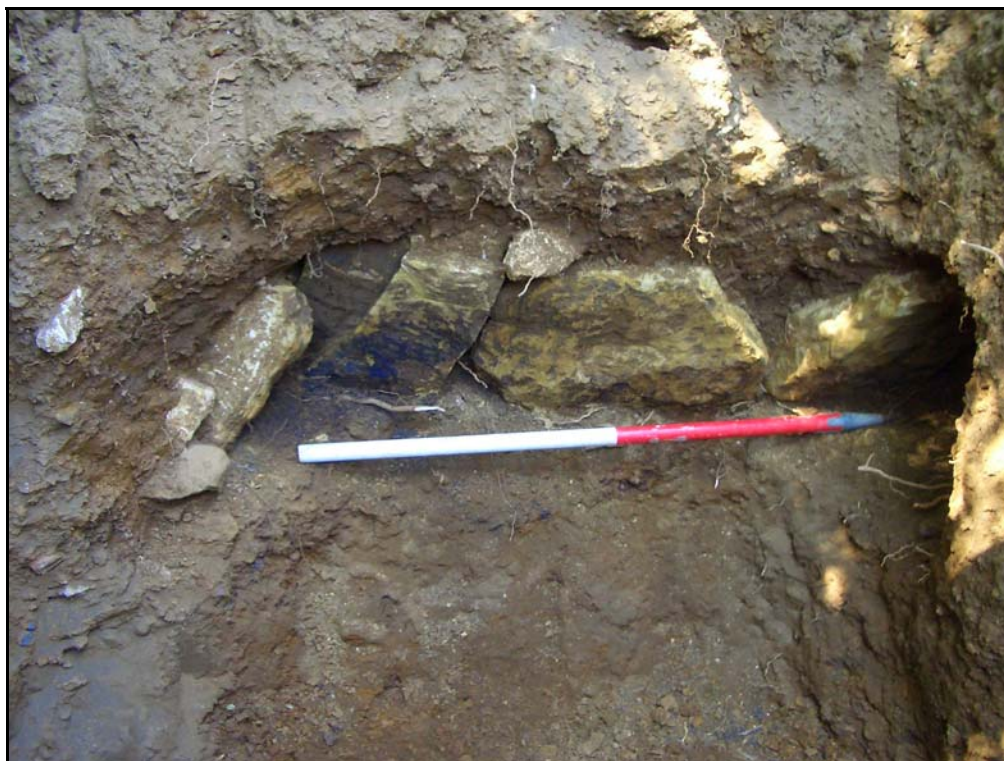
Plate 1 Ironstone slabs covering medieval burial

The manhole in the south western corner of the churchyard measured *c* 1.7m by 2m. At a depth of 1.65m below the present ground surface a single extended supine inhumation was observed. The burial had been laid directly onto the ironstone natural and had then been covered with two lines of ironstone slabs set steeply pitched to form in section a triangular cavity or cist (Plate 1). No finds were recovered from the grave, but the nature of the stone cist would be appropriate for a burial of medieval date. The burial was overlain by 1.45m of sandy loam subsoil which in turn was overlain by 0.2m of topsoil and turf.

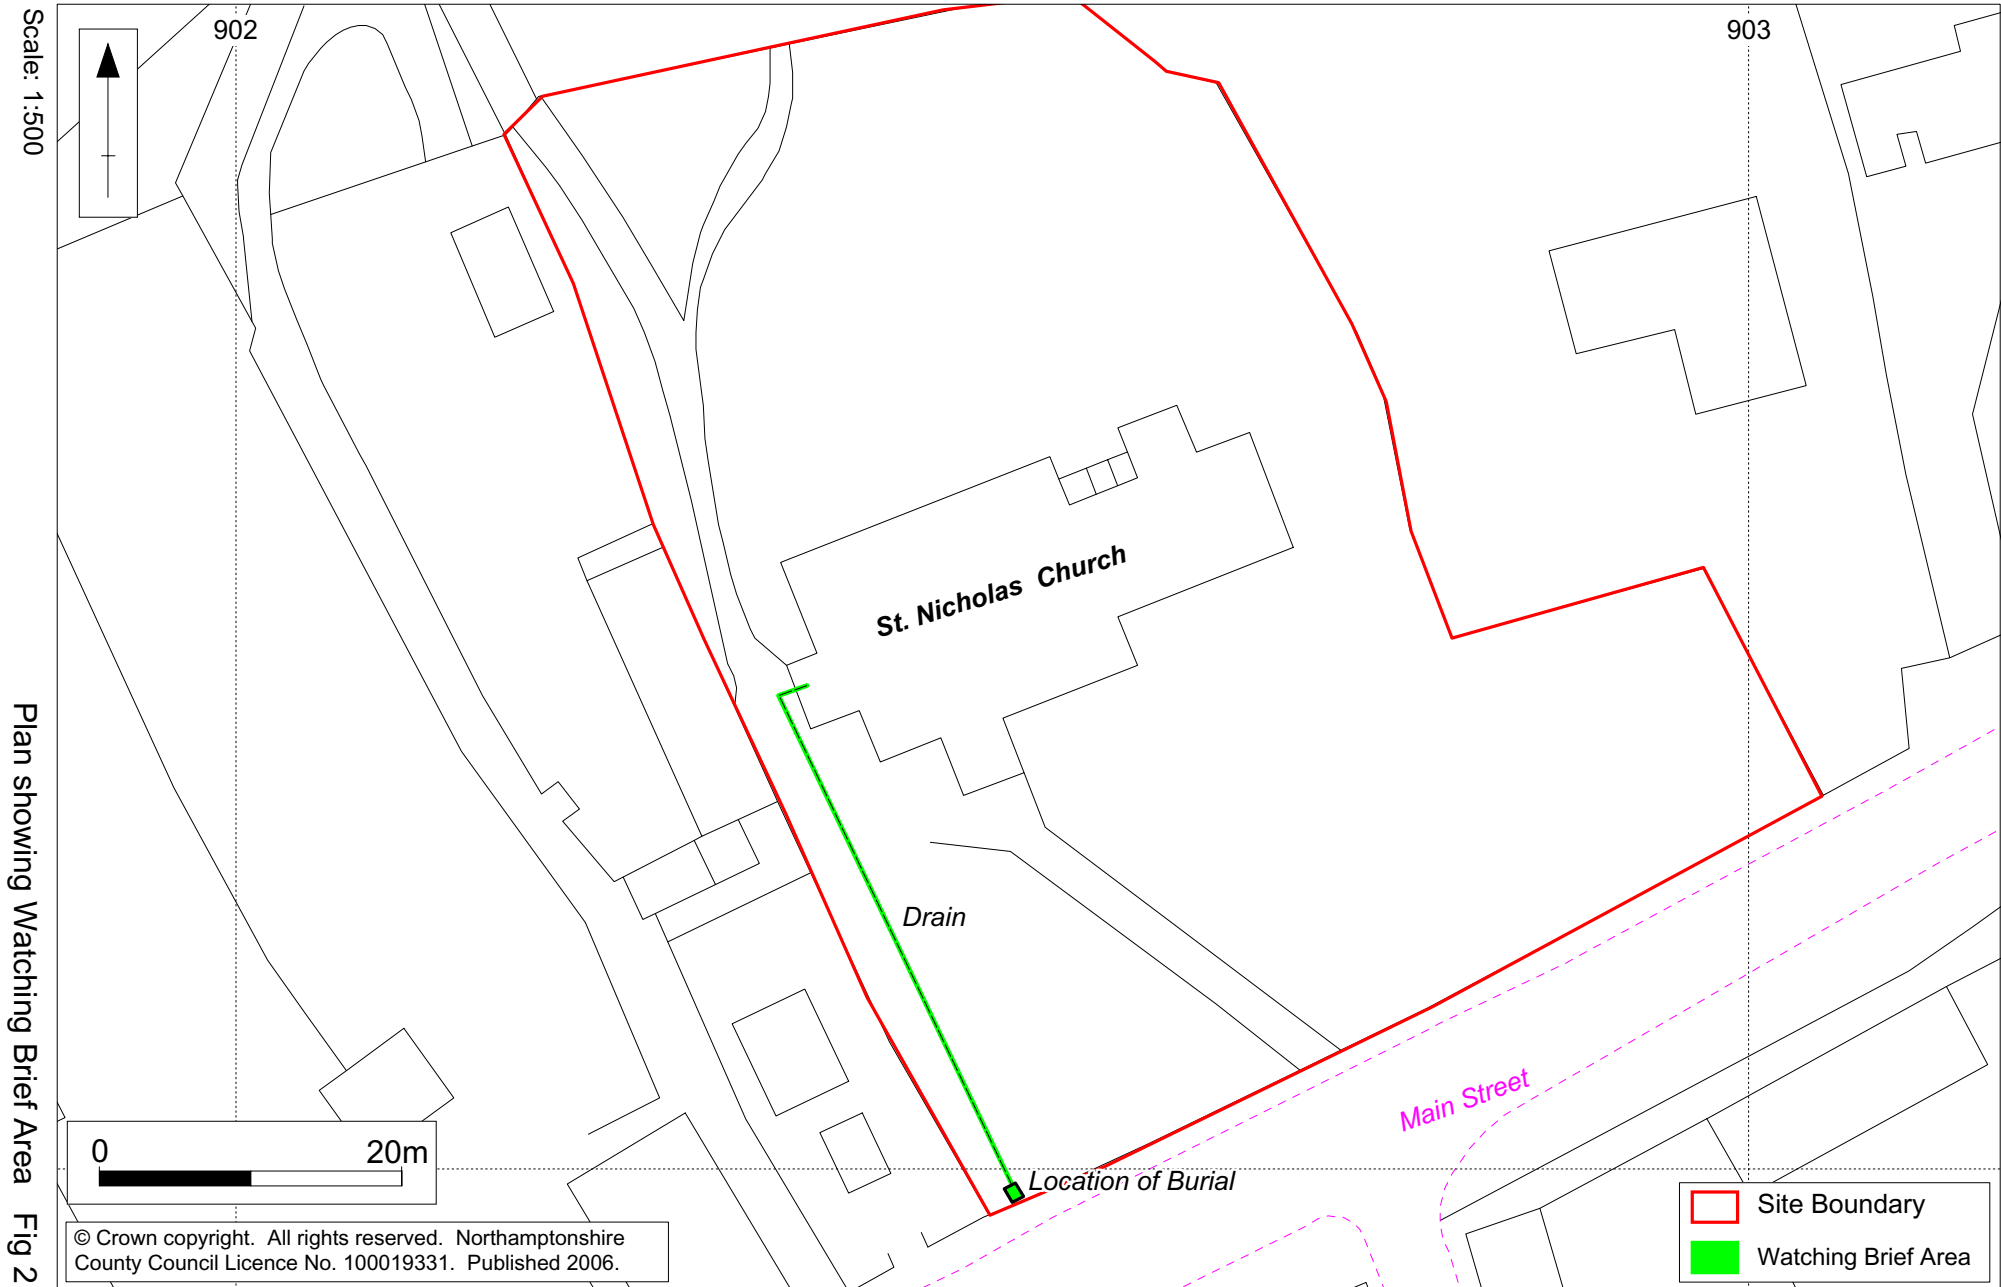
Fig 2: Site plan

The watching brief was carried out as a series of visits in July 2006 to view the excavation of the manhole and the associated drain run (Fig 2). The drain run was typically 0.4m wide by 1.05m deep dug into a sandy loam subsoil which was overlain by 0.2m of topsoil and turf.
