Edgcote House, Northamptonshire

New lift pit

Report 06/89

NEW LIFT PIT

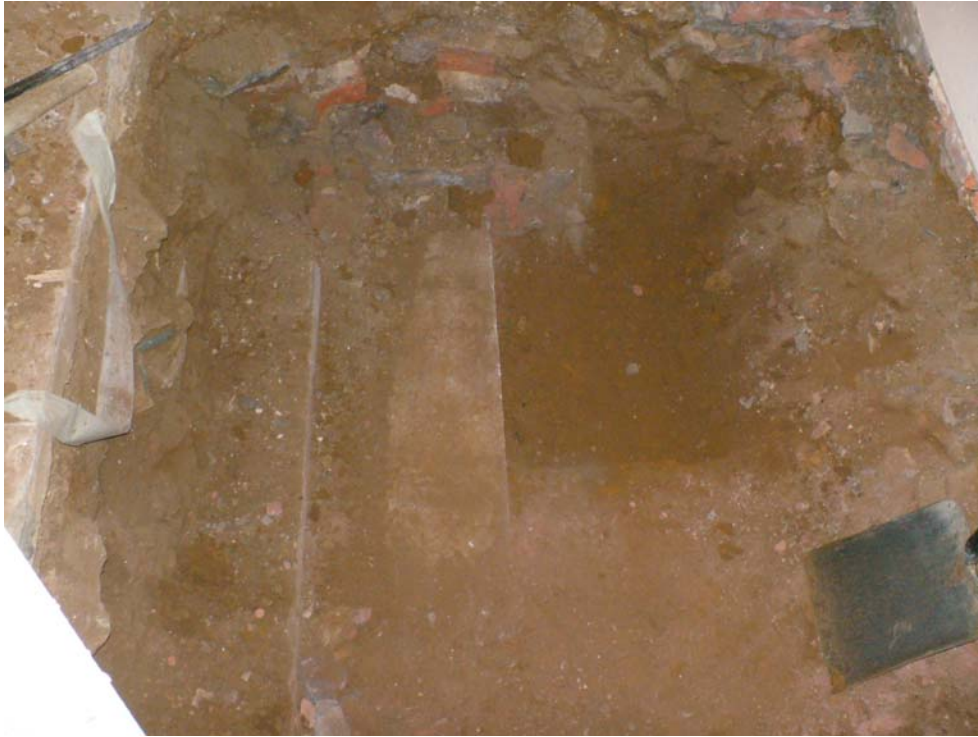
Plate 1 Lift installation pit showing concrete raft and rubble

Below the original concrete raft (Plate 1) the new lift pit was excavated to the new required level, 600mm below the raft. There was no solid bedrock, but a clean sterile compacted reddish brown sand (Plate 2). The raft itself was only 60-80mm thick and was partially covered by a single course of frogged bricks stamped with the initials LBC, the London Brick Company. Above this was a layer of rubble composed of broken brick and stone approximately 460mm thick just below the flagstones.
