**Archaeological Evaluation (Trial Trenching) at  
Leicester College, Abbey Park Campus,  
Leicester  
April 2006  
Y.A15.2006**

Report 06/68

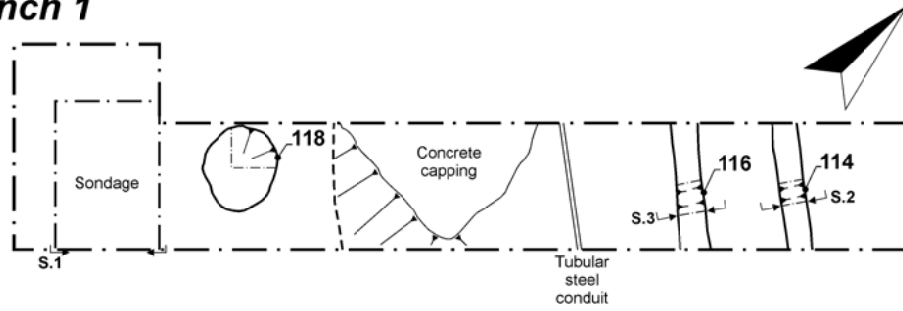
### Trench 1

Trench plans Fig 3

Trench 1, measuring 15m by 1.6m, was 'L' shaped and located in the centre of the existing car park area (Figs 2 and 3, Plate 1). A clean reddish brown clay alluvium (112) was present at a depth of *c* 1.25m below the modern ground surface (52.59m OD) (Fig 4, Section 1). A mechanically excavated sondage in the southern end of the trench showed this deposit to be undisturbed natural geology, more than 0.5m thick. No buried soil or subsoil was present.

Cut into the natural geology towards the northern end of the trench were two narrow linear gullies were aligned roughly east-west [114], [116]. They measured up to 0.54m wide and 0.2m deep and were filled with a blue grey clay (Fig 4, Sections 4 and 5). Sherds of 19<sup>th</sup> century pottery were present in the fill of one of the gullies (115). Towards the southern end of the trench a circular depression in the alluvium [118] with a diameter of 0.9m and a depth of 0.09m was also filled with blue grey clay flecked with charcoal (117). No dating evidence was retrieved from this feature.

Between these features, in the centre of the trench, a tongue of concrete protruding from its western edge overlay a hard packed conglomeration of stone and concrete. The mechanical digger was unable to remove these obstacles which were thought to cap a void of some description, perhaps a well. As a result of this the top of the alluvium was not observed in the centre of the trench.

Away from this intrusion a 0.5m thick layer of light green grey clay (111) overlay the alluvium. This in turn was overlain by a succession of 19<sup>th</sup> and 20<sup>th</sup> century construction, surface and demolition layers which are summarised in Appendix 1.

A tubular steel conduit was aligned roughly east-west to the immediate north of the concrete cap.

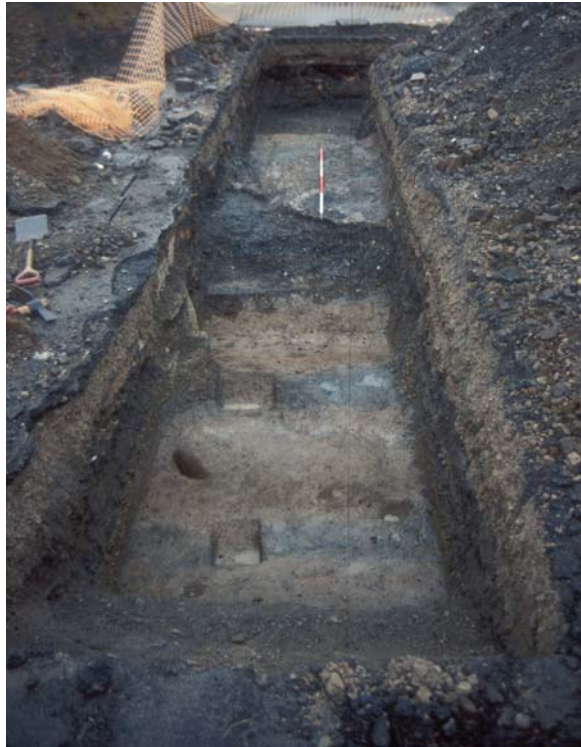
Plate 1: Trench 1

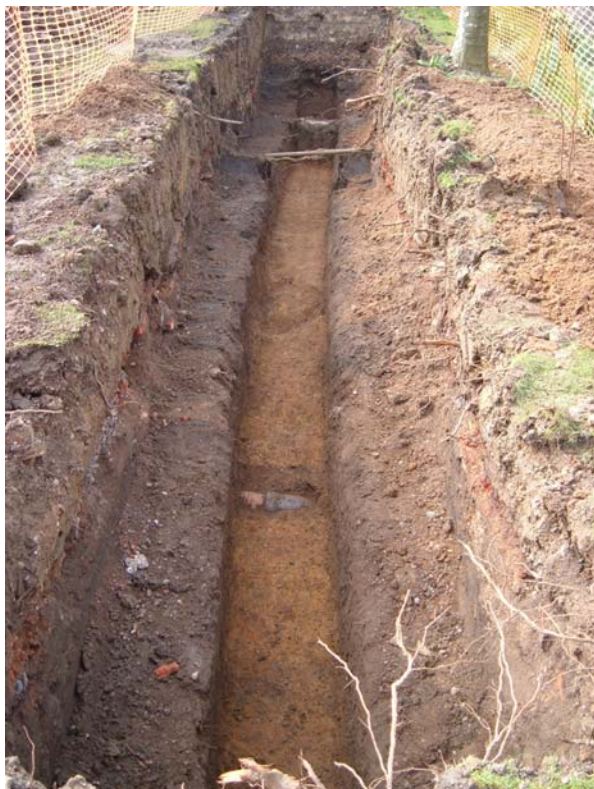
Plate 2: Trench 2

Trench 2, measuring 13.5m by 1.6m, was aligned roughly east-west to the north of the area of modern soft landscaping fronting Painter Street (Figs 2 and 3, Plate 2). The underlying natural geology, a yellow brown gravelly clay (211), was revealed *c* 2m below the surface (*c* 52m OD), in a 0.6m slot dug along the centre of the trench (Fig 4, Section 7). A wider exposure of the natural geology was not possible due the restricted space offered by services aligned parallel with either side of the trench.

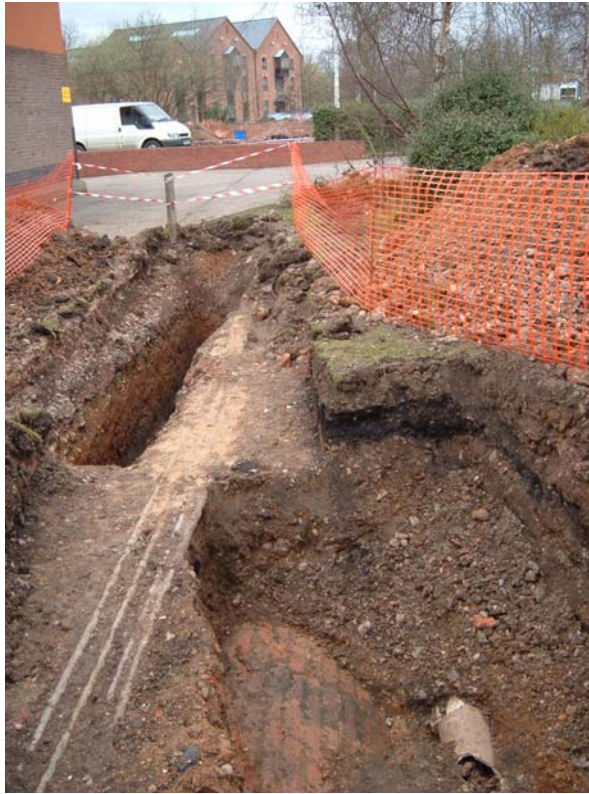
Plate 3: Trench 3 showing barrel vaulted culvert/sewer

Along the northern edge of the strip was the cut of the foundation trench for the large brick sewer/culvert [318]. An excavated section revealed the southern side of the sewer/culvert

which was evidently aligned west north-west to east south-east, in excess of 2m wide and only 1.24m below the surface of the modern soft landscaping at its highest point (c 52.6m OD) (Plate 3).

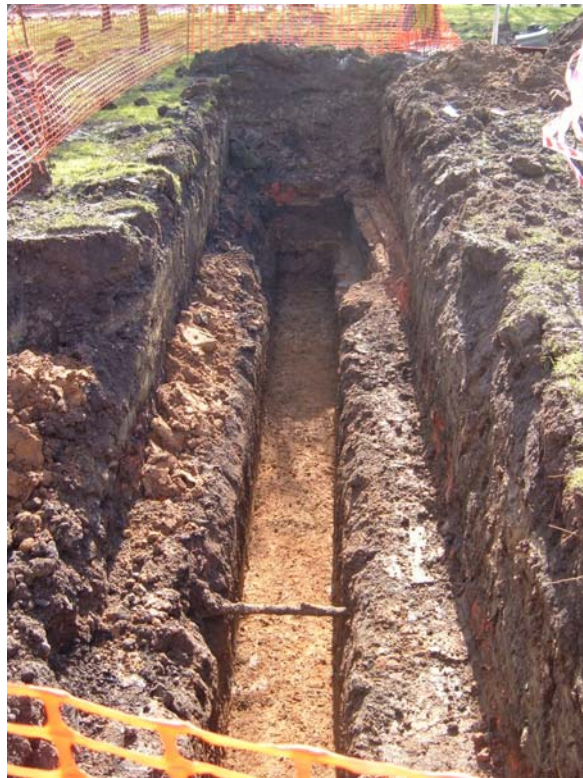
Plate 4: Trench 4

An additional trench was excavated to compensate for the diminished area covered by Trenches 1-3. Trench 4, measuring 9.5m by up to 2.10m, was located c 6.5m to the south of Trench 1 and aligned roughly east-west (Figs 2 and 3, Plate 4). A combination of unmapped services and depth resulted in the need to excavate a 0.60m wide slot along the centre of the trench in order to reach the underlying natural geology. The natural geology, a yellow brown gravelly clay (412), was located c 2.15m below the ground surface (c 52.30m OD) (Fig 4, Section 6). It was overlain by c 0.35m of light yellow brown subsoil (411) and a layer of mid grey brown clay loam topsoil (410) also measuring c 0.35m thick.

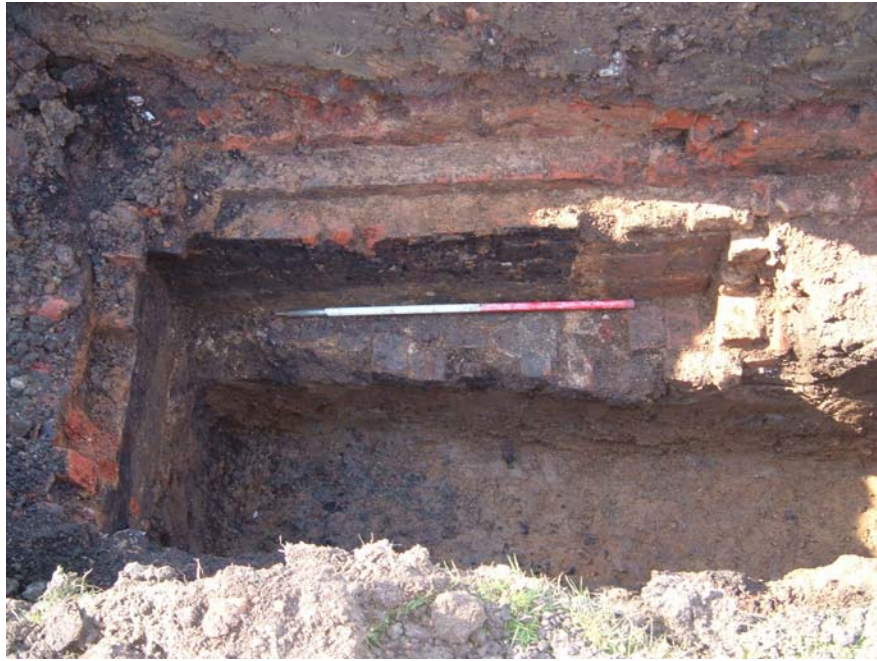
Plate 5: Brick structure (Trench 4)

Neither the underlying geology, subsoil or topsoil contained any archaeological features. These layers sealed by a of mid grey brown silty clay (409) which may have been imported to level the ground in the 19<sup>th</sup> century, roughly corresponding with the construction of a square or rectangular brick-built structure or building of 19<sup>th</sup> century date [407] (Plate 5). Abutting the western side of this structure were the remains of a broken-up brick surface (408) similar to that observed in Trench 2. This lay 0.9m below the ground surface at c 53.60m OD, some 0.75m above the level of the floor surface within the structure. Overlying the brickwork was a 0.65m thick deposit of imported clay (403) and the modern topsoil (402). All brickwork was of regular handmade red bricks, bound with a lime mortar.
