Archaeological Watching Brief
at
The Corinthian Arch
Stowe Landscape Gardens, Buckinghamshire
August 2006

Anne Foard-Colby
October 2006
Report 06/127

ARCHAEOLOGICAL WATCHING BRIEF

THE CORINTHIAN ARCH

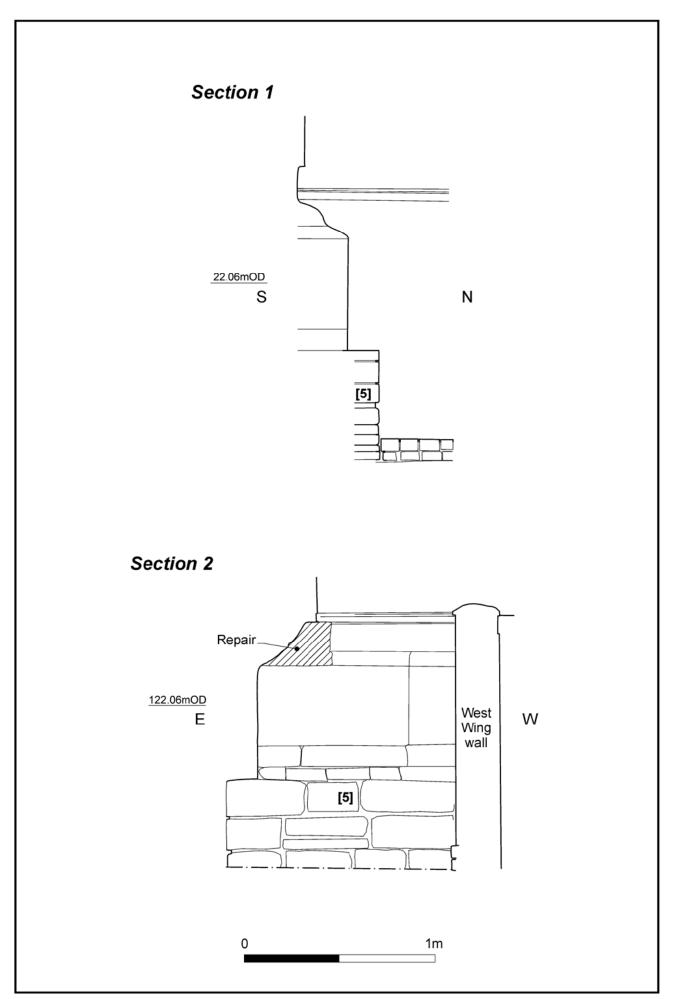
Miliary column, wall sections 1 and 2

Foundations of the miliary columns were revealed (Figs 2 & 3, Plates 5 & 6) during the stripping of soil for drainage around the base of the wing walls. Between 0.2m - 0.5m of soil was removed to enable limestone chippings to be laid next to the foundations for efficient drainage of surface water and to enhance the wing walls against the grass surface after re-seeding.

During the excavation of soil from around the wing walls for the laying of limestone chippings, the foundations of the south-west miliary column were observed and recorded.

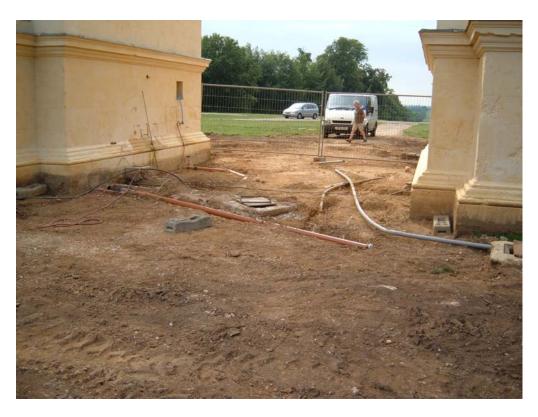
Plate 1: Service runs under arch, looking south-east

Other observable features included a number of square to sub-square shaped manhole covers/drains measuring up to 0.8-1m in diameter interlinked by a number of ceramic water pipes, one of which fed into the well (Plate 1).

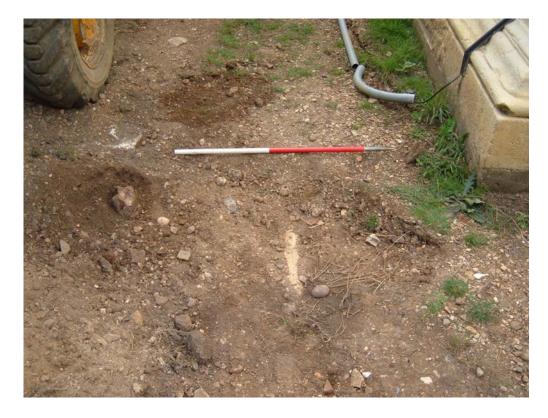
Plate 2: Timber post, looking east

Remains of two timber fence posts [4] were observed to the north-west corner of the arch (Plate 2).

The topsoil stripping also revealed a 20th century, brick-lined well to the west of the Corinthian Arch, which may be contemporary with its use as accommodation. Two wooden fence posts were revealed situated to the north-west of the arch.

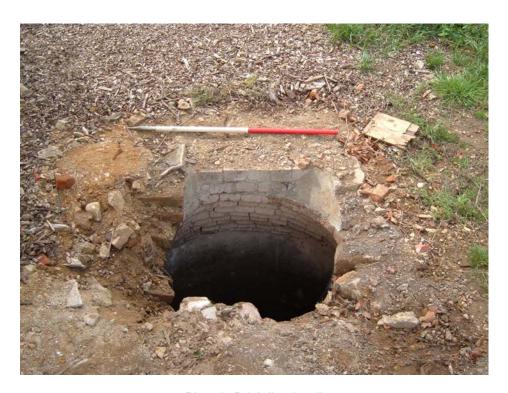
Plate 3: Brick-lined well

A well [2] was uncovered approximately 2.5m to the western side of the arch building. It was brick-lined with individual bricks measuring up to 0.23m long by 0.11m wide by 0.06m thick and had a circular shaft measuring up to 1.2m in diameter with stepped corbelling leading to a squared opening. The interior of the brick face was lined with a hard mortar or concrete screed to help retain the water which was observed at a depth of 2.3 metres. The well shaft was constructed within a roughly square cut measuring up to 1.8m square. A modern cover was built over the opening of the well (Plates 3 & 4).

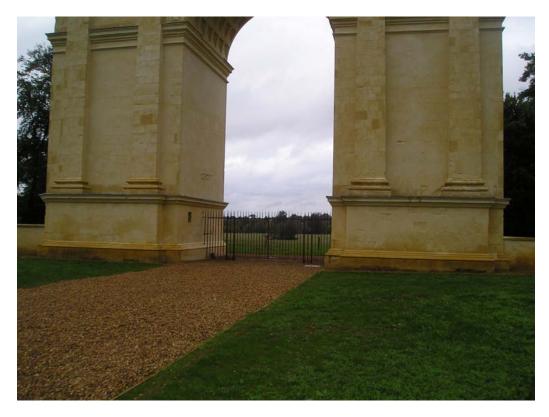
Plate 7: Corinthian Arch with new gates

As part of its ongoing programme of restoration of monuments within the estate at Stowe Landscape Gardens, Buckinghamshire, the National Trust has undertaken the repair and restoration of the Corinthian Arch (NGR SP 6805 3630; National Trust SMR no. 150340; Fig 1). As part of the same programme of works the Trust has undertaken the restoration of the landscape setting around the structure, reinstating the original width of a road called the 'Queen's Drive' and restoring the gates and railings beneath the arch to their original construction height (Plates 7 & 8).
