Archaeological Evaluation at the former
Guest and Chrimes Foundry,
Don Street,
Rotherham
November 2006

Report 06/170

**ARCHAEOLOGICAL EVALUATION
AT THE FORMER GUEST AND CHRIMES FOUNDRY,
ROTHERHAM
SOUTH YORKSHIRE
NOVEMBER 2006
06/170**

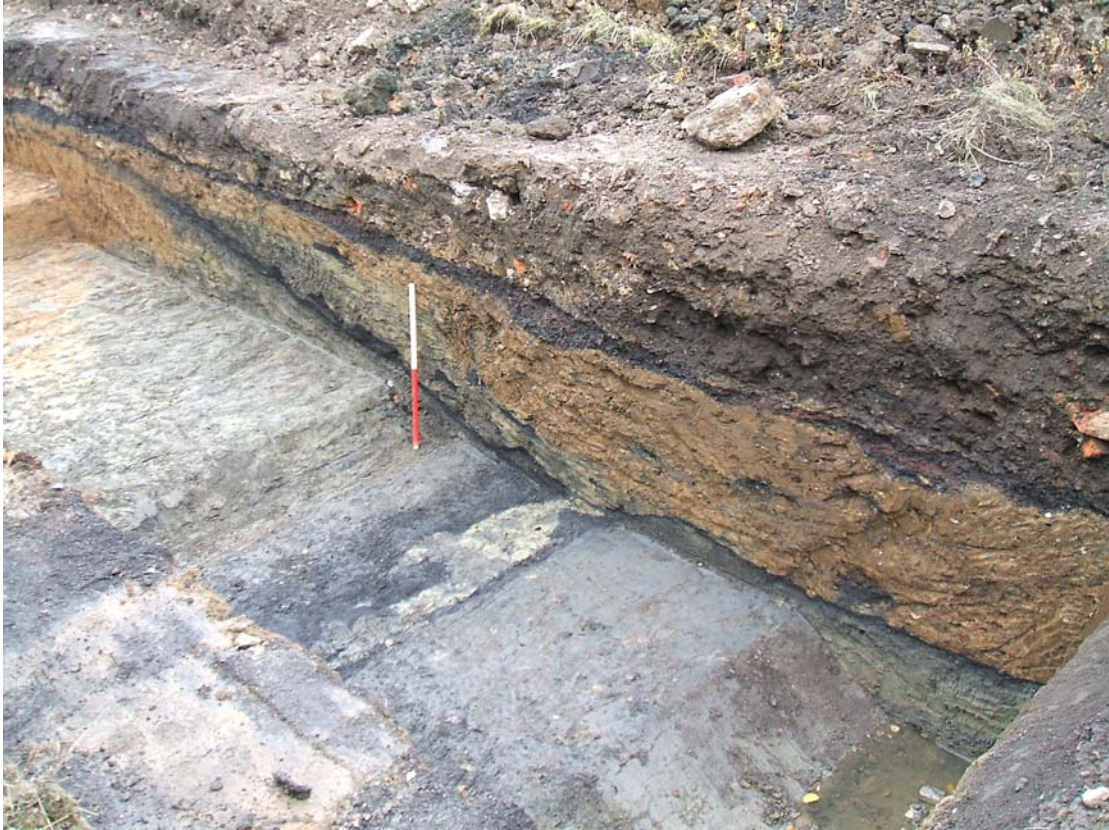
Plate 1: Trench 2. Holmes Tail Goit channel [208], looking north

at 25.1m AOD. Cutting into this was a probable natural watercourse [208], which extended across the trench on a north to south orientation (Fig 4, Section 1). Only the western edge was present within the trench; it was wide and shallow and measured 7m wide and at least 0.8m deep. At the base was a thin layer of black silt and organic material (206) 0.10m thick. Above (206) was a patch of blue/grey clayey silt alluvium (205) 0.5m thick. These fills were natural water-borne stream deposits. They were overlain by (204), mid-brown sandy clay, 0.84m thick, containing brick fragments and charcoal. This was a later deliberate backfilling of the partly silted up channel.

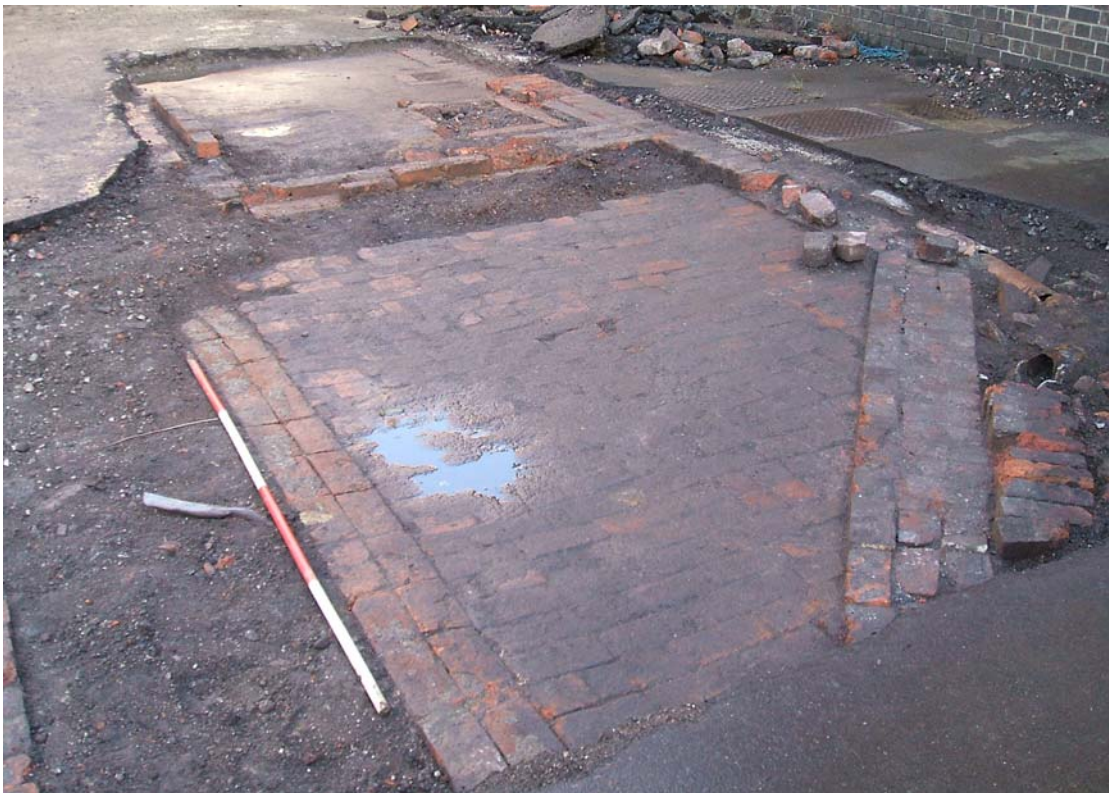
Plate 2: Trench 3. General shot, looking north-east

These structures were most likely internal floors, walls and drains of small foundry workshops within the west wing of the foundry. Wall (303) respected the position and alignment of the surrounding upstanding buildings, whilst wall (304) cut the right angle corner formed between (303) and the existing buildings to the south, possibly opening up the area for easier access. Between (303) and (304) was a brick floor surface (302). A brick drain (307) lay parallel to (303) and between them lay a concrete floor surface (306) with two drain soakways (307) and (308) set within it.

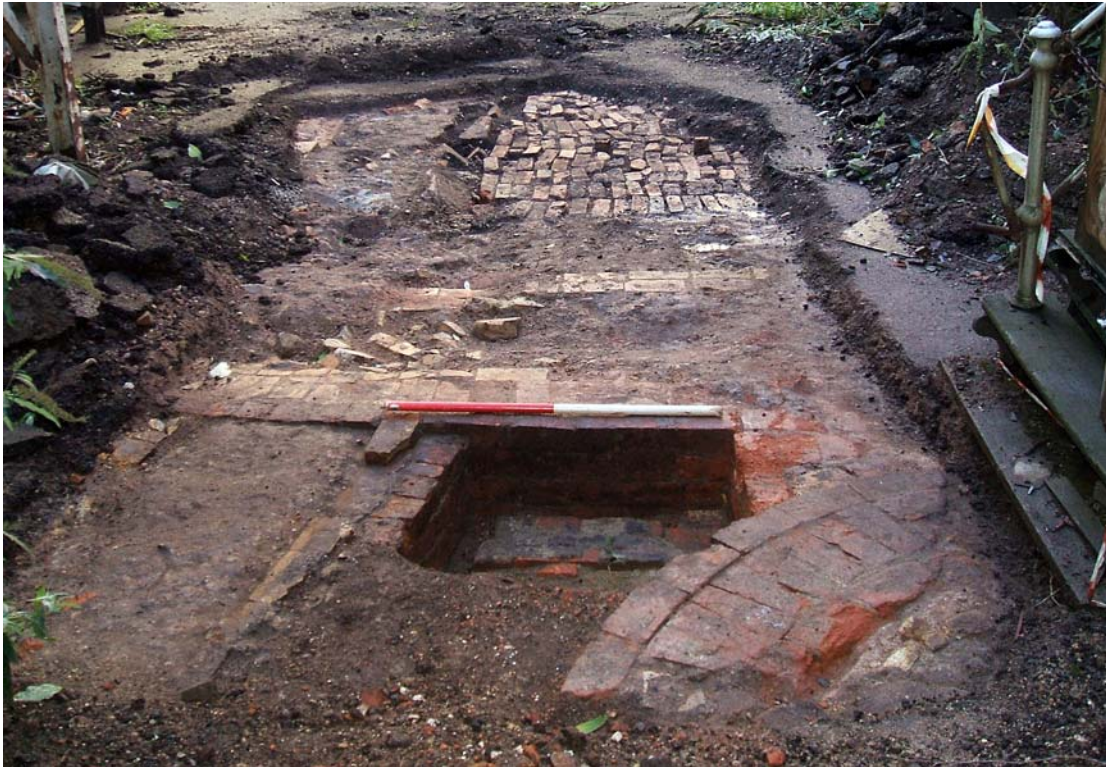
Plate 3: Trench 4. General shot, looking east

A section of the chimney (406) was revealed on the north-east corner of the trench. It was circular in plan with a construction cross-section of four courses of brick. This comprised an outer skin laid end-to-end enclosing a mid layer of bricks arrayed in a radial pattern. The inner lining of the flue was of two courses of brick laid end to end as in the outer layer. The chimney was filled by brick and ash rubble (402). Based on the part visible in plan, the chimney probably had a diameter of 2.5-3m. A slot excavated against the exterior of the chimney revealed that the brick foundations survived to at least four courses deep, overlain by (410) a yellow sand and mortar deposit beneath the ubiquitous rubble (402). Abutting the chimney were several brick walls (405), (407) and (408), presumably part of the boiler house.

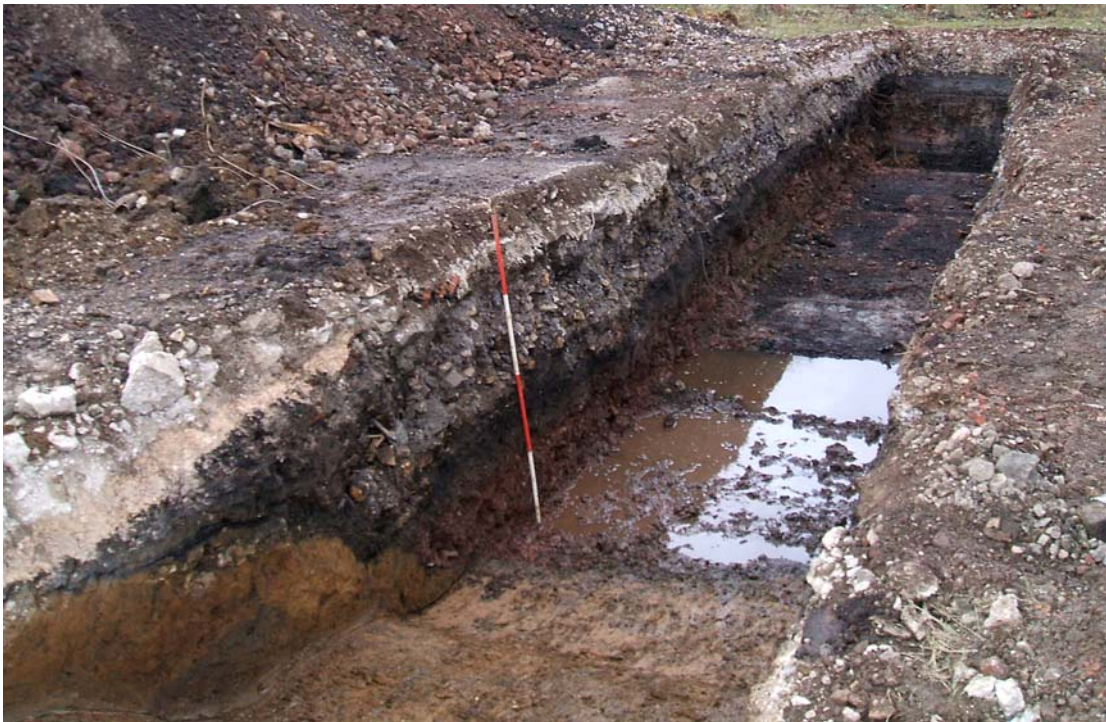
Plate 4: Trench 6. Southern edge of canal basin [602], looking north-west

Undisturbed alluvium (608) was encountered across the east to west arm of the trench at an elevation of 24.8m AOD. Cut into this were several pits containing modern debris. In the north to south arm, the alluvium was cut by the southern edge of the canal basin [602]. This had a gently sloped, rather irregular profile at least 1.5m deep. At this depth the water table was encountered.

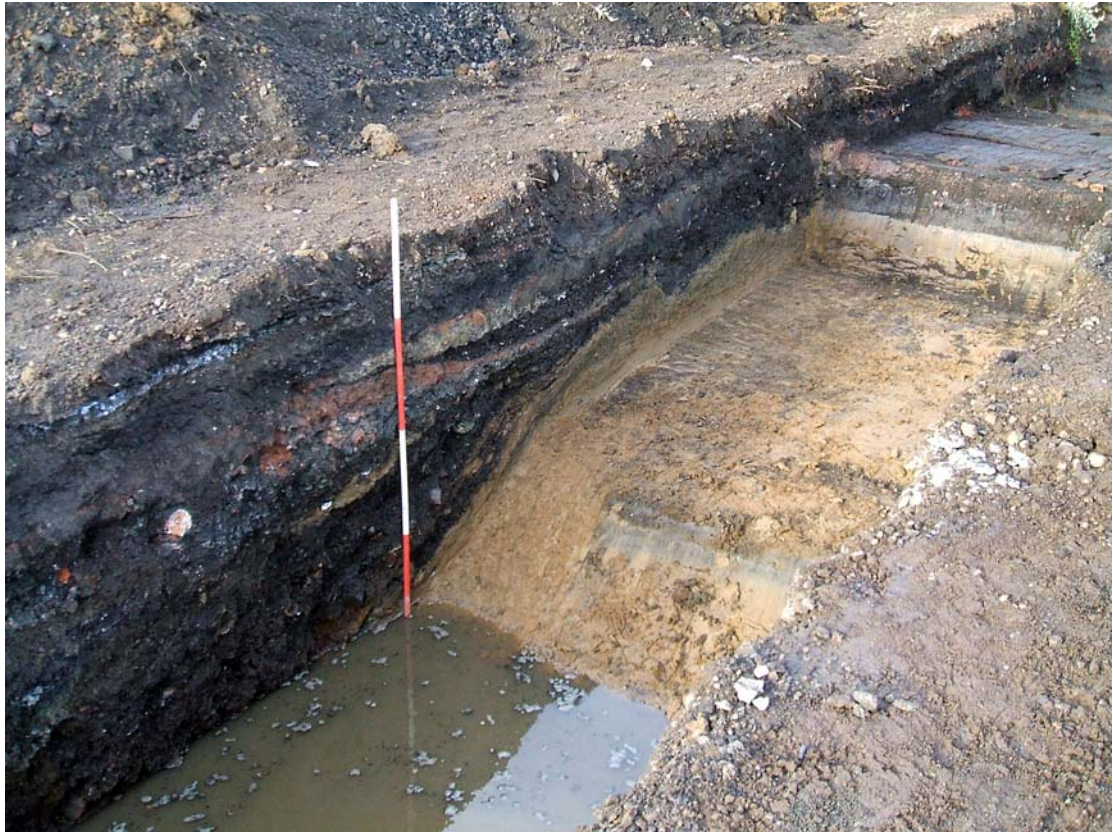
Plate 5: Trench 8. Northern edge of canal basin [820], looking north-west

Alluvium (821) was encountered at a depth of 0.9m, at 24.6m AOD. Located 10m from the north end of the trench was the edge of the canal basin [820] (Fig 3, Section 4; Plate 5). With shallow sloping cut it was similar to the southern edge, previously revealed in Trench 6. Its depth exceeded 1.7m; however the water table was reached at this depth. The basin contained six fills (814)–(819), which were clearly deliberate backfilling, which appeared to have been tipped in from the north side. These fills were all similar,

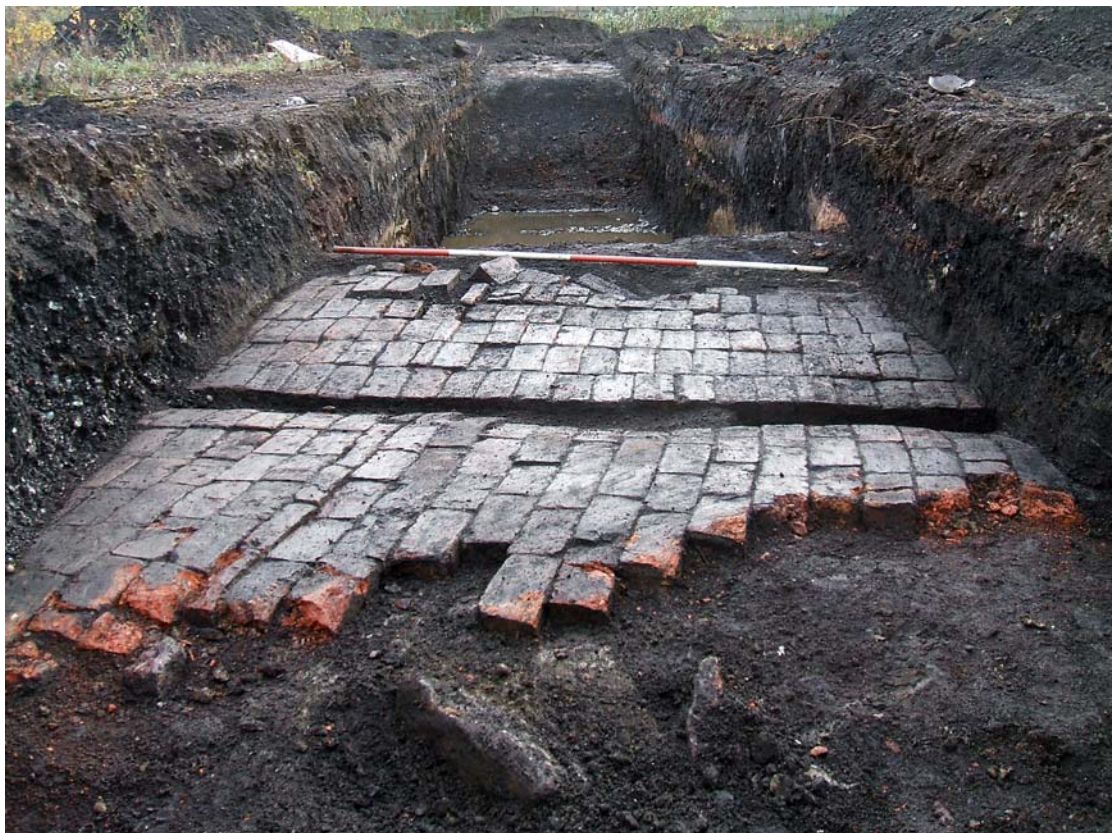
Plate 6: Trench 8. Brick trackway (822), looking south

Located 3.6m to the north of the edge of the canal basin, overlying (812), was a well-laid brick surface (822), or possibly a trackway (Plate 6). Consisting of a single layer of bricks, it extended across the width of the trench on an east-west alignment. and measured 2.4m wide, north-south. Aligned down the middle of the surface was a narrow slot, 0.15m wide, which contained decayed wood. Although possibly a drain, this was may have been a slot for a wooden beam.

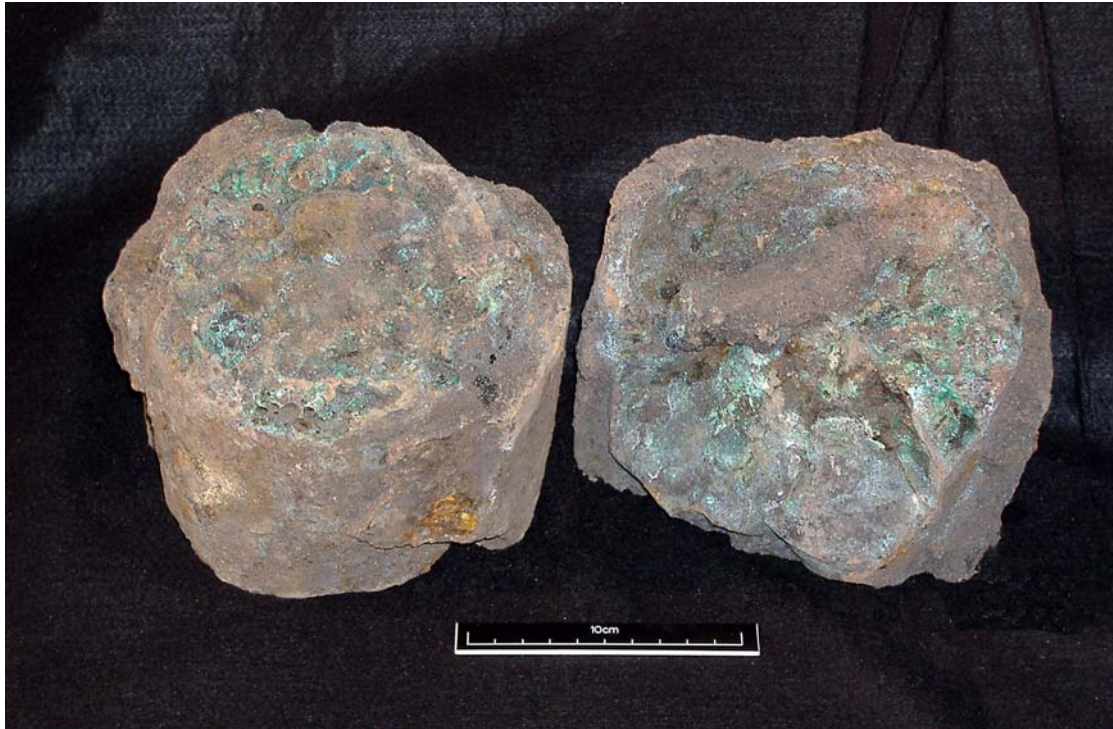
Plate 7: Crucibles, from pit [916], fill (917)

Pit [916] was circular in plan and vertical sided. It measured 2.4m wide at least 1.2m deep. It was not fully excavated. It was filled by (917) which consisted of a series of thin laminations of sand and slag. Several pieces of crucible were recovered from this fill.
