Archaeological Survey of the Ice House
at Moseley Court
Northycote Farm Country Park
Wolverhampton

March 2006

Report 06/36

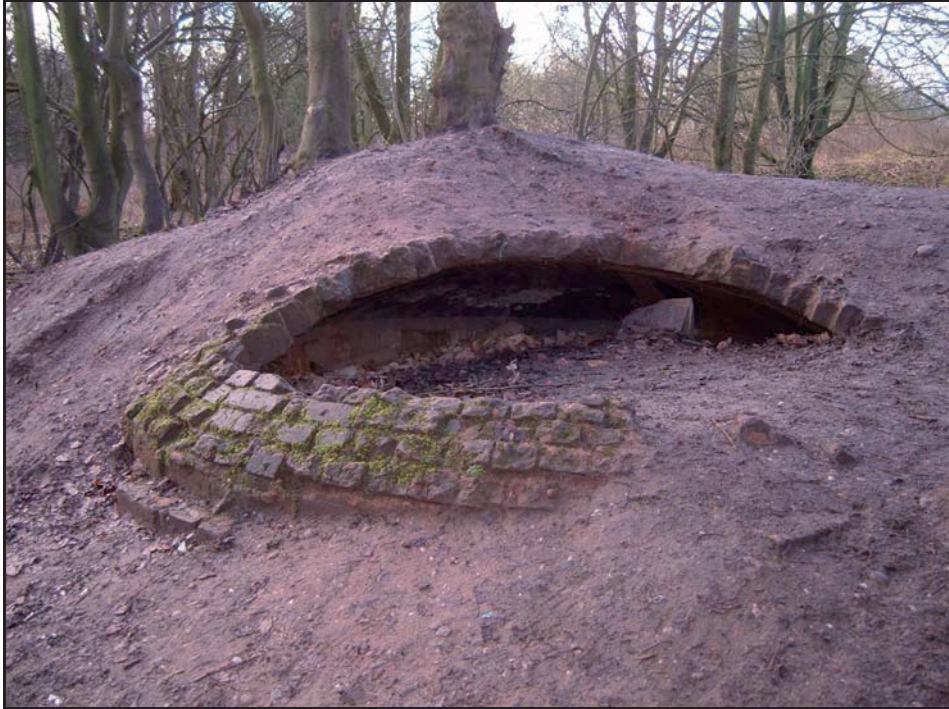
Plate 1 The ice house looking south prior to cleaning

The archaeological survey of the ice house began with the removal of the loose leaf mould and rubbish which was covering the structure and which had collected inside (Plate 1). A small excavation was carried out on the north-western side of the ice house where the presence of brickwork which did not form part of the circle of the structure suggested the location of the entrance. This area was excavated only to show the form of the entrance in plan with no unnecessary excavation being undertaken.

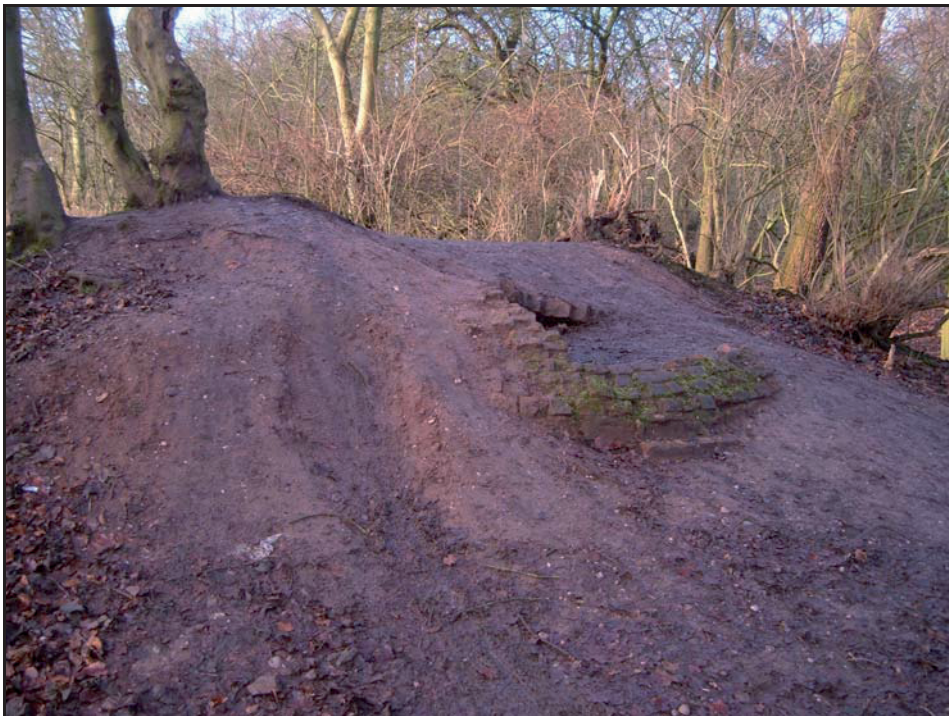
Plate 2 Erosion caused by bicycles

The ice house was covered by a surviving mound (001), measuring *c*12m northwest-southeast by *c*6m northeast-southwest and was made up of a compact orange brown sandy loam with frequent rounded quartz pebbles. The mound had a number of small scrubby trees growing on its north-western side; its south-eastern side had been eroded by its use as part of a cycle track (Plate 2).

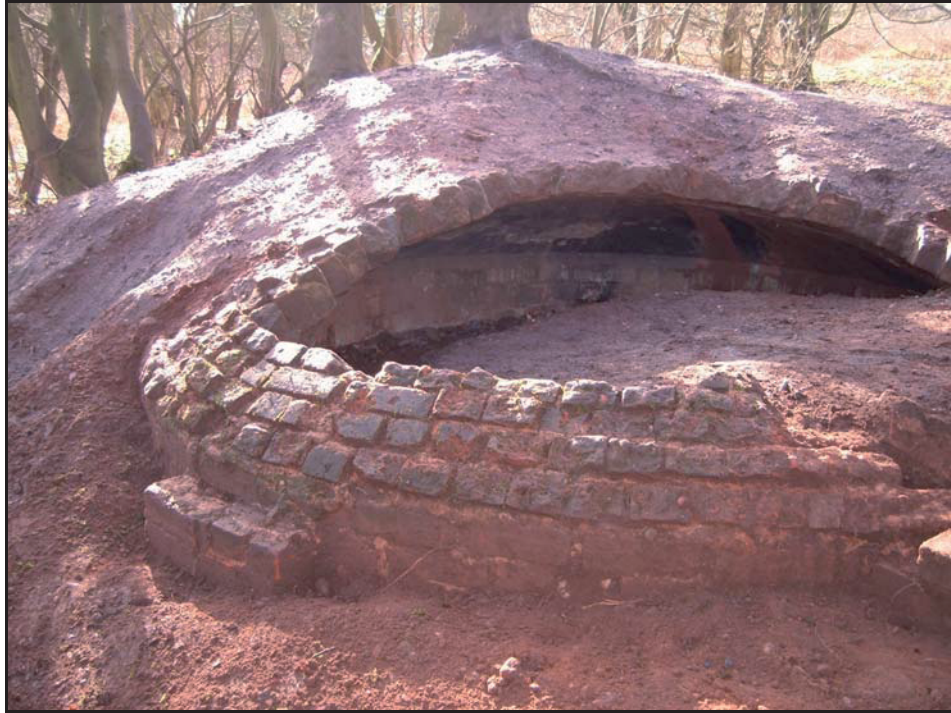
Plate 3 The ice house looking south showing buttress

The brick structure of the ice house was roughly circular with an external diameter of *c*3.2m and an internal diameter of *c*2.5m, the measurements were taken at the widest exposed points (Figs 3 & 4, Plates 3 & 4). It was not possible to measure the full height/depth of the structure.

The ice house superstructure [005] was constructed in handmade red/orange brick laid in stretcher bond (brick size: metric 235mm x 115mm x 68mm; imperial 9 ¼” x 4 ½” x 2 ¾”). The outer finish was roughly pointed with a dull creamy yellow mortar. The internal finish was neatly pointed, with a possible lime wash finish. The wall was *c*0.3m thick. On the north-eastern side of the structure there was a brick buttress which, at the level seen, was not bonded into the ice house (Figs 3 & 4, Plate 3).

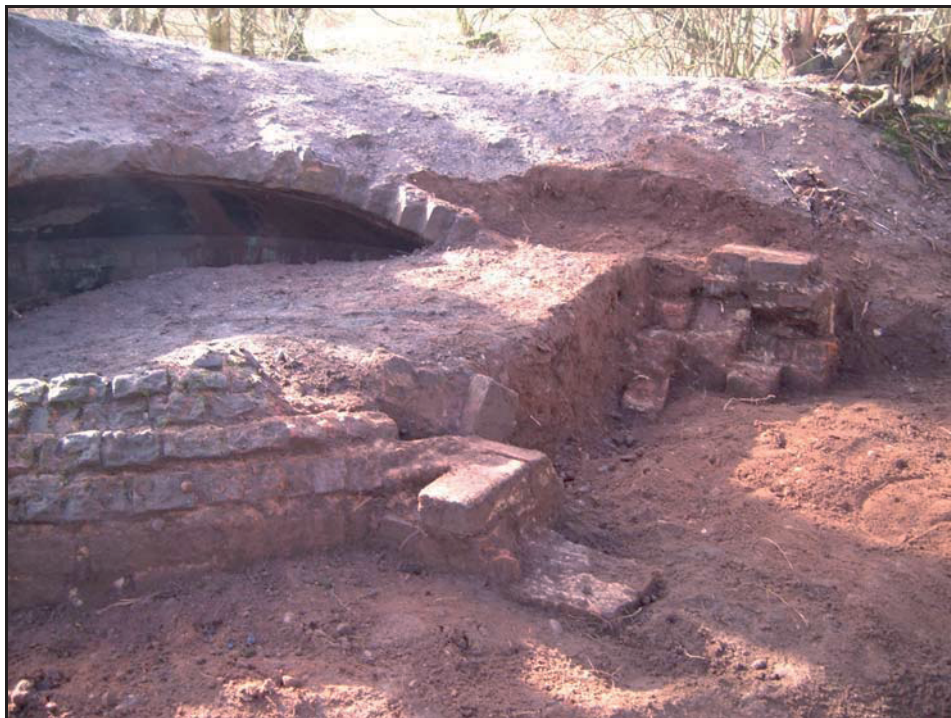
Plate 4 The ice house looking south-entrance to right

The dome of the ice house had been breached, so the relationship between it and the entrance was not clear. The surviving entrance brickwork [006] demonstrated that the entrance was *c*0.95m wide with an arch, of which only the springer brick on either side survived (Plates 4 & 5). The entrance structure was not placed centrally to the circular super structure but was offset; it is not clear whether this was part of the original design or a simple construction error.

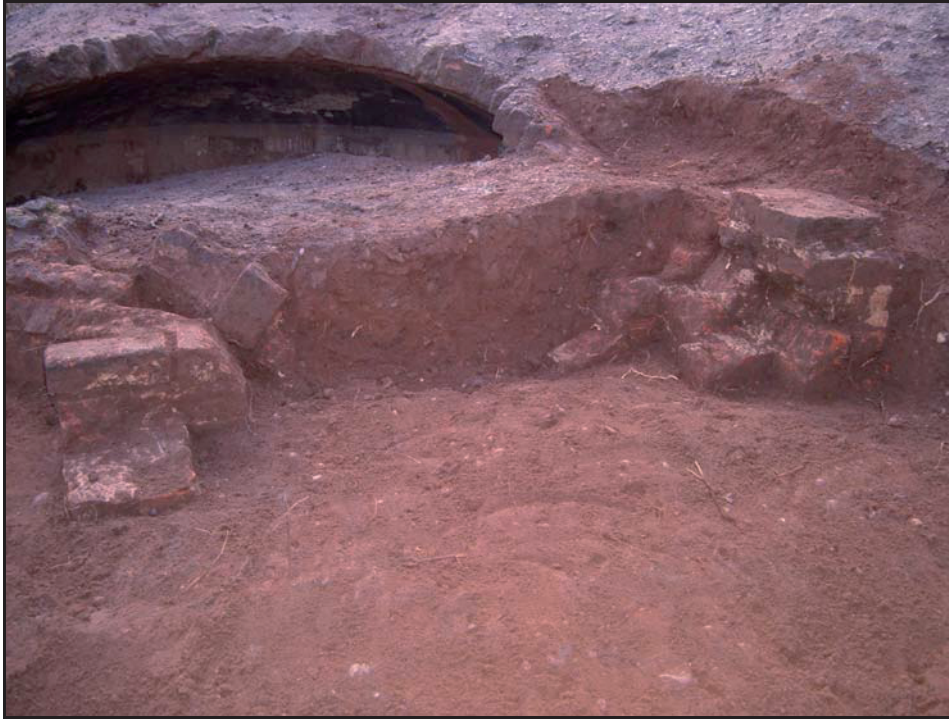
Plate 5 The entrance structure

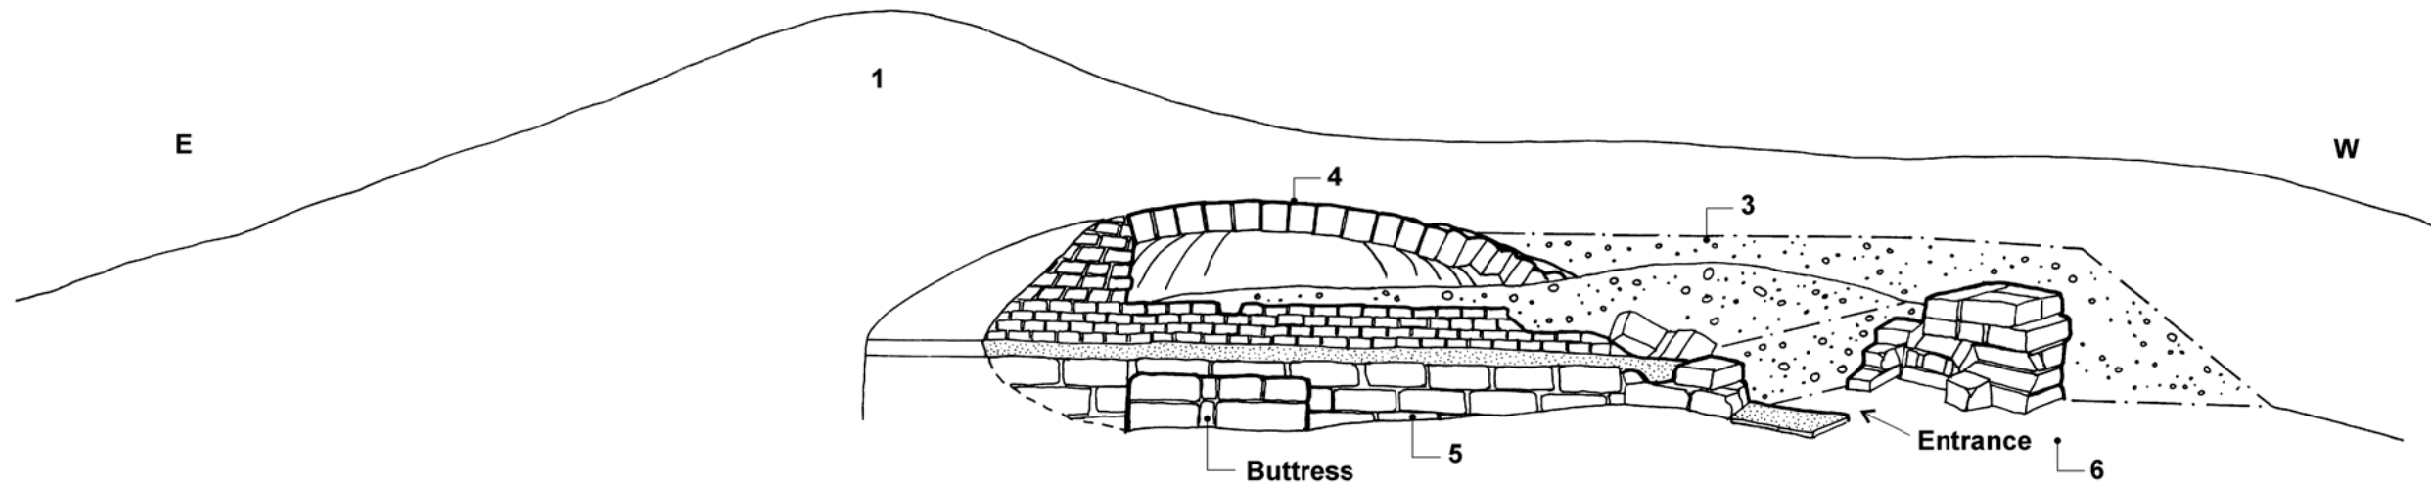
Section 1

Moseley Ice House
Sectional elevation
