Northamptonshire Archaeology

An archaeological watching brief
at Canons Ashby House, Canons Ashby
Northamptonshire
November 2004 – April 2005

David Leigh
March 2007
07/019

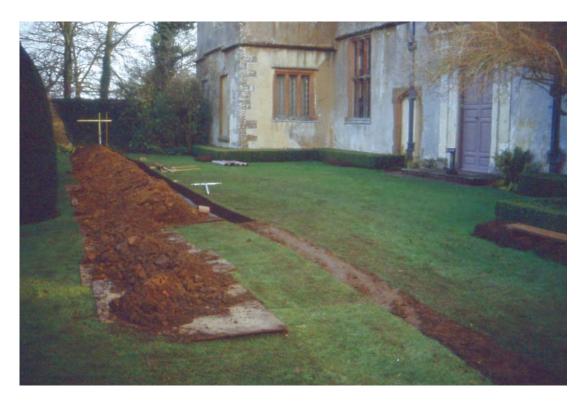
Plate 5: General view of the ground-works in the northern garden of Canons Ashby House

From the western corner to the north corner (Plates 5 & 6) the stratigraphic sequence comprised, red/brown fragmented natural ironstone encountered at a depth of 0.98m, overlain by grey/brown silt loam subsoil, up to 0.70m thick, containing occasional small fragments, less than 0.06m, of limestone and occasional rounded stones. This was sealed by a grey/black topsoil/turf layer, up to 0.28m thick. Mid way, for approximately 15m and corresponding with the position of the original entrance, the stratigraphic sequence differed. Here the stratigraphic sequence comprised, red/brown fragmented natural ironstone encountered at a depth of 1.10m, overlain by grey/brown silt loam subsoil, up to 0.45m thick, containing occasional small fragments, less than 0.06m, of limestone and occasional rounded stones. This was cut by a layer of disturbed material, up to 0.25m thick, comprising mixed gravels and fragments of modern ceramic building material. A single architectural limestone fragment was recovered from this deposit. Sealing this was a grey/black topsoil/turf layer, up to 0.28m thick.

The ground-works comprised the excavation of trenches for the new drainage system along with a further trench for the laying of a new security cable (Fig 2; Plates 2, 5 & 6) for an alarm system to protect The Shepherd Boy statue. All the ground-works were undertaken under archaeological supervision and were carried out using hand tools. A photographic record in both black and white negative and colour slide was kept, along with supplementary photographs in digital format. The written record used Northamptonshire Archaeology pro-forma sheets. The watching brief was carried out in accordance with the standards and guidelines for an archaeological watching brief (IFA 2001).
