Historical analysis of the site of  
the former kitchen garden at  
The Old Rectory, Cranford St Andrew,  
Northamptonshire  
February 2007

Report 07/29

**HISTORICAL ANALYSIS OF THE SITE OF  
THE FORMER KITCHEN GARDEN  
AT CRANFORD ST ANDREW OLD RECTORY,  
NORTHAMPTONSHIRE**

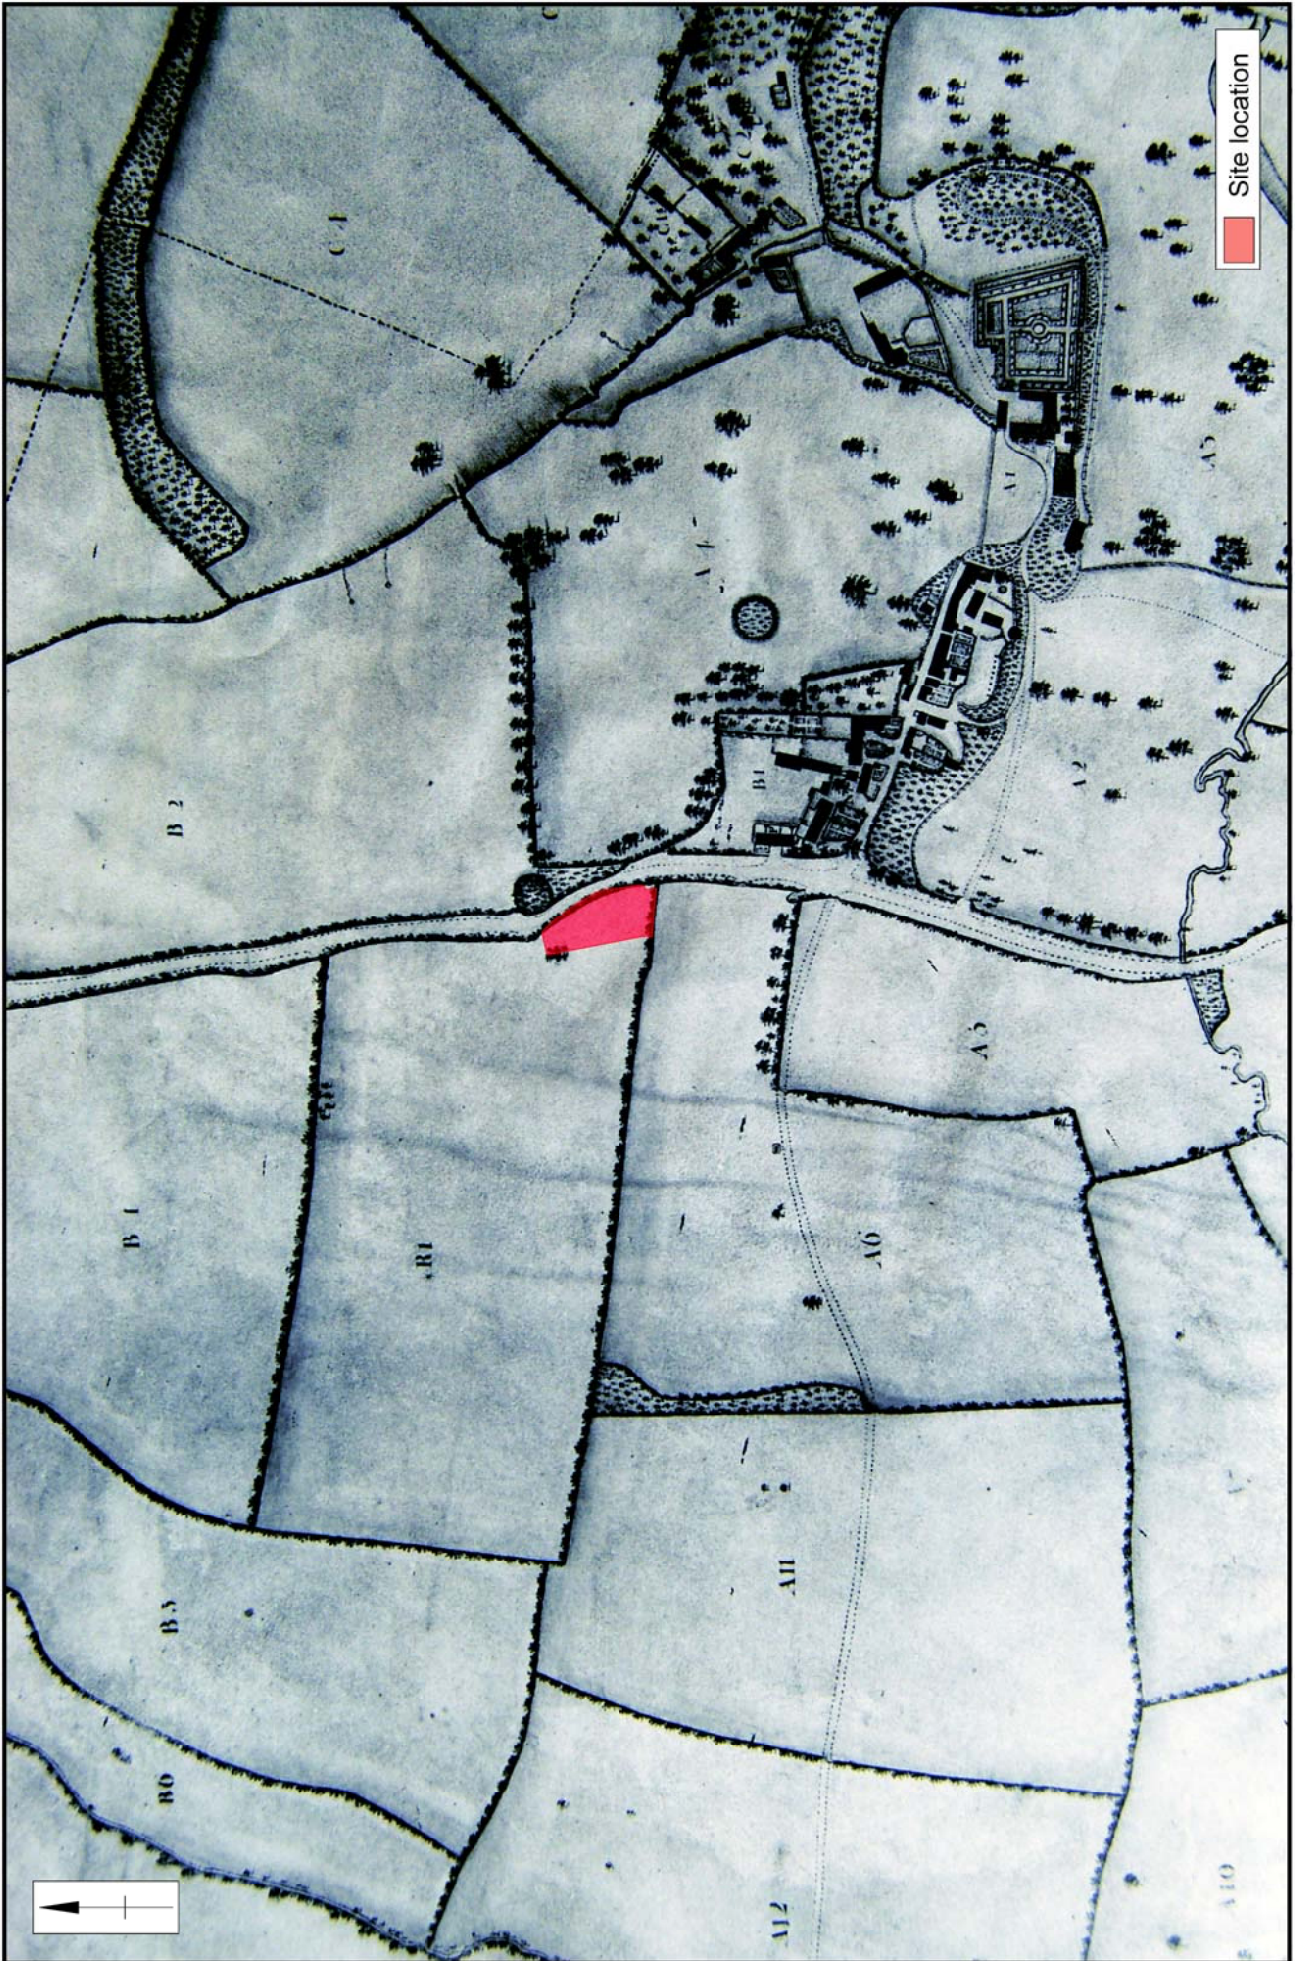
William Crosby map, 1782 Fig 3

- 3.3 Documentary research. The first located map of the site dates from 1782 by William Crosby which shows the Lordship of Cranford St Andrew (Fig 3, NRO map 4446 A-D). Whilst the village, hall and church are easily comparable to the modern layout, the area where the rectory is situated is shown blank. Either the Rectory was not drawn for some reason, which seems unlikely on such a detailed map, or it was built shortly after this map was made, dating it therefore to the very end of the eighteenth century which corresponds with the English Heritage listing which simply calls the building late eighteenth century. The 1810 Surveyors map of the county indicates 'The Parsonage' but the detail is not sufficient to determine what lies in the area currently being investigated (Fig 4). A tithe map dated 1849 and listed in NRO as showing Cranford does not in fact depict the village and has therefore not been reproduced here. The next useful map is that of 1875 which shows the estate of Sir John Robinson, baronet (Fig 5, NRO map 4160). This too shows the village and Hall, and for some reason just shows the southern side of the Rectory building and the outline of the plot in which it stands. No indication is made of any other buildings or features associated with the Rectory, and no indication is made of the wall alongside Rectory Hill or access routes into the plot. The 1<sup>st</sup> Edition Ordnance Survey map of 1885 shows that the area was subdivided by two sets of paths, roughly quartering the area (Fig 6). Two buildings are indicated at the northern end and the wall alongside the road is probably present, though at this scale it is impossible to distinguish between walls and other boundary divisions.
