Archaeological building analysis
and desk-based research on
The Old Rectory, Barnwell,
Northamptonshire
2007

October 2007

Report 07/155

**ARCHAEOLOGICAL BUILDING RECORDING AND
DESK-BASED ASSESSMENT AT
THE OLD RECTORY,
BARNWELL, NORTHAMPTONSHIRE
2007**

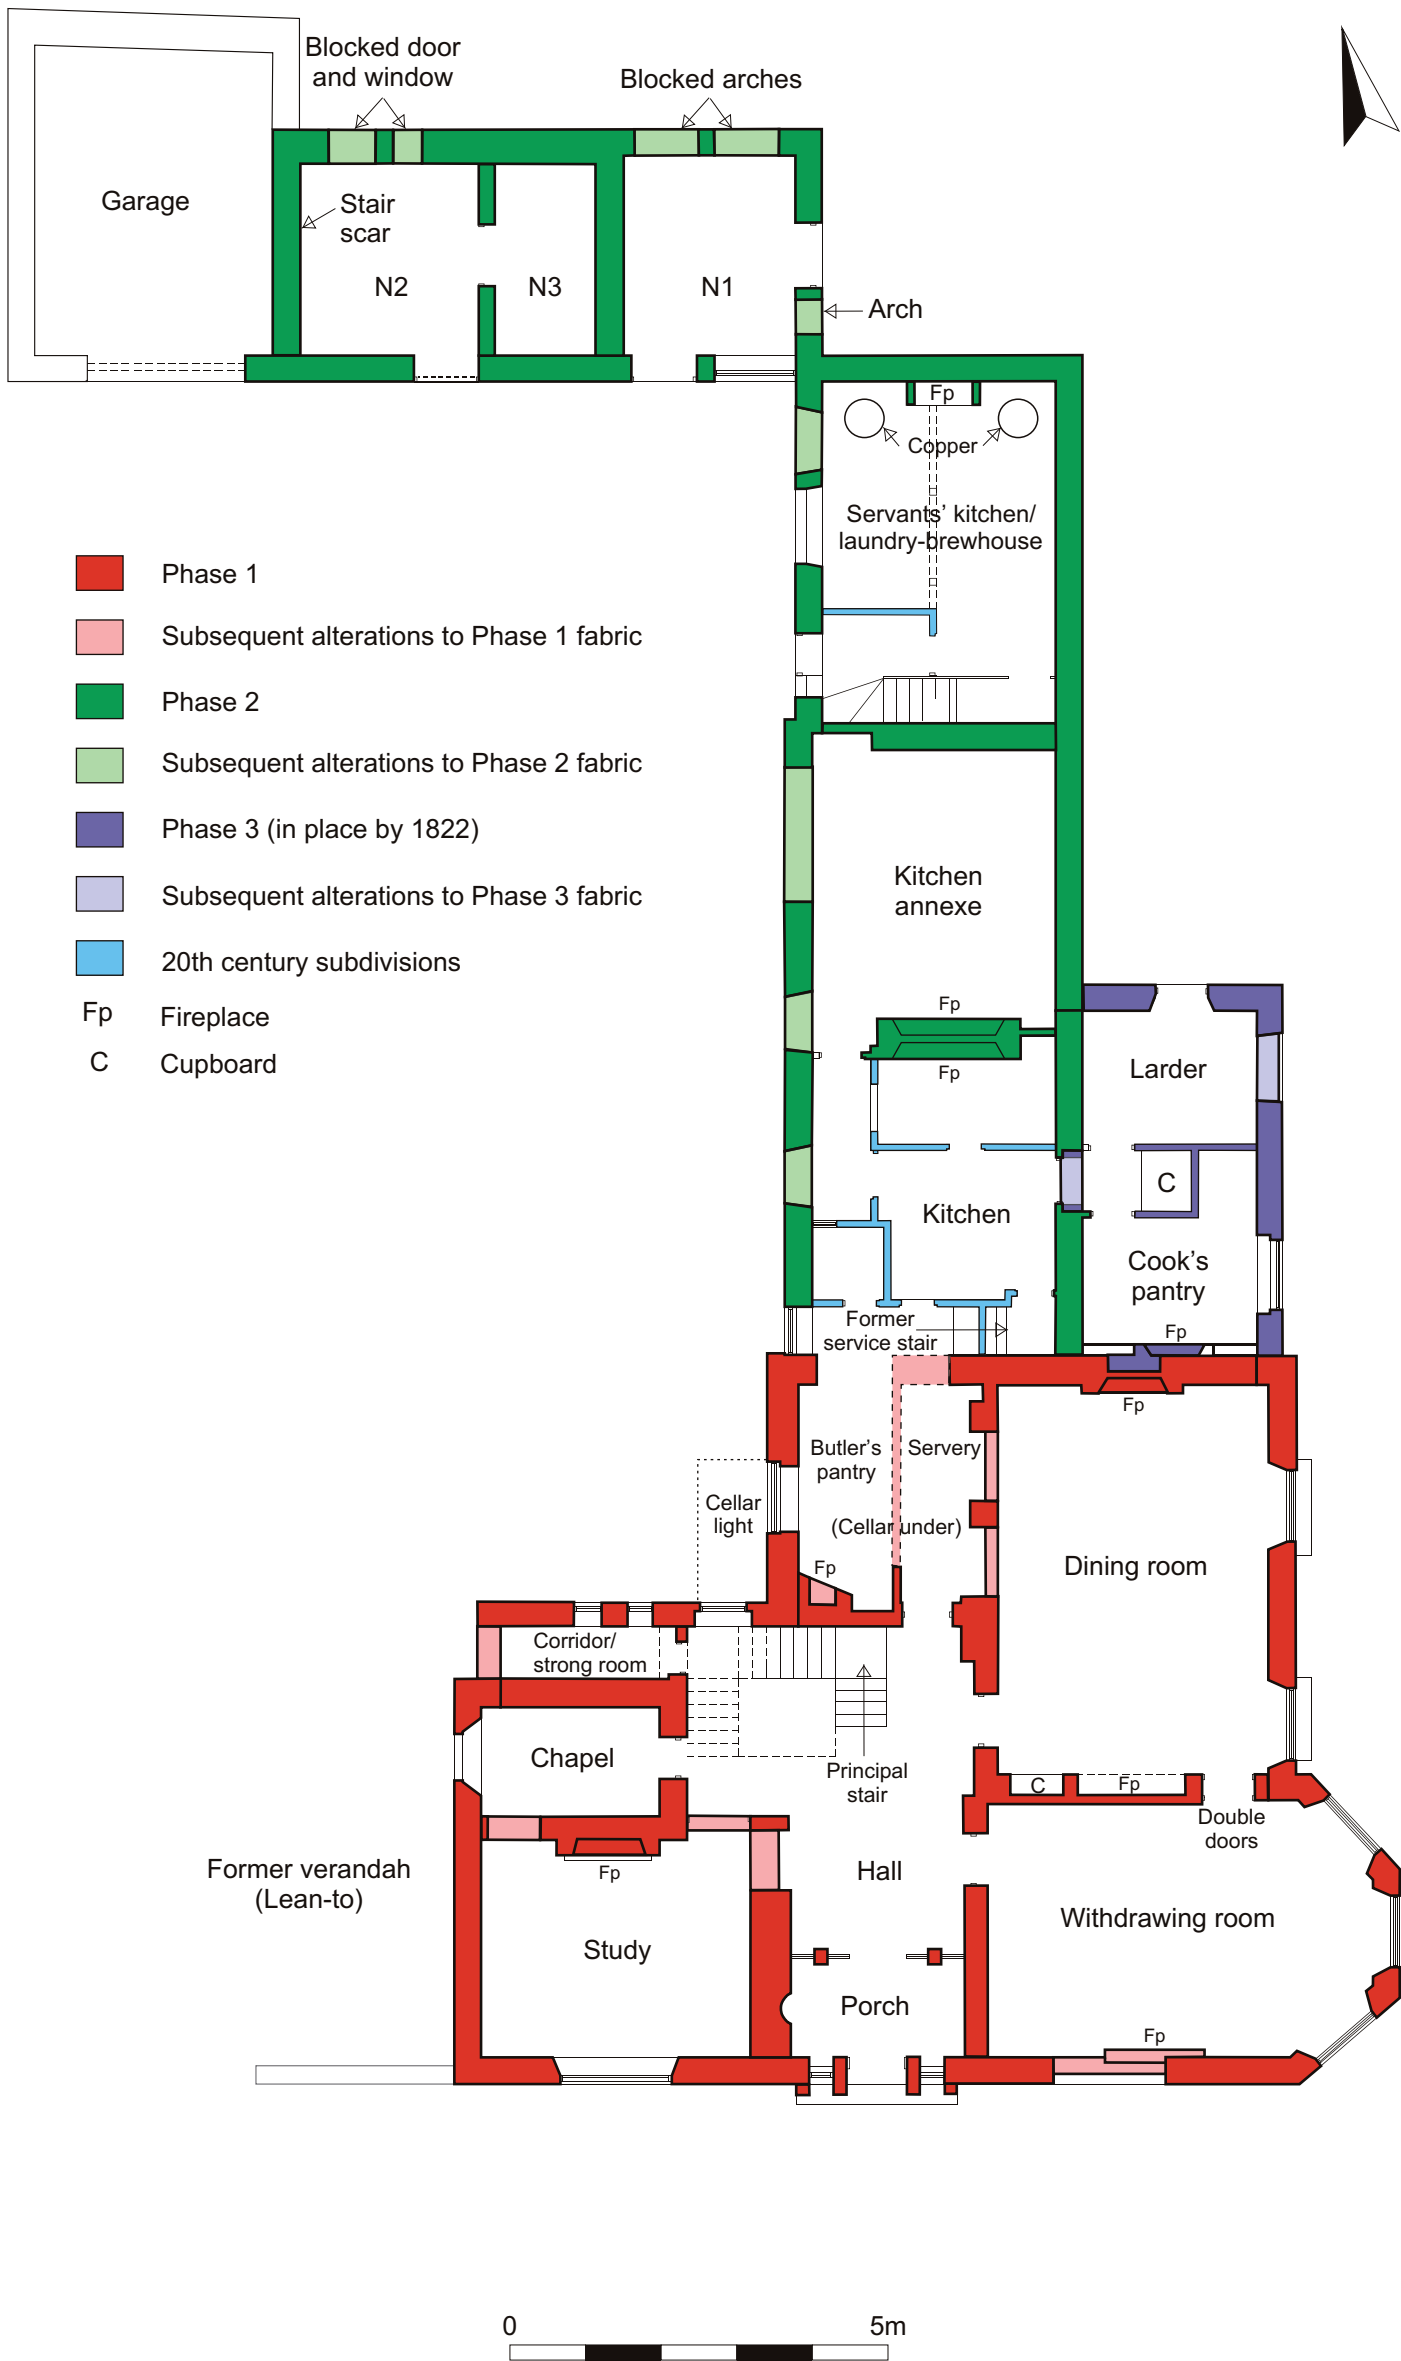
Ground Floor Plan Fig 2

Recording on the ground floor has employed room names related, not to known uses at any one period (none of which might be either original or consistent), but by those which best represent what is suggested by other rectories and higher-status dwellings in use throughout the nineteenth century and into the modern era. Evidence has been brought to bear from the contents of the rooms which have survived, particularly where the removal of wall or ceiling plaster, the removal of floors or the demolition of recent partitions has briefly recalled the original, intended room layout.

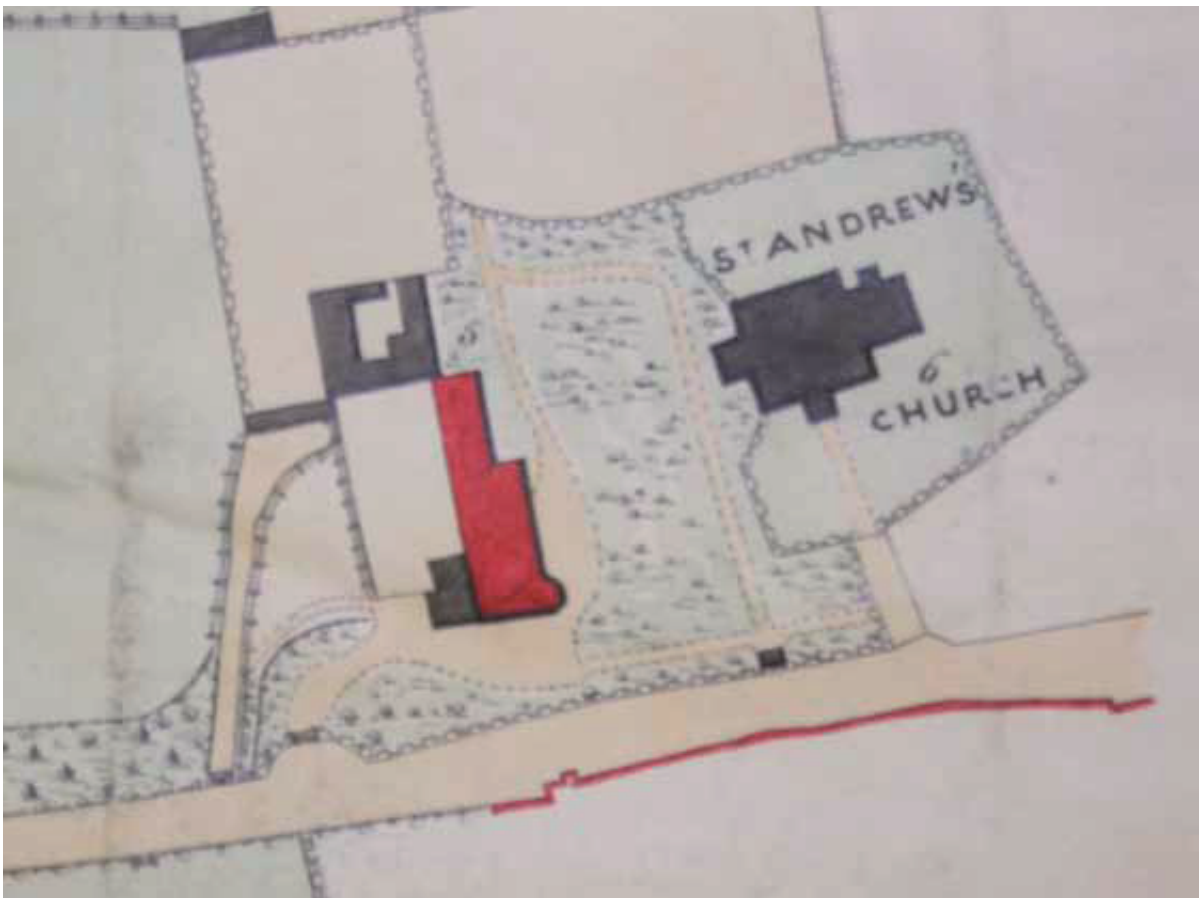
Plate 2: Plan of the rectory in 1853.

- 3.6 A Glebe Terrier map of 1853 depicts the rectory, gardens and adjacent buildings in greater detail than any other map, before or after, confirming that the complex had indeed reached its greatest plan-extent by this date and bearing out the 1822 map in detail (Plate 2). A rear range of three sides lies around a courtyard of its own and faces north, away from the rectory. This represents three sides of the former two-sided, L-shaped range seen in the map of 1822. It has thus gained an east range of its own between 1822 and 1853. The fourth, north side was almost infilled.

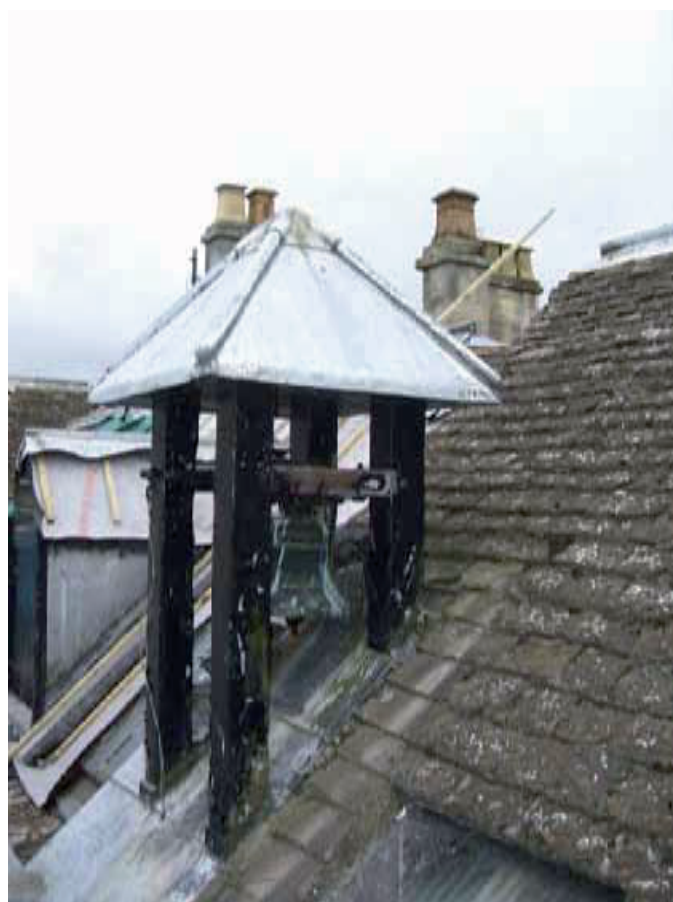
Plate 4: The Sunday-school bell cupola on the roof, 1852.

- 4.1 The main building which comprises the former rectory of Barnwell St Andrew is constructed of local limestone, roughly coursed, with quoins and other angles and most embrasures stressed in ashlar blocks (Plate 3). Chimney stacks are of ashlar limestone blocks too. The roof is of Collyweston-type tile-stones. Hidden in a roof valley is a cupola from which is hung a bell, cast in Oxford in 1852 for calling scholars to Sunday School which was formerly held in the rectory (Plate 4).

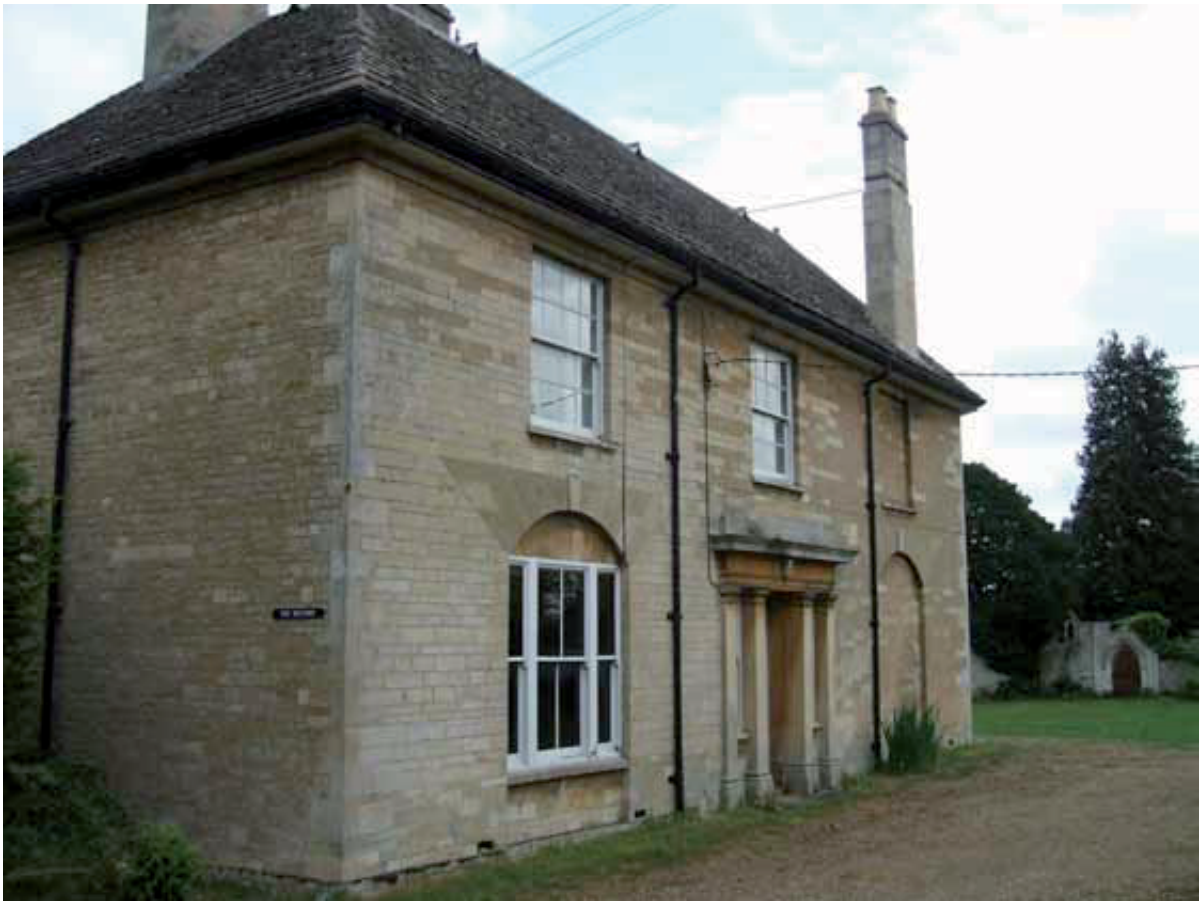
Plate 5: The south, entrance façade.

- 4.2 The main entrance to the building is on the south side and is flanked by plain, rather severe pilasters supporting an equally restrained entablature (Plate 5). This aspect was once symmetrical about the entrance but has been unbalanced by the blocking of two windows east of the entrance (of which more below). The long axis of the building has distinct differences in its east and west elevations, pertaining to the relative importance of the two aspects. To the east is the principal aspect which faces the church and the churchyard. Up until at least 1853 the churchyard could be seen directly from this side of the rectory, after which the current folly was created of architectural fragments reputedly from the demolished All Saints Church, Barnwell (Plate 6). Facing the church and the rectory's manicured gardens, this eastern side related to the rector, his family and parish guests. To the west, by contrast, is a far more cluttered, service aspect (Plate 7). The following walk through the historic building follows:

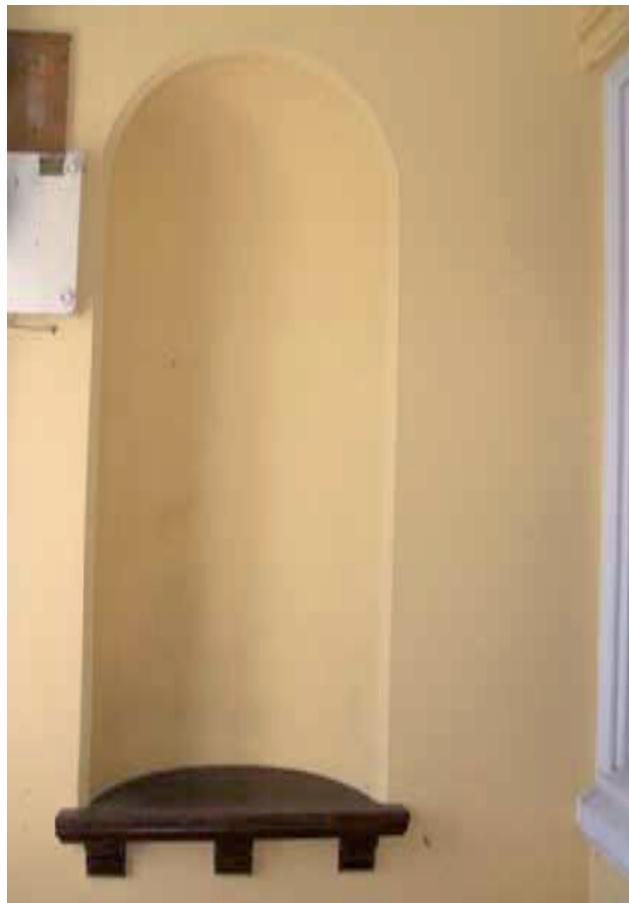
Plate 11: Statue-niche in porch.

- 5.1 The entrance **Hallway** is the crossroads of the house and leads off into the reception and entertaining rooms (to the right), the rector's private rooms (to the left), and the service-range (directly ahead), with the stairs to the first floor adjacent to the last of these (Plate 8). The hallway is floored in very late Victorian (c1890-1901) or Edwardian (1901-10) tiles, laid in geometric patterns (Plate 9). The skirting and door-cases throughout this first part of the house are felt to be of a suite and it is probable that they were put in when the house had reached its current layout. Part-glazed double doors have partitioned off the immediate entrance area to create an internal **Porch** from which the servants' attention could be sought via a bell-pull set into the eastern wall (Plate 10). A large niche is set into the west wall, in which a statue (probably of Christ or possibly of St Andrew) once probably stood (Plate 11).

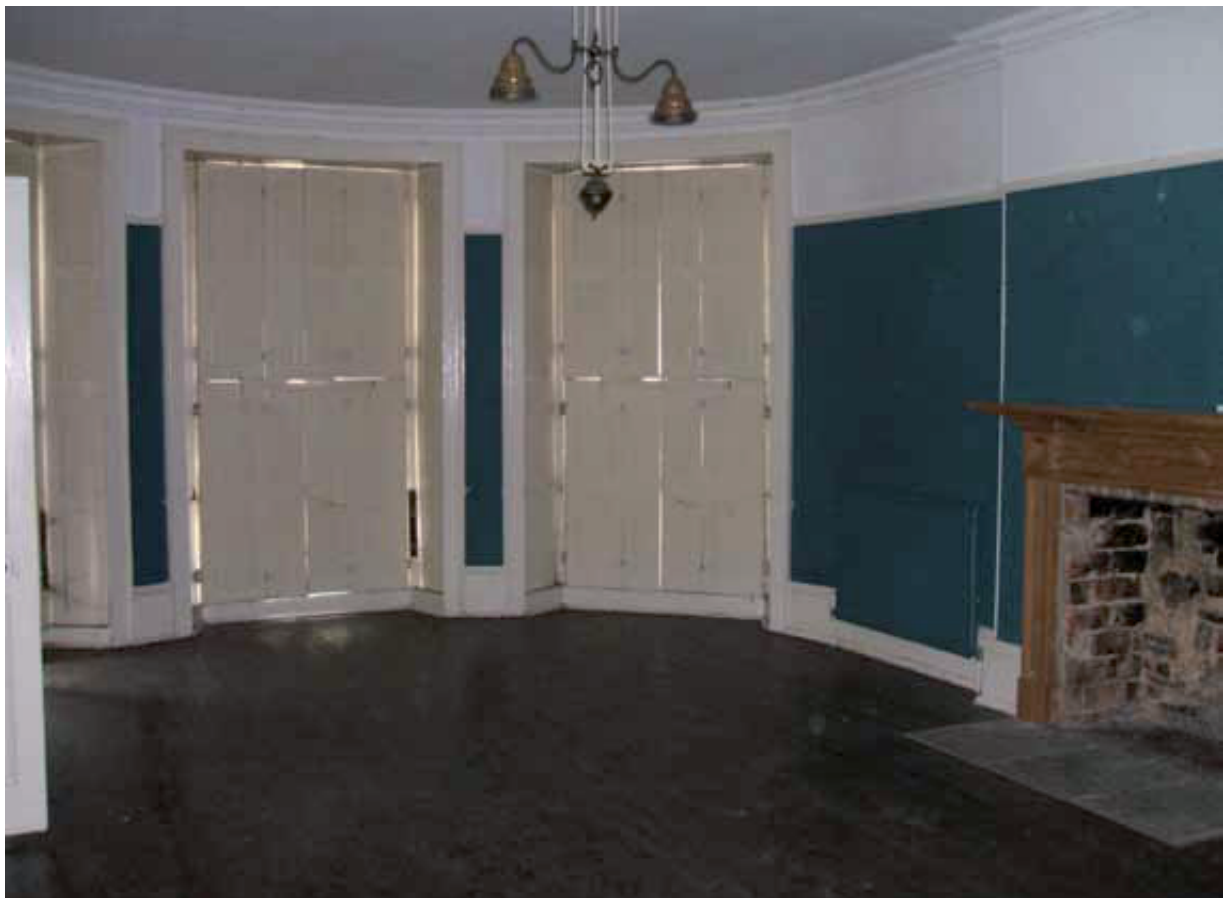
Plate 12: The drawing room, looking towards the apse, shutters closed.

- 5.2 To the right of the hallway lie the two principal reception rooms. The first (southerly) is the **Drawing Room**, dominated by its faceted apse overlooking the garden. Although already present on the map of 1822 (but best seen on the 1853 map), its layout is not original, since the fireplace and chimney breast above in the south wall is inserted, necessitating the blocking of the two window embrasures seen to the right of the entrance in the southern façade (Plate 12). Each full-height sash window in the facets of the apse can be closed off by a set of shutters, but it is felt that whole fenestration in this room is a

replacement for sets of French windows, raised doorsteps for each of which still lie on the ground just outside the embrasure. All of the sashes are horned, suggesting their insertion took place no earlier than c1850. The floor of this room, taken up in the current works, had been replaced in recent times, the under-floor void having been made good in cement/concrete.

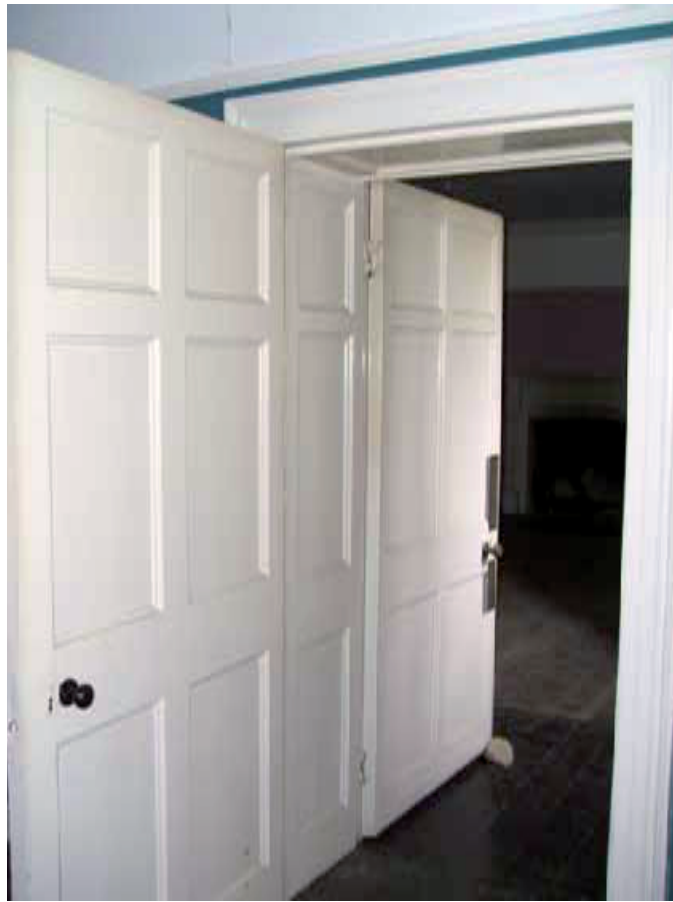
Plate 13: Double doors for privacy from Dining Room to Drawing Room.

- 5.3 Linked to the Drawing Room and on its north side is the **Dining Room**, which sports a handsome marble fireplace at one end. The link between the two rooms is via a distinctive double door on a single frame, a manner of achieving privacy, common at (in particular) the older Oxbridge colleges (Plate 13). If both doors were closed, the occupant of the inner room wished not to be disturbed under any circumstances; however, if only the inner door was closed, the room was occupied but the occupant might still be disturbed.

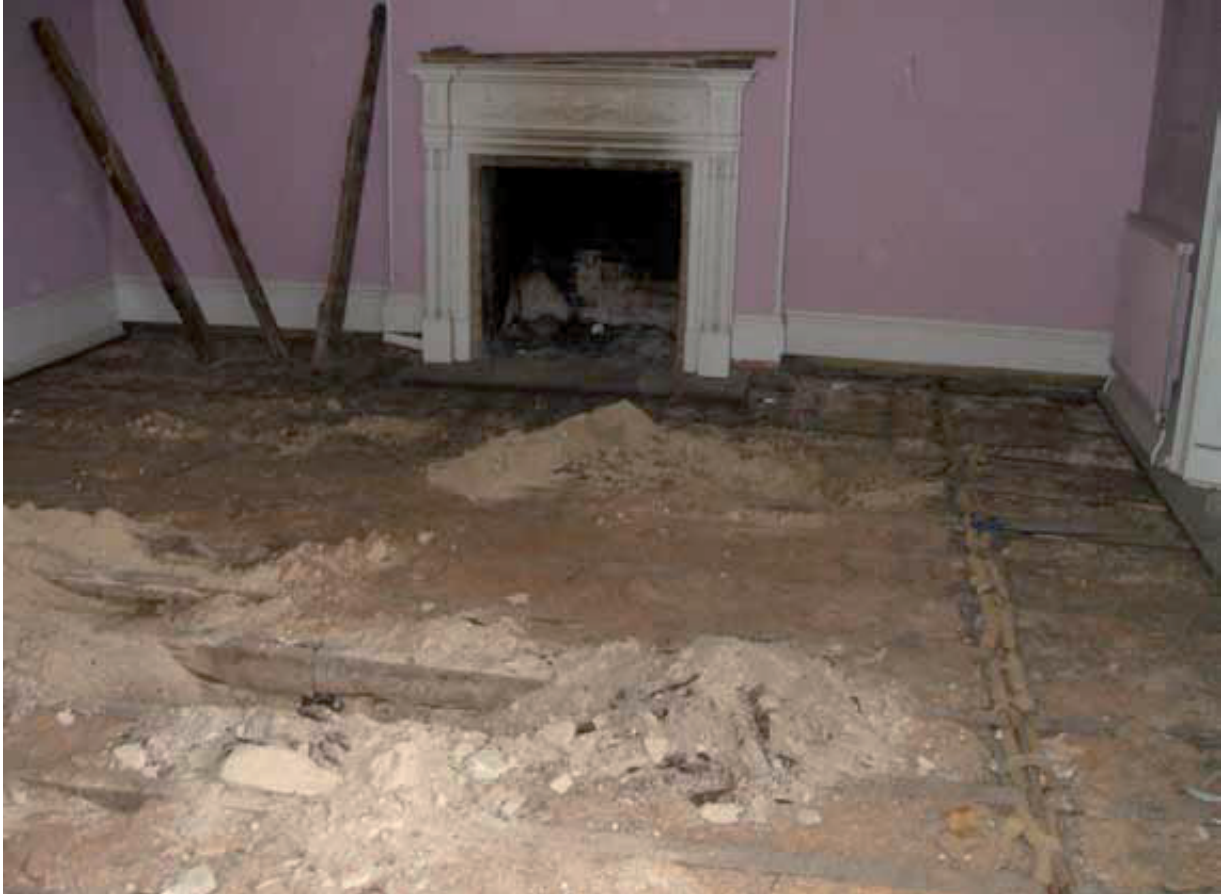
Plate 14: The exposed sub-floor of the dining room.

Adjacent to the linking door stands a shallow arched alcove, probably once used to display china or silver. On the other side of this is a cupboard, its presence creating symmetry in the wall elevation. The room is lit entirely from the east side by two, full-height sash windows with shutters, while the west side contains the direct doorway from the hall and two blocked entrance-ways into the former servery, most recently part of the kitchen and only recognised by the continuance of a former ceiling cornice across half of that former area. Evidence for the base of the two blockings comprised bricks visible below the skirting board, which had itself had new pieces let into it. The floorboards of this room were taken up to reveal an early sub-floor (Plate 14). This comprised (in common with the drawing room) oak joists 12” apart, supported on beams or brick sleepers, but in this room having the inter-joist spaces packed out with dry sandy soil and fragments of limestone. A low level of damp in this material had caused the supporting beams to begin to rot. This space was emptied and the joists renewed as appropriate.

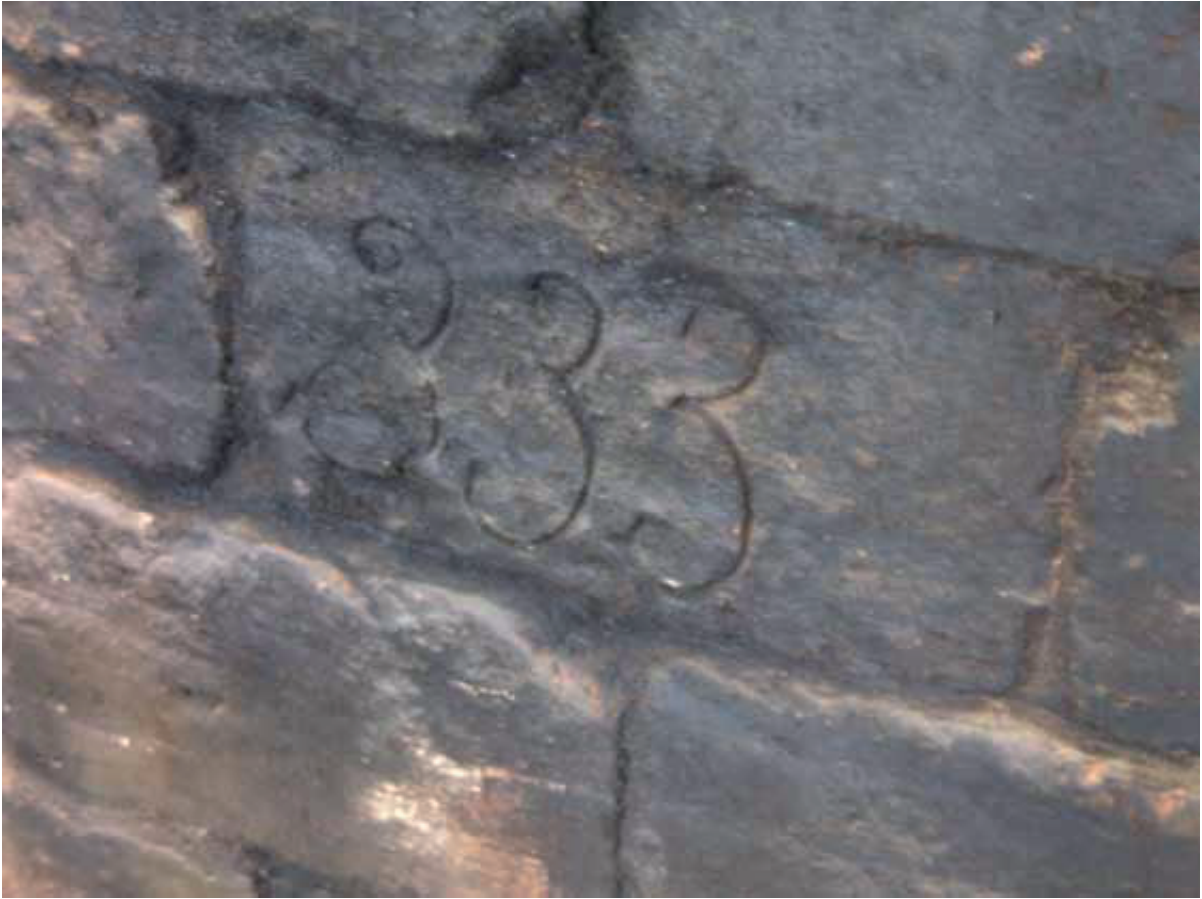
Plate 15: Incised brick in the study fireplace.

- 5.4 To the west of the hallway lies the part of the building used for religious purposes. This comprises the Rector’s **Study** and an adjacent **Chapel**. The study is wood-panelled and has doubled as a library to judge by the bookshelves there. It was once accessed directly from the hall but the former doorway has long since been blocked, the former arched doorway becoming a simple alcove now containing a hall radiator. The replacement doorway was put through around the corner. Once within the Study itself access to the adjacent Chapel was formerly via another arched doorway in the north-west corner, now blocked up. Between these two arched features stands the fireplace, relatively unremarkable but for a single brick in the back of the fireplace. This has been scratched with the number 333, a numerical play on the concept of the Trinity, the mystery of the three-in-one – Father, Son and Holy Spirit (Plate 15). This was marked on the brick before firing, indicating that the brick or bricks were bought especially from the brickyard, not already made.

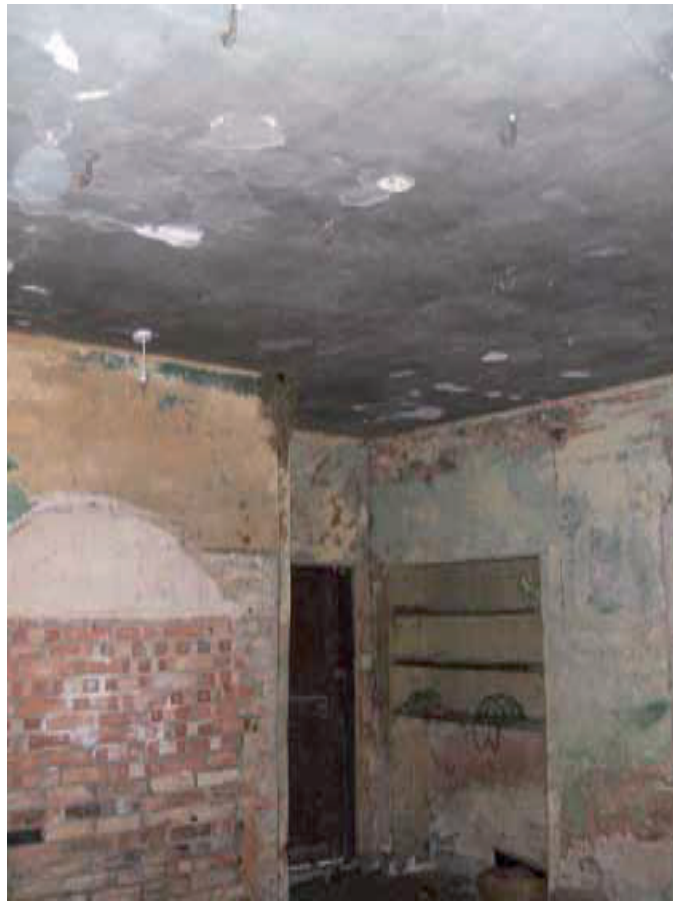
Plate 19: Kitchen annex, note meat hooks in ceiling.

A second **kitchen annexe** lay directly to the north, its fireplace back to back with the main kitchen cooking range. This had been converted into a garage and was otherwise almost devoid of surviving historic features (Plate 19). Further north than this even lay the **servants' kitchen**, which doubled as **laundry** and **brewhouse**. In the north wall lay a central fireplace, flanked by two bases for coppers for heating water (Plate 20). Both had long been removed leaving only the barest traces, as had a sink which once stood below the west-facing window. A related brick-built soak-away survived below the flag-stone floor.

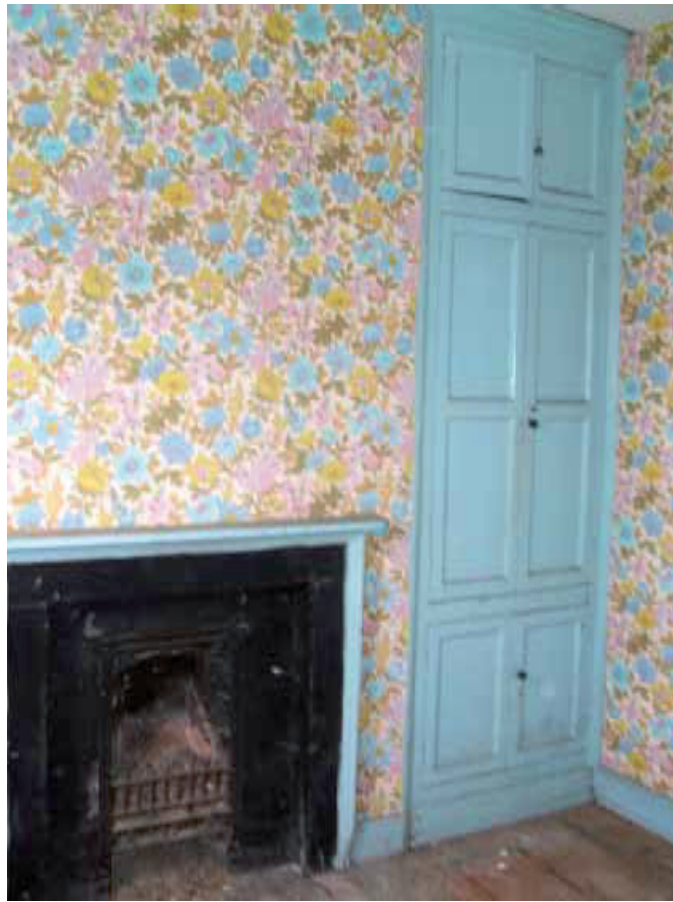
Plate 21: The range in the Cook's pantry.

- 5.7 Opening directly off the main kitchen lay an addition to the range, comprising the **Cook's Pantry** and adjoining **Larder**. Unlike all the other service rooms this did have windows on the east, since no other light source was available; one had been subsequently blocked in the Larder and an exterior door cut through the north wall. Meat-hooks survived in the ceiling of both rooms, while the pantry was also provided with a sturdy range of substantial cupboards, drawers and a small cooking range for the cook herself (Plate 21). The windows were also provided with shutters. The whole surviving ensemble dated to c1900. When all this was stripped out it could be seen that the whole building had been added to the outside of the dining room north wall and the kitchen east wall, both of which were clearly exterior faces beneath the plaster. The small cook's fireplace had been chopped into the back of the dining room fireplace and added to the thickness of that stone wall in brick (Plate 22). Reduction of the floor level produced pottery of nineteenth-century date but showed also that the rooms had been built directly into the topsoil, which was over 30cm deep below the floor. Map evidence shows that this block of rooms existed by 1822.

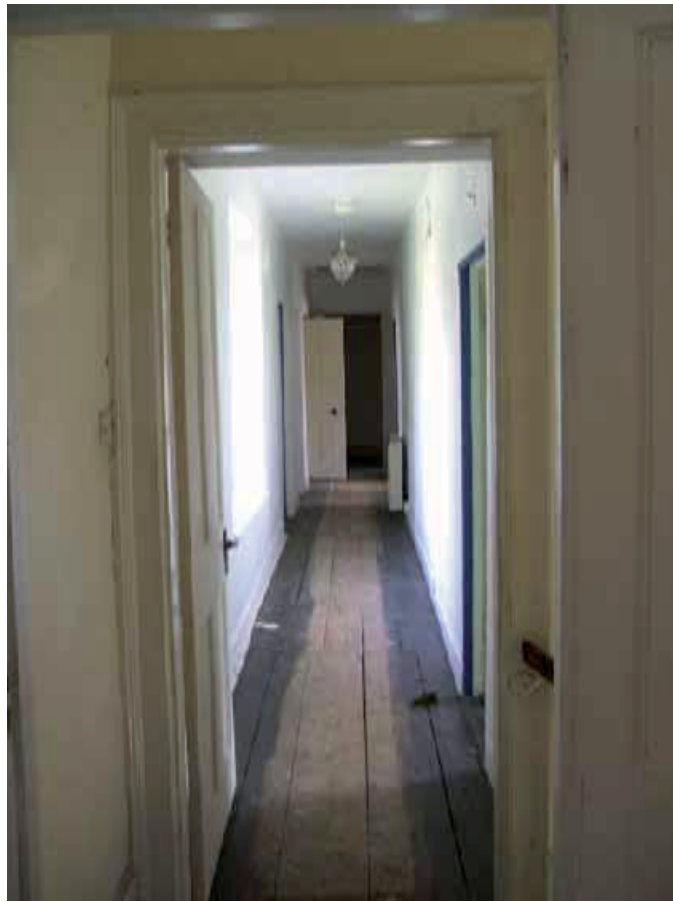
Plate 23: The first floor service corridor.

The servants' bathroom/washroom lay behind the former stairs (F10) while a long corridor stretched (and still stretches) north (F11; Plate 23). Off this corridor lay a row of bedrooms. To the right probably lay the **Cook's** and the **Housemaid's bedrooms** (F12; Plate 24, and F13). The latter was unheated. They face east so as to catch the earliest morning light as both had to be up at dawn, one to prepare breakfast, the other to light the fires in the grates. It is telling that, uniquely amongst all the bedrooms, neither of the east-facing windows to these bedrooms possessed shutters, facilitating the unique need for an early morning call.

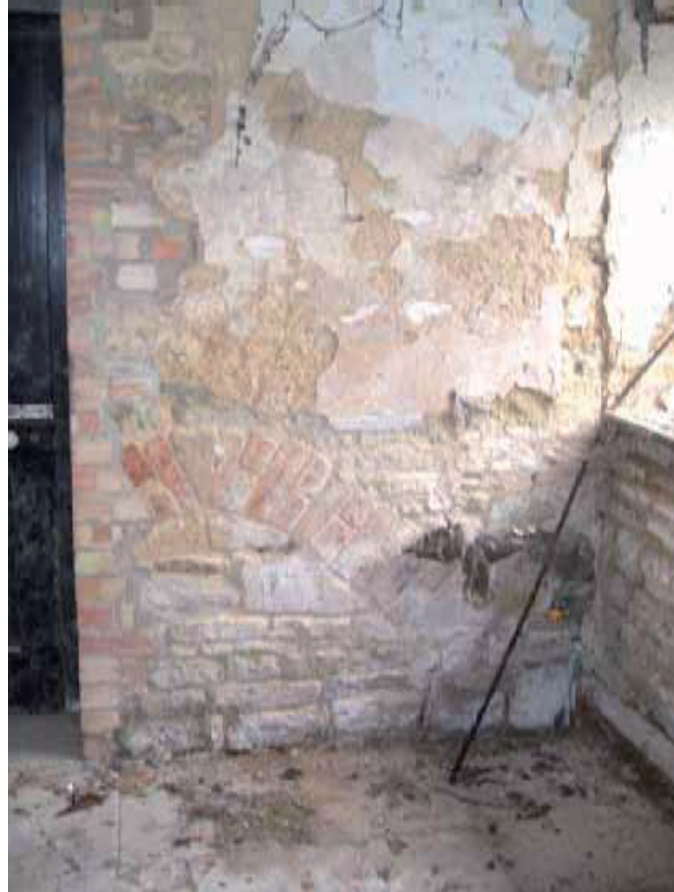
Plate 26: North annexe, brick arch low in east wall (N1).

- 7.2 Room N1 can be accessed both from the service yard and the former Rectory garden. It is part of a limestone building floored in limestone cobbles but is separate from the other surviving rooms in the row. A low brick arch, now blocked, once also connected through to the garden at the foot of the east wall (Plate 26). Its purpose is unknown. The rear (north) wall contains two tall brick-built arches, subsequently blocked in 1940s brick, suggesting a former internal link to a now lost north-east range, seen on the 1853 plan (Plate 27).

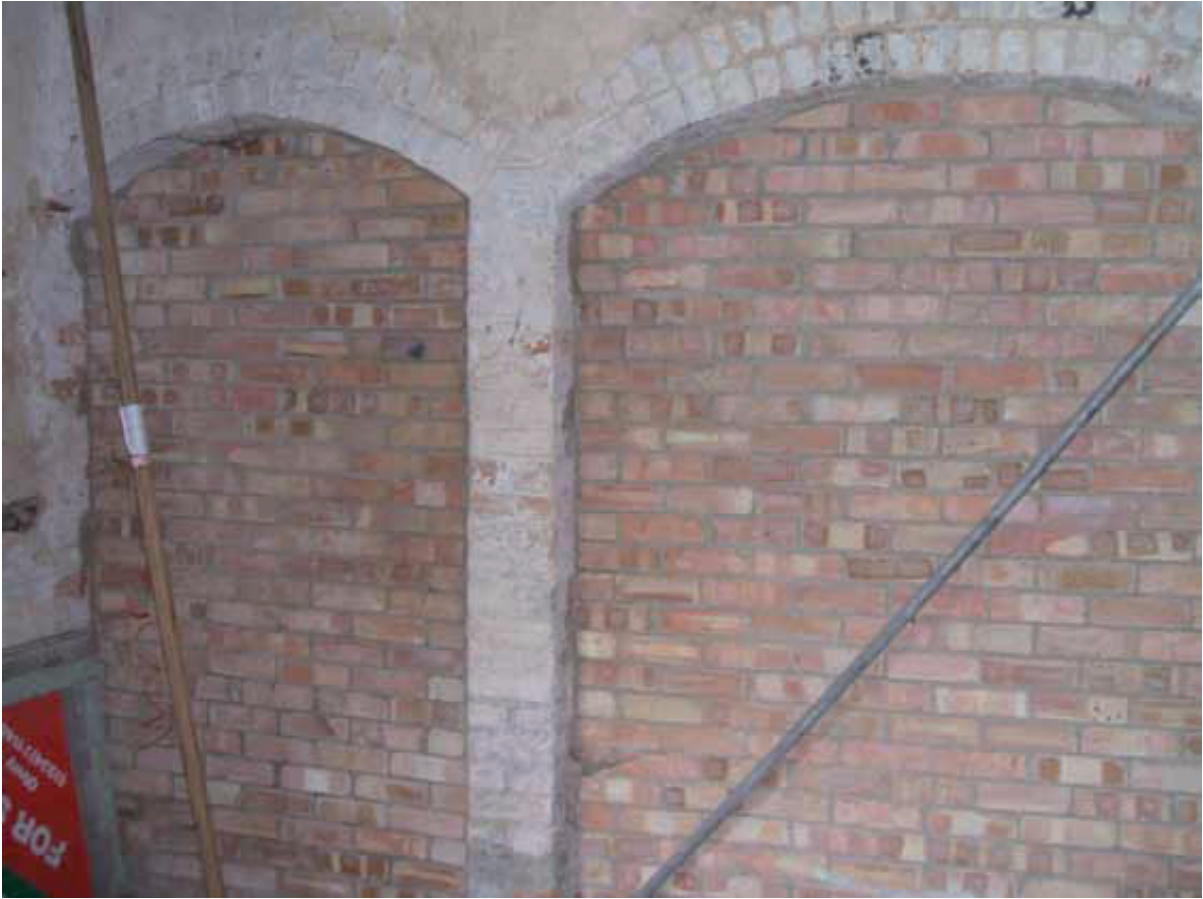
Plate 27: North annexe, blocked arcade in north wall (N1).

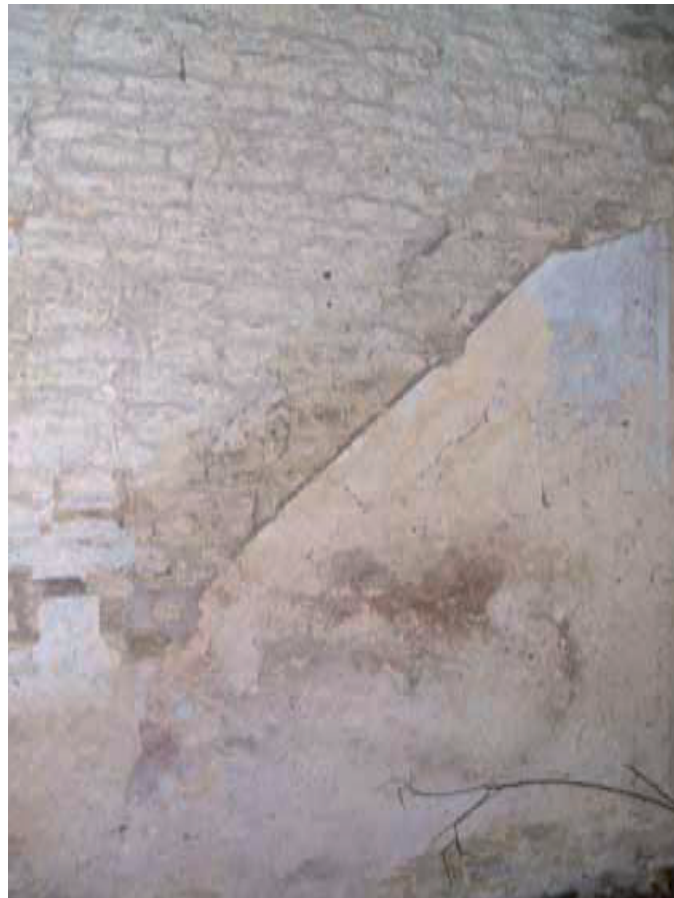
Plate 28: North annexe, scar of former cottage stair (N2).

- 7.3 Next door lie the conjoined rooms N2 and N3. In the former are remnants which indicate the range was once of two storeys: in the west wall of Room N2 lies the scar of a former staircase (Plate 28), while at the top of the dividing wall is the 1940s brick which was laid to create the current single fall roof as an addition to the building (Plate 29). In the back wall lie blocked embrasures of a door and window which indicate the buildings were formerly of a cottage-scale and use. The adjacent room N3 contains slate benches common in a nineteenth-century larder (Plate 30).

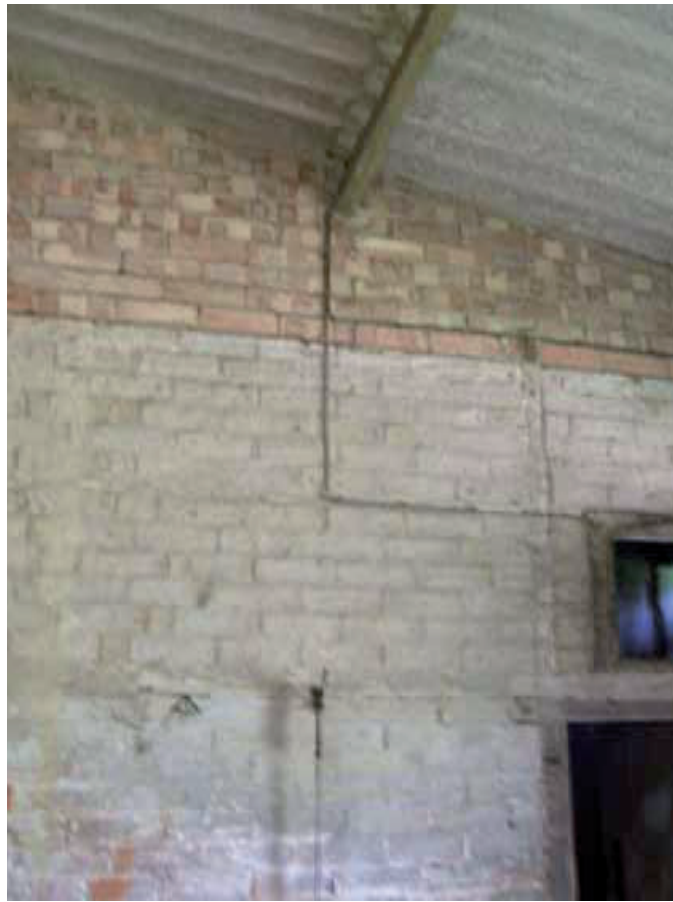
Plate 29: North annexe, brick lift to add current roof to reduced cottage (N2/3).

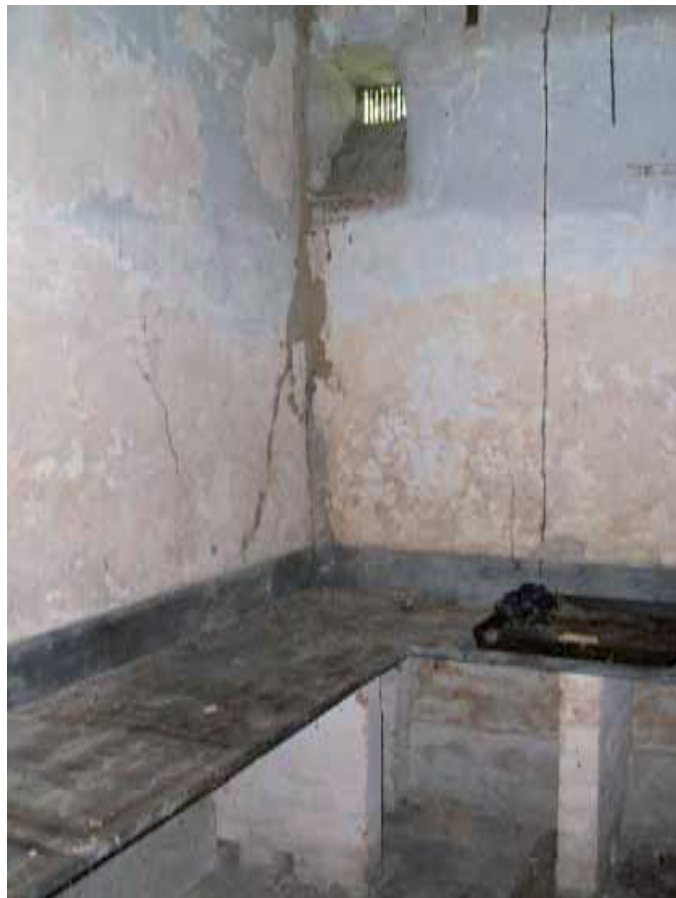
Plate 30: North annexe, slate benches in former larder (N3)
