# Northamptonshire Archaeology

Second phase geophysical survey and trial  
trenching on the site of Bentley Hall,  
off Queen Elizabeth Avenue, Walsall  
September - October 2007

Report 07/187

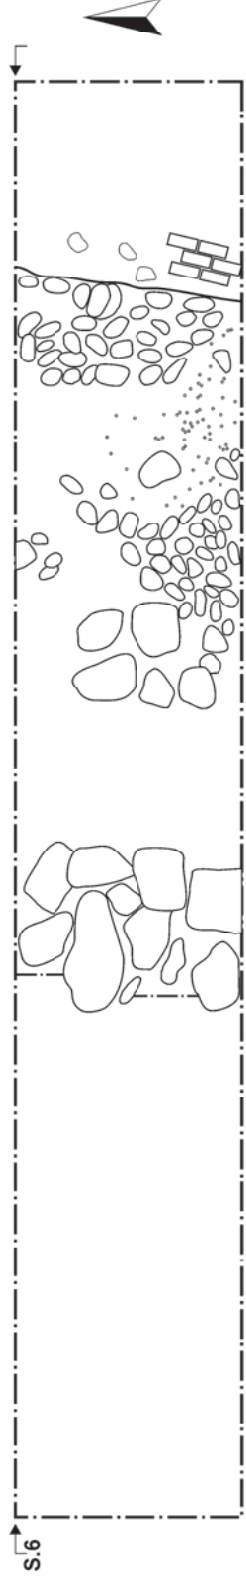
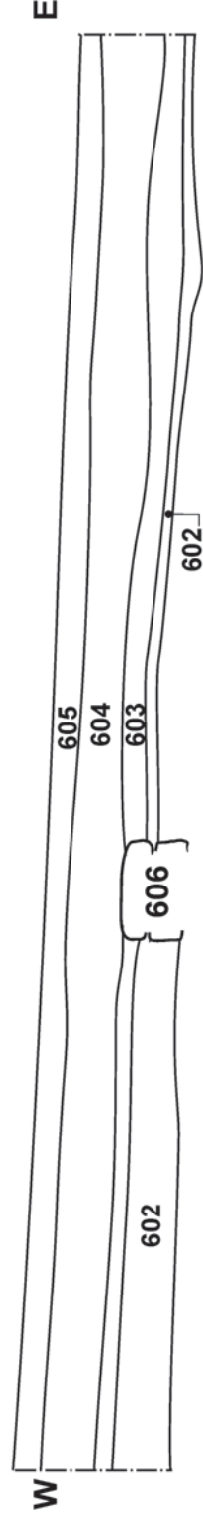
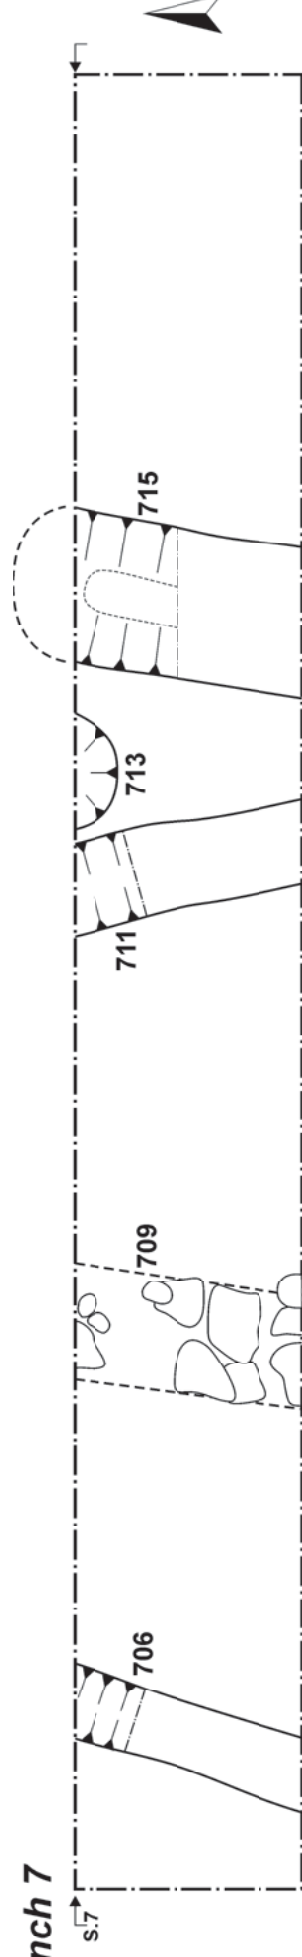
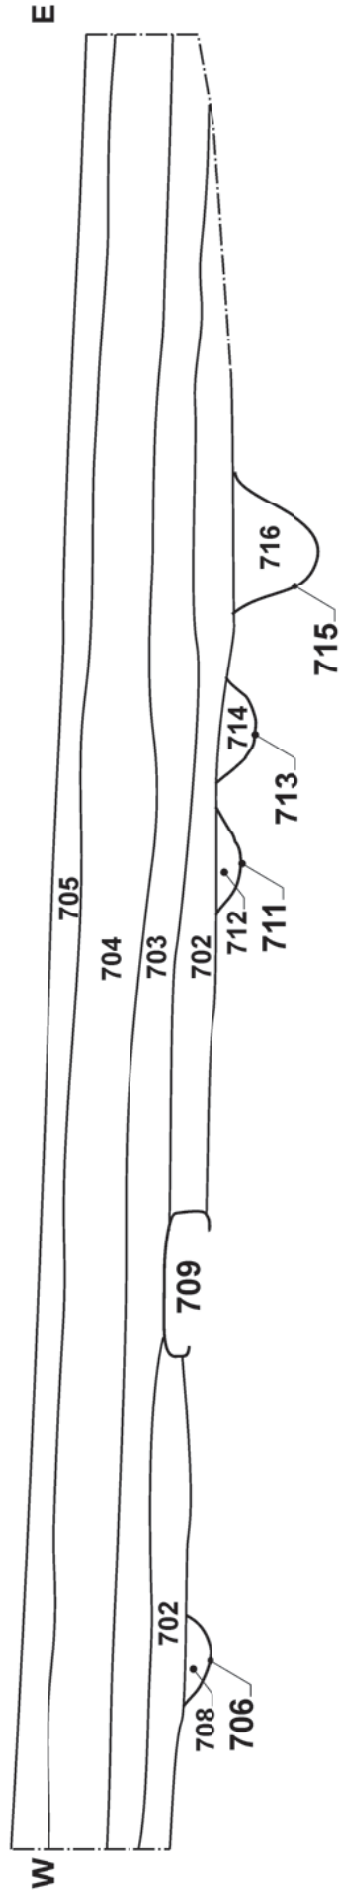
**Trench 6**

**Section 6 - Trench 6**

**Trench 7**

**Section 7 - Trench 7**

At the east of Trench 6, a construction trench [606] 0.7m wide and 0.45m deep was aligned across the trench from north to south. It contained a foundation (607) of angular stone blocks bonded with coarse gritty white lime mortar. Impressions in the upper mortar layer indicate it had supported a brick wall built of bricks measuring 8<sup>3</sup>/<sub>4</sub>"-9" x 4<sup>1</sup>/<sub>4</sub>" x 2<sup>1</sup>/<sub>4</sub>" and laid head to head forming a wall 18" wide (Fig 8 and 10). These are of similar size to the Jacobean bricks observed in Trench 5.

To the east was a foundation trench [709] 0.8m wide, cut up to 0.6m deep and aligned north-south across the trench (Fig 8 and 10, Plate 11). It had vertical sides and contained a foundation wall (710) made up of irregular chunks of sandstone and dolerite stone bonded with yellow/white lime mortar. The foundation included fragments of broken brick from bricks measuring 8<sup>3</sup>/<sub>4</sub>"-9" x 4<sup>1</sup>/<sub>4</sub>" x 2". The upper surface was badly disturbed and no evidence of the superstructure survived. The bricks incorporated into the stone foundation appear similar to the Jacobean bricks noted in the continuation of this feature in Trenches 5 and 6.

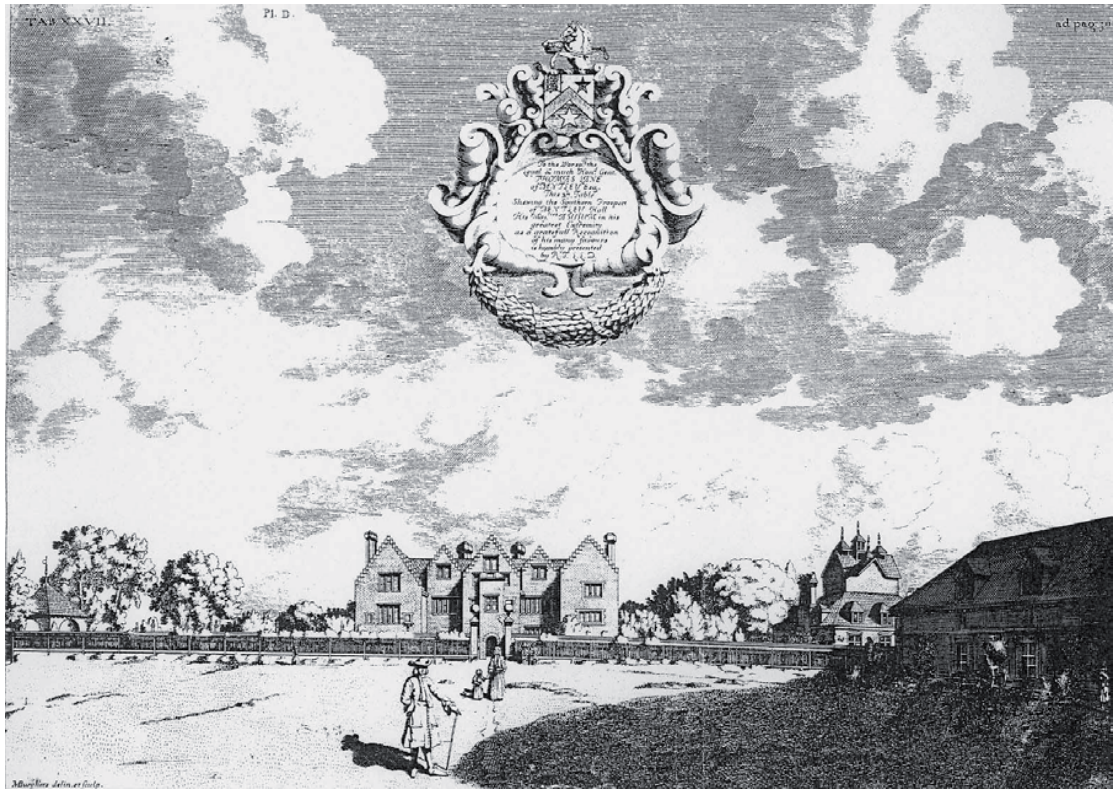
Plate 1: Engraving of Bentley Hall published in Robert Plot's Natural History of Staffordshire (1686)

This early hall was replaced in the early 17th century by a substantial Jacobean residence. The hall is shown in an engraving of 1682 published in Robert Plot's *Natural History of Staffordshire*, 1686 (Plate 1) .

The hall appears to be a fairly typical Jacobean Mansion house with five bays and three storeys. To its west is a small summer house and to the east a most peculiar and elaborate building, possibly a stables (see below) but with chimneys and windows suggesting that it had some residential function. In the foreground to the right is a long low building with dormer windows which may be a terrace of cottages for estate workers.

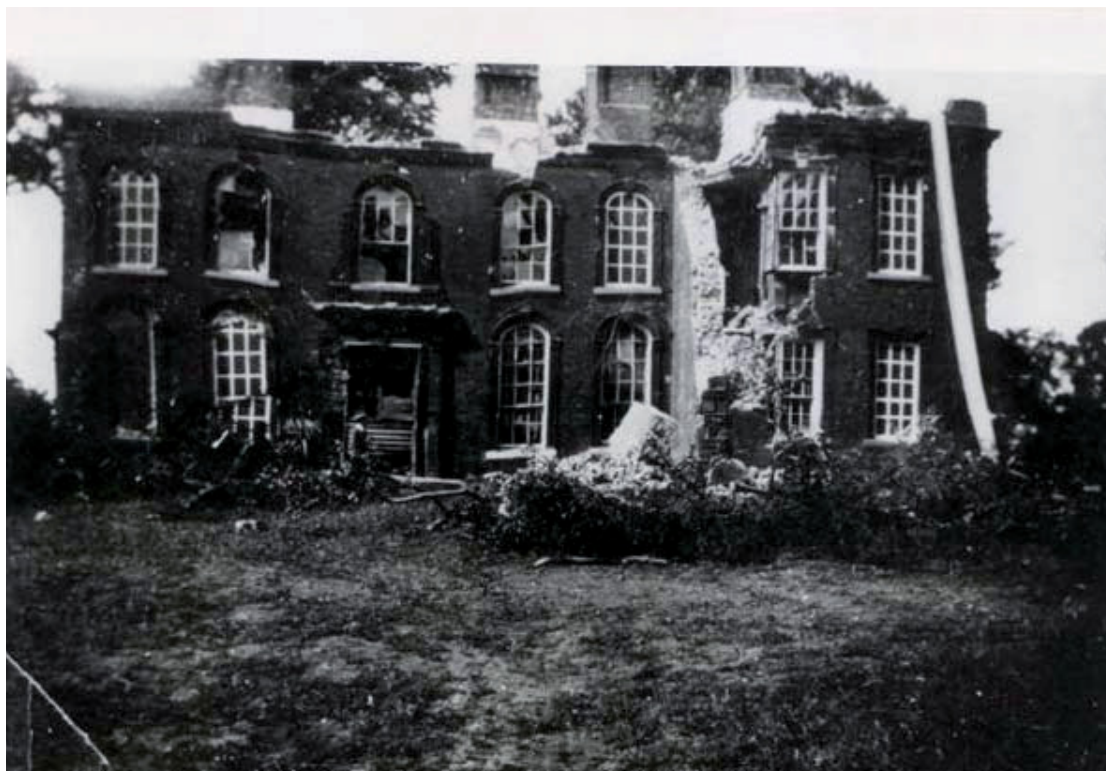
Plate 5: Bentley Hall demolition 1929  
*(from a photo supplied by Sally Birch)*

The proximity of the shaft and workings caused the partial collapse of the main house in 1926 and by 1929, the building was in such poor condition that it was demolished (Plate 5). The coal workings were no longer viable and the remaining buildings were levelled by the Walsall local authority at the same time.

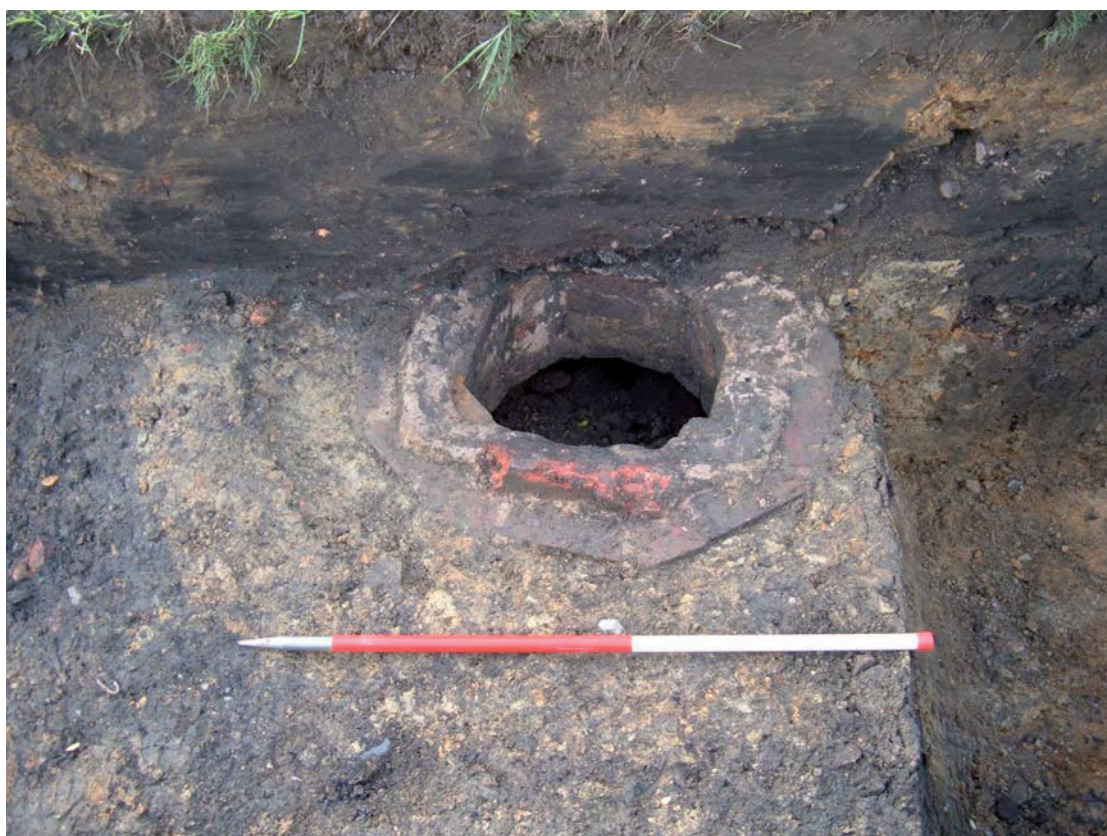
Plate 6: Trench 4 – brick lined well (407)

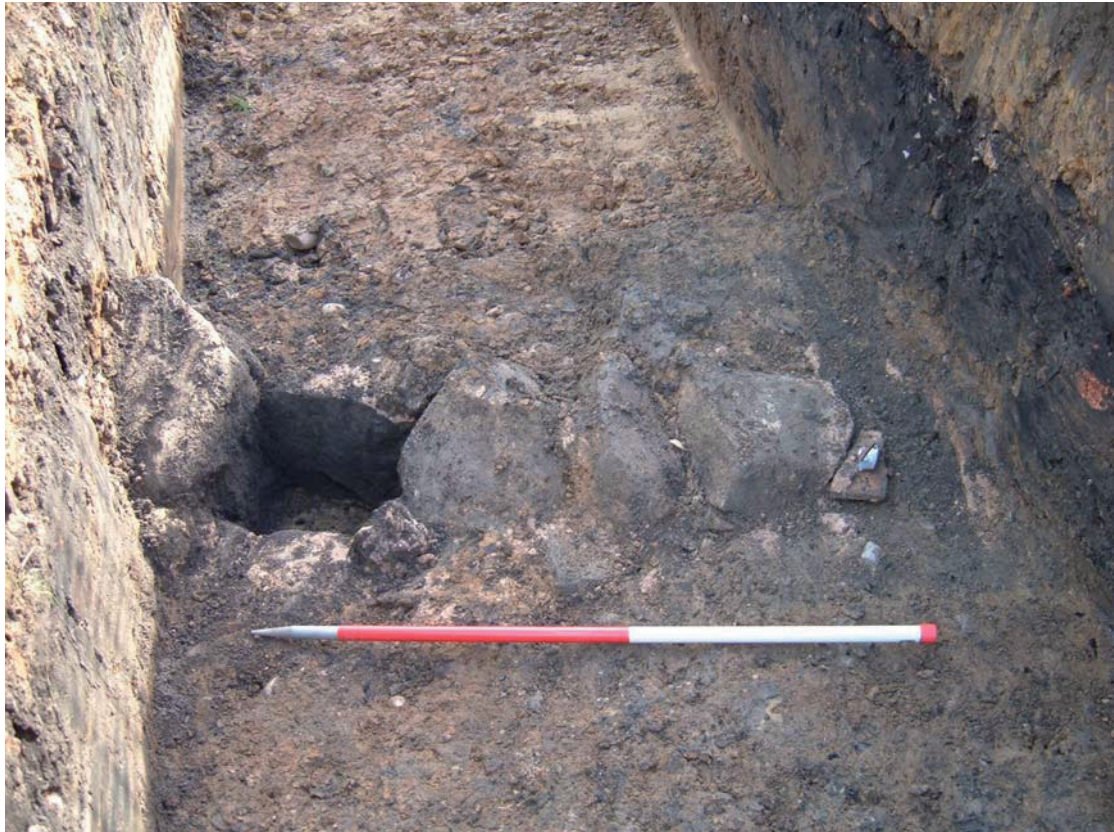
Plate 7: Trench 4 - stone lined drain (410)

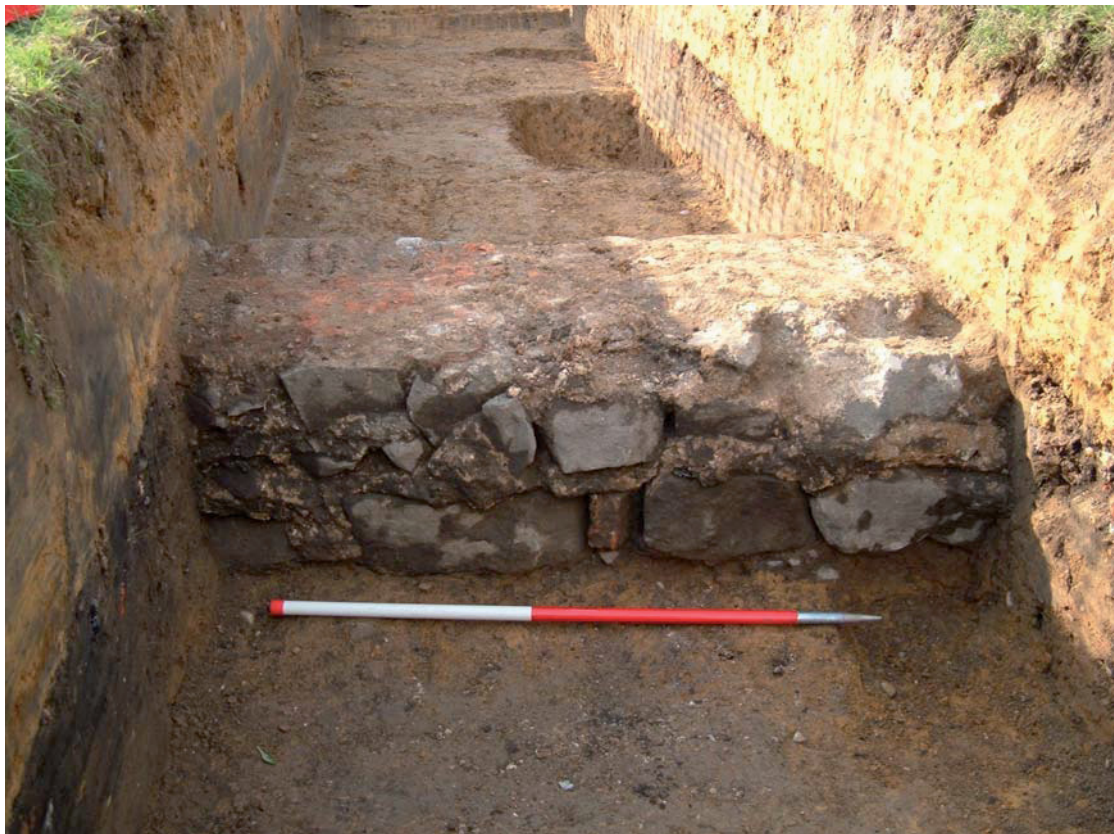
Plate 8: Trench 5 – Wall foundation (511)

About 2m further east, foundation trench [512] 0.8m wide and cut up to 0.6m deep was aligned north-south across the trench (Fig 8-9, Plate 8). It had vertical sides and contained a foundation wall (511) made up of irregular chunks of sandstone and dolerite bonded with yellow/white lime mortar. The foundation included fragments of broken brick measuring up to 8<sup>3</sup>/<sub>4</sub>"-9" x 4<sup>1</sup>/<sub>4</sub>" x 2". The foundation formed a flat surface on which was laid a red brick wall (510). Only part of a single course of brickwork survived. The bricks were laid on edge, aligned with each side of the wall, with a single brick stretcher in between the two, this formed a wall base two and a half bricks wide (0.6m). The bricks measured 8<sup>3</sup>/<sub>4</sub>"-9<sup>1</sup>/<sub>2</sub>" x 4<sup>1</sup>/<sub>4</sub>" x 2<sup>1</sup>/<sub>4</sub>-2<sup>1</sup>/<sub>2</sub>" and were bonded with hard white mortar. They are probably Jacobean based on the size and distinctive diagonal skintlings and made prior to the 18<sup>th</sup> century.

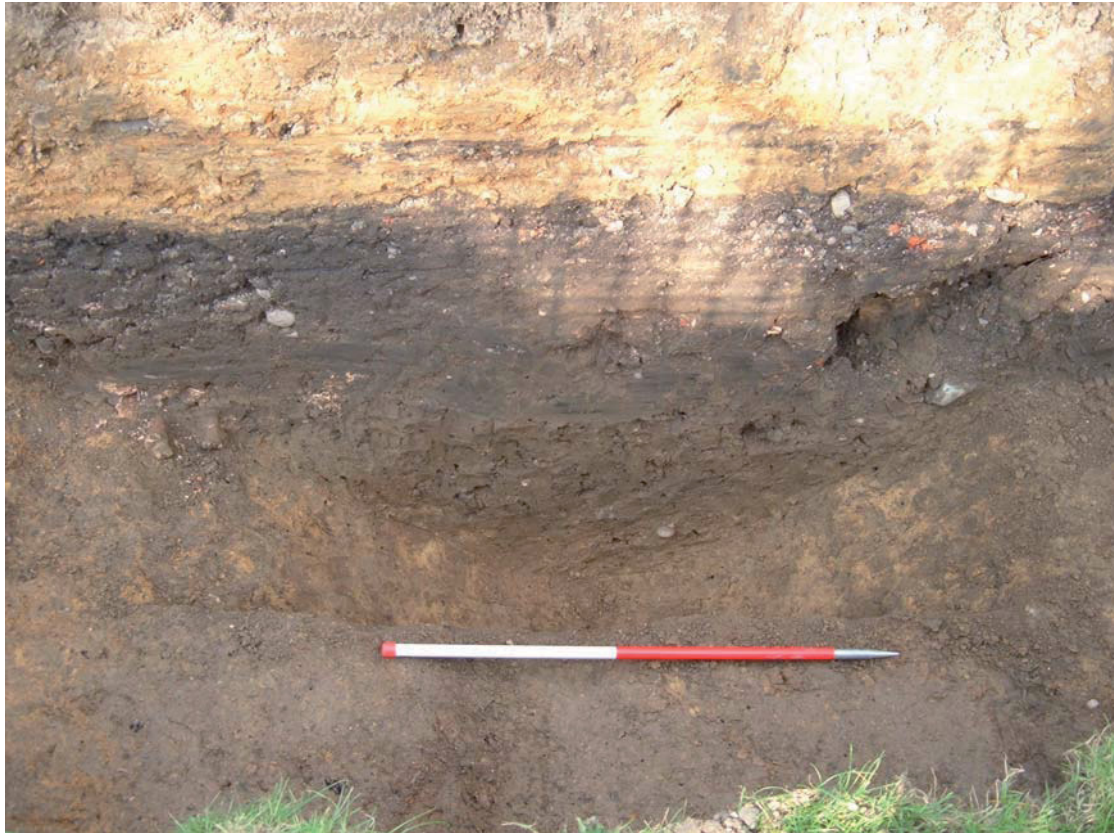
Plate 9: Trench 5 – ditch [515] with pit [513] to the west (left)

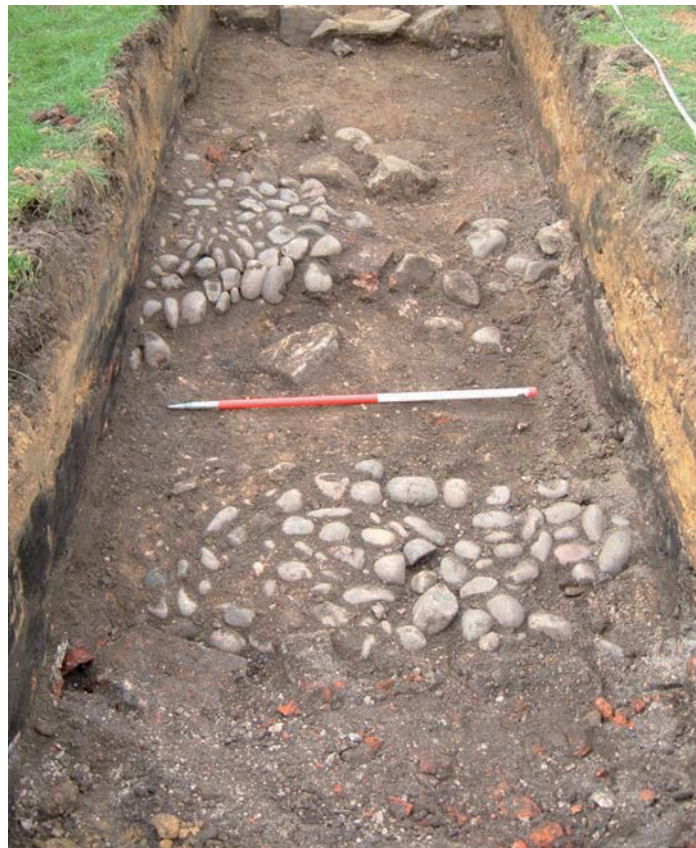
Plate 10: Trench 6 – cobble surface (608) foundation wall (607) to west

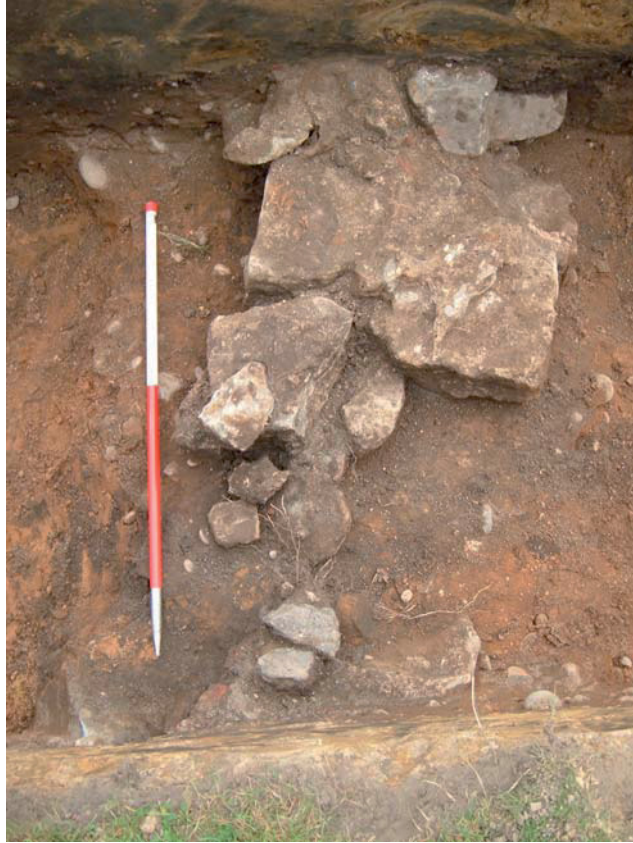
Plate 11: Trench 7 – foundation wall [709]

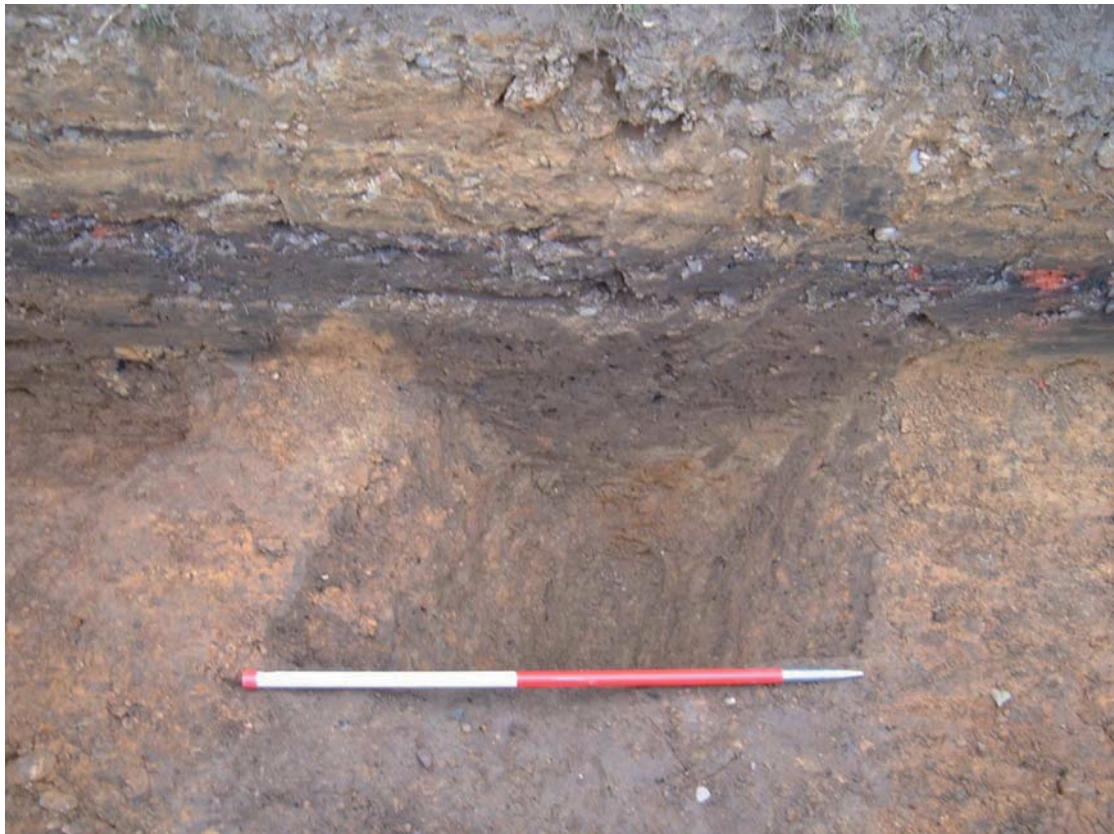
Plate 12: Trench 7 – ditch [715]

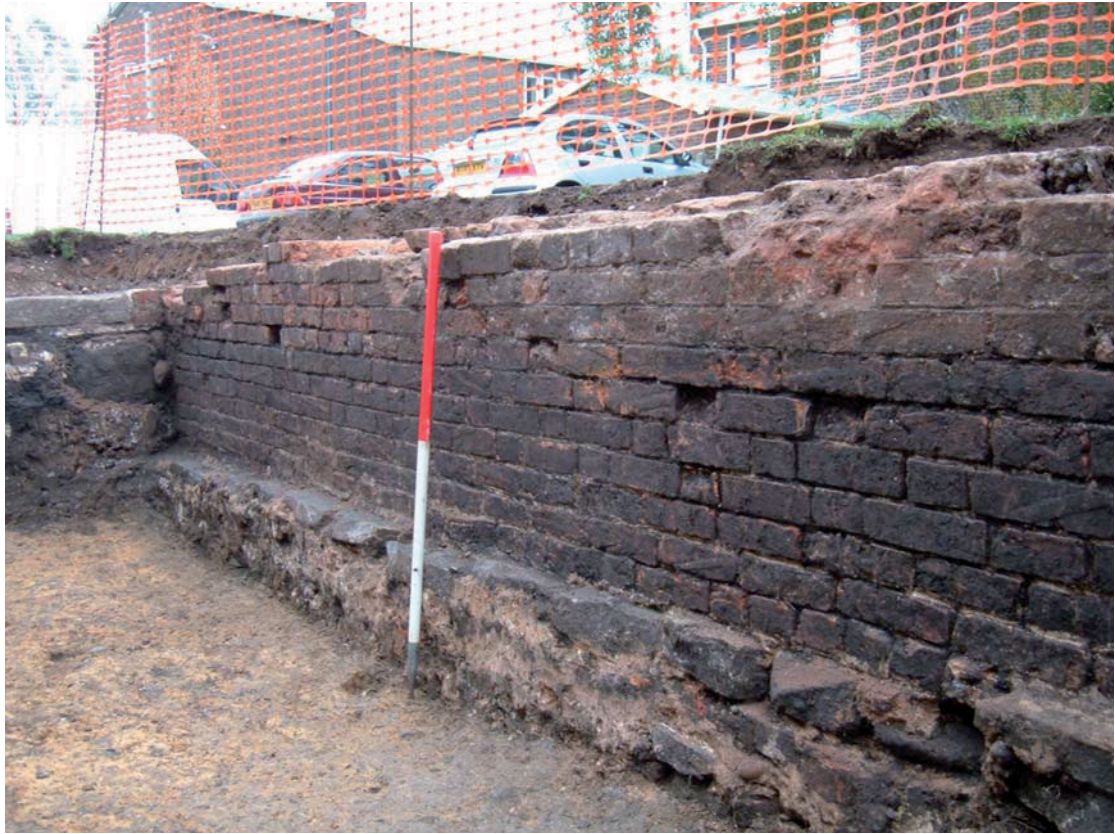
Plate13: Trench 8 – wall (803) on foundation (805)

In Trench 8, a linear ditch or trench [810] aligned roughly north-south, cut the natural up to 0.25m deep (Fig 8 and 11). It was filled orange-brown sand and clay (809) containing three pieces of unabraded medieval pottery. Set into this fill was a foundation of yellow-white lime mortar and cut blue basalt/dolerite stone blocks (805) measuring up to 0.4m long, 0.2m thick and supporting a red brick wall (803).

The bricks were all hard fired brick measuring 8¾"-9" x 4¼" x 2¼". Most displayed diagonal skintlings which are generally thought to indicate a pre 1780 date of manufacture (Norfolk Landscape Archaeology, unpublished data). The bricks were laid as a foundation layer of headers followed by two courses of stretchers. These were followed by three courses of Flemish bond and topped by further courses of stretcher bond.

The lowest four-five courses of brickwork were stained and discoloured from lengthy contact with the soil and much of the lime mortar had leached away. The upper courses all showed evidence of weathering but retained the original mortar. It is probable that the lower courses represent the foundation layers of the wall up to the original ground level. The demolition debris included both bricks matching the surviving walls and also thicker bricks, 9" x 4½" x 3".

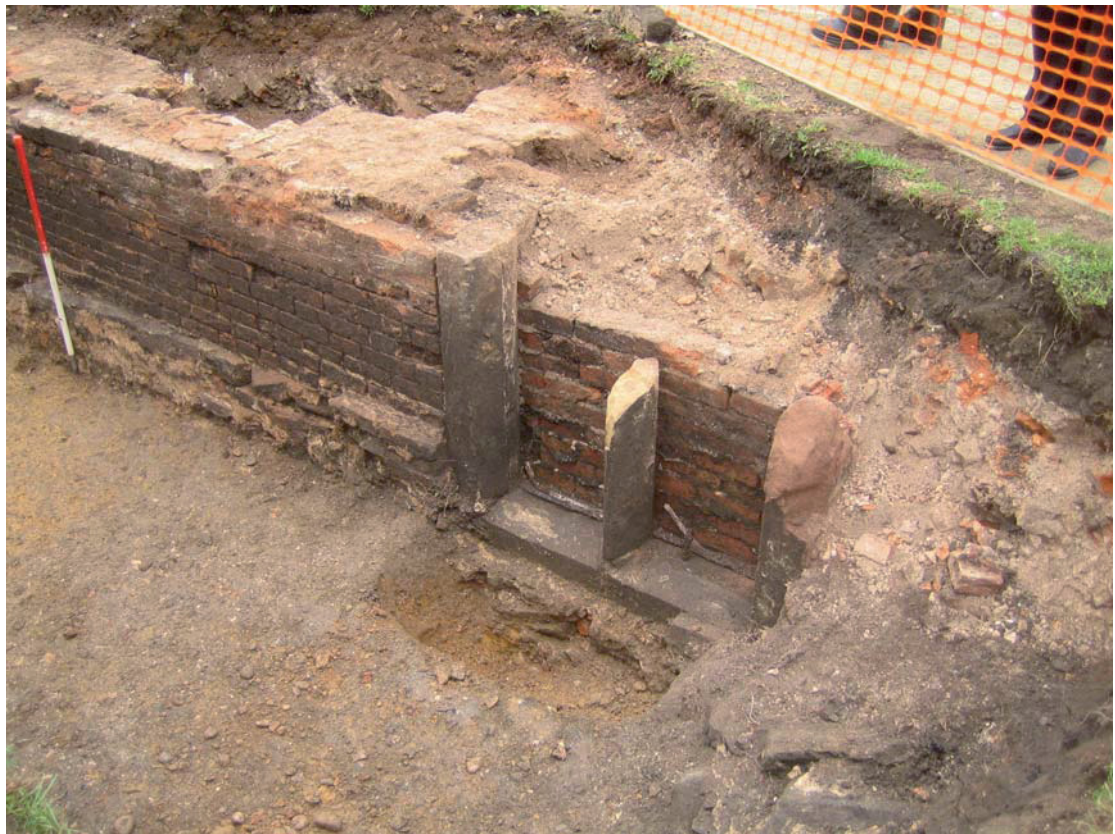
Plate 14: Trench 8 – wall (803), splay of wall (804) and window (807)

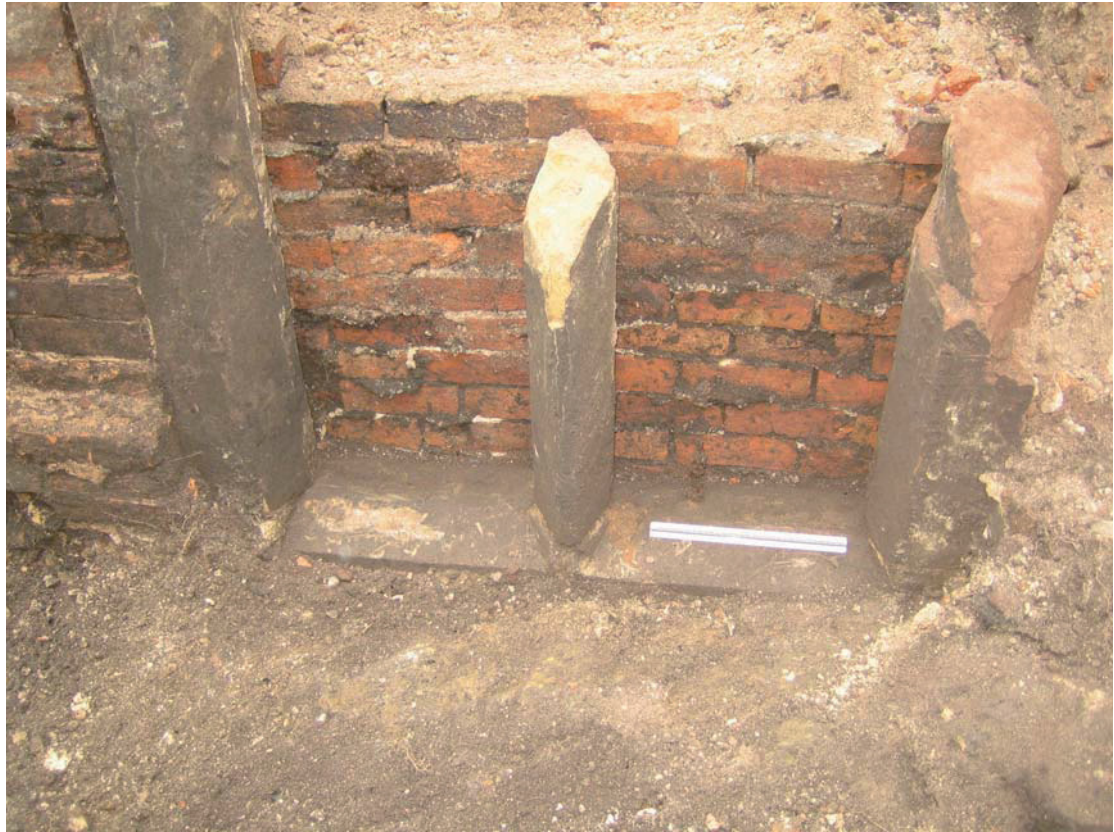
Plate 15: Trench 8 – window (807) detail

The horizontal sill was formed of a single block of sandstone 4'8" (1.29m) long and bedded on a foundation of cut stone similar to the foundation (805) but some 0.3m deeper into the ground. A single socket was cut into sill to the north of the mullion and contained a remnant of a vertical metal bar. This may mark a hinge support for an opening casement.

It is immediately apparent that the yellow sandstone used for the mullion is different from the red sandstone used for the jambs and sill. In addition, the diamond profile of the mullion is smaller than the carved base for the mullion on the sill. It is also clear that the number of glazing bar sockets cut into the jambs and mullion do not match. The obvious inference is that the mullion is a later replacement.

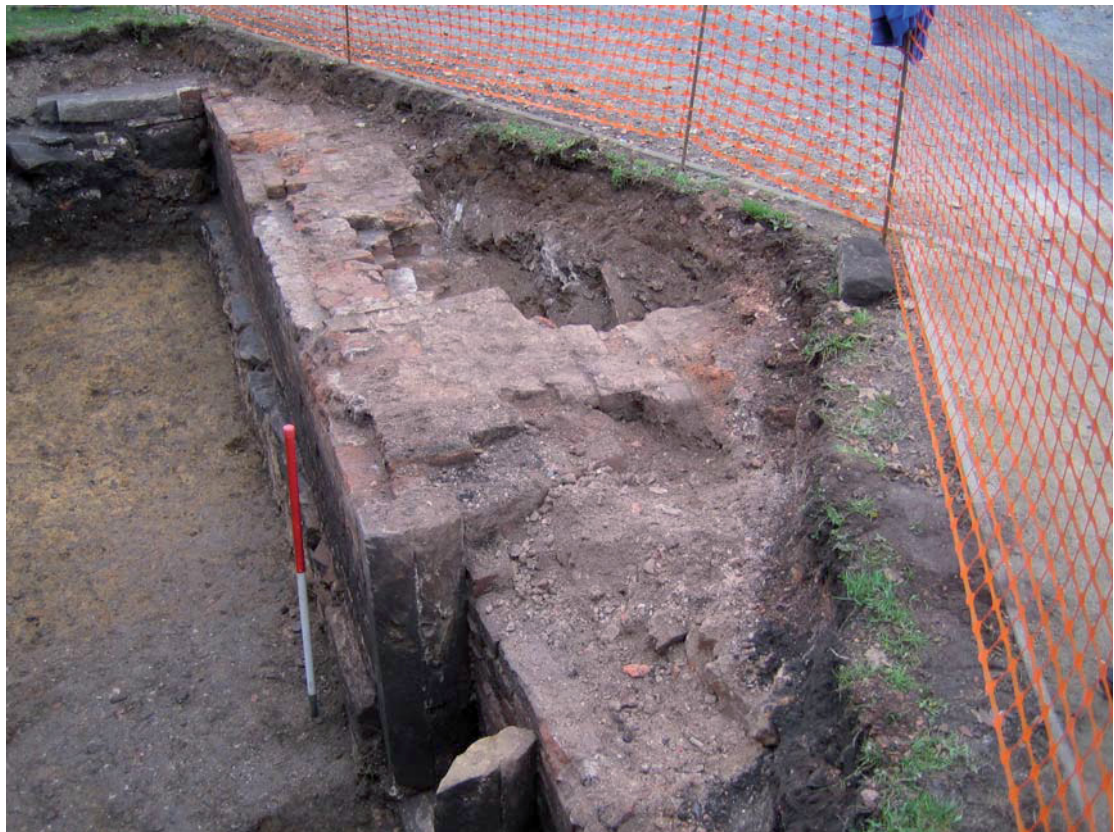
Plate 16: Trench 8 – window, wall and threshold stone (top left of picture)

Located at the south-west of trench 8 and at right angles to wall (803), a cut stone foundation stone (806) was laid on a foundation of stone rubble and mortar just below the modern ground surface. It had a neatly cut square recess on the north-east corner to take a timber gatepost (Plate 16).
