An archaeological watching brief at the  
Market Place, Kettering  
Northamptonshire

August 2008

Report 08/145

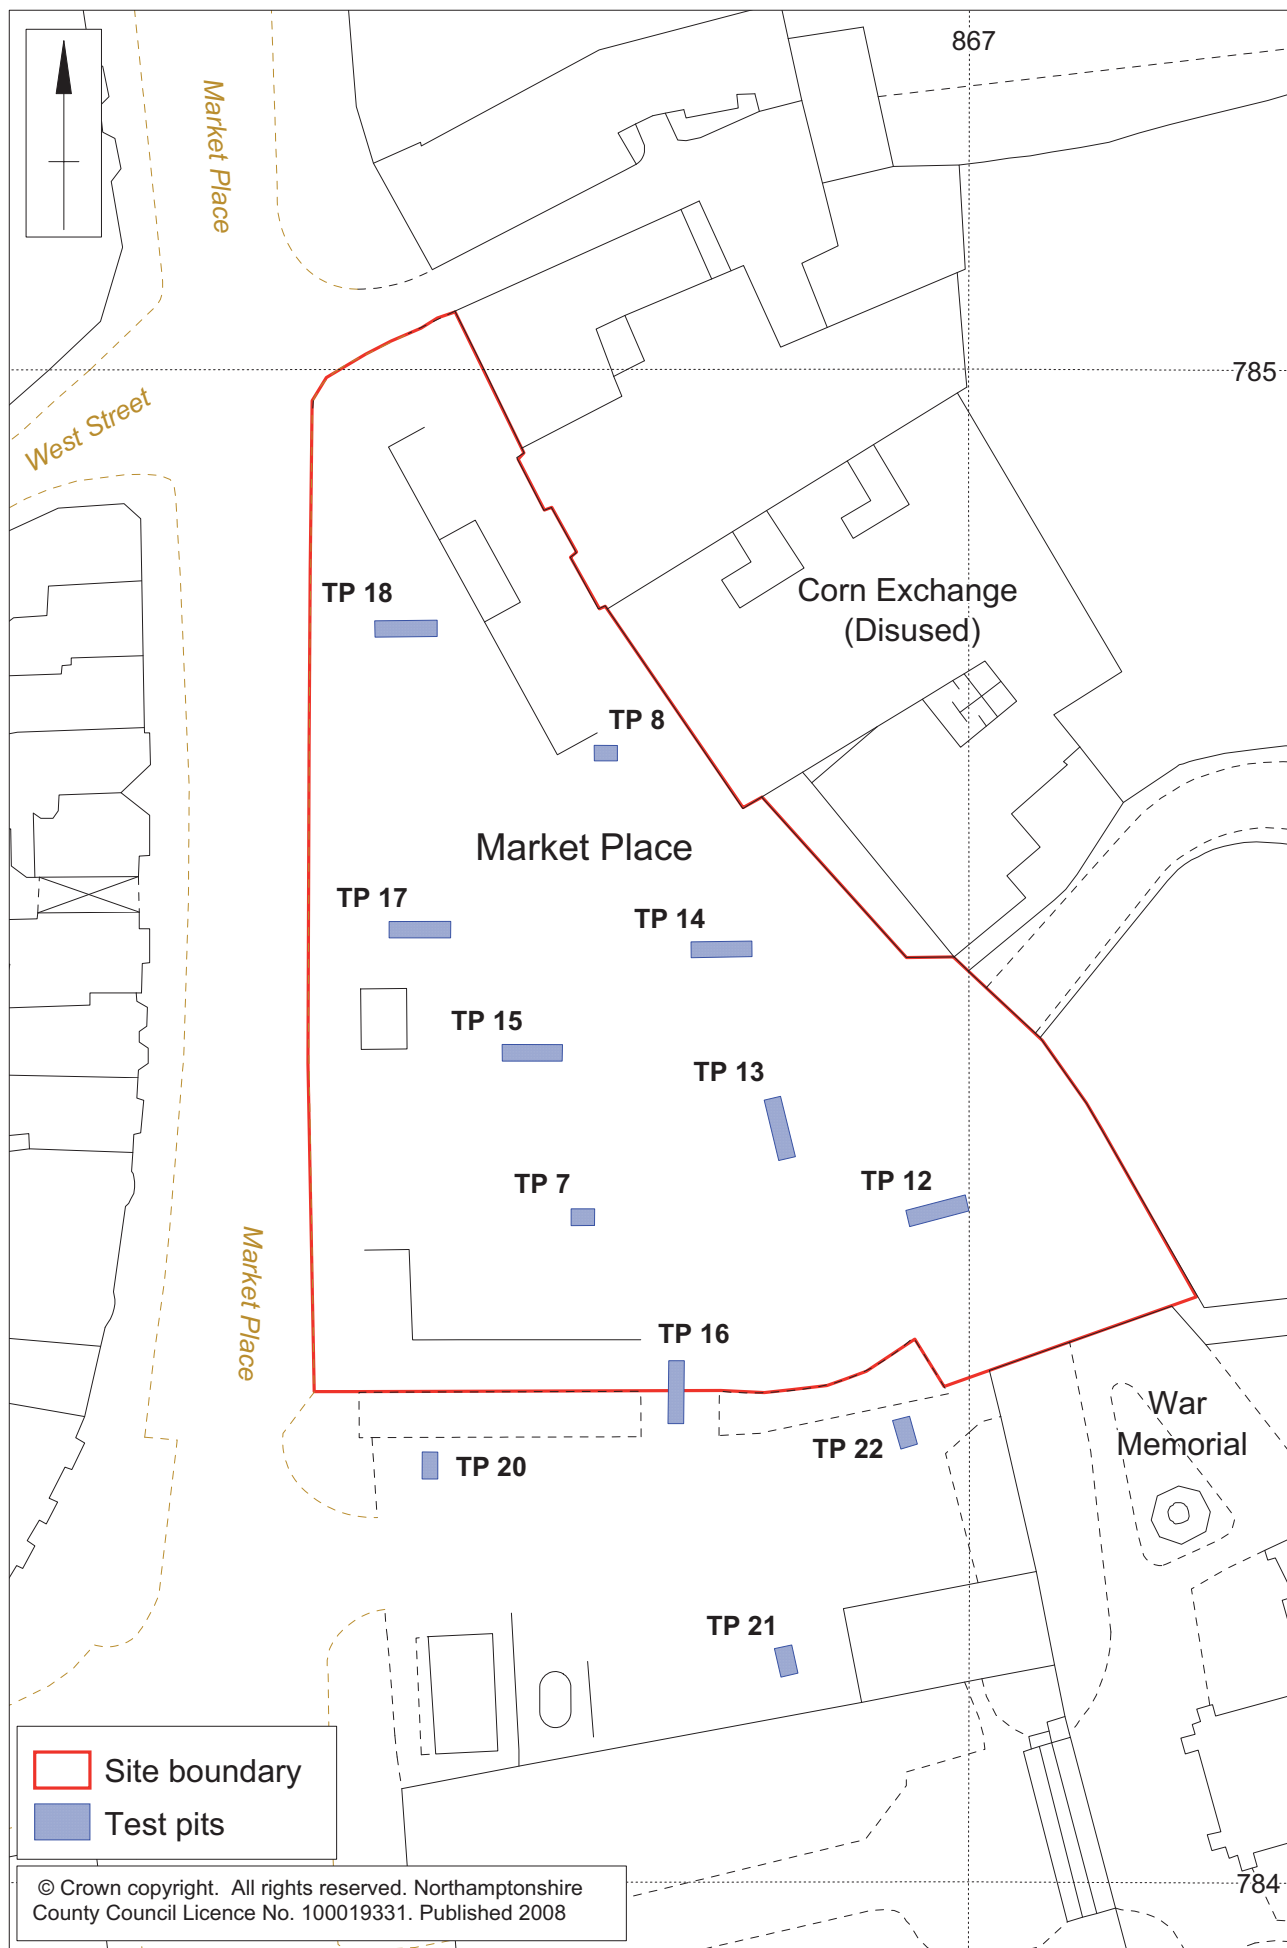
Location of geotechnical test pits Fig 2

Twelve geotechnical test pits were located within the Market Place as part of a much larger survey extending beyond the scope of the watching brief, and hence the numbering sequence appearing unusual (Fig 2). Each test pit varied slightly in size, adjusted for buried services or obstructions, but were no more than 4m long by 1m wide by 1.8m deep.

For the most part the deposits observed in the test pits across the Market Place were similar, in the majority of cases these comprised the make-up of the present plaza and its levelling layers (Fig 2). In the central area of the site there were indications in Test pits 7 and 13 of demolition deposits of late post-medieval date, which may relate to the Sessions House that was built in 1629 and demolished in 1805 (Mason 2008, 4). Variations were most apparent at the southern end of the site in the vicinity of the former Market Hill frontage that was demolished c1926-1950. Late post-medieval features were encountered in Test Pits 12, 20 and 22 that indicate some survival for deeper features such as cellars and brick-lined pits, although the exact nature of the features could not be determined during these works.

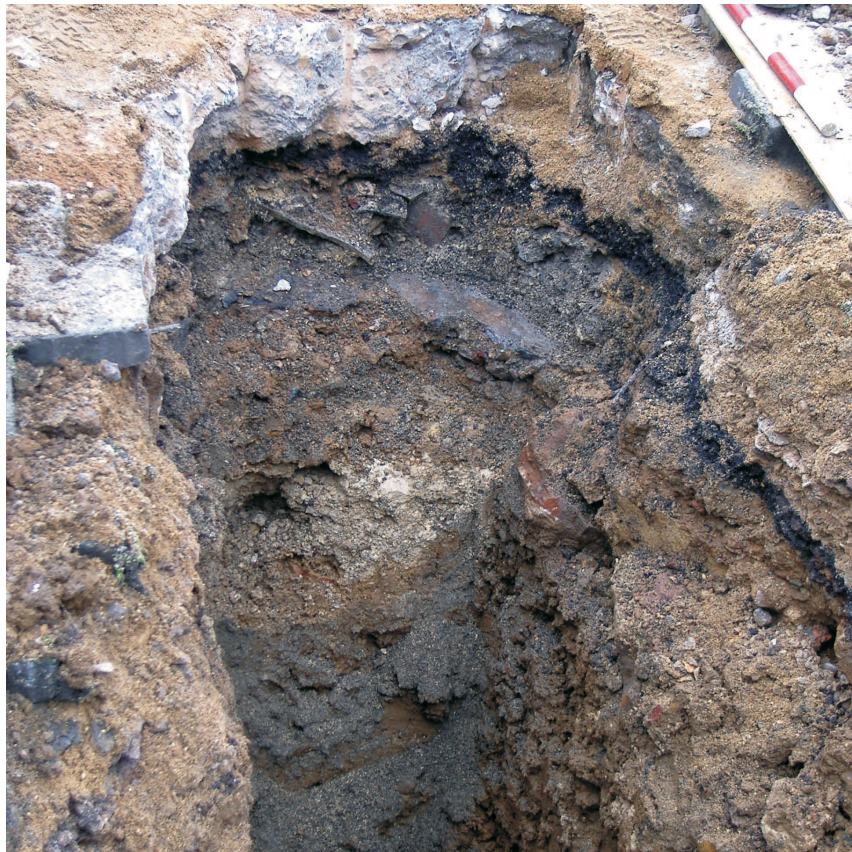
The test pit was 4m long by 0.8m wide by 1.6m deep, located within the plaza. Natural substrate was encountered at c0.73m below the present ground surface. Overlying it was a thin 100-200mm thick layer of dirty cream coloured crushed mortar and sandy loam (1210). Above this was the remnant of an ironstone wall footing [1205] aligned across the west end of the trench from north-west to south-east (Plate 1). The wall comprised a single course of ironstone blocks of varying size measuring up to 500mm long by 200mm wide by 300-400mm thick. There was no mortar bonding the stones and it had been badly disturbed. Immediately surrounding the stones were also fragments of Collyweston limestone roofing tile, handmade brick and freshwater oyster shells. The wall footing had been truncated vertically by a brown lead glazed foul water pipe [1208] above which 20mm of degraded greyish-black tarmac dust (1211) was spread. This also formed the base for a 200mm thick slab of grey concrete (1203) that lay at the west end of the test pit. These layers were sealed by the construction layers of the present plaza.

Plate 1: Wall 1205 at the west end of Test Pit 12, facing north

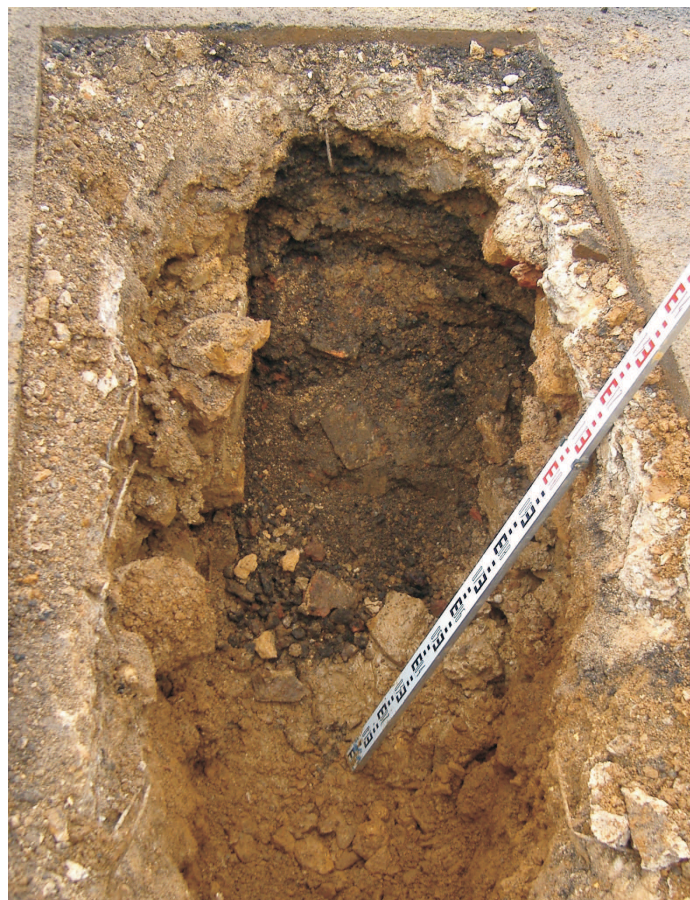
The test pit was 2m long by 0.98m wide by 1.2m deep, located within the southern car park. Natural substrate was encountered at 0.25m below the present ground surface. Cut into this was what is probably part of a late post-medieval cellar wall [2204] located close to the north-east corner of the cellar (Plate 2). The wall was aligned east to west and measured 0.5m wide by 0.95m deep, the full depth of the cellar was not revealed. There was a visible north to south return of the wall in the east side of the test pit. It was constructed from large cut ironstone blocks of varying sizes up to 300mm long by 180mm wide by 140mm thick. These were bonded together with a coarse hard white sandy-lime mix. The cellar was filled by demolition rubble (2205) which largely comprised a mixture of loose dark greyish-brown sandy loam, orange sand, shattered ironstone, brick fragments, mortar, greyish-blue slate roof tile and plaster. The whole of the test pit was sealed by a 20mm thickness of degraded greyish-black tarmac dust (2203). Upon this was a layer of concrete that was 150mm thick and comprised white concrete (2202) with moderate coarse mixed gravel inclusions. The surface layer comprised 80mm of solid greyish-black tarmac.

Plate 2: Cellar wall 2204 in Test Pit 22, facing south
