Archaeological Building Recording
and Watching Brief at
5 The Green, Lyddington, Rutland
OAKRM.2009.5

Jason Clarke and
Joe Prentice
December 2008 Revised May 2009

Report 08/173

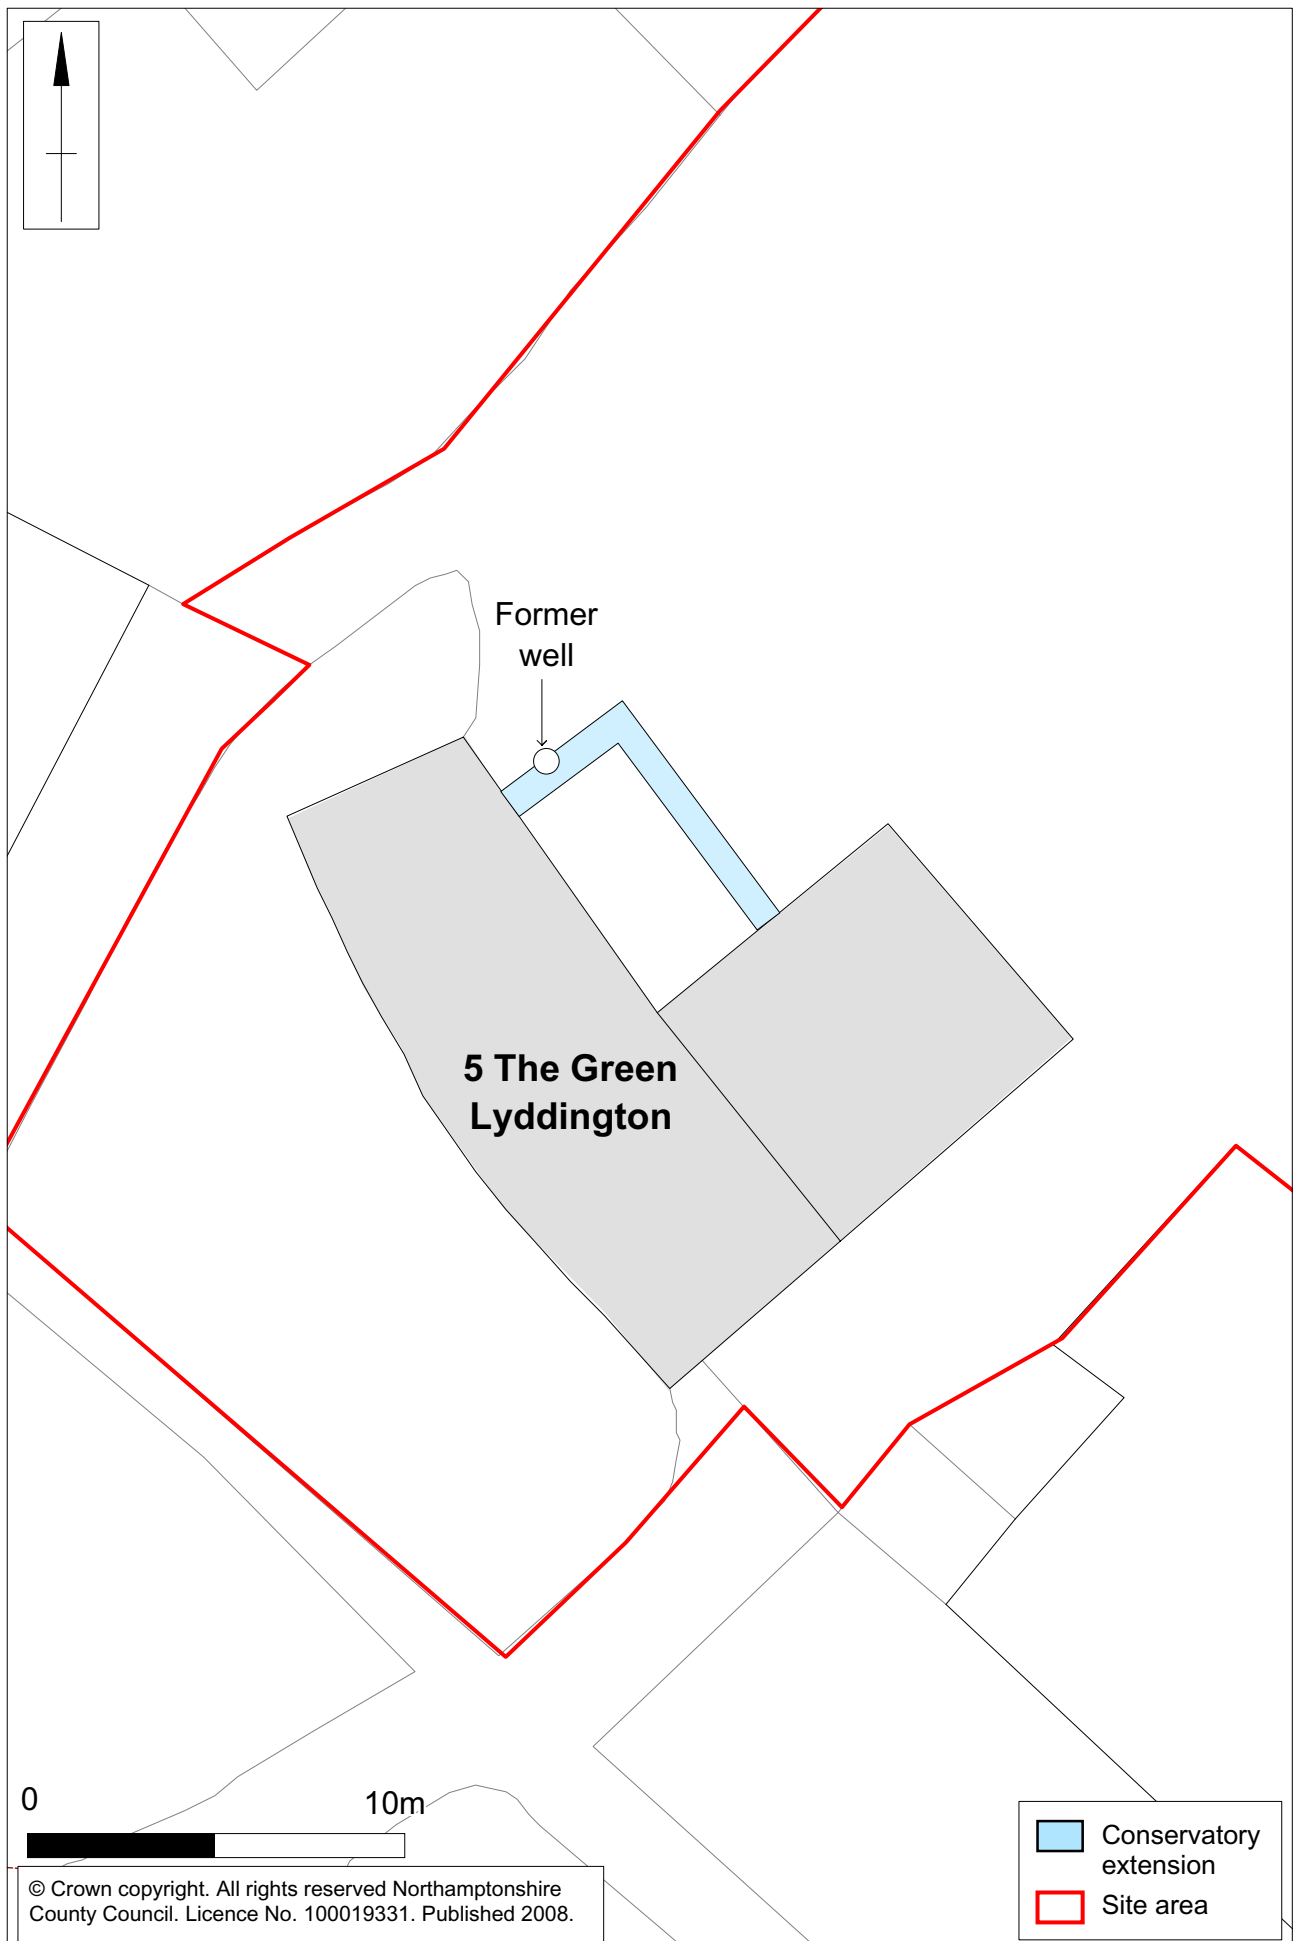
Conservatory extension location Fig 2

The site of the new conservatory lies to the rear of the building in the angle of the L-shape which the house comprises in plan (Fig 2). The north-east facing elevation comprises two phases of building, the original seventeenth-century building with a chimney on what would have been the gable end, and a later extension against that gable (Plate 1). In the original section at ground floor level there is a small fireplace window fitted with a modern frame, set beneath an oak lintel. To the north-west is a former doorway, now half blocked and

The only feature present was a disused, ironstone-lined well [5] in the north-west section of the north-east/south-west aligned trench (Fig 2, Plate 5). The well produced no finds, making the date of its construction and demise uncertain, but the ironstone used in its construction is the same material for the house fabric and therefore the two may be contemporary. The well had been backfilled with stone rubble and overlaid by garden soil.

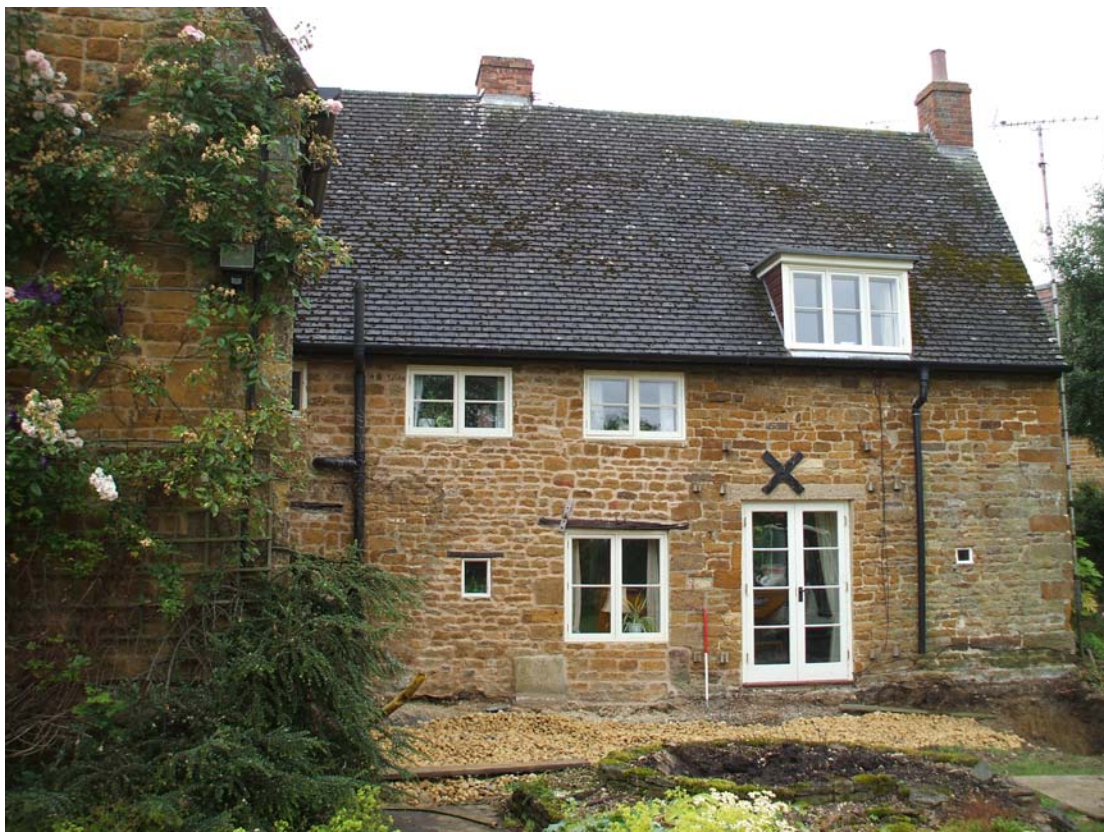
Plate 1: North-east facing elevation

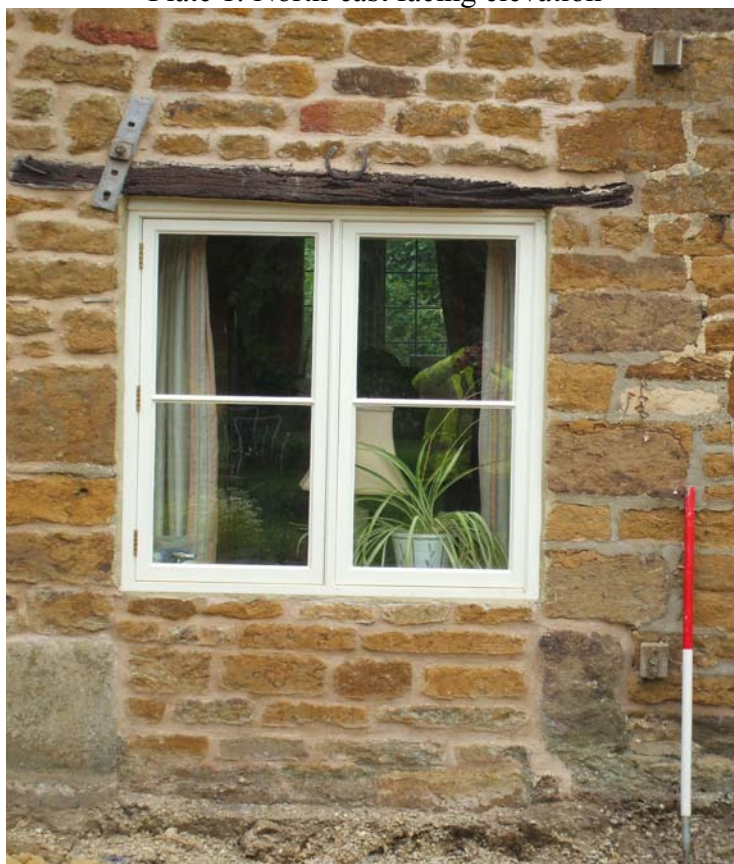
fitted with a modern casement window beneath the original oak lintel with a modern iron tie set just above it (Plate 2). To the north-west of this is a modern French door set beneath a concrete lintel immediately above which is an iron-tie. This elevation unsurprisingly combines a mixture of well-laid and dressed stonework where the original structure remains, and less well-laid stonework in those areas affected by later alterations, often set in cement rather than lime mortar. This elevation unsurprisingly combines a mixture of well-laid and dressed stonework where the original structure remains, and less well-laid stonework in those areas affected by later alterations, often set in cement rather than lime mortar.

Plate 2: Former doorway in the north-east facing elevation, now half blocked and fitted with a modern casement window beneath the original oak lintel with a modern iron tie set just above it

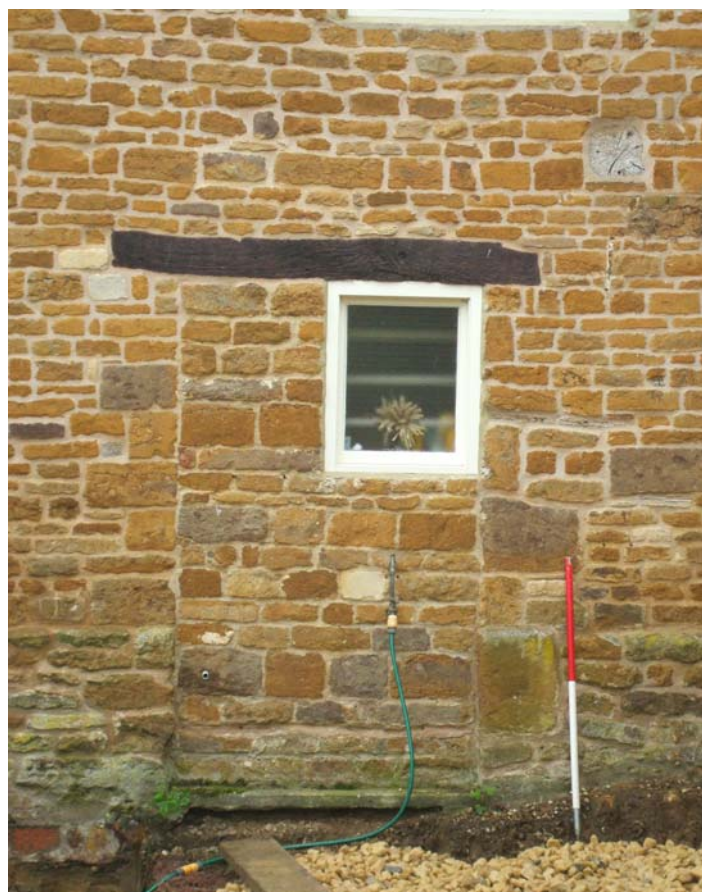
The north-west facing elevation of the rear wing extension also contains a blocked doorway (Plates 3 and 4). It too is set beneath an oak lintel and has a small fixed modern window set within the former opening. To its south-west is a modern doorway set beneath a concrete lintel and fitted with a glazed door. Apart from the blocking and new stonework on the jambs of the modern doorway the stonework of this façade is more consistent, suggesting that the wing is of a single phase. The exposed end of an oak floor beam can be seen in the wall above the lintels of the two doorways (Plate 4).

Plate 3: Blocked doorway in the north-west elevation, is set beneath an oak lintel and has a small fixed modern window set within the former opening.

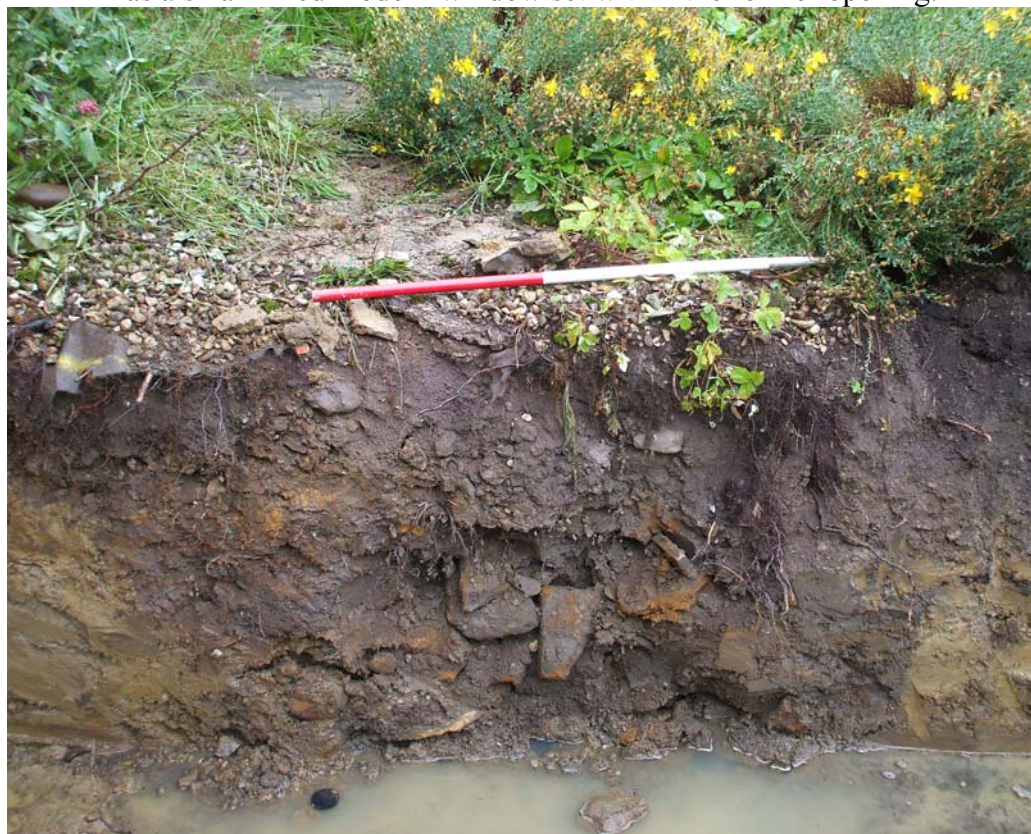
An undated stone-lined well (Plate 5) was the only feature present in the excavated area. The well was probably used for a water supply for the house until water was piped into the house, probably in the twentieth century.

Plate 4: Truncated Well [5]

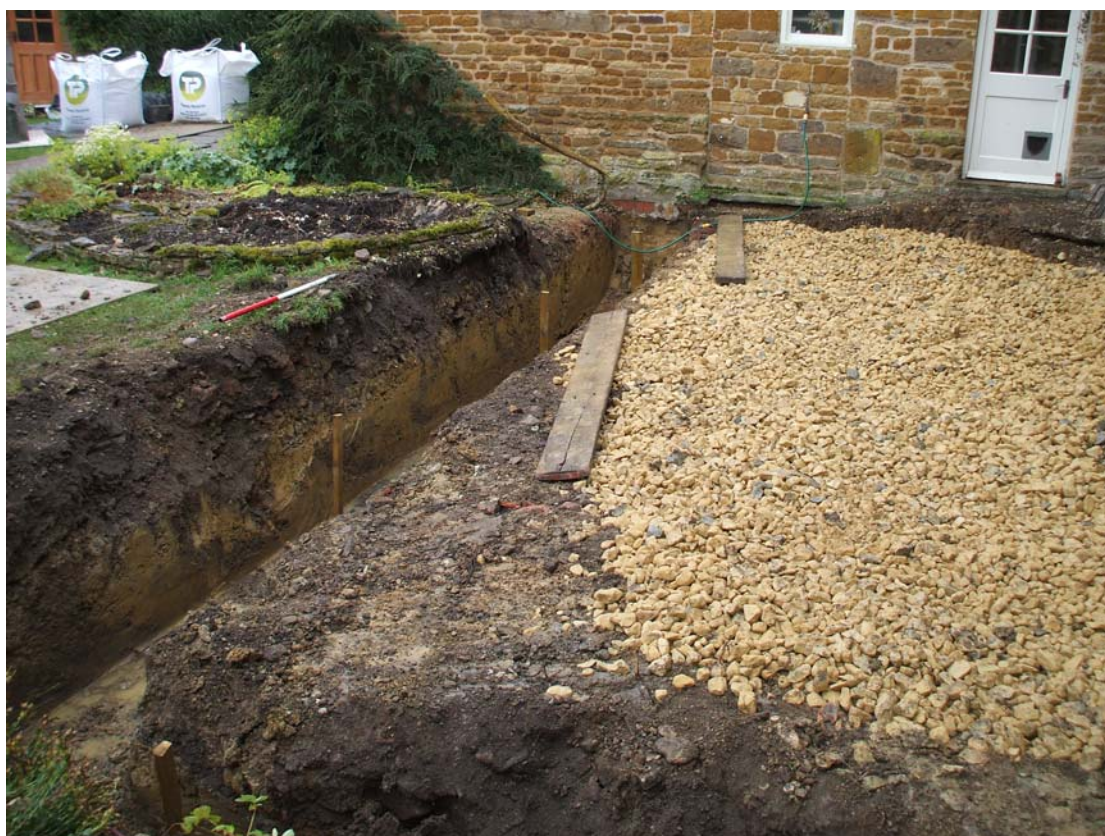
The area of the proposed development had been a paved patio. Topsoil had formerly been removed and the area levelled for its construction. The area was then levelled again for the development, before a hardcore base was laid. The footing trench was aligned north-east/south-west for 4m, turning to a north-west/south-east alignment for 7m, and was excavated to a depth of 1m and 0.8m wide (Fig 2, Plate 6). Where the foundation trench for the new conservatory exposed the foundations of the house, the footings there were revealed to be of undressed ironstone bonded in clay and lime mortar. Both foundations appeared to be trench-built and were approximately 0.5m in depth. The natural geology was clay.

Plate 5: General shot of the footing trench
