An Archaeological Evaluation at

Christleton Bridges

Cheshire

Report 08/206

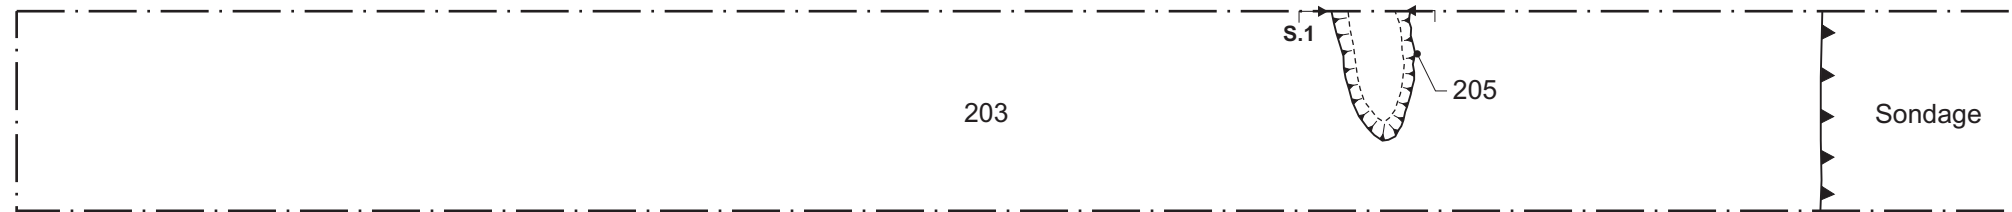
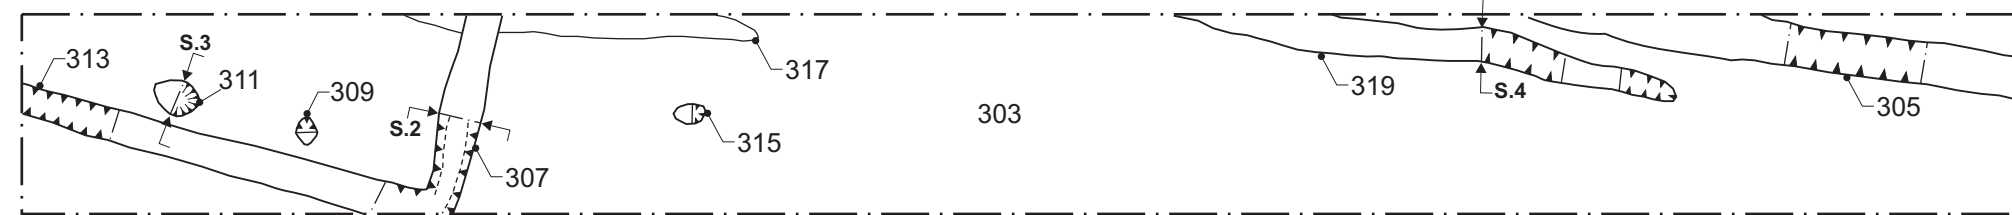
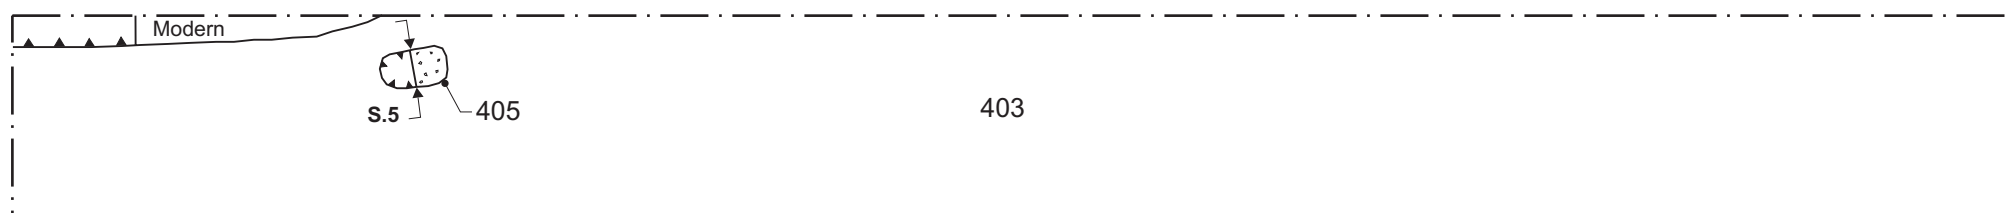
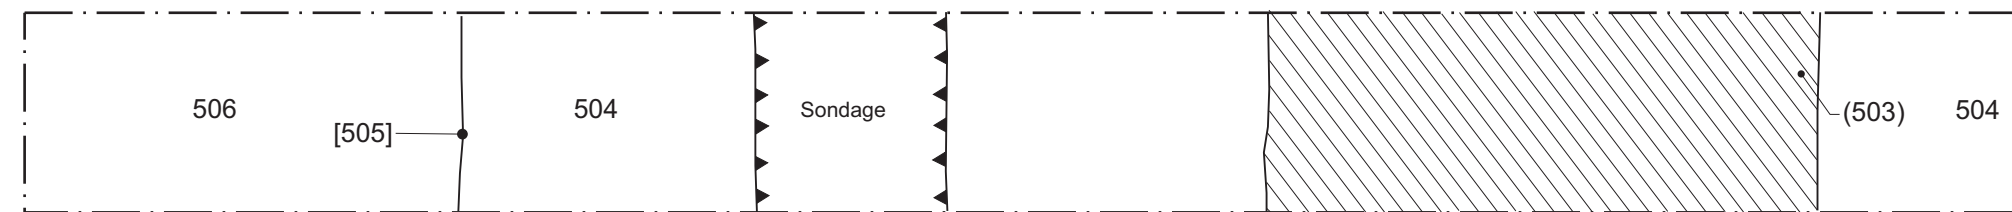
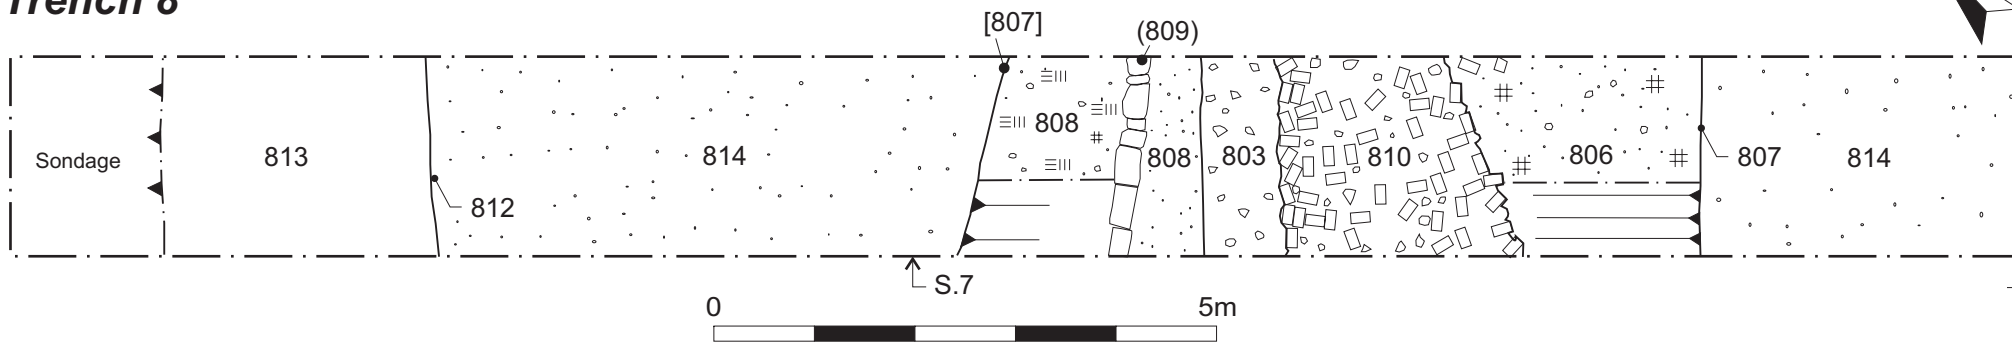
Trenches 2,3,4,5 and 8 Fig 3

Trench 2 was aligned north-east to south-west. The general stratigraphic sequence found was the same as that in Trench 1.

The natural silty sand substrate (209) was present at a depth of 1.10m, at 33.01m aOD. A small, shallow gully terminal [205] (Fig 5, Section 1) extended on a north-west to south-east alignment. It had a steep concave profile and measured 0.6m wide and 0.2m deep. Fill (204) comprised dark grey sandy silt containing charcoal flecks. No datable material

Trench 3 was aligned north-west to south-east. The natural silty sand horizon (303) lay at a depth of 0.3m, at 32.5m aOD. Six archaeological features were present in this trench; three gullies and three postholes. All were interpreted as being post-medieval in date.

This trench was aligned north-west to south-east and contained one archaeological feature, a pit. The natural silty sand substrate (403) lay at a depth of 0.25m at 32.5m aOD. Pit [405] (Fig 5, Section 5) was a small oval feature with a steep sided, flat based profile. It measured 0.3m wide and 0.2m deep. Fill (404) was dark grey brown sandy loam containing modern earthenware ceramics and clay pipe. Subsoil (402) was dark grey brown sandy silt 0.15-0.2m thick. Topsoil (401), a dark grey brown sandy loam 0.15m thick, completed the sequence.

Trench 5 was orientated north-west to south-east. The natural horizon (507) lay at a depth of 0.3m at 32.11m aOD. This was overlain by a thin layer of mid brown clayey silt subsoil, (506). These layers were truncated by a modern feature, [505] with a north-western edge aligned north-east to south-west. No other edges were present within the trench and the depth of the feature was unknown but was tested to a depth of 1.6m before rising ground water curtailed further excavation. The purpose or full extent of this feature was unclear but it may be the cut of the large drain depicted in the project design (Gifford 2008b:7, fig 1).

This trench was orientated north-east to south-west. It contained what was interpreted as a probable trackway leading from the former Christleton Lodge (now Cheshire Cat Hotel) and modern dump deposits.

This was truncated by [807], the construction cut for the overlying track (Fig 5, Section 7, Plate 2). This cut had a gently sloping and flat based profile 7.4m wide and 0.7m deep. The lower fill (812) was a pinkish red silty sand with frequent charcoal, brick and gravel inclusions which measured 0.4m thick and was present only on the northern side of the cut. Fill (806)/(811) was a very dark grey sandy silt layer up to 0.5m thick, with frequent charcoal and coal inclusions. Overlying these deposits on the northern half of the cut was a layer of tumbled bricks and brick fragments (810). This layer was 2.2m wide and 0.2m deep and formed a solid but water permeable base layer for the overlying track surface.

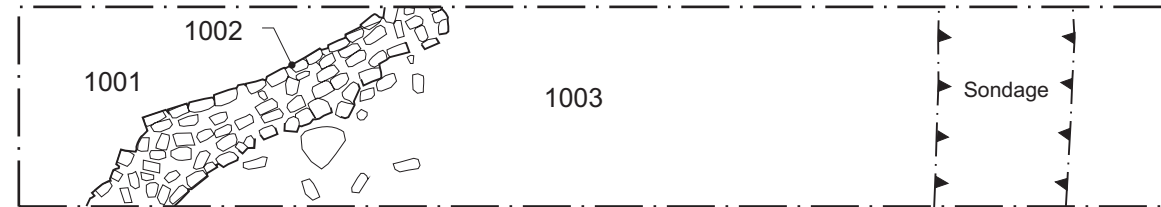
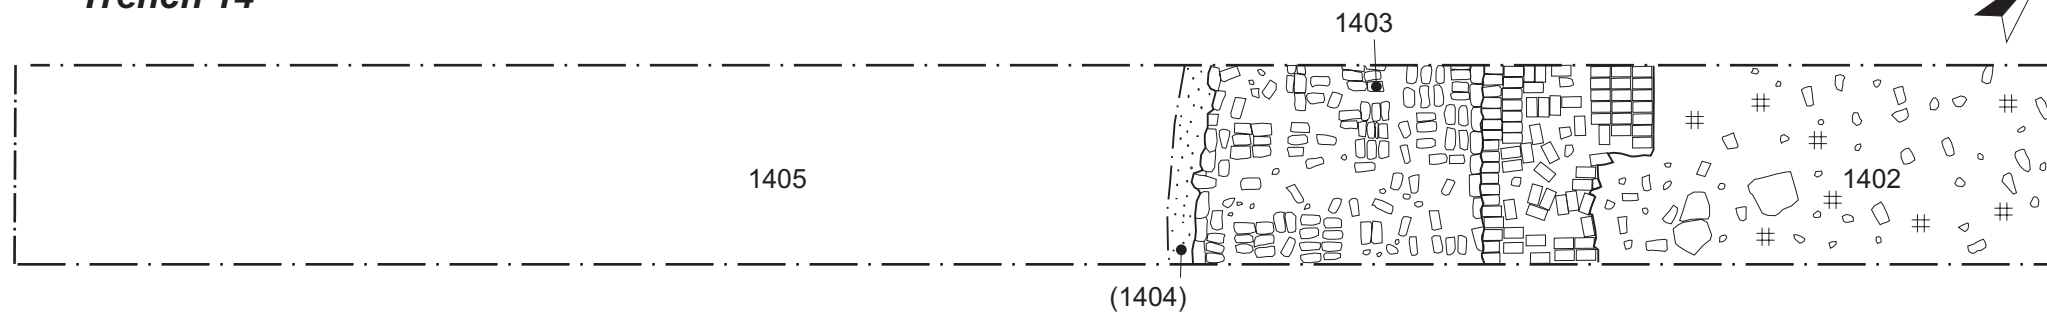
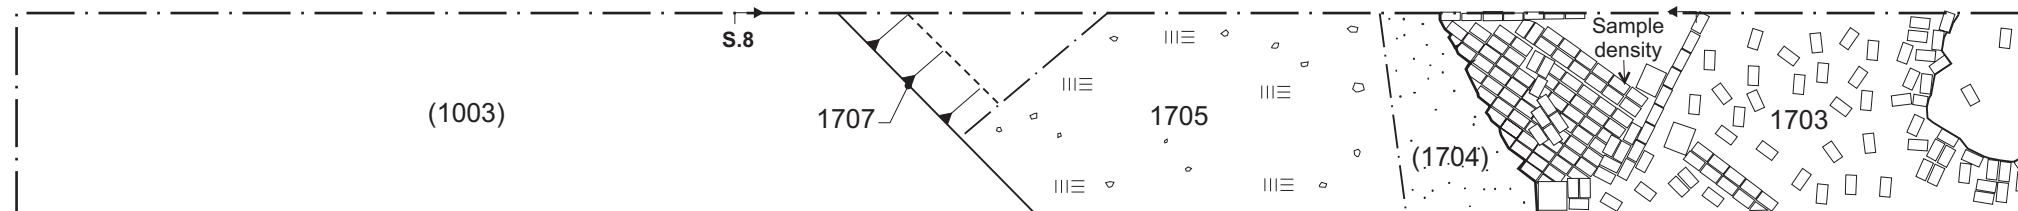
This trench was aligned north-west to south-east and differed from the others by measuring 10m by 2m. The natural horizon (1003), an orange sandy silt was present at a depth of only 0.3m, at 30.8m aOD at the highest point. Sitting atop the natural was a

small pathway constructed of brick (1002). It was oriented east to west and measured a maximum of 0.6m wide with a length within the trench of 4m. The bricks were unmarked and unbonded, mostly set end to end down the longitudinal axis of the path. They were overlain by (1001), a dark grey brown clay loam topsoil up to 0.28m thick. This path was most likely associated with the numerous farming structures or gardening plots known to exist on the site up until the late 20th century.

Trench 14 was oriented north-east to south-west and contained the brick floor surface of a building. Natural orange sand (1405) was present at a maximum depth of 0.45m, at 28.05m aOD. Subsoil (1404) was dark brown sandy silt, up to 0.35m thick. Sitting directly on top of the subsoil was a brick floor surface (1403) (Plate 5). This measured 4.6m in length and for the most part was fairly crudely laid, with the single layer of bricks bonded with a white lime mortar. There was no evidence for a construction cut within which the floor surface was sitting. Nor was there any evidence for walls. The northern section of floor had clearly been heavily disturbed during demolition.

The location of this trench was moved slightly to avoid low overhead power cables, and was aligned north-west to south-east. It contained a broad, shallow cut feature, probably a planting trench dating to when the field was used as a market garden. A brick floor surface overlay this feature (Plate 6 and Cover).

Sitting atop this layer was brick floor surface (1703). It extended for 6m before continuing under the south-east end of the trench. This surface comprised a single layer of well laid but unbonded bricks. The bricks were for the most part laid lengthways across the trench, but with no consistent pattern to their alignment. Several large square grey ceramic tiles were laid in among the bricks. The brick surface on the far south-east end had sustained damage and most of it had been ripped out, revealing (1704) beneath.

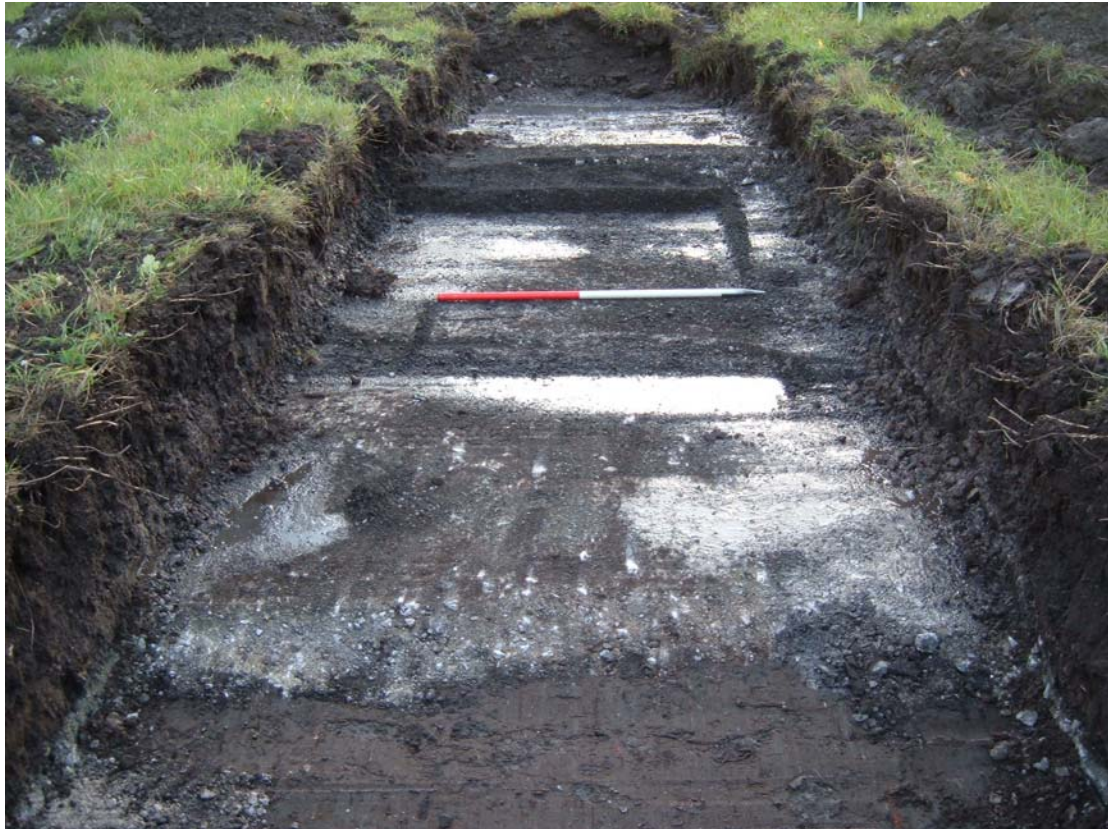
This feature contained (504), a dump of material including brick, ceramics and general detritus within a firm dark grey clayey matrix. Overlying (504) on the south-east side of the trench was a thin layer of compacted white mortar (503) (Plate 1). This extended for 5.5m along the trench and had a thickness of 0.08m. This may have been a capping layer for the drain pipe within its trench. It was overlain by (502), a modern dump deposit consisting of gravel, brick, ceramic and plastics. Topsoil (501) was the regular dark grey brown sandy loam, 0.10-0.15m thick.

Plate 1: Trench 5; Mortar layer (503), with layer (504) in the foreground

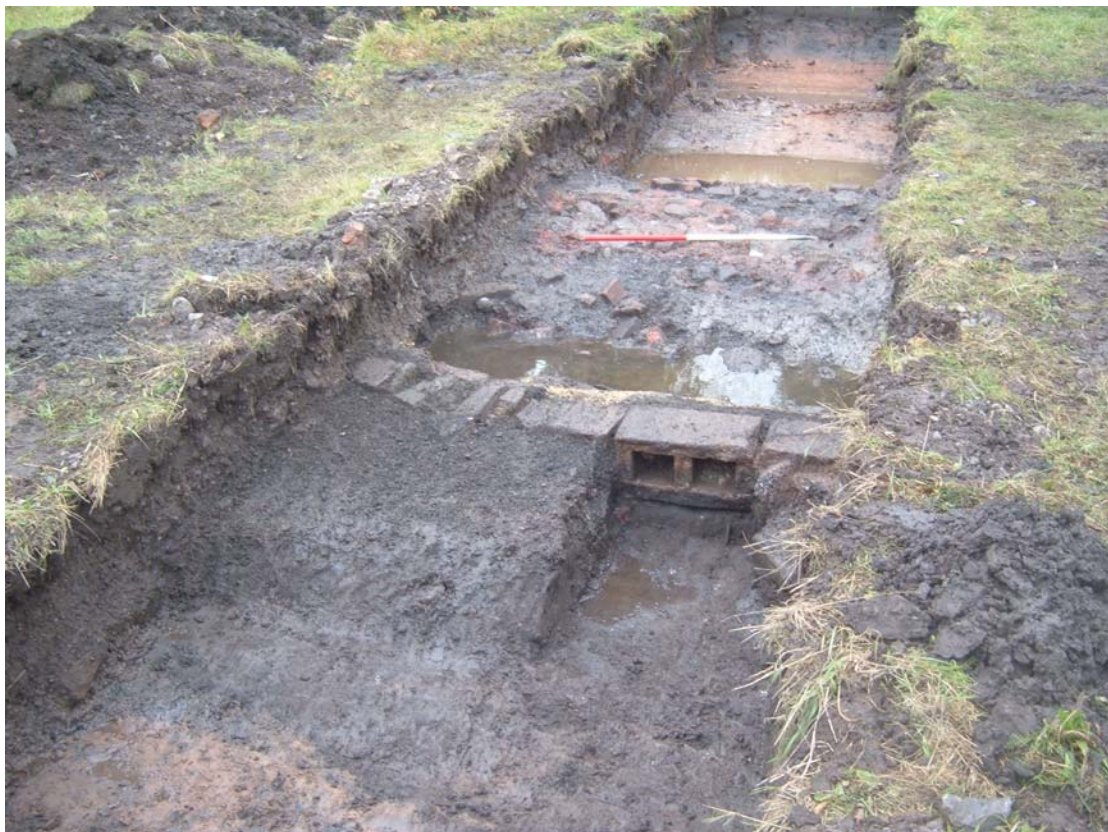
The pottery recovered from this layer dated from the late 17th to 20th centuries. A rubble layer of similar but more fragmentary brick fragments (805) lay over the northern side of (810) and containing Creamwares and Midland Black pottery from the 17th-18th centuries. On the southern side of the cut, a single line of cinder breezeblocks (809) was set into (811) and bonded with a mixed layer of compact black ash, pea gravel and yellow lime mortar (808). This was interpreted as a curbing, securing the down-slope edge of the trackway. Overlying these layers was the surface of the trackway (803), comprising a very compact layer of white and grey angular gravel up to 0.3m thick.

Plate 2: Trench 8; path structure. Note cut [807] and breezeblock edging (809) in foreground and brick base layer (810) in background

The desk-based research indicates that such trackways were present in this area at least from the time of the 1875 OS map (Gifford 2008a:16). This is supported by the presence of 19th century ceramics and cinder breezeblocks, known to have been in use from the 1870s onwards (J. Prentice *pers comm*).

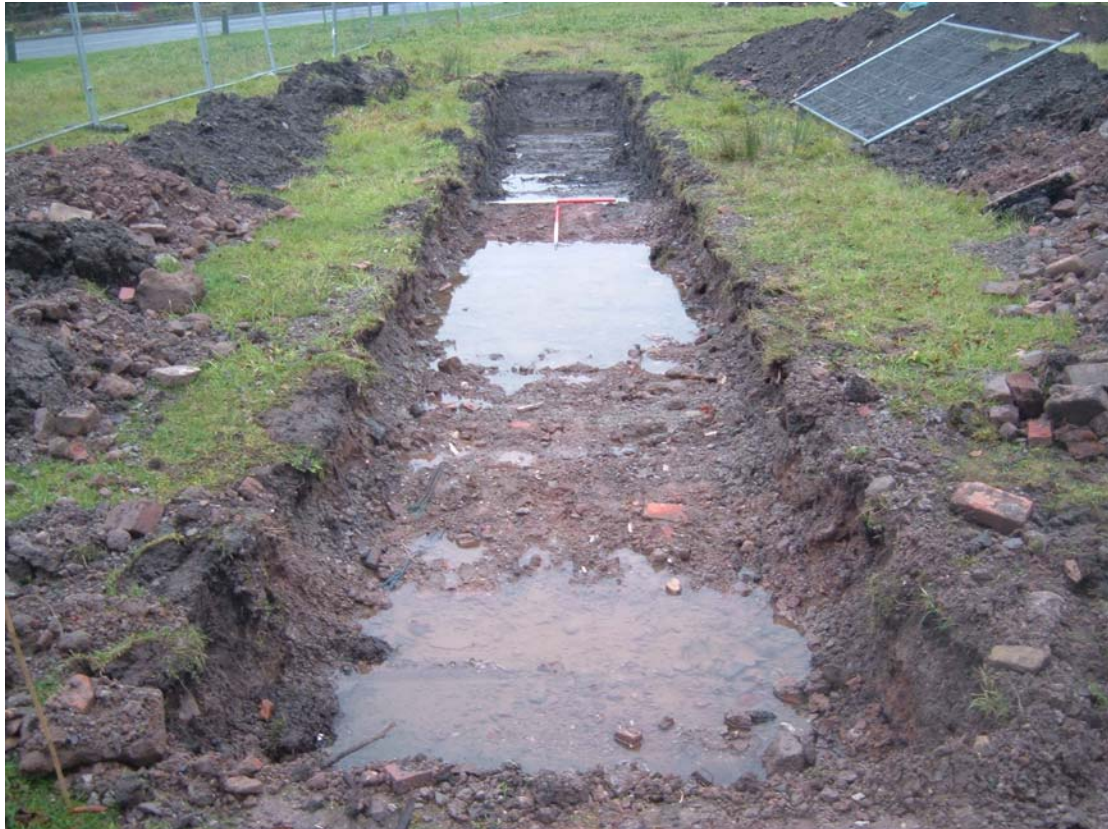
Trench 9 was aligned west north west to east south-east. As in Trench 7, the natural substrate was entirely truncated away by modern deposits, to a depth exceeding 1.8m (Plate 3). Layer (903), on the eastern side of the trench comprises a compact deposit of brick rubble, mortar and limestone hardcore lying directly beneath the topsoil. This appeared to be truncated on the western side by [904], the cut for yet another modern feature containing dump material. This material (902) was the usual dark grey clay loam containing large quantities of brick rubble, ceramics, glass, plastics and scrap metal.

Plate 3: Trench 9 with modern rubble layers (903) in foreground and (902) in the background

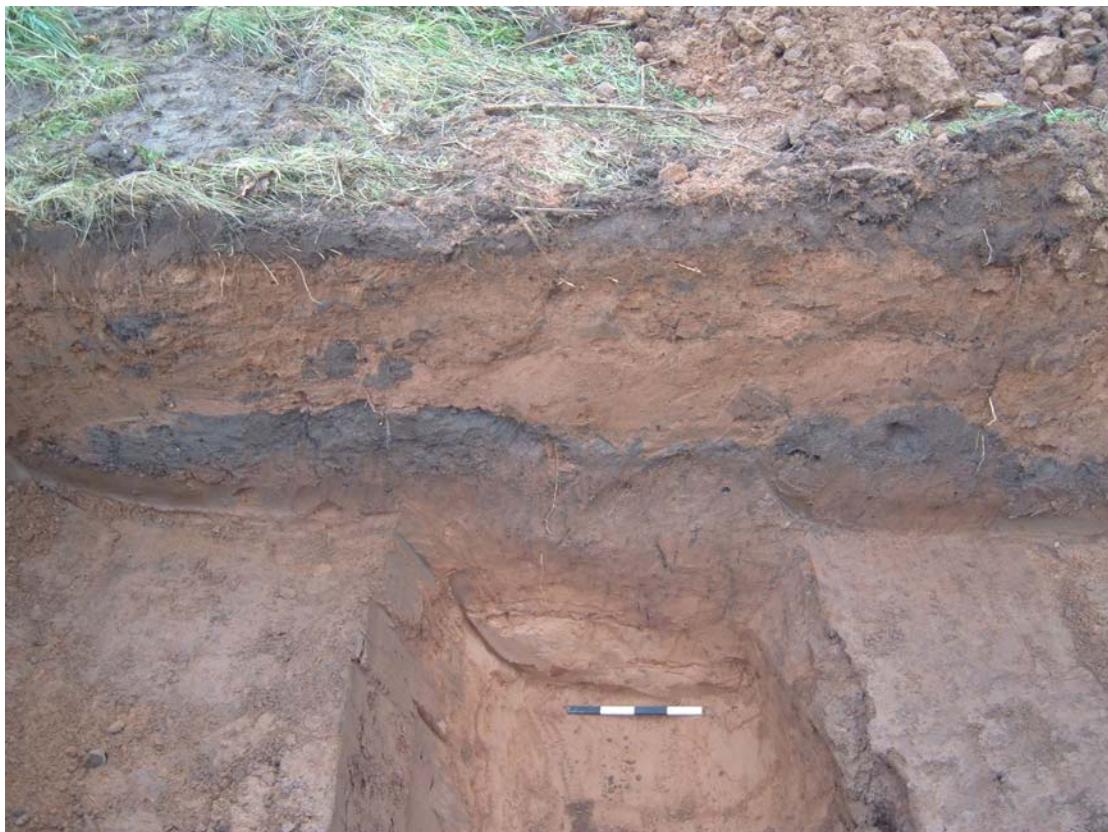
Trench 12 was aligned north-west to south-east. Undisturbed natural (1205), a yellow sand, was present at a depth of 1.2m, at 30m aOD. Overlying this was a sequence of buried subsoil (1204) and topsoil (1203) (Plate 4). Layer (1204) was a mid brown sandy silt layer 0.5m thick. Layer (1203) was dark brown grey clay loam 0.15m thick and represented the original ground surface. These layers were overlain by a thick dump deposit of re-deposited natural orange sand (1202). This layer contained many small patches of dark grey clay. No dating evidence was recovered from this layer other than brick fragments and it was considered possible though unlikely that this deposit be upcast from the construction of the canal, some 50m up slope to the north. It is more likely to be 'made ground' related to the more recent agricultural practices. The modern topsoil layer (1201) was the usual dark grey brown clay loam, 0.10m thick.

Plate 4: Trench 12, showing buried topsoil (1203) in mid section with redeposited natural (1202) above

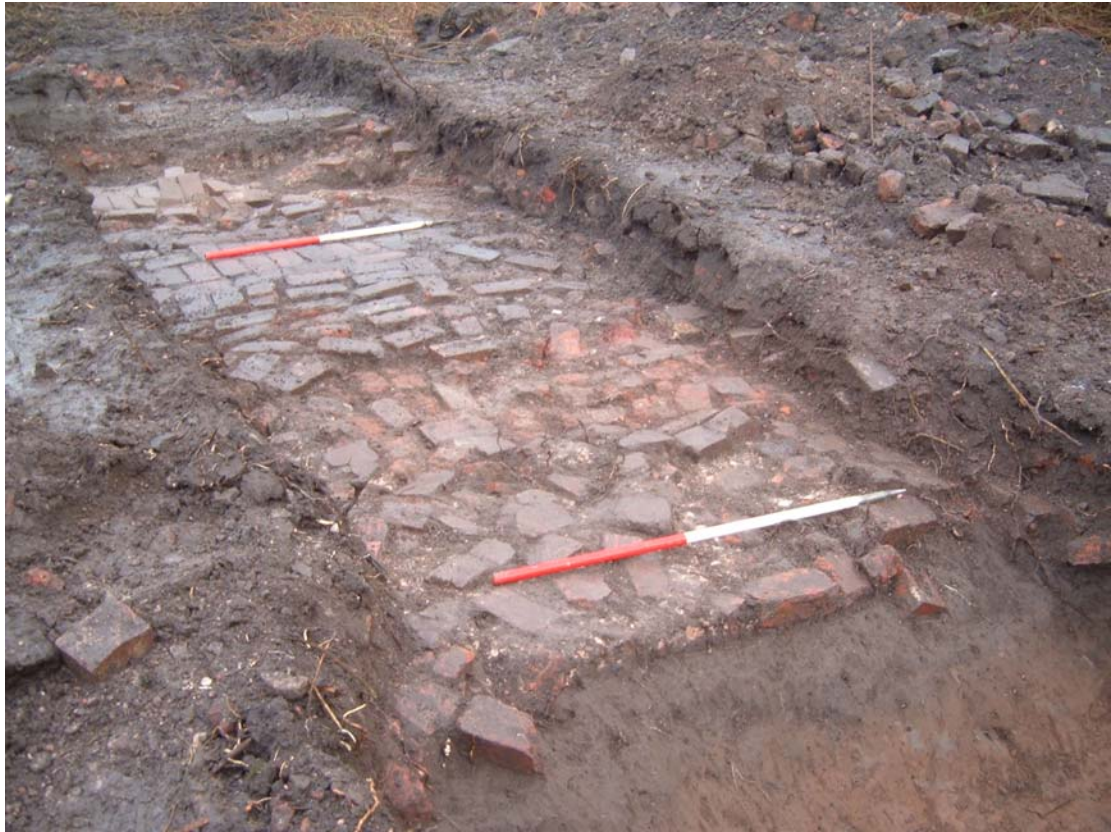
The brickwork was overlain by a layer of brick rubble (1402) from the demolition of the structure. This rubble also extended to the north of the floor surface. The brickwork lay only 0.3m below the present ground surface. The modern topsoil (1401) overlay the rubble. A pocket calendar dating from 1959 and a large number of pieces of 20th century stoneware mixing bowls retrieved from the floor surface provided a *terminus post quem* for the demolition of this building.

Plate 5: Trench 14; brick floor surface (1403)

This structure was most likely one of the numerous farming or market gardening structures existing in this area throughout the 20th century, although probably not the farm building depicted on the 1982 Ordnance Survey map (Gifford 2008a:16).

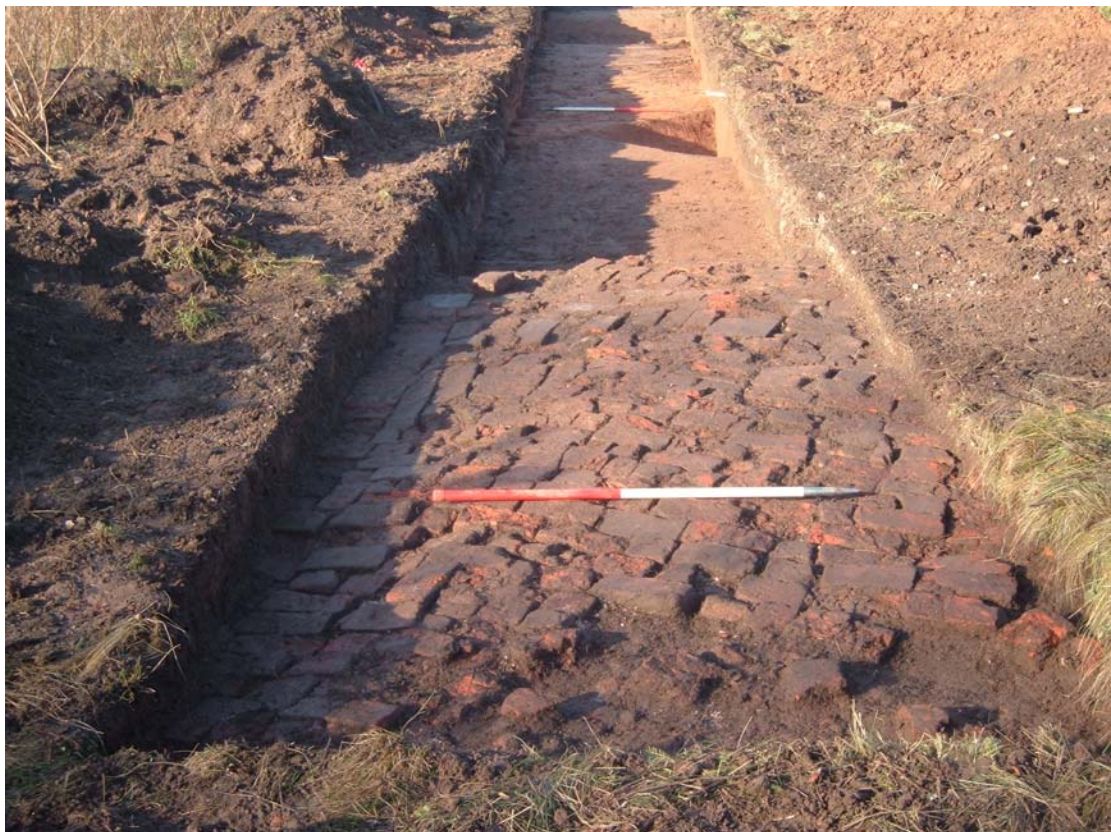
Natural red silty sand (1708) lay at a depth of only 0.10-0.15m, at 32.9m aOD. It was truncated by the western edge of cut [707], orientated just off north to south. This cut had a shallow, gently sloping profile with a flat base 0.35m deep. Lower fill (1706) was a thin compact layer of black stained fine gravel 80mm thick containing large quantities of 18th-19th century Blackware ceramics. Fill (1705) was light brown sandy silt partly derived from the natural substrate which measured 0.25m thick. Overlying this, fill (1704) was dark brown grey sandy silt up to 0.12m thick containing frequent pieces of coal and brick fragments.

Plate 6: Trench 17; brick floor surface (1703) in foreground, with cut [1707] in the background

It is possible that this feature is a result of 'double-digging' ground working, a common agricultural practice in order to create a planting trench with a deeper topsoil layer for crop growing (Campbell 2005, 262). A base layer of porous gravel and ceramic, such as (1706), was routinely used to increase the drainage of the soils. Such activity might be expected on land used as a market garden for a considerable period of time.
