Geophysical survey at Wothorpe Towers Cambridgeshire February 2008

Adrian Butler and Joe Prentice
February 2008
Report 08/28

GEOPHYSICAL SURVEY
AT WOTHORPE TOWERS,
PETERBOROUGH
DECEMBER 2007

**Report 08/028**

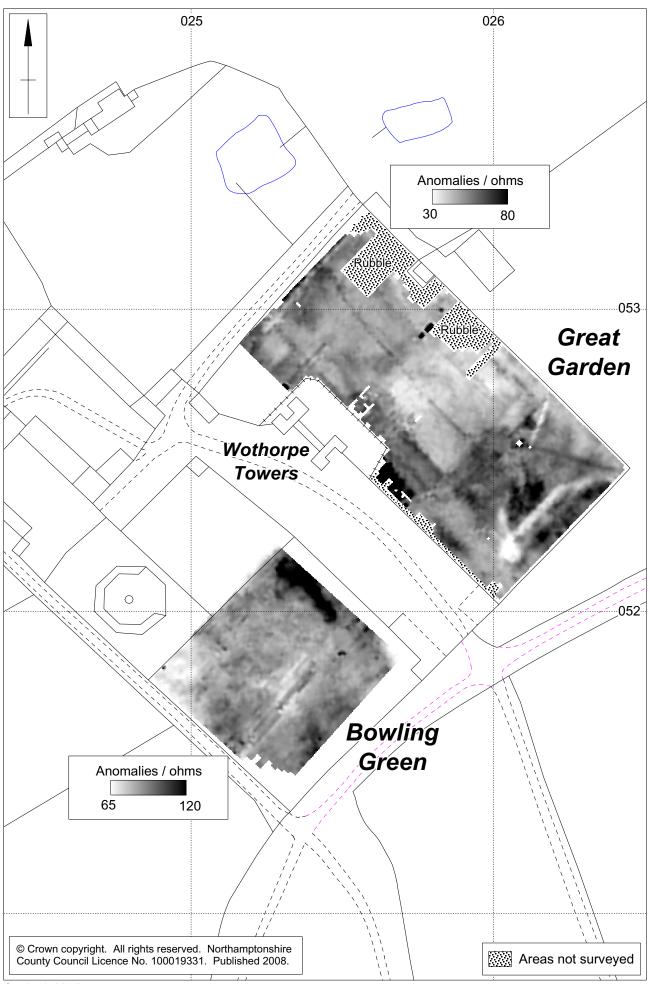
The data was analysed using Geoplot 3.00u software. Low resistances are shown as white and high resistance as black in the resultant greyscale plots (Figs 2 and 3). The resistance data grids were each matched so that the background levels were consistent across the survey. Extreme data values caused by the presence of frozen and very stony ground were excised from the data set. The final images have been interpolated to 0.5m x 0.5m to produce a smoother appearance.

The processed data is presented here in the form of greyscales highlighting the resistance anomalies with a scale of  $65-120\Omega$  in the Bowling Green and  $30-80\Omega$  in Great Garden (Fig 2). Interpretive plots (Fig 3) have been generated from the result and both figures are referred to directly in the following Survey Results section.

The survey in the area of the Great Garden produced a number of archaeologically significant anomalies, including possible walls, drains and earth cut features (Fig 2). Their form, alignment and character would suggest that they relate to or are part of the earlier formal garden (Fig 3).

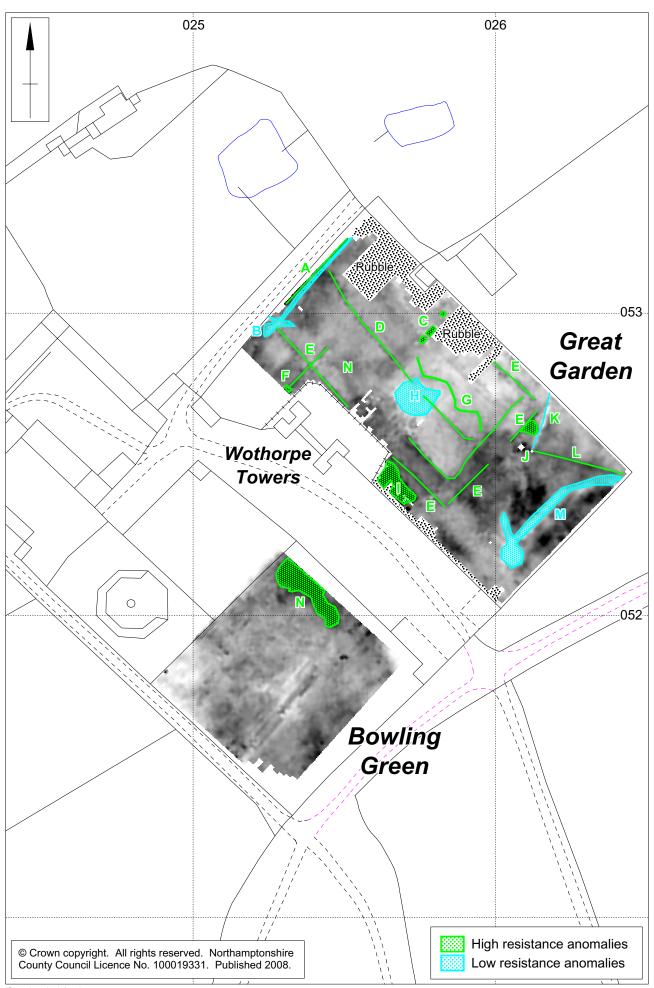
A a linear, north-east to south-west aligned, high-resistance anomaly. This response is the wall

revetting the track on the northern boundary to the Great Garden.

- **B** an amorphous low-resistance anomaly which may represent an earth-cut feature running along the base of anomaly 'A'.
- C three discrete areas of high resistance which simply represent isolated areas of buried rubble.

- **D** a linear north-west to south-east aligned anomaly. At its southern end it turns eastwards, possibly heading towards well 'J'. At its north-west end it turns slightly towards the north. Its form and location suggests it could be interpreted as a drain or culvert.

- **E** a series of high-resistance linear anomalies, perhaps representing boundaries to the former garden, possibly terrace walls.
- F a linear anomaly, possibly a wall aligned north-east to south-west.

- a sinuous anomaly, although of relatively low resistance, still higher than the surrounds suggesting an earth-fast structure, perhaps a gravel-filled trench. The shape and location accords well with a zigzag feature shown on the 1615 map of the garden, interpreted as water feature (Taylor 1997).

- H a low-resistance, roughly circular anomaly located towards the centre of the survey area. The nature of the anomaly is undetermined, but its position in the lowest part of the garden, at the base of a bank and around a possible drain, suggests a naturally water-saturated area.

- I An area of high resistance situated under the embanked south-west of the Great Garden, probably representing a buried rubble core.
- **J** the location of an existing pair of well caps.

- **K** is a low-resistance linear anomaly aligned north-east to south-west, a putative metal pipeline in a trench. This feature appears associated with well 'J'.

- L a linear high-resistance anomaly representing a known conduit feeding well 'J'.
- M a low-resistance anomaly. This comprises two curvilinear features joining an oval anomaly.

N an area of high-resistance readings on the slope down north-east towards the boundary wall, possibly indicating buried rubble.

The survey within the Great Garden has revealed what appears to be very good evidence of the survival of the zigzag water feature indicated on the map if 1615 (Fig 3, G). Associated with it appears to be a series of regular walls laid out either parallel or perpendicular to each other suggesting the presence of retaining or terrace walls (Fig 3, E). Other features may relate to water culverts for the supply of water to or from the garden (Fig 3, D and L).

Closer to the former house a number of anomalies are at present less easy to interpret. Linear features (Fig 3, F) may be related to either contemporary or later features. Large areas of what could be rubble may be from either the construction or demolition of the building (Fig 3, I).

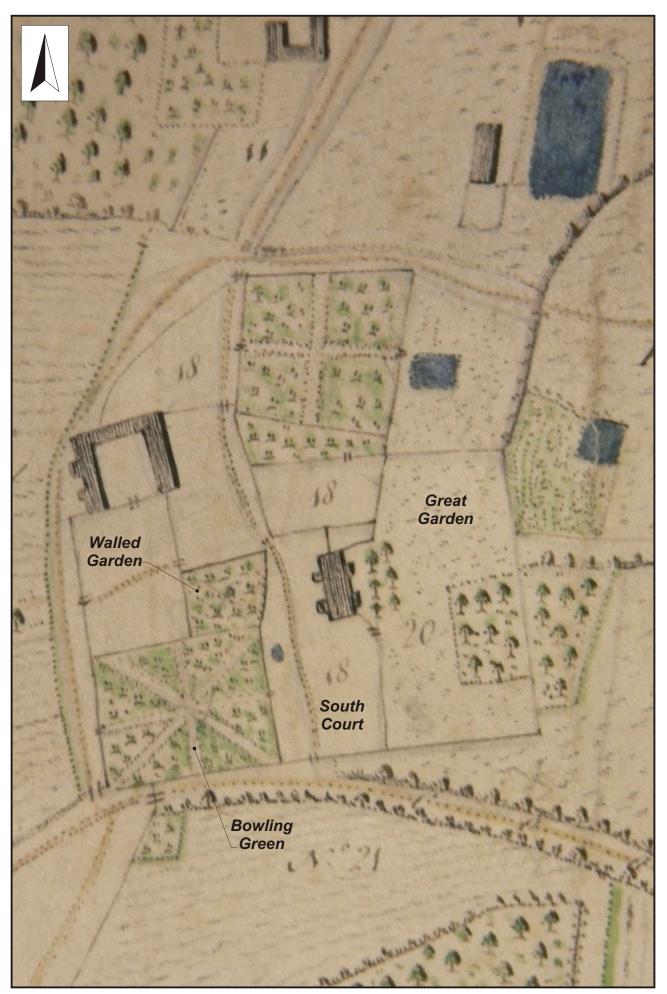
Beo Estate map, 1772, Burghley Estate Archives

There are no features within the area of the Bowling Green which can be related to features depicted in that area on the 1772 Estate map. At the period at which this was laid out it is most likely that the diagonal and cross paths would have been laid to grass which will not leave detectable traces. No indications of planting pits for the trees are present either.

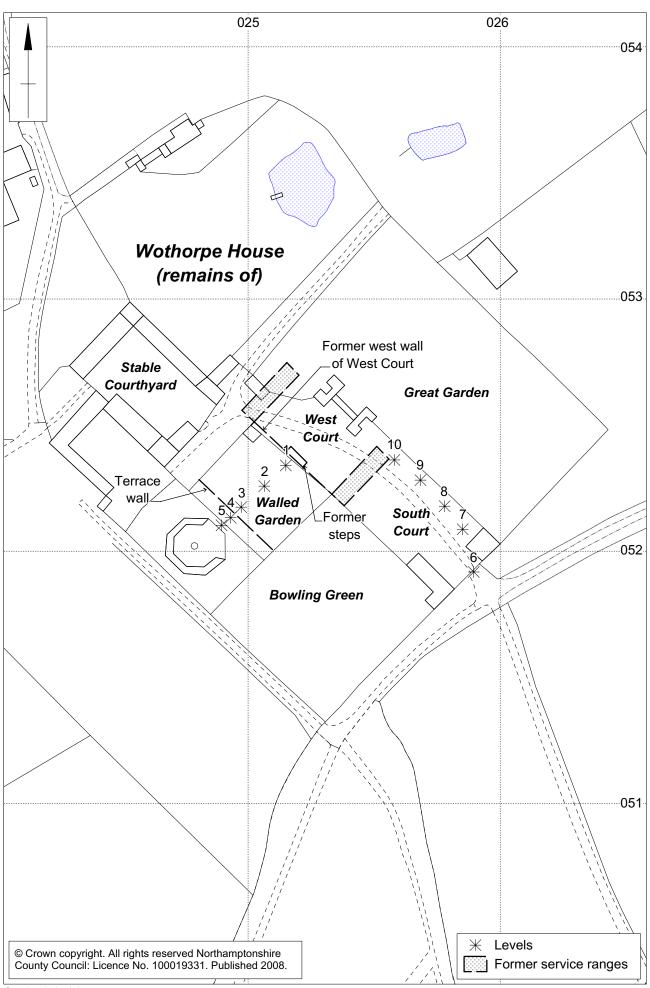
The following heights are all values above the level of the sub-base in the West Court. The numbers in brackets refer to the locations on Figure 6.

```
Floor of Walled Garden immediately to the west of the West Court (1) 1.35m (4 feet 5 inches)
```

```
Floor of Walled Garden (2)
1.84m (6 feet)
```

Floor of garden at the base of the terrace at the west side of the Walled Garden (3) 2.46m (8 feet 1 inch)

```
Top of terrace at west side of Walled Garden (4) 3.21m (10 feet 6 inches)
```

Soil level in the area containing the octagonal building (5) 4.66m (15 feet 3 ½ inches)

Gateway sill in south wall (6)

3.08m (10 feet 1 inch)

Pitched stone surface (7)

2.24m (7 feet 4 inches)

Pitched stone surface (8)

1.79m (5 feet 10 inches)

Pitched stone surface (9)

1.48m (4 feet 10 inches)

Pitched stone surface (10)

1.02m 3 feet 4 inches)

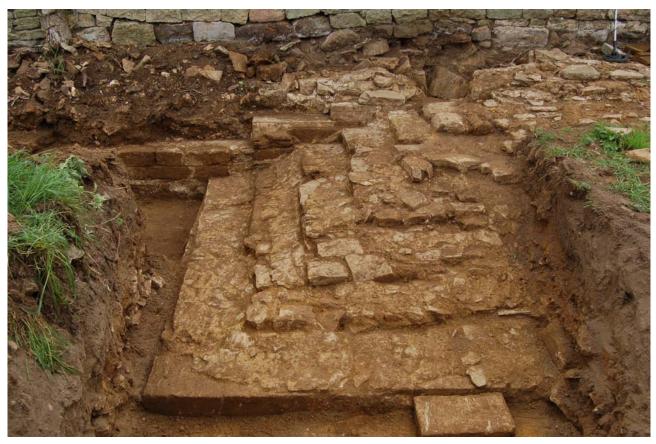
Plate 1: The steps on the west side of the West Court, looking west.

The lowest point recorded on the present survey was that within the West Court situated immediately to the west of the remains of Wothorpe House, now called the Towers (Fig 1). Excavation by the owners has revealed the foundations of a flight of steps which formerly allowed access between the West Court and the Walled Garden (Plate 1). The footing of the steps comprises local limestone blocks, some dressed others rubble pieces, set in a soft lime mortar and indicate that the steps were rectangular in plan 6.88m x 2.40m (22 feet 7 inches x 7 feet 10 inches) at foundation size. None of the treads remain *in situ* nor does the paved West Court surface, however, a single piece of stone lying horizontal close to the base of the lowest step foundation may represent a fragment of *in situ* paving. The exposed surface on which the paved court must have been laid comprises a compact layer of sandy marl-like material mixed with small fragments of limestone. The upper surface of this levelling layer will be given the value 0.00. All levels in this document refer to that point.

The upper surface of the step foundations from this point upwards are:

Given that the remains exposed are simply the foundations and some places retain thick deposits of mortar the height of the risers can be indicative only but suggest a riser height of c 0.125m (5 inches). The uppermost level of 0.94m (37 inches) suggest an approximate height of around 3 feet for the level of the base of a stone balustrade which is known to have surmounted the west wall of the court from contemporary depictions. This wall and flight of steps precludes this side from being a principal entrance way for carriages and horses which, if they had access to the West Court, must have entered the area either through the south or north service ranges. It seems that the south service is the most likely as it is served by the large and well paved South Court, in turn served by a roadway which led from Burghley House (see below).

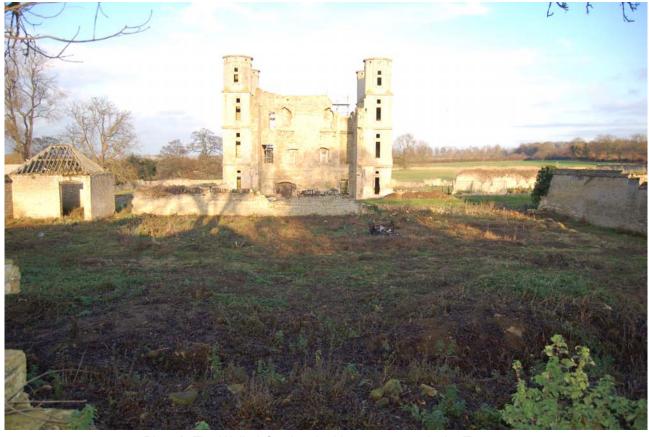
Plate 2: The Walled Garden, looking east towards the Towers.

The walled garden lies immediately to the west of the West Court and is surrounded on three sides (the north, south and west) by high stone walls, that to the east has largely now collapsed and what remains is a later construction as it is not aligned on the original foundations (which survive along the west side of the West Court) but veers slightly towards the west at the northern end and now connects with the corner of a later small building (Fig 6 and Plate 2). The garden rises gently to the west where a stone revetment wall indicates the position of a terrace 4.17m wide (13 feet 8 inches) along the western side of the garden. A currently blocked doorway in the south wall at the southern

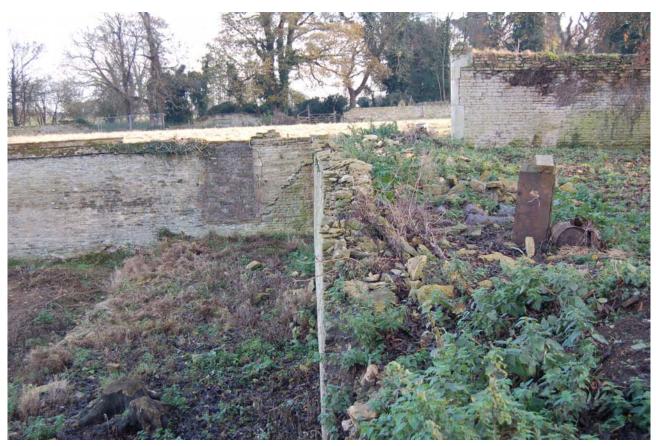
Plate 3: The west wall of the Walled Garden, the terrace within it (to the left) and the blocked doorway at the southern end of the terrace formerly leading to the Bowling Green beyond.

end of the terrace indicates that there was a connection with the Bowling Green which lies to the south, although the ground level in that area is considerably higher (Plate 3). What appears to be the remains of another doorway survives in the west wall, central to the garden which suggests a second entrance (aligned on the steps to the West Court and main front of the Towers) to the area to the west, now occupied by the nineteenth-century octagonal building. There are at present no indications of steps, but these would have been necessary if the present soil levels represent historic ones, as the soil level in the area of the octagonal building is considerably higher than those in the Walled Garden.

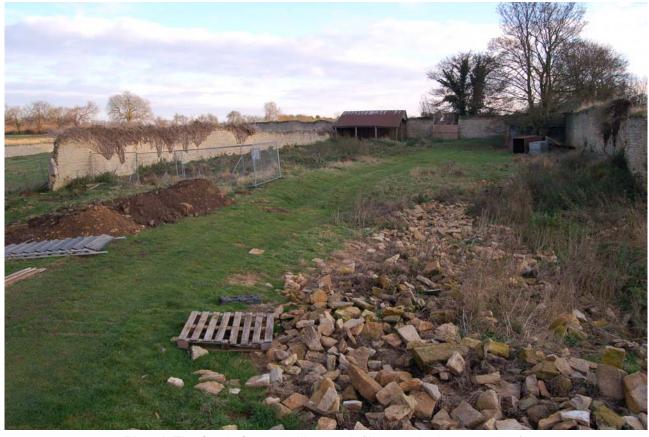
Plate 4: The South Court, looking south (the two sheds are modern).

The South Court lies on the southern side of the former house and is walled on the east, south and west sides, the north side was formerly enclosed by a service range connected to the house but which was demolished with it. At present the court is grassed over and there are two modern timber and corrugated iron sheds at the south-east and south west corners (Plate 4). A double width gateway in the south wall appears to be a later re-modelling, though in the position of an original entrance. This gateway gave access to a road which led to and from Burghley House and which still remains as a track. An area of pitched stone paving has been exposed by the owners and this seems to indicate that much, if not all, of the court was paved in this fashion (Plate 5). Within the paving the direction in which the stones are laid indicate that there was a curving roadway which led to the south side of

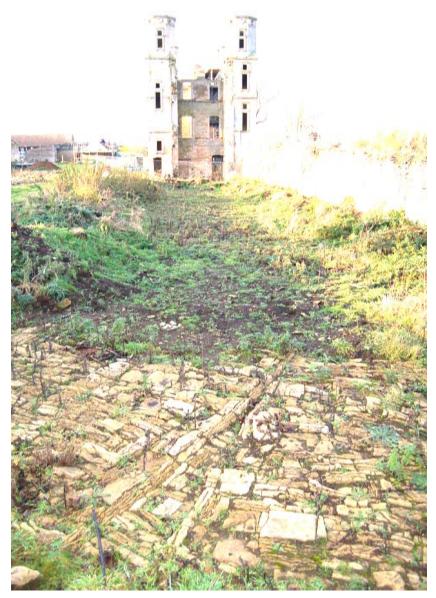
Plate 5: The pitched-stone surface in the South Court, looking north.

The soil overlying the surface deepens towards the north (the end nearest the former house) though throughout it appears to be a rich humic soil with little or no evidence of rubble or other dumping. At the southern end this soil is approximately 0.10-0.15m deep, at the northern end it is approximately 0.7m deep. It is not known at present the depth of soil adjacent to, or over, the remains of the former service range since this has not been exposed.
