Archaeological desk-based assessment
and building recording
at the former Atlanta Works
Irthlingborough, Northamptonshire
March 2008

Report 08/55

**ARCHAEOLOGICAL DESK-BASED ASSESSMENT
AND BUILDING RECORDING
AT THE FORMER ATLANTA WORKS
IRTHLINGBOROUGH, NORTHAMPTONSHIRE
MARCH 2008**

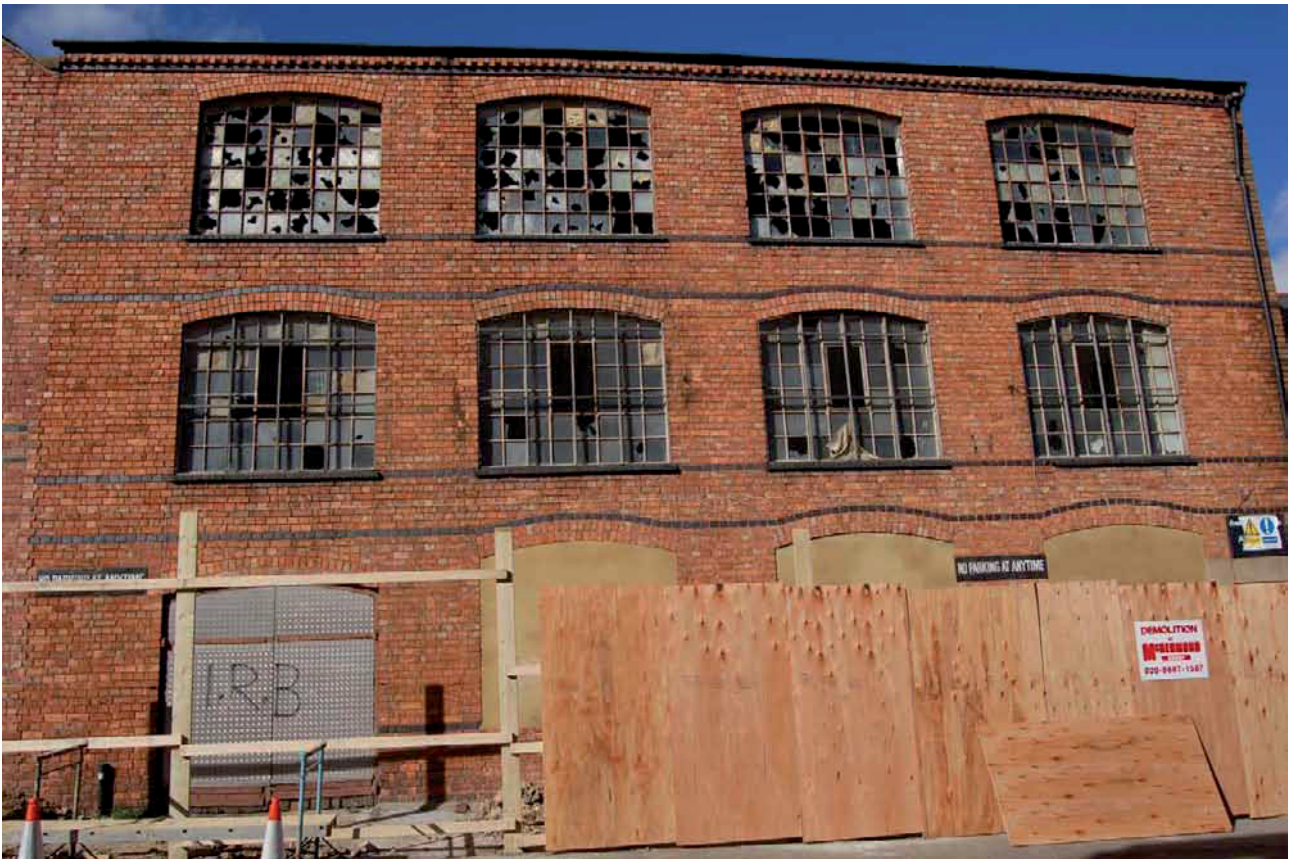
Plate 1: Victoria Street elevation of Phase 1 factory, looking north-east.

The Victoria Street façade at ground floor level has double doors at the western end and three large windows of the same width, each fitted with cast iron frames of 48 lights beneath a segmental arched top. The openings have been filled by breeze blocks externally to make the building secure. The centre six lights of each frame could be opened for ventilation. The same configuration of windows is present on the other two floors making the façade regular and clearly of one period. A doorway has been inserted on the ground floor at the eastern end during the early twentieth century, probably during the 1930s. There are no chimney stacks and never appear to never have been any.

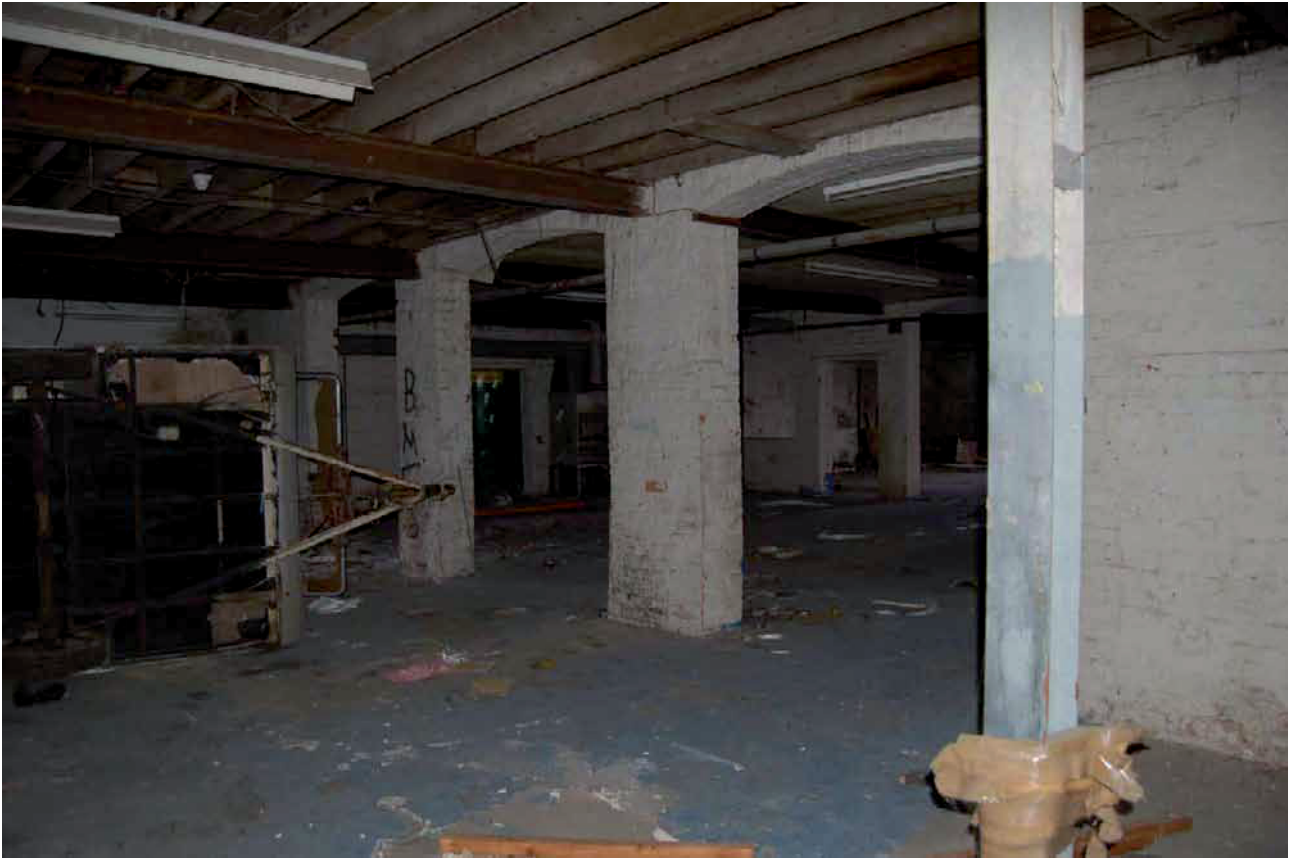
Plate 3: Former windows in north wall of Phase 1, ground floor.

have been removed and the wall below sill level removed allowing access through to the next phase of building (Plate 3). Vertical scars along the jambs of the original window openings indicate that they were positioned exactly as those which remain *in situ* in the south wall. At the west end of the north wall is a blocked single width doorway corresponding with the access to the building indicated on the 1900 Ordnance Survey map; it is not known if this was a single storey or taller addition (Figs 5 and 8). At the eastern end there is a single door to the east of the window which has been knocked through to create access to the offices added later on the eastern end of the building. A timber screen wall has been added at the same time to separate the lobby from the factory floor. Timber (pine) stairs lead up to the first floor, boarded in on their west side by vertical matchboard. There are no fixtures or fitting which give any indication of what process was carried out on this floor. The timber floor joists of the floor above are supported on H-section steel beams. They are awkwardly positioned at the western end due to the location of the openings in the north wall which precludes them from being placed perpendicular to the wall. The westernmost beam is a later insertion as its north end sits within the blocked doorway. The ceiling was not covered or boarded in any way, it is simply the underside of the floor boards of the first floor.

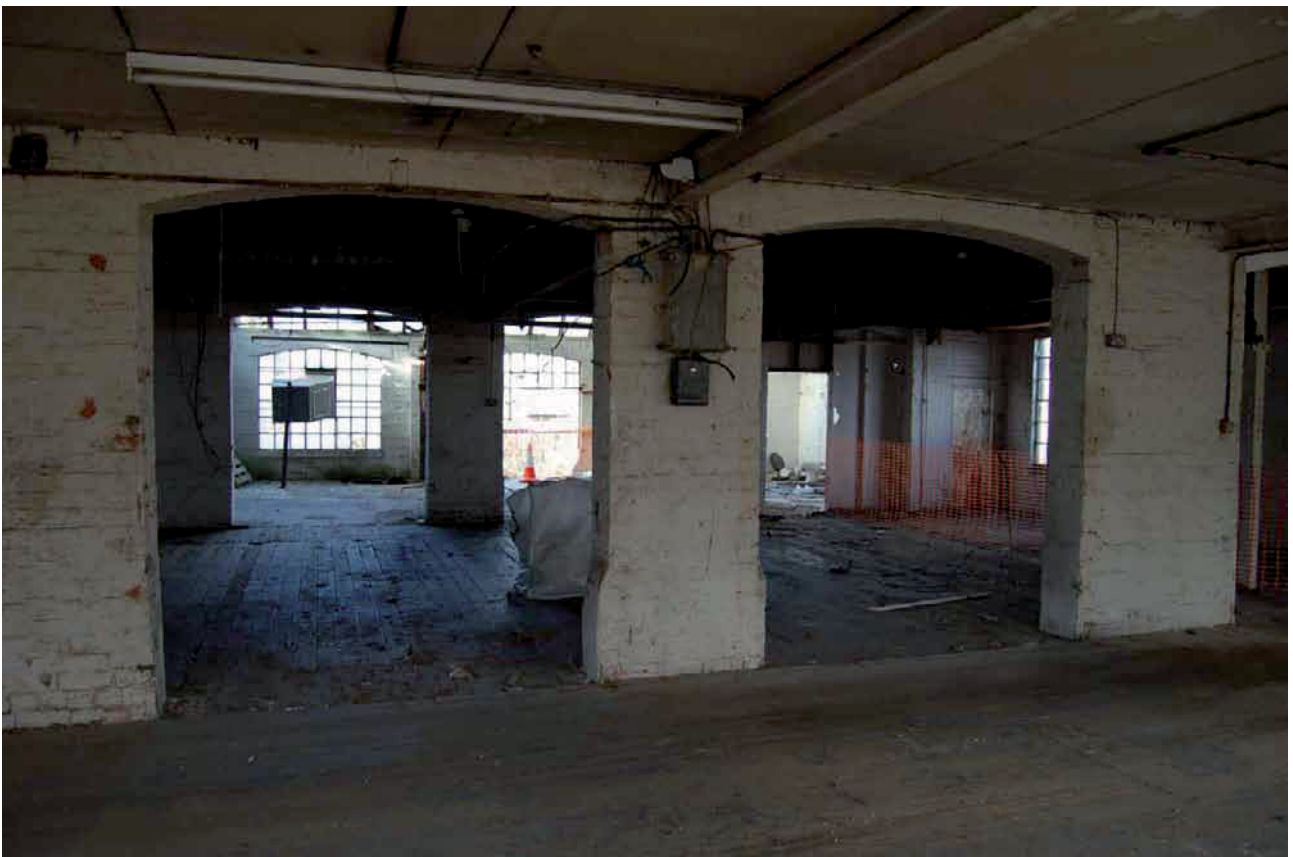
Plate 4: Former windows in north wall of Phase 1, first floor.

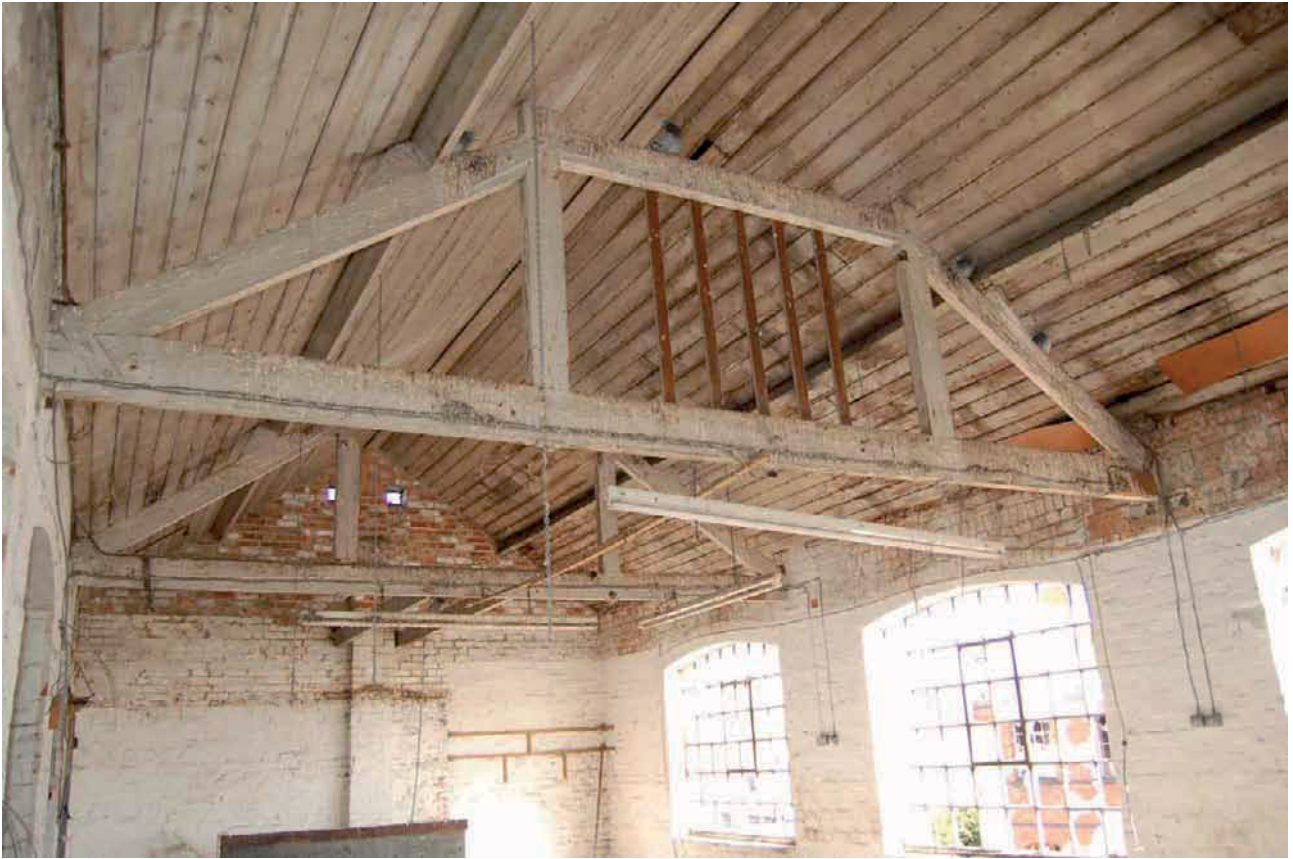
Plate 5: Queen post roof trusses in Phase 1, looking east.

- 5.5 ***Phase 1. Interior, Second floor.*** Essentially the same as the ground and first floors, the north wall has had the windows removed and the sill knocked out to allow movement through to the next phase extension (Fig 10). There is a modern opening through the west wall to phase 3. The roof is supported on three timber trusses, almost certainly pine (Plate 5). It is of Queen post construction but without the upper part of the truss; the reason for this is not immediately obvious although it might be to allow drive belt or other machinery to be placed high up close to the ridge. There is not, however, any evidence to support this view. The truss is fixed together by flat iron plates bolted onto the wooden frame, all is now painted white. The underside of the roof is covered by pine boards, each side has only one purlin supported by a cleat on the upper surface of the truss.

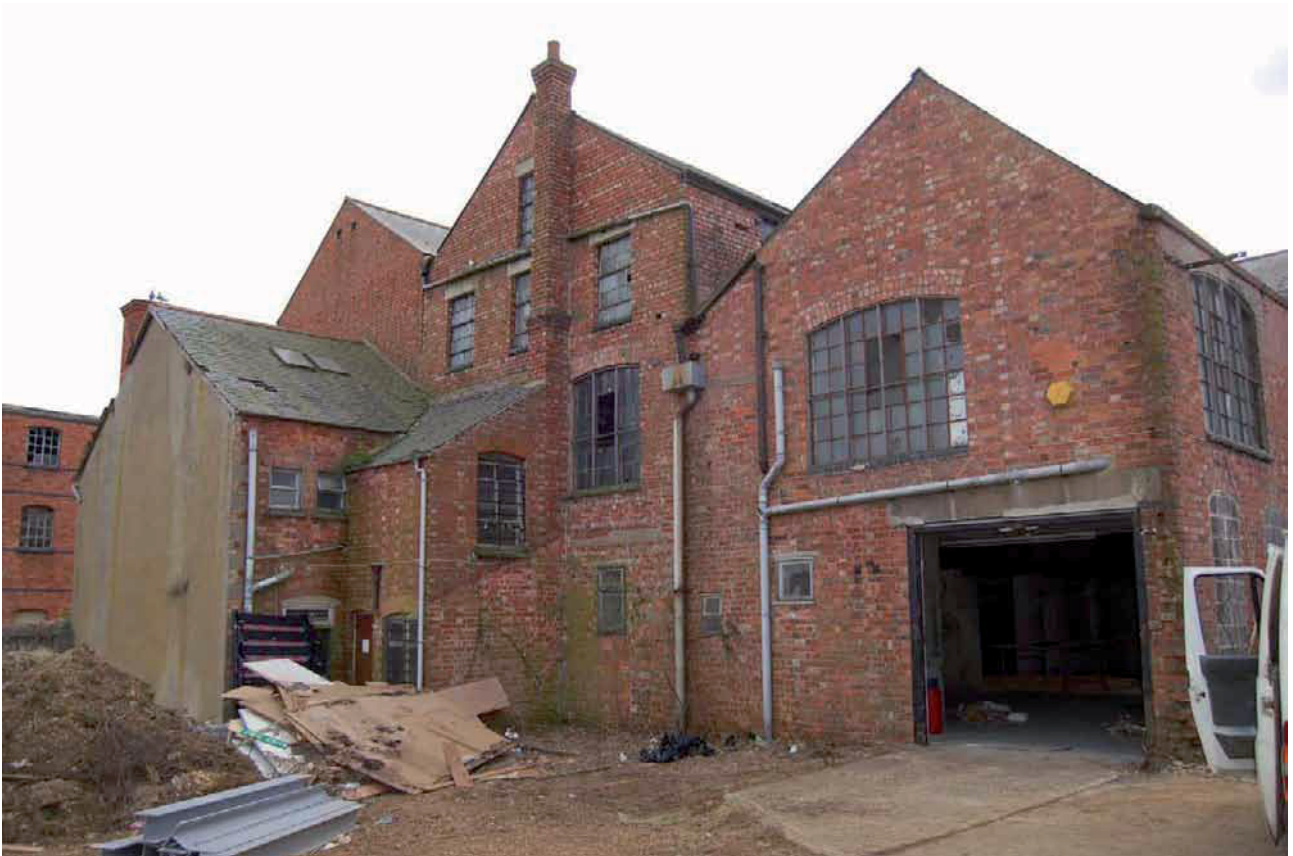
Plate 6: East elevation of the factory with Phase 2, central gabled section.

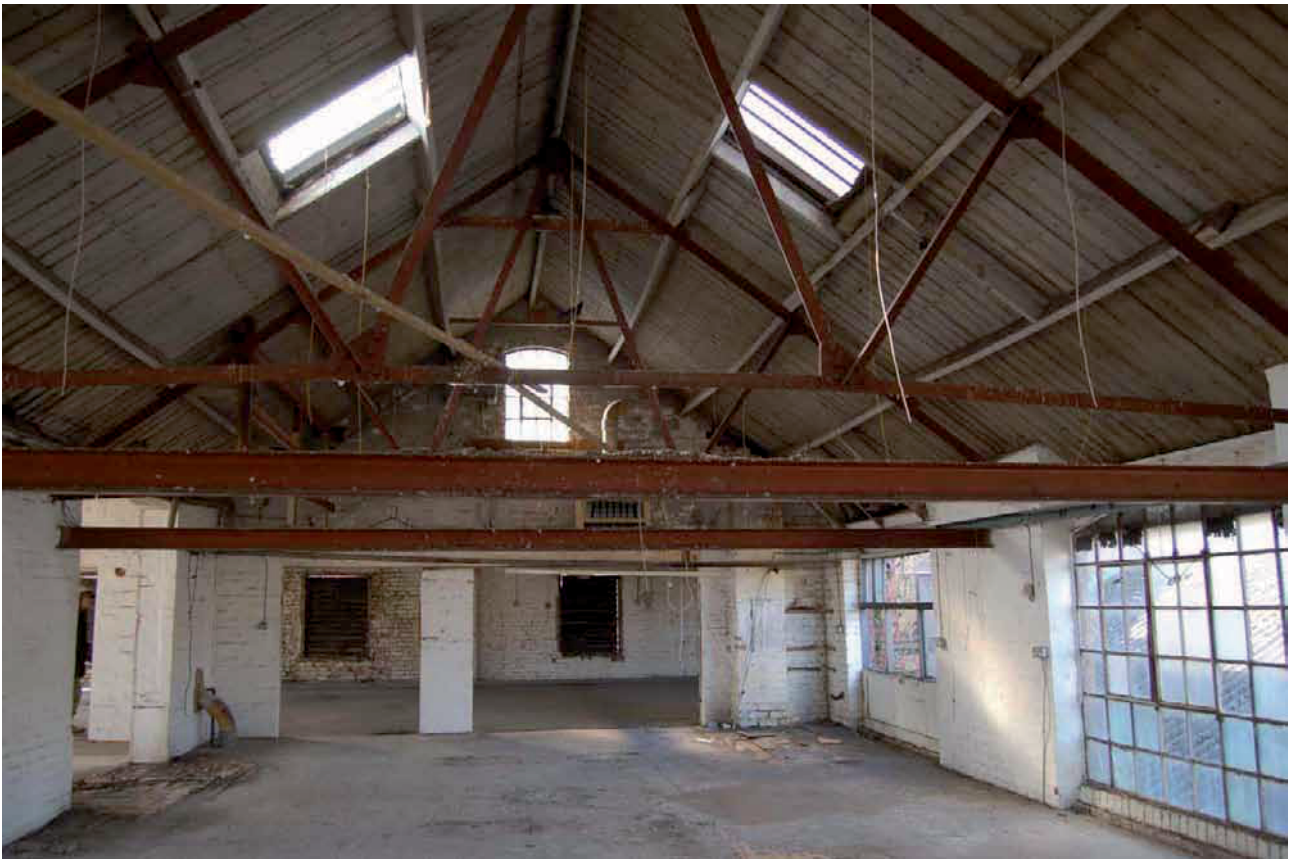
Plate 7: Angle-iron roof trusses of Phase 2, looking west.

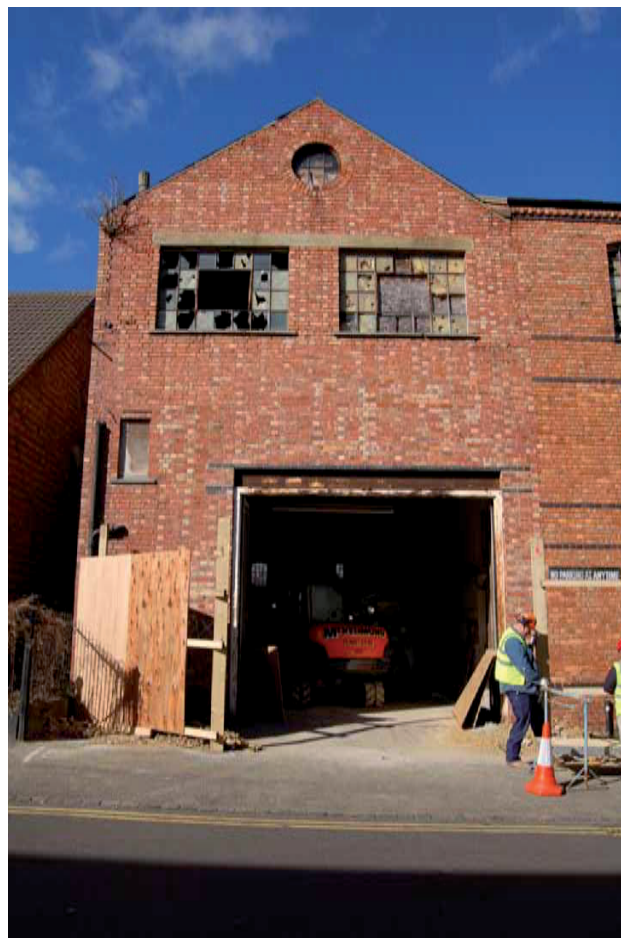
Plate 8: Victoria Street elevation of Phase 3, looking north.

- 5.10 **Phase 3. Exterior.** This phase comprises a rectangular building with its gable ends aligned perpendicular to phase 1 (Figs 7 and 11, Plate 8). Built of a paler and poorer quality red brick compared to the original building it has none of the detail which characterises phase 1 and is clearly a much more utilitarian structure. This addition (and phase 4, see below section 5.13) is present on the 1926 Ordnance Survey map, though the English Heritage Rapid Survey Record incorrectly suggests it was added along with phase 4 in a single phase in the 1930s. The original configuration of the gable end on Victoria Street is not entirely clear. A large doorway has been inserted at ground level which has removed any earlier layout though an original pedestrian door survives close to the west wall (Fig 11). The west wall is partly below the ground level of the adjoining plot and serves not only as the west wall of the building, but also as a retaining wall; it has no windows at this level. On the first floor there appears to be some evidence of former windows on the street frontage but this is not certain. A small window remains set beneath a flat lintel of edge set bricks capped by a single, slightly projecting course of tiles to form a drip mould. The sill is concrete. In the west wall at first floor level there are two wide windows beneath concrete lintels set with 28 light cast iron frames, the central six of which could be opened. The same size and shape windows are present in the south elevation. In the gable above eaves level is an oculus, set within two rows of edge set brick. The

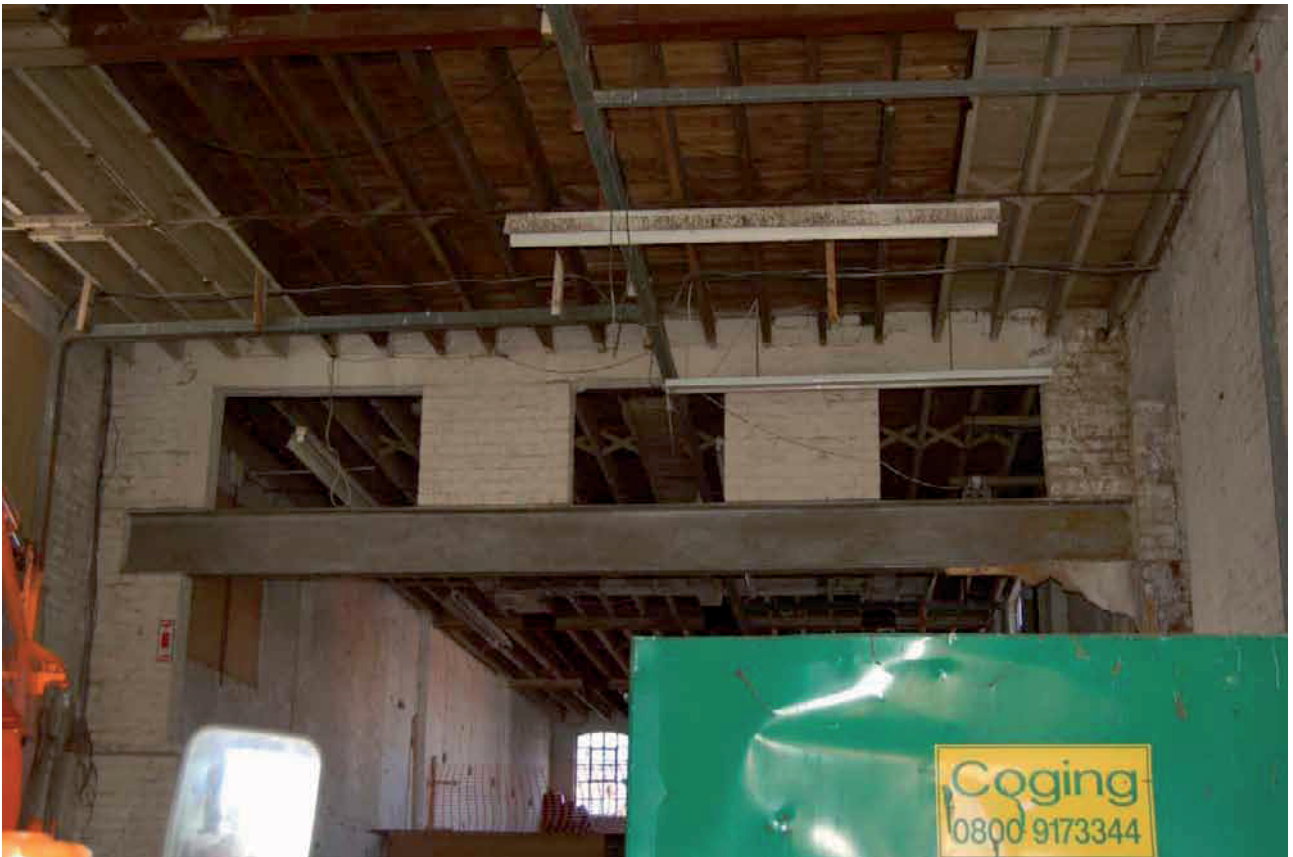
Plate 9: North wall of Phase 3 with truncated windows at first floor level, looking north.

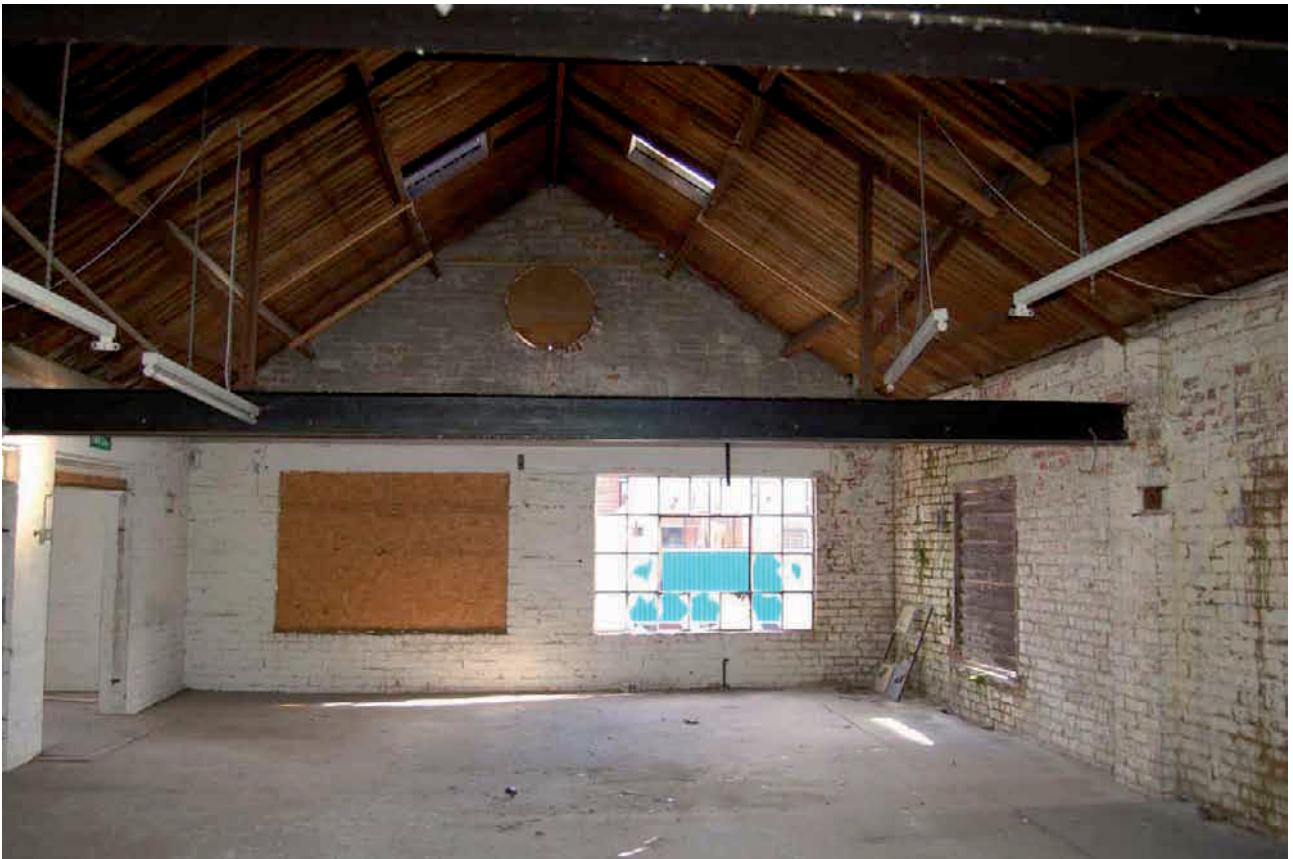
Plate 11: South gable end of Phase 3, looking south.

- 5.12 **Phase 3. Interior, Second floor.** The second floor is accessed either via the stairs in phase 1 or phase 4, but it has none of its own (Fig 10). The floor is a single open space and is lit by windows in the south wall (see section 5.10, Plate 11). The west wall has three openings but these are fitted with horizontal wooden louvres not windows (Plate 12). This suggests that the upper floor was used for the drying of materials, almost certainly leather, at some stage. Each horizontal section of the arrangement is hinged at either end on the outer frame and would have been connected to a central vertical bar which when moved up or down would have opened or closed the louvres. There are two full height opening in the east wall which connects with phase 1 and two through to phase 2, both with concrete lintels. The remainder of the room is a single open space. The roof is supported on simple angle-iron steel trusses which rest on H section beams (Plate 11). The underside of the slate roof is boarded.

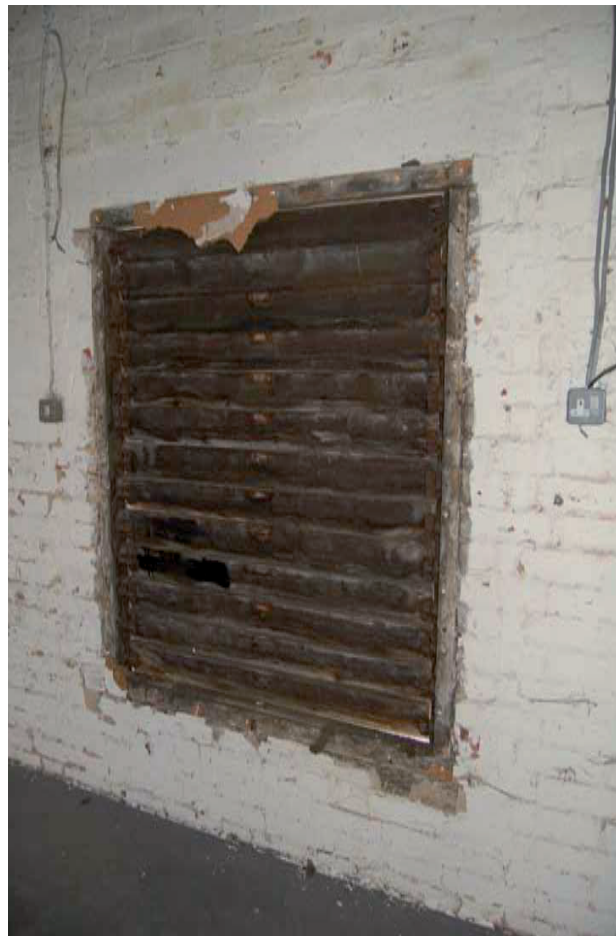
Plate 12: Louvred window in west wall of Phase 3.

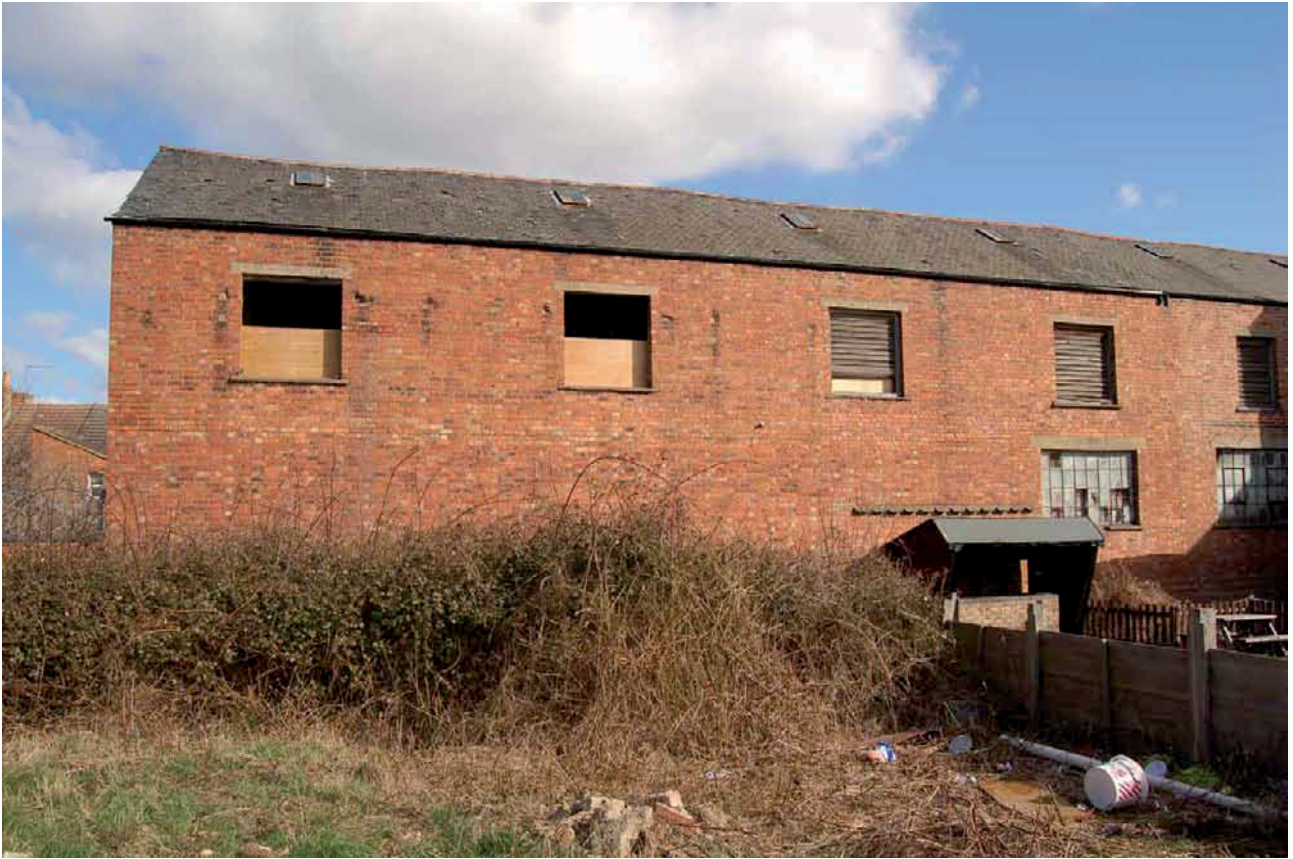
Plate 13: West elevation of Phase 4, looking east.

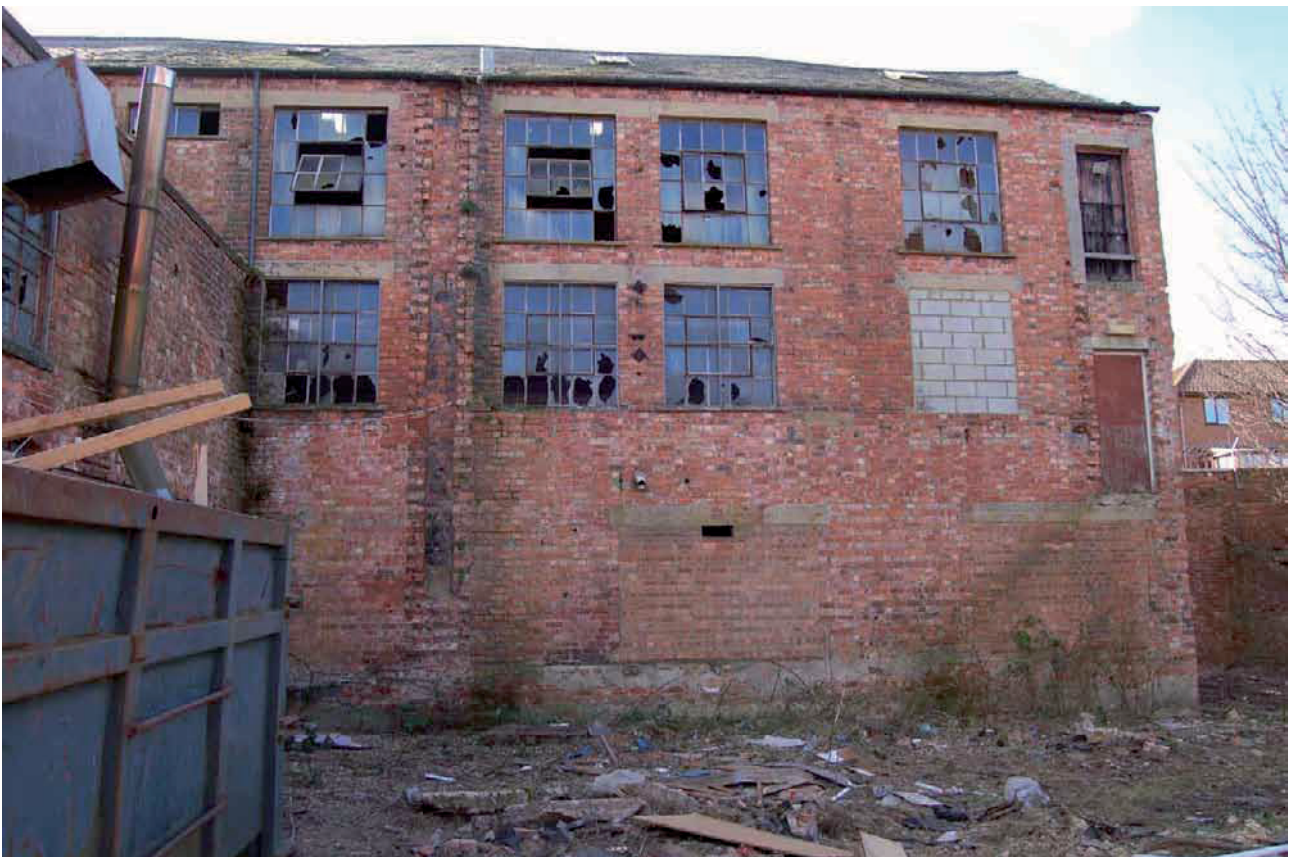
Plate 14: East elevation of Phase 4, looking west.

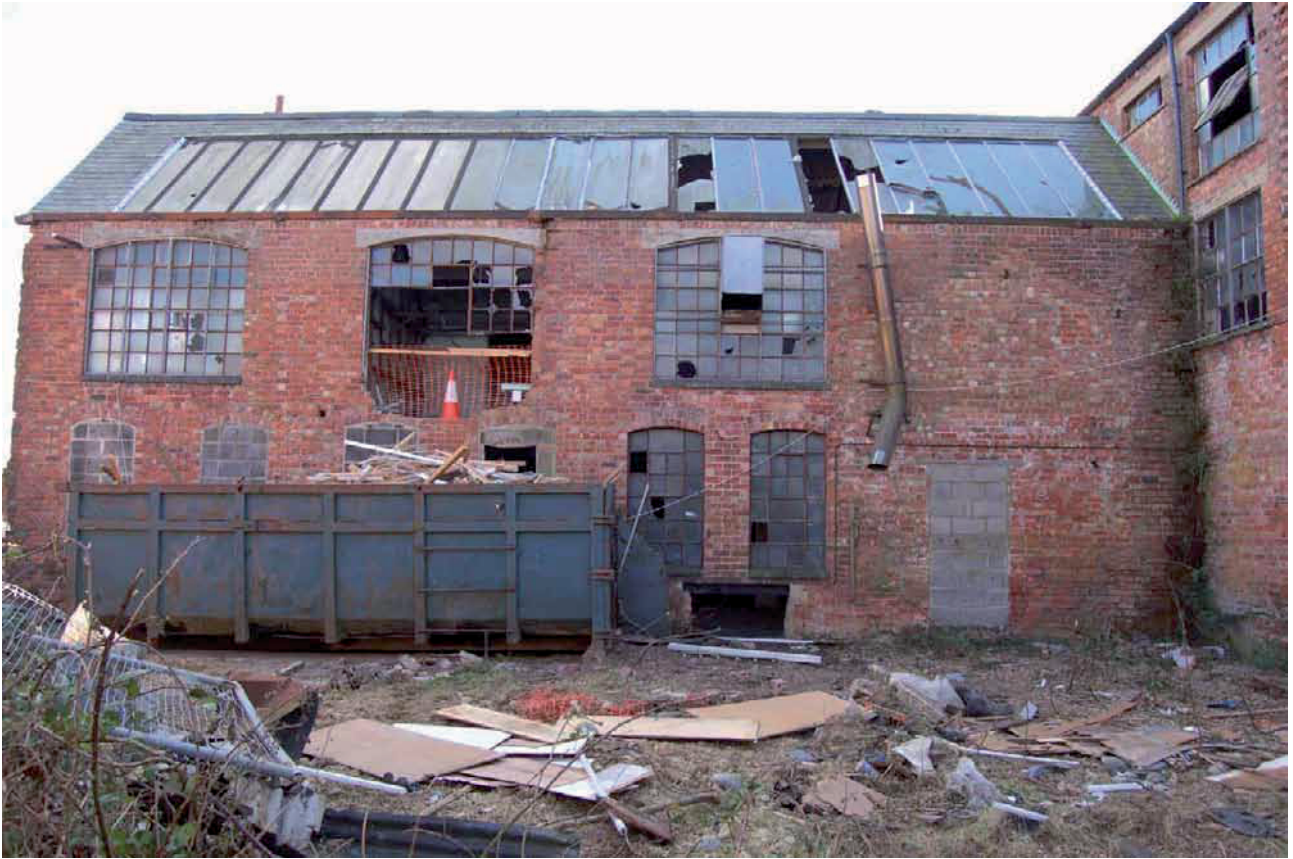
Plate 15: North elevation of Phase 5, looking south.

- 5.17 **Phase 5. Exterior.** The same width as phase 1 and 2 but curiously built slightly off-square (Figs 7 and 12). It is two storeys high and constructed of pale red brick beneath a Welsh slate and glass roof (Plate 15).

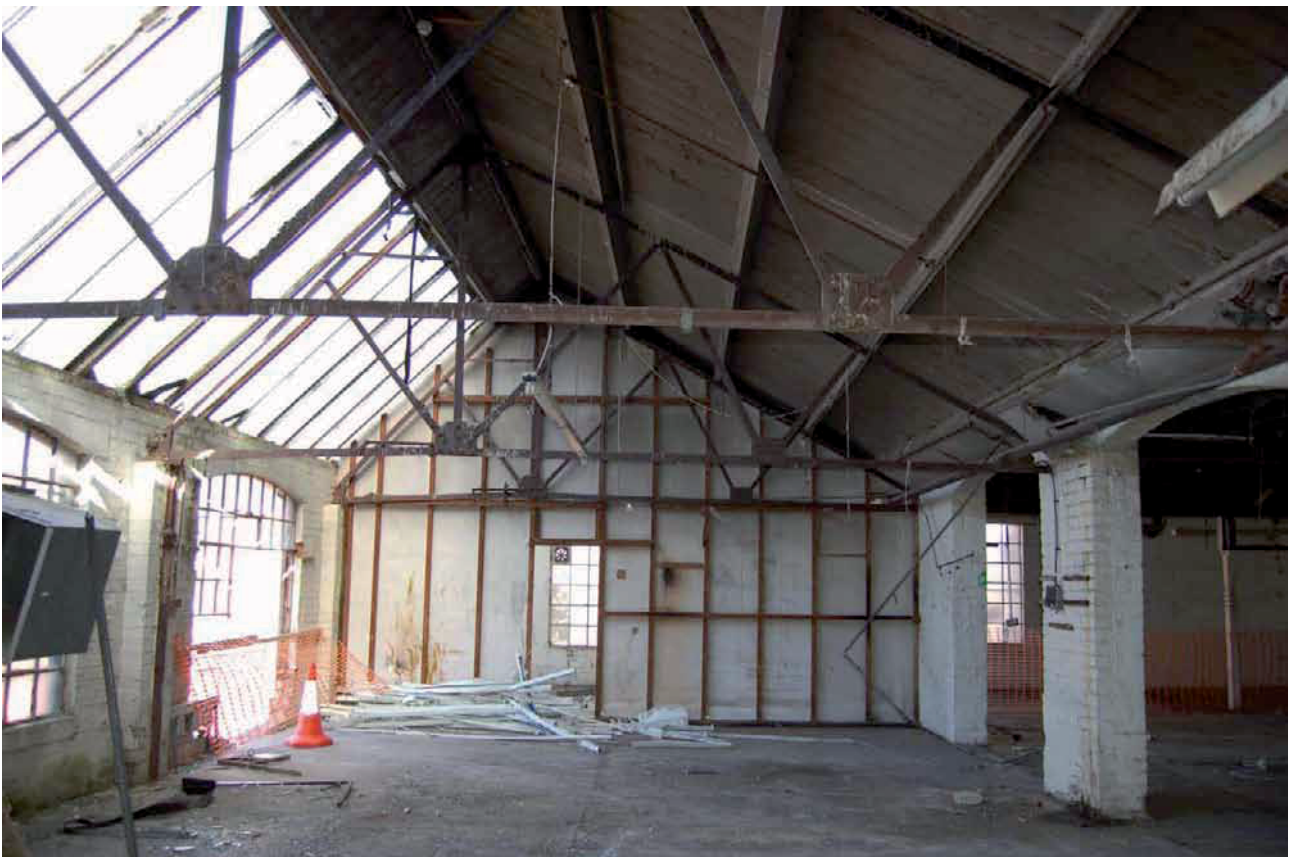
Plate 16: Angle-iron roof trusses of Phase 5 and skylights, looking east.

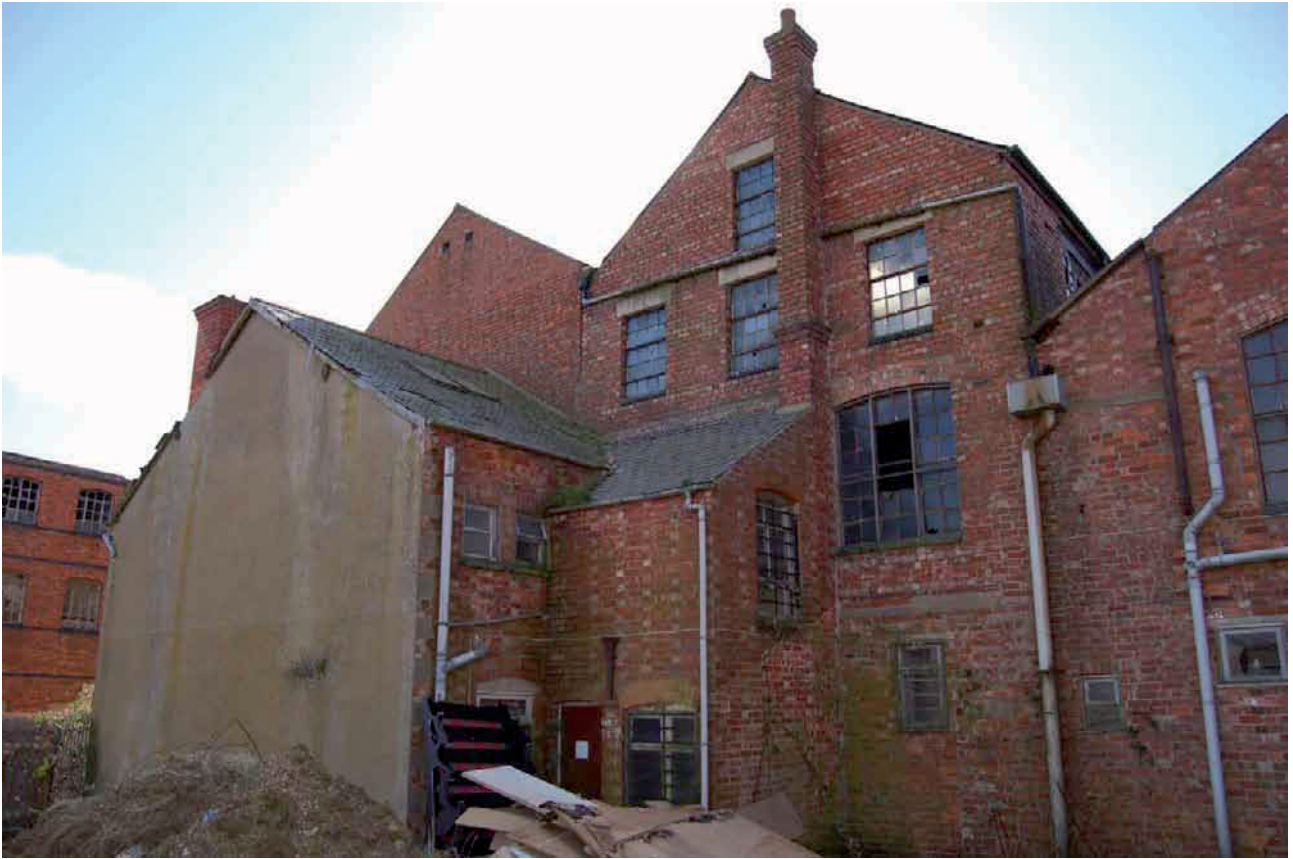
Plate 17: East elevation of the terraced house with cement rendered east gable wall showing where the adjoining terrace has been removed.
