Archaeological Investigation of

Priory Farm, Bell Lane

Husbands Bosworth

Report 07/147

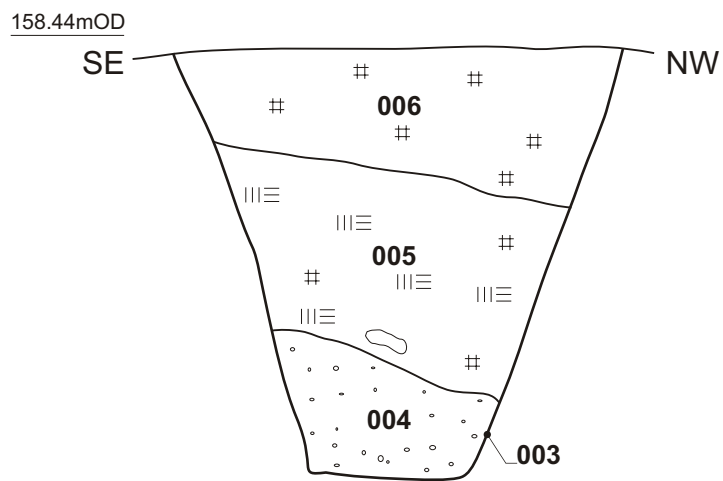
**Section 1**

The area of the house footprint was excavated to the required level. This was parallel to Bell Lane in the southern area of the development area (Fig 2). The natural substrata comprised orange/brown clay with flint nodules, sealed by a layer of mid brown silt topsoil, 0.30m – 0.40m thick. A pit [003] was uncovered within this house footprint (Fig 2, Plate 4). It measured 0.64m wide by 0.57m deep and had a steep side with a flat base

(Fig 3, section 1). A clay pipe bowl dated to the early/middle 18th century was found in the pit's lowest fill (004). Immediately to the south of the house footprint approximately one third of a post-medieval millstone was found within the topsoil (Fig 2, Plate 1). It remained on site as part of the property of the owner.

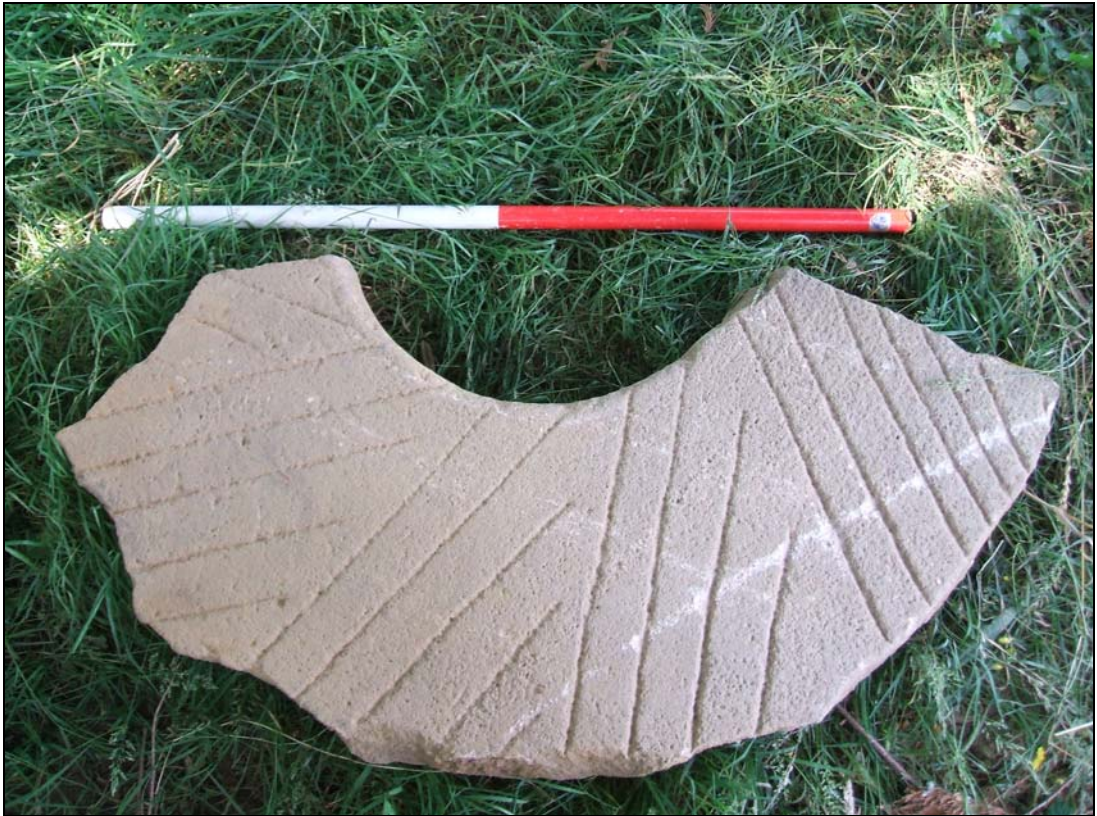
Plate 1: Piece of Millstone found in topsoil at southern end of site (scale 1 metre)

The only feature found was one pit dating to the 18th and 19th centuries. A disturbed stratigraphy was revealed in the northern area of the site, which had been caused by the demolition of the old farmhouse. The post-medieval millstone found in the topsoil in the southern end of the site may have been used as an ornament in the farmhouse garden.

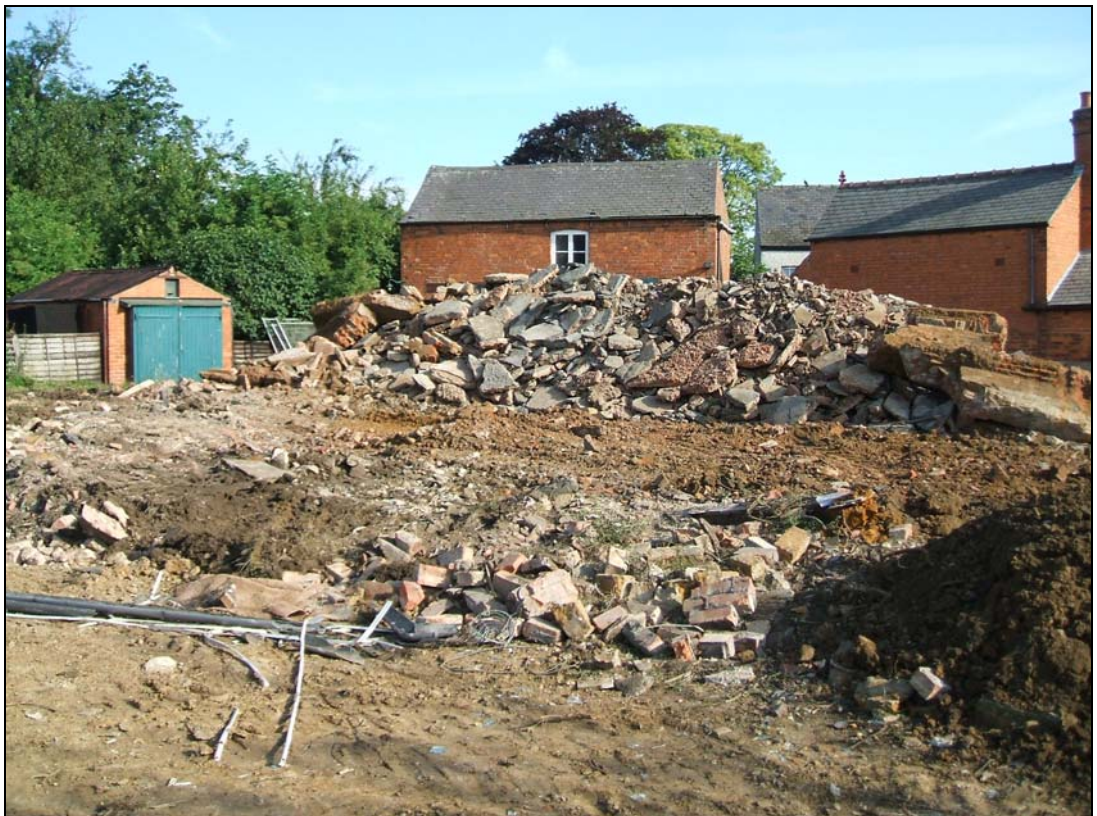
The foundations for House Plot 2 were excavated to the required level in the northern area of the site (Fig 2). The natural substrata comprised orange/brown clay with flint nodules, this was sealed by a layer of mid brown silt topsoil, 0.30m – 0.40m thick. The house footprint area was disturbed by the foundations of the previous house situated in this area (Fig 2, Plates 2, 3). The area to the north of House Plot 2 was covered in reinforced concrete. No archaeology was present in the northern area of the site.

Plate 2: Northern area of site after the demolition of the old farmhouse

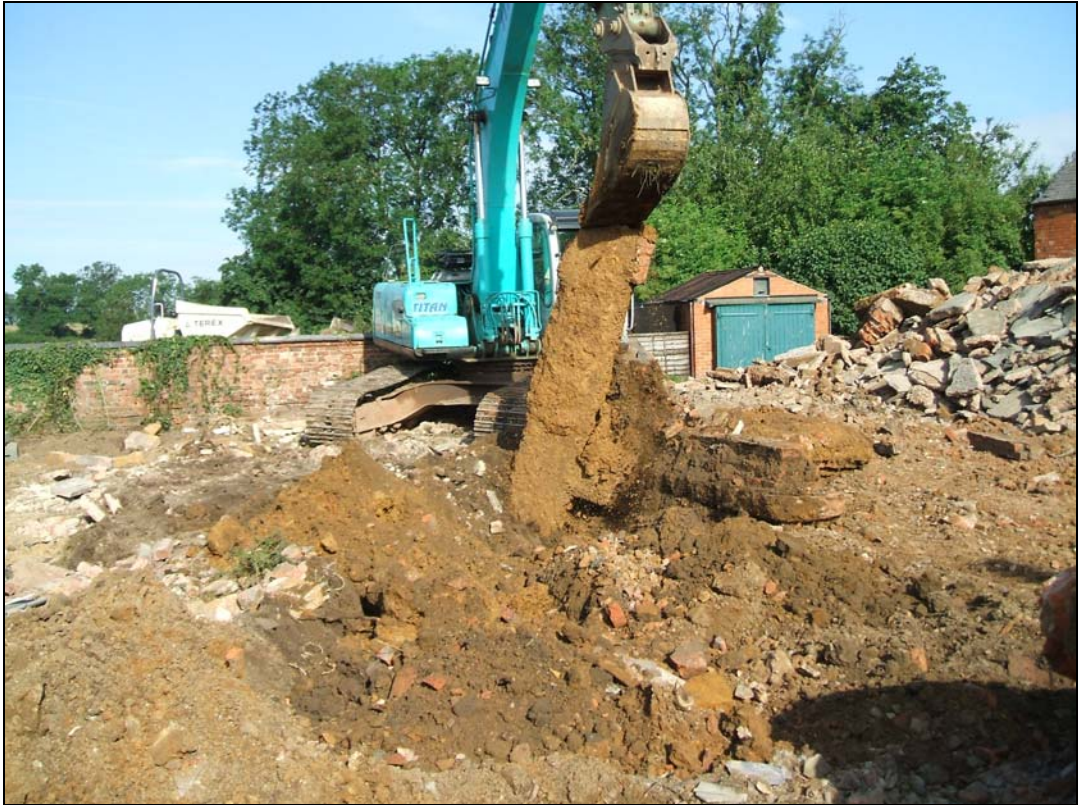
Plate 3: Machine excavating the foundations of the old farmhouse

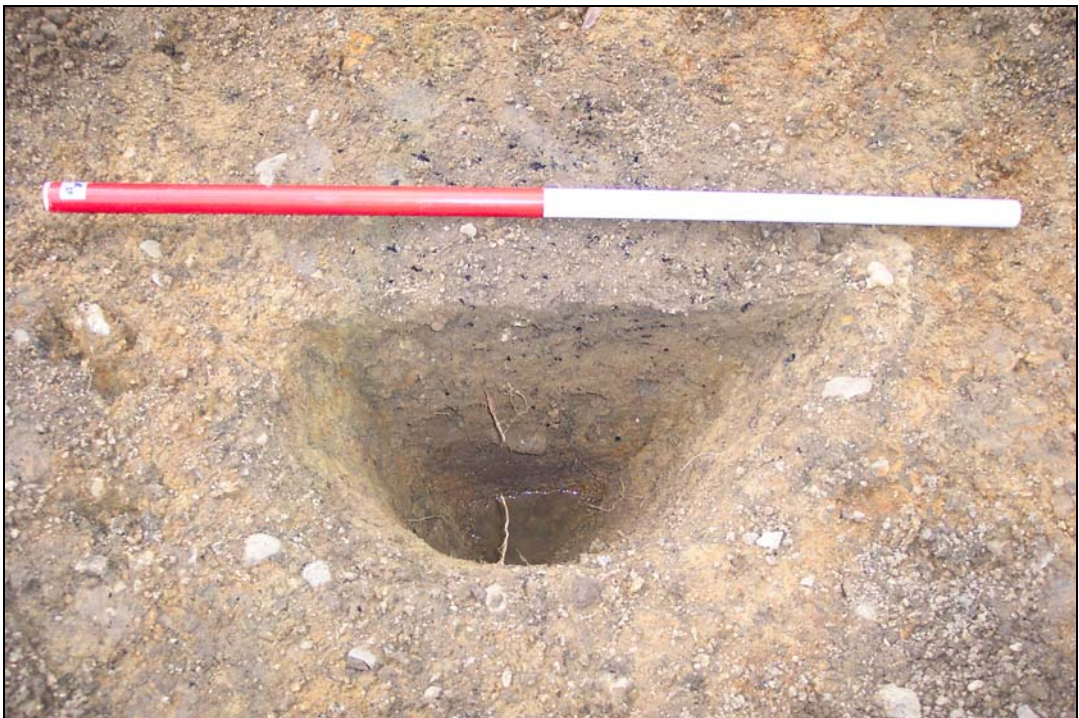
Plate 4: Post-medieval pit [003] found within House Plot 1 (scale 1 metre)
