An archaeological watching brief at
Holy Trinity Church,
Old Wolverton, Buckinghamshire
November 2006
Accession No: 2007.38

March 2007

Report 07/35

**AN ARCHAEOLOGICAL WATCHING BRIEF
AT HOLY TRINITY CHURCH,
OLD WOLVERTON, BUCKINGHAMSHIRE
NOVEMBER 2006**

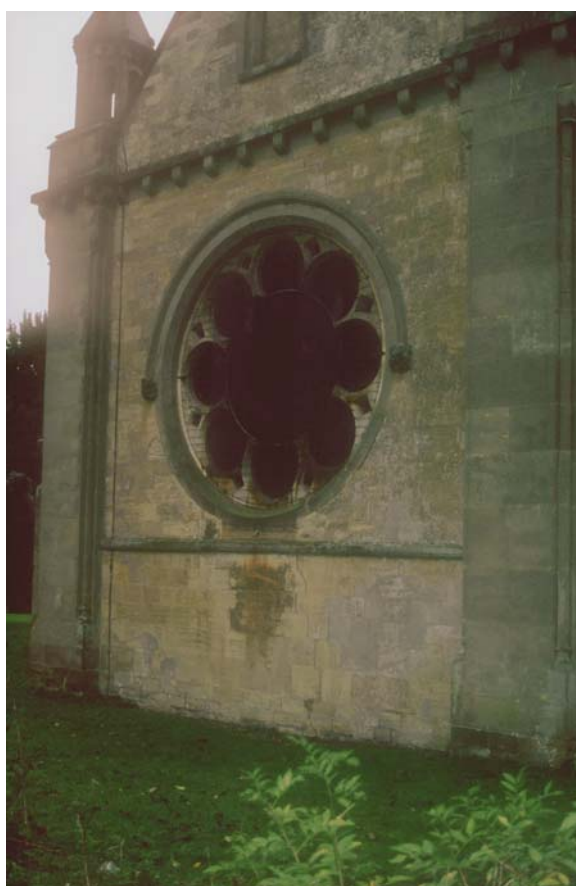
Plate 2: The east wall of the Chancel

Two test pits were excavated at the eastern end of the church against the east wall of the chancel (Plate 2). These were excavated using hand tools with an extension in test pit two using drilling equipment.

Test pit 1 was excavated against the north-east corner of the chancel and measured 0.40m square with a maximum depth of 1.0m. The stratigraphic sequence comprised grey/brown natural clay encountered at a depth of c0.36m below present ground level. Sealing this was grey/brown topsoil/turf layer, up to 0.30m thick, containing occasional fragments of modern, red ceramic building material and occasional fragments of sandstone. No cut for a construction trench could be discerned, however disturbed material, comprising numerous fragments of sandstone and ceramic building material adjacent to the chancel wall clearly indicates the presence of a construction trench.

An examination of the wall foundation within the test pit revealed that the masonry steps out 0.18m at a depth of around 0.25m. This is of similar construction, although rather more rudimentary, to the masonry above and extends down to a depth of c0.85m below present ground level.

Test pit 2 was excavated against the south-east corner of the chancel and measured 1.55m square with a maximum depth of 1.9m. An examination of the stratigraphic sequence revealed made up ground, comprising numerous fragments of modern ceramic building material and occasional fragments of sandstone within a matrix of mid brown silt loam with occasional pockets of gravel and coal ash. This extended from the base of the pit up to 0.30m below present ground level and was sealed by grey/brown silt loam topsoil/turf layer containing occasional fragments of modern ceramic building material, up to 0.30m thick.

The construction of the wall foundation differed to that revealed in test pit 1 in that it was stepped out four times to a maximum distance of 1.32m from the face of the upper wall. The largest step-out was 0.70m at a depth of 1.67m below present ground level, this extended to the base of the trench. Above this, the second step projected out approximately 0.45m from the upper wall face and was 0.20m high. The two upper steps measured 0.07m and 0.10m and measured a combined distance of 0.17m from the upper wall face. The foundation was of similar construction although rather more rudimentary to the above ground wall.

No dating evidence was recovered during the course of the watching brief, however the foundations revealed in both of the test pits suggest that, although constructed of rougher material, they are probably contemporary with the upper wall of the chancel.

The results of the watching brief show that the north-east corner of the chancel is built on natural clays, whereas the south-east corner is constructed on made up ground containing modern ceramic building material suggesting some relatively recent levelling up activity, presumably during the 19th century construction. The builders of the present church appear to have taken this into account during construction and provided this area with more substantial foundations than that employed at the north-east corner.

The church is built in close proximity to the motte and bailey that stands to the east and it is probable that the church stands above a feature such as a defensive ditch which has been levelled over prior to the construction of the church. It is possible that this relatively unstable ground accounts for at least some of the subsidence that the church is presently suffering.
