Northamptonshire Archaeology

An archaeological watching brief
on land at Upton Deserted Medieval Village,
Upton, Northamptonshire
February – October 2006

June 2007

Report 07/090

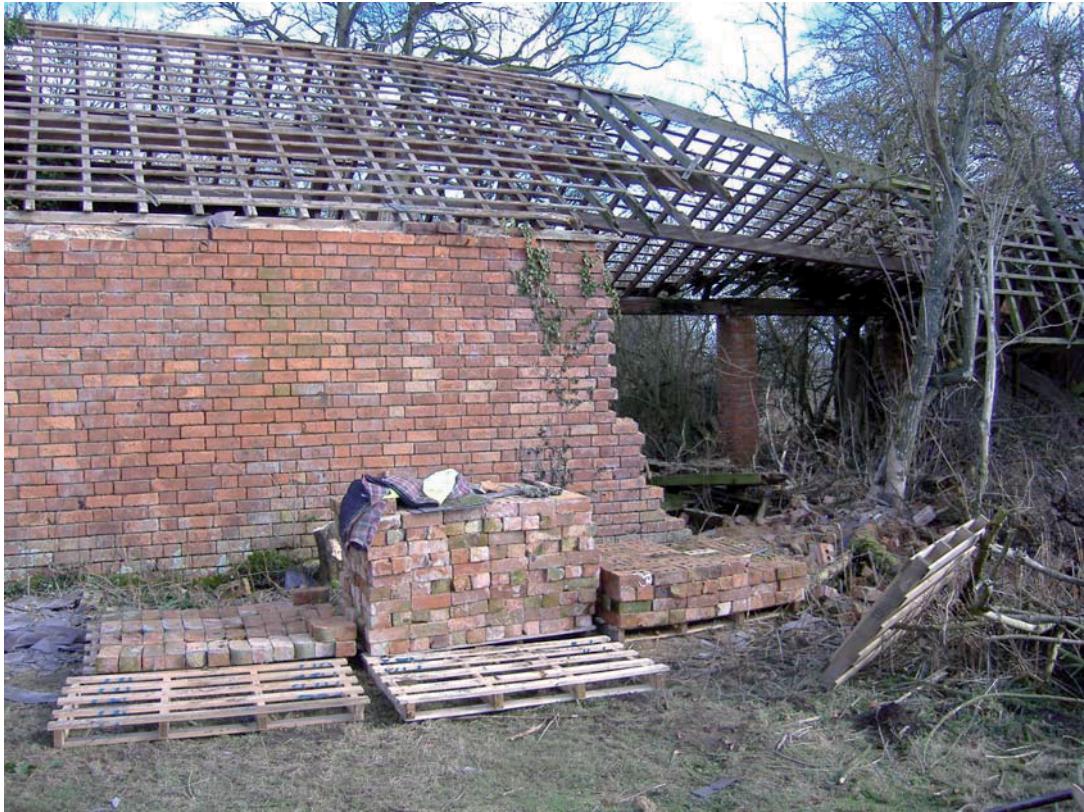
Plate 1: The derelict buildings during demolition, view towards the east

The fieldwork comprised periodic visits to the site during the demolition of the derelict buildings (Plates 1 & 2) and the dismantling and re-building of the stone boundary wall. The buildings were of mainly red brick construction with stone patching that had clearly been inserted later. The ground-works connected with the building demolition were limited in nature and did not therefore impinge on any below ground deposits. Around the vicinity of the buildings extensive 'fly tipping' had taken place, this was cleared during the demolition phase of works.

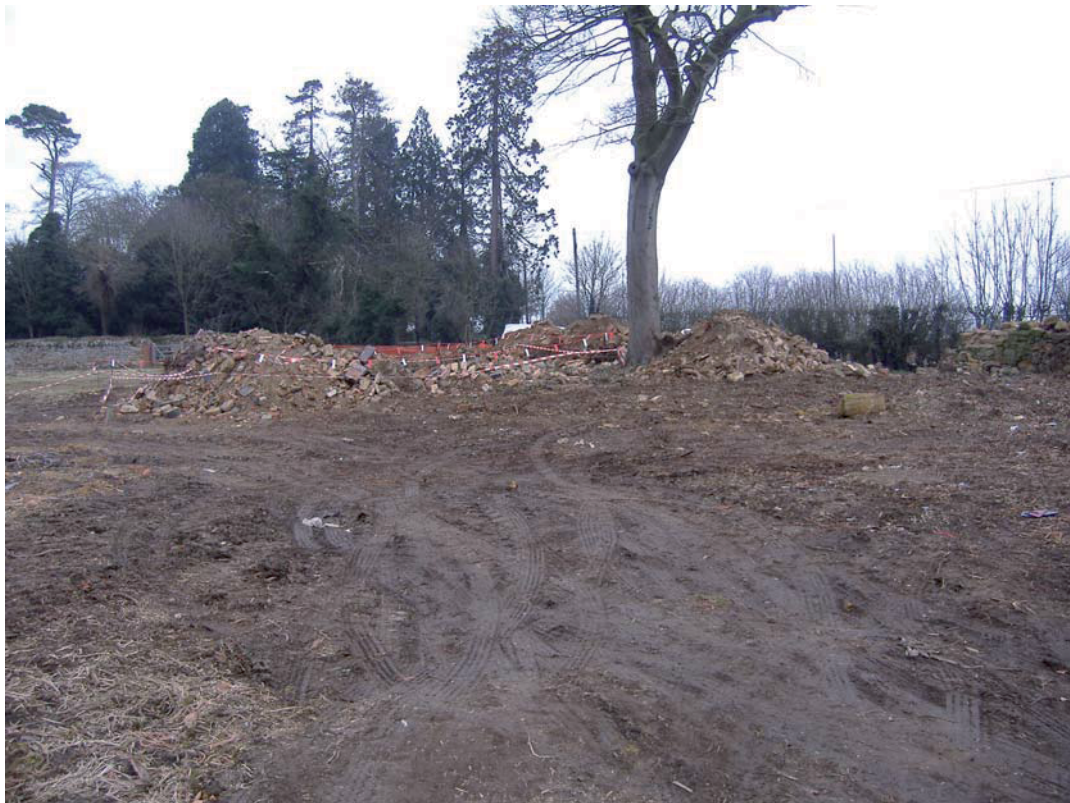
Plate 2: The area of the derelict buildings after demolition with the boundary wall in the background

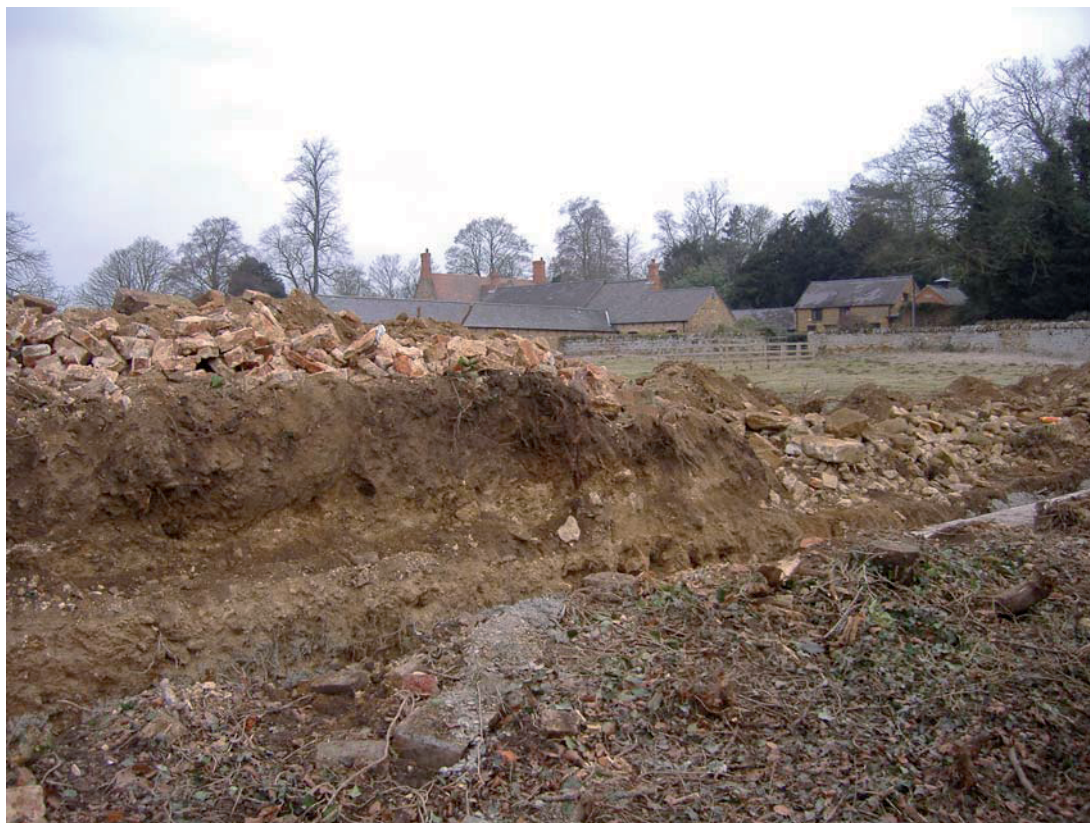
Plate 3: The wall trench in the area of the derelict buildings

A consistent stratigraphy was revealed along most of the line of the new wall foundation, the only variation being in the area where the derelict buildings and several large trees had stood, here the subsoil increased in thickness to 0.48m.

No archaeological features were observed in the exposed sides and base of the wall’s original foundation trench.

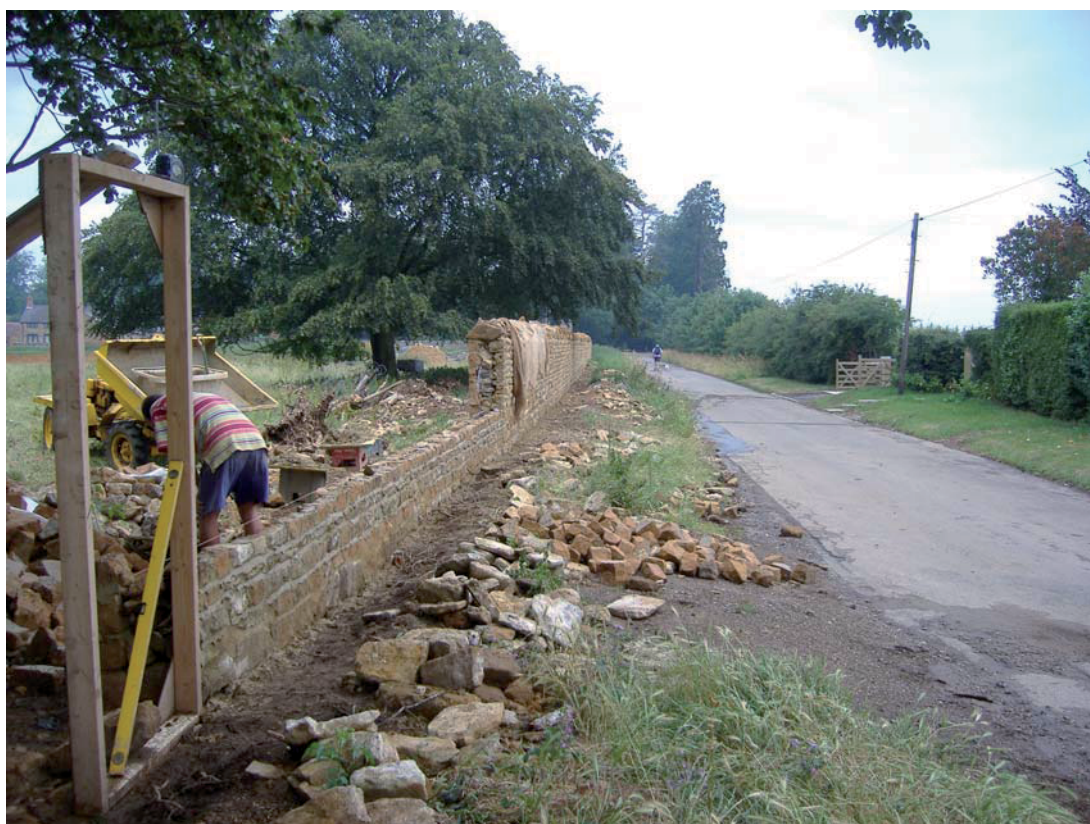
Plate 4: The new wall during construction, viewed to the north

The stone masonry of the wall was dismantled down to, and including the foundations in sections of up to 50m in length (Plate 4). As much original material was retained for re-use in the reconstruction, this was supplemented with a mixture of re-claimed stone from the derelict buildings and new imported stone. The line of the new foundation was then excavated to a maximum depth of 0.42m using a mechanical excavator, the new foundations being contained within the original footprint mitigating the impact on any potential archaeological deposits.
