An archaeological desk-based and building
assessment of Chesham House, Kettering
Northamptonshire

May 2008

Report 08/103

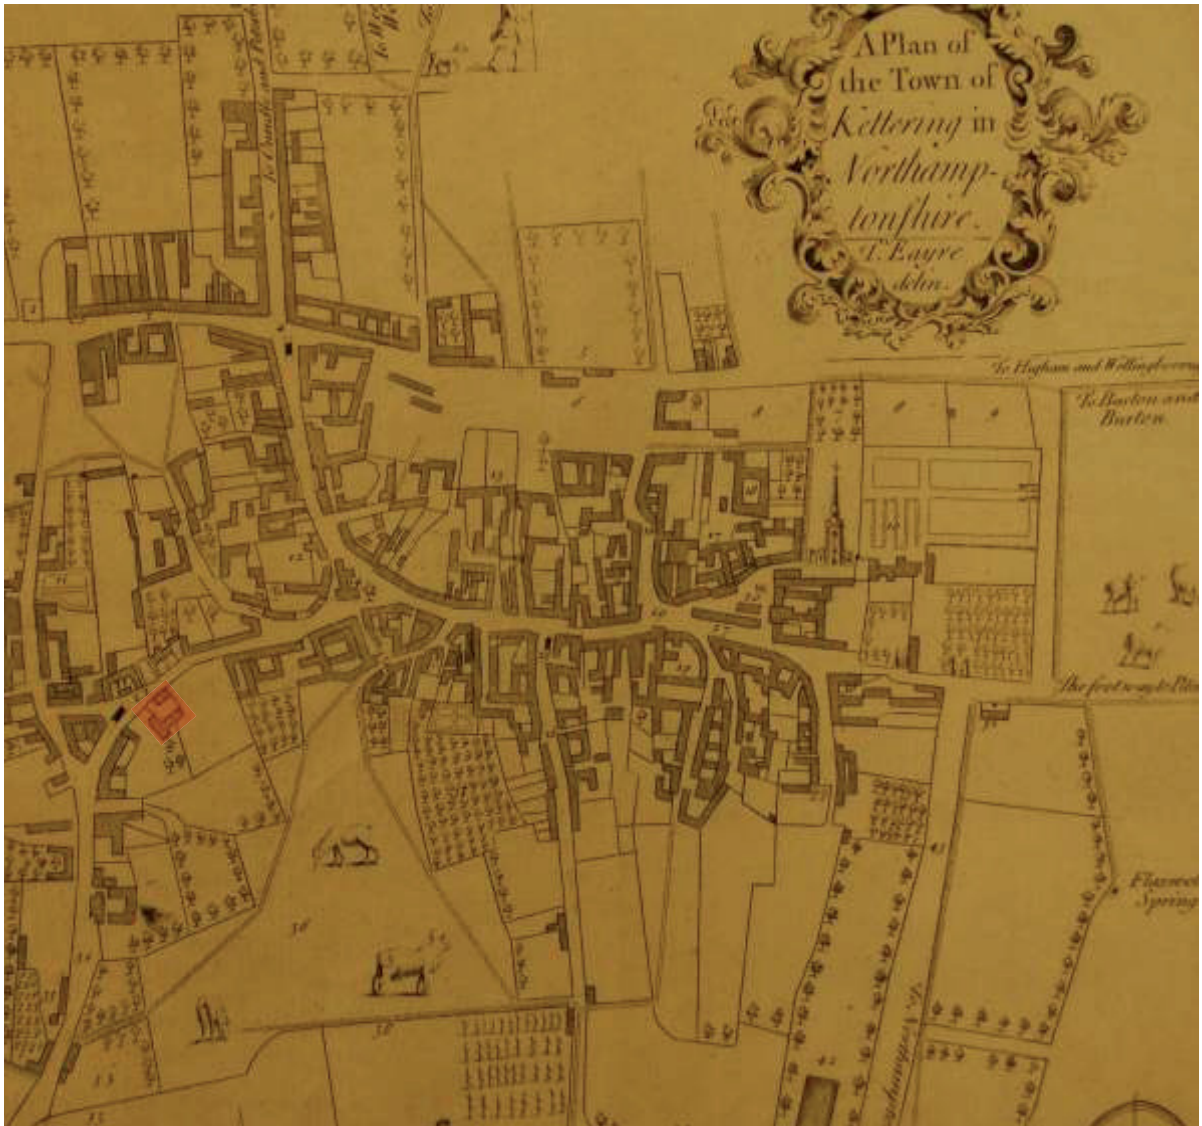
This map shows the town in a high level of detail with individual buildings marked (NRO 1161). There is a building depicted on the plot currently occupied by Chesham House, but which does not correspond with the present structure. It would seem that this is an earlier building demolished to make way for the present house.

Site of the forerunner to the current Chesham House

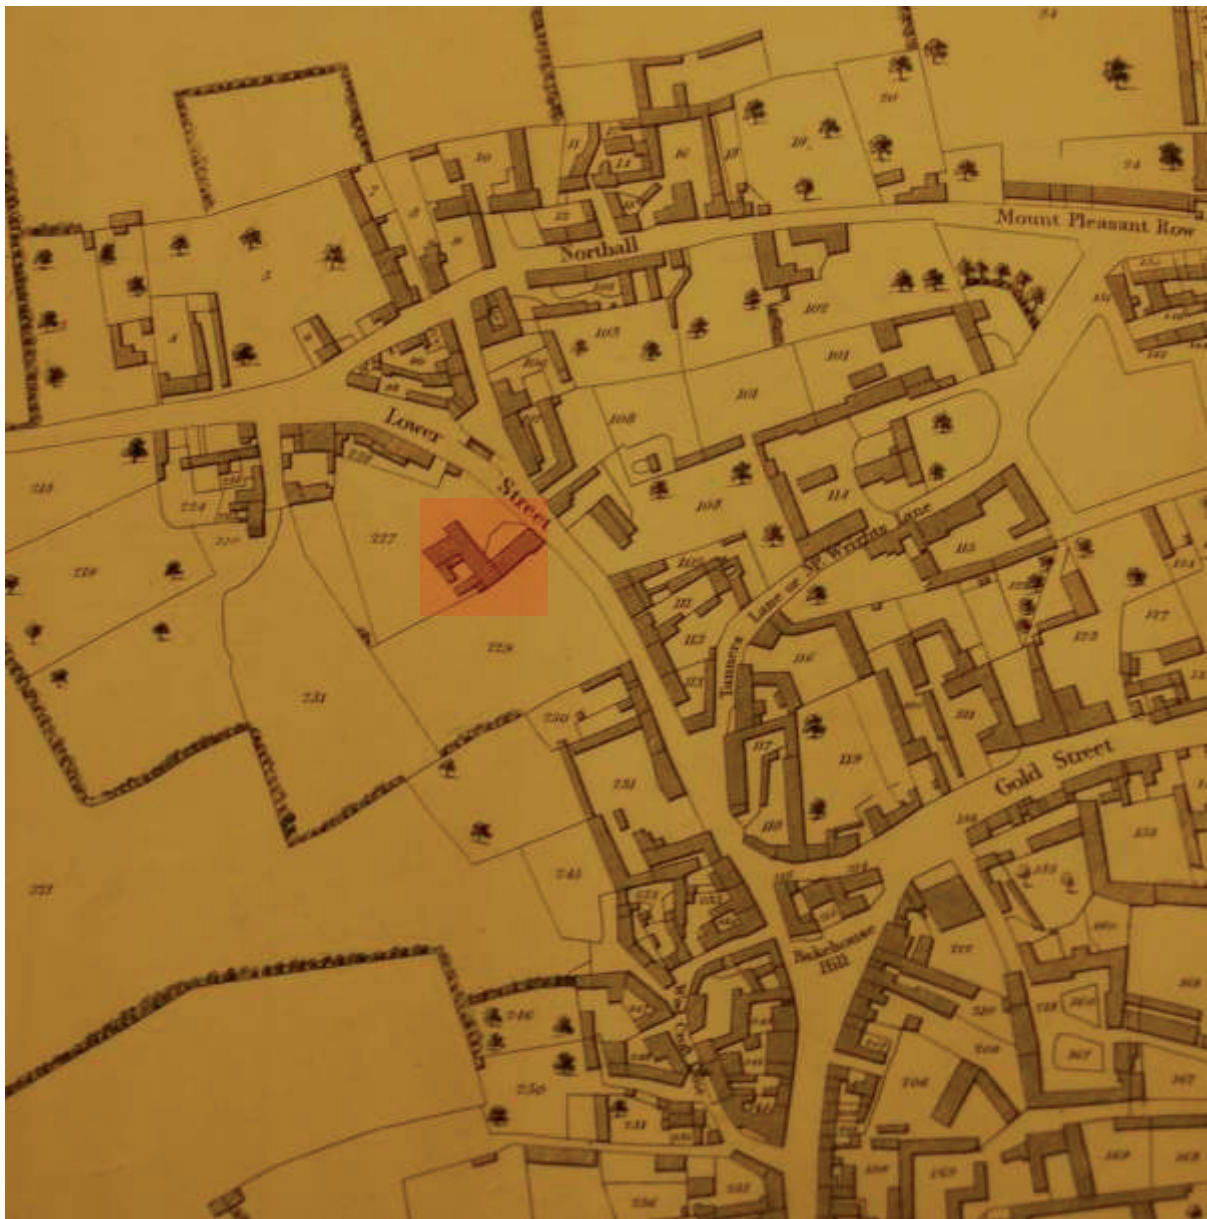
Robert Smith, 1826 Fig 3

This plan of the town depicts a similar level of detail and by now Chesham House is clearly present, with some additions which have been subsequently removed (NRO map 5596). With the exception of the long range which reaches the street frontage along the southern side of the plot, the remainder of the building appears to be almost entirely as that which exists today. A number of small additions or alterations at the rear of the building have been made, these will have been service facilities and do not affect the main part of the house.

Rooms G12-G15 are currently divided by partitions into toilets and storage in what is now the flat roofed part at the rear of the building, although this part of the building is shown on Robert Smith's map of 1826 and may originally have had a pitched roof (Fig 3). Room G19 is used as toilets with modern partitions.

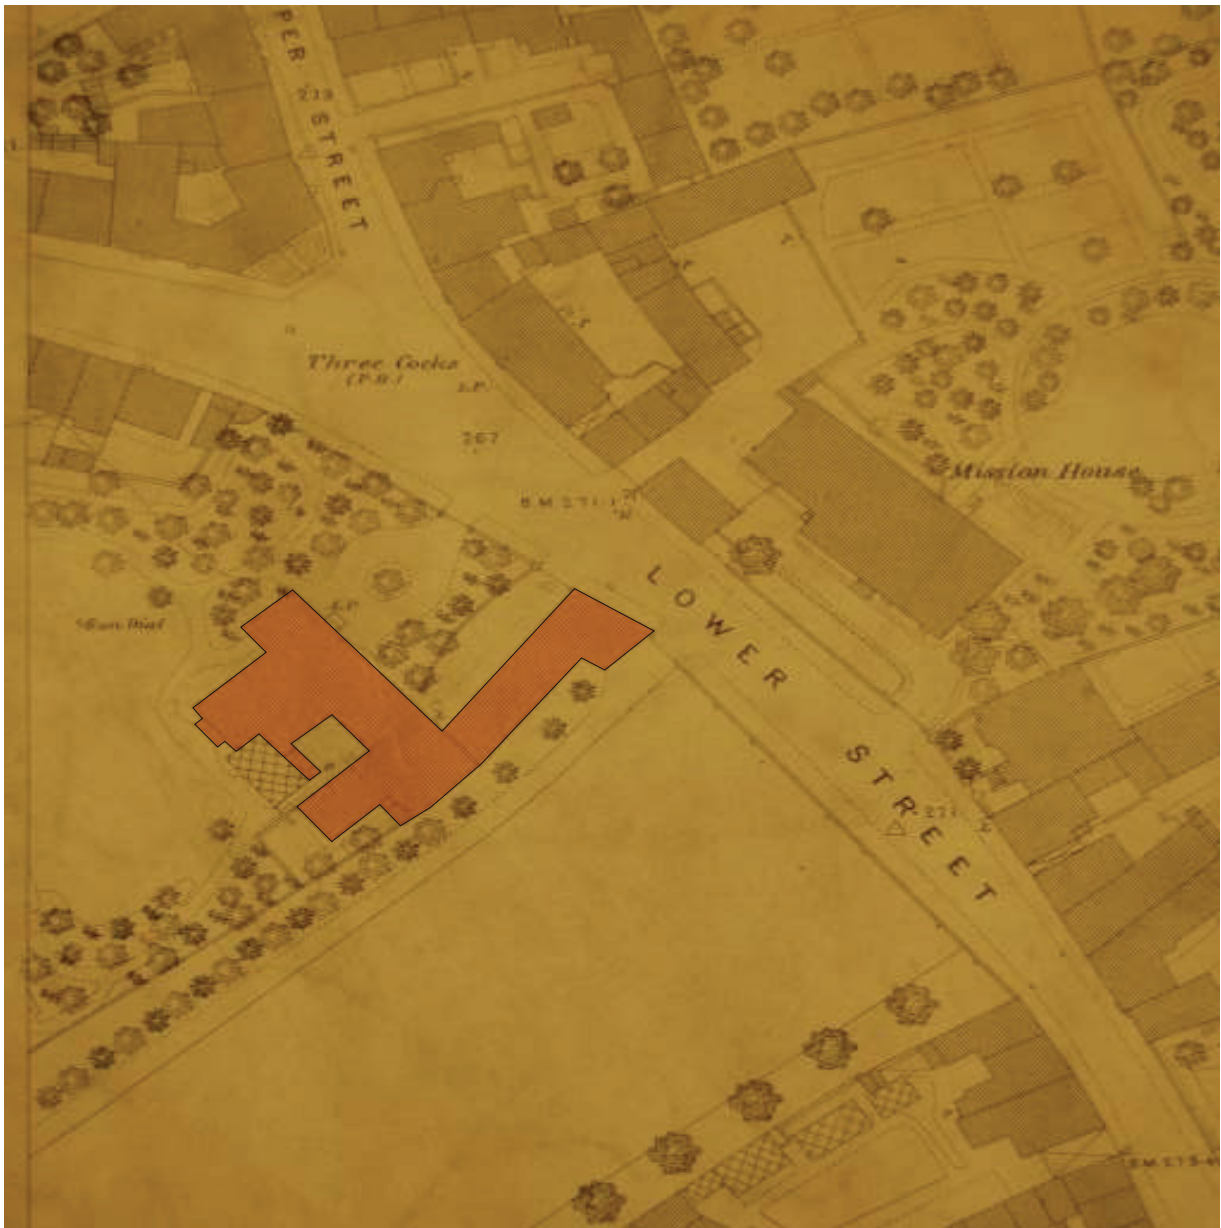
The map shows an almost identical layout to the 1826 plan, with the addition of a glasshouse (diagonally hatched area) and the inclusion of garden layout details. The long south range is still present but neither of the canted bay windows are shown indicating that they were added after this date.

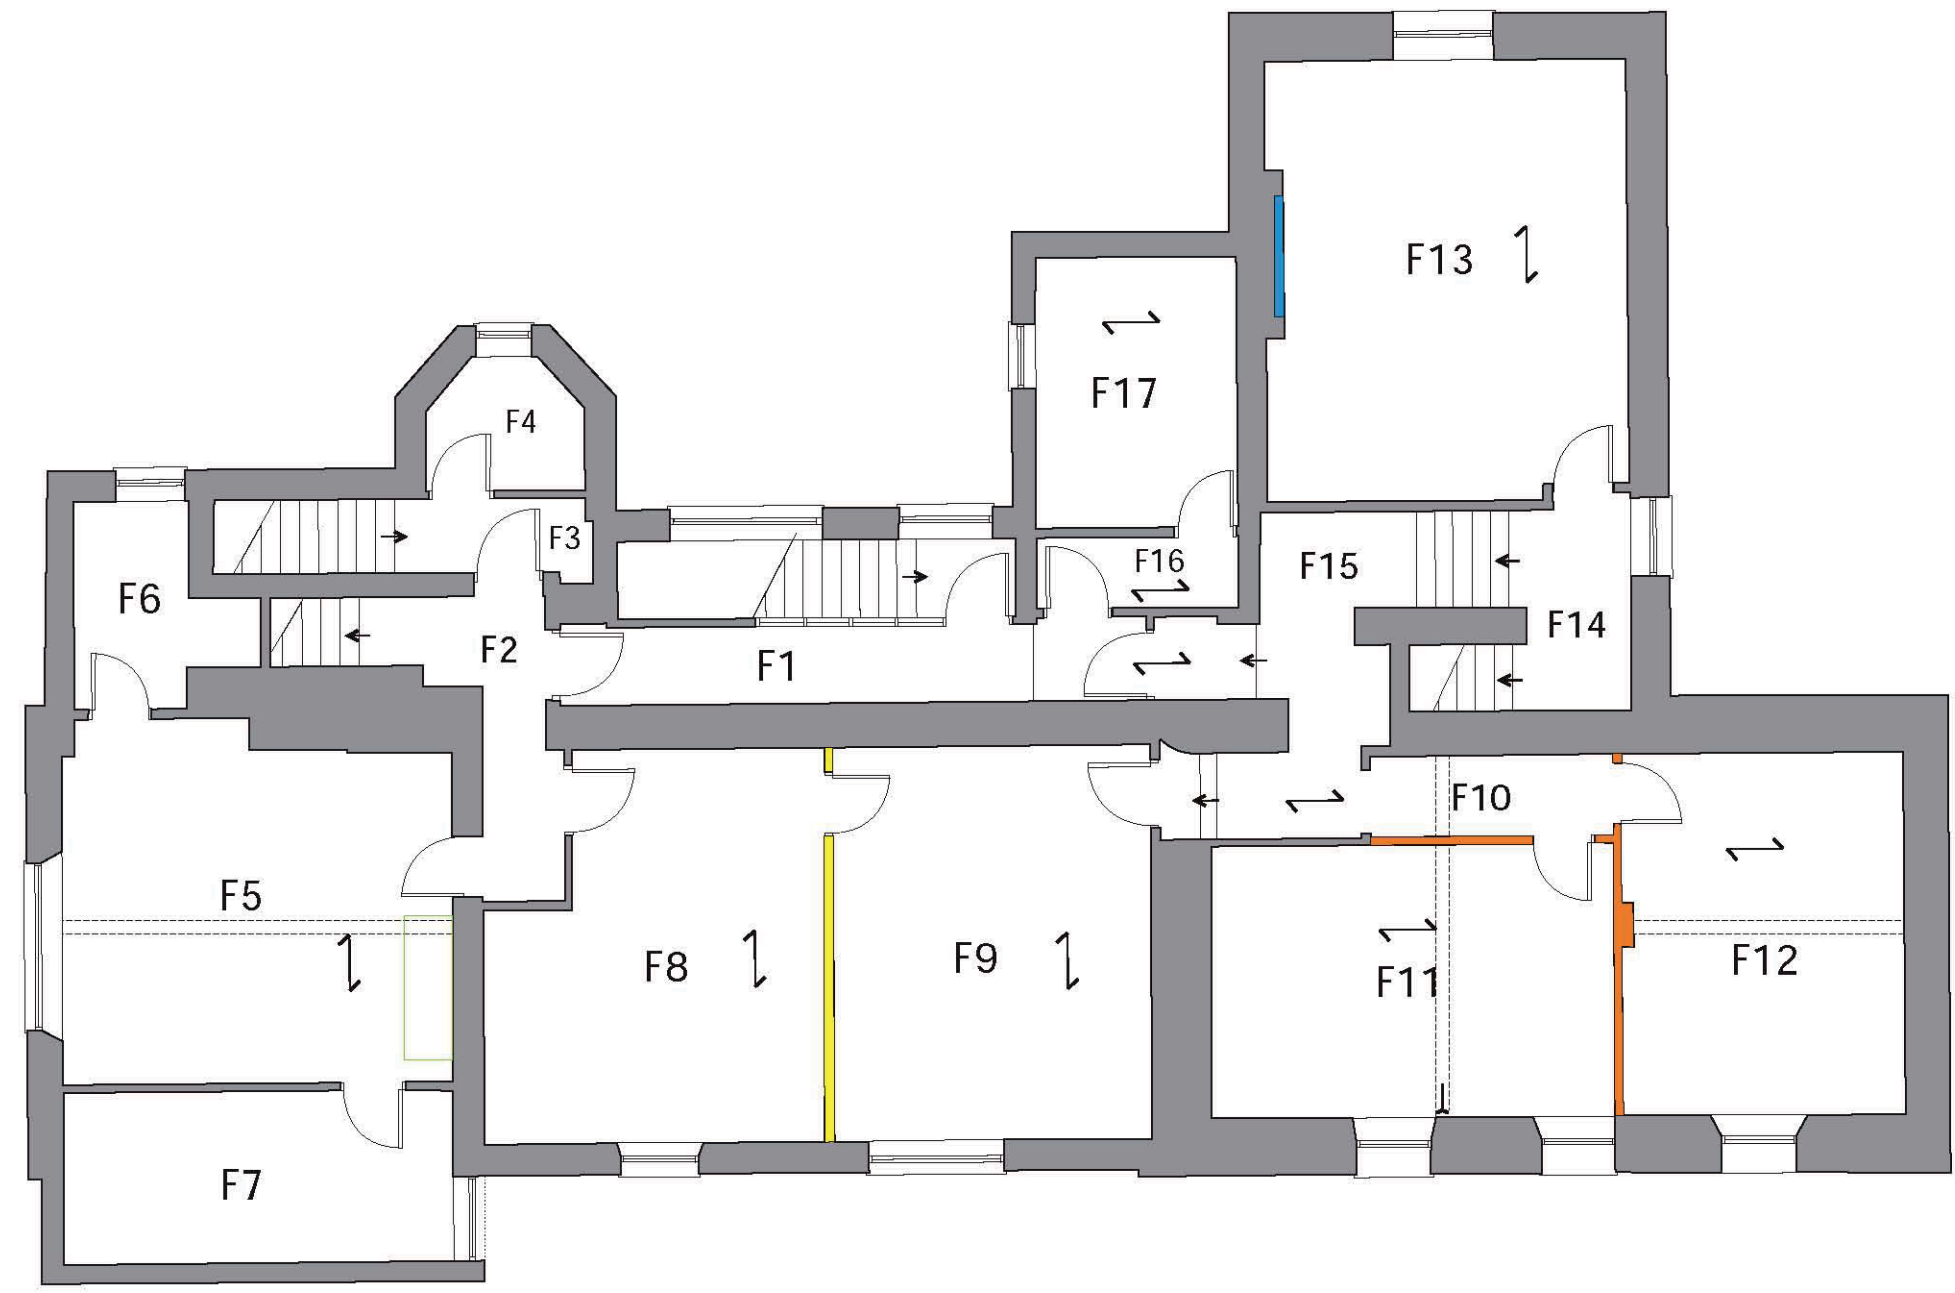
Fig 6

All of the rooms on the first floor and the second floor have replacement modern tongue and groove floor boards c140mm wide. The ceilings on this floor appear to be all lath and plaster.

On the first floor rooms F11, 12 and 13 retained their twelve pane (six over six), un-horned sash windows with those in rooms F11 and 12 retaining their shutter boxes (Plate 10). The only room to retain evidence of a fireplace was F13 where there was a scar on the chimney breast, suggesting that the opening for the fireplace was c1.4m wide. There were no hearth slabs in any of the rooms, these presumably had been removed when the new flooring was introduced.

Room F10 is a passageway created out of a larger room, the remainder of which is F11. Room F12 appears to remain unaltered. Rooms F8 and F9 have also been created by the division of a single room with a lobby and fire door added to create a fire break as well as access to F5. Room F5 and F7 have been made out of a former single room. Room F5 has a semi built in cupboard (Plate 11).

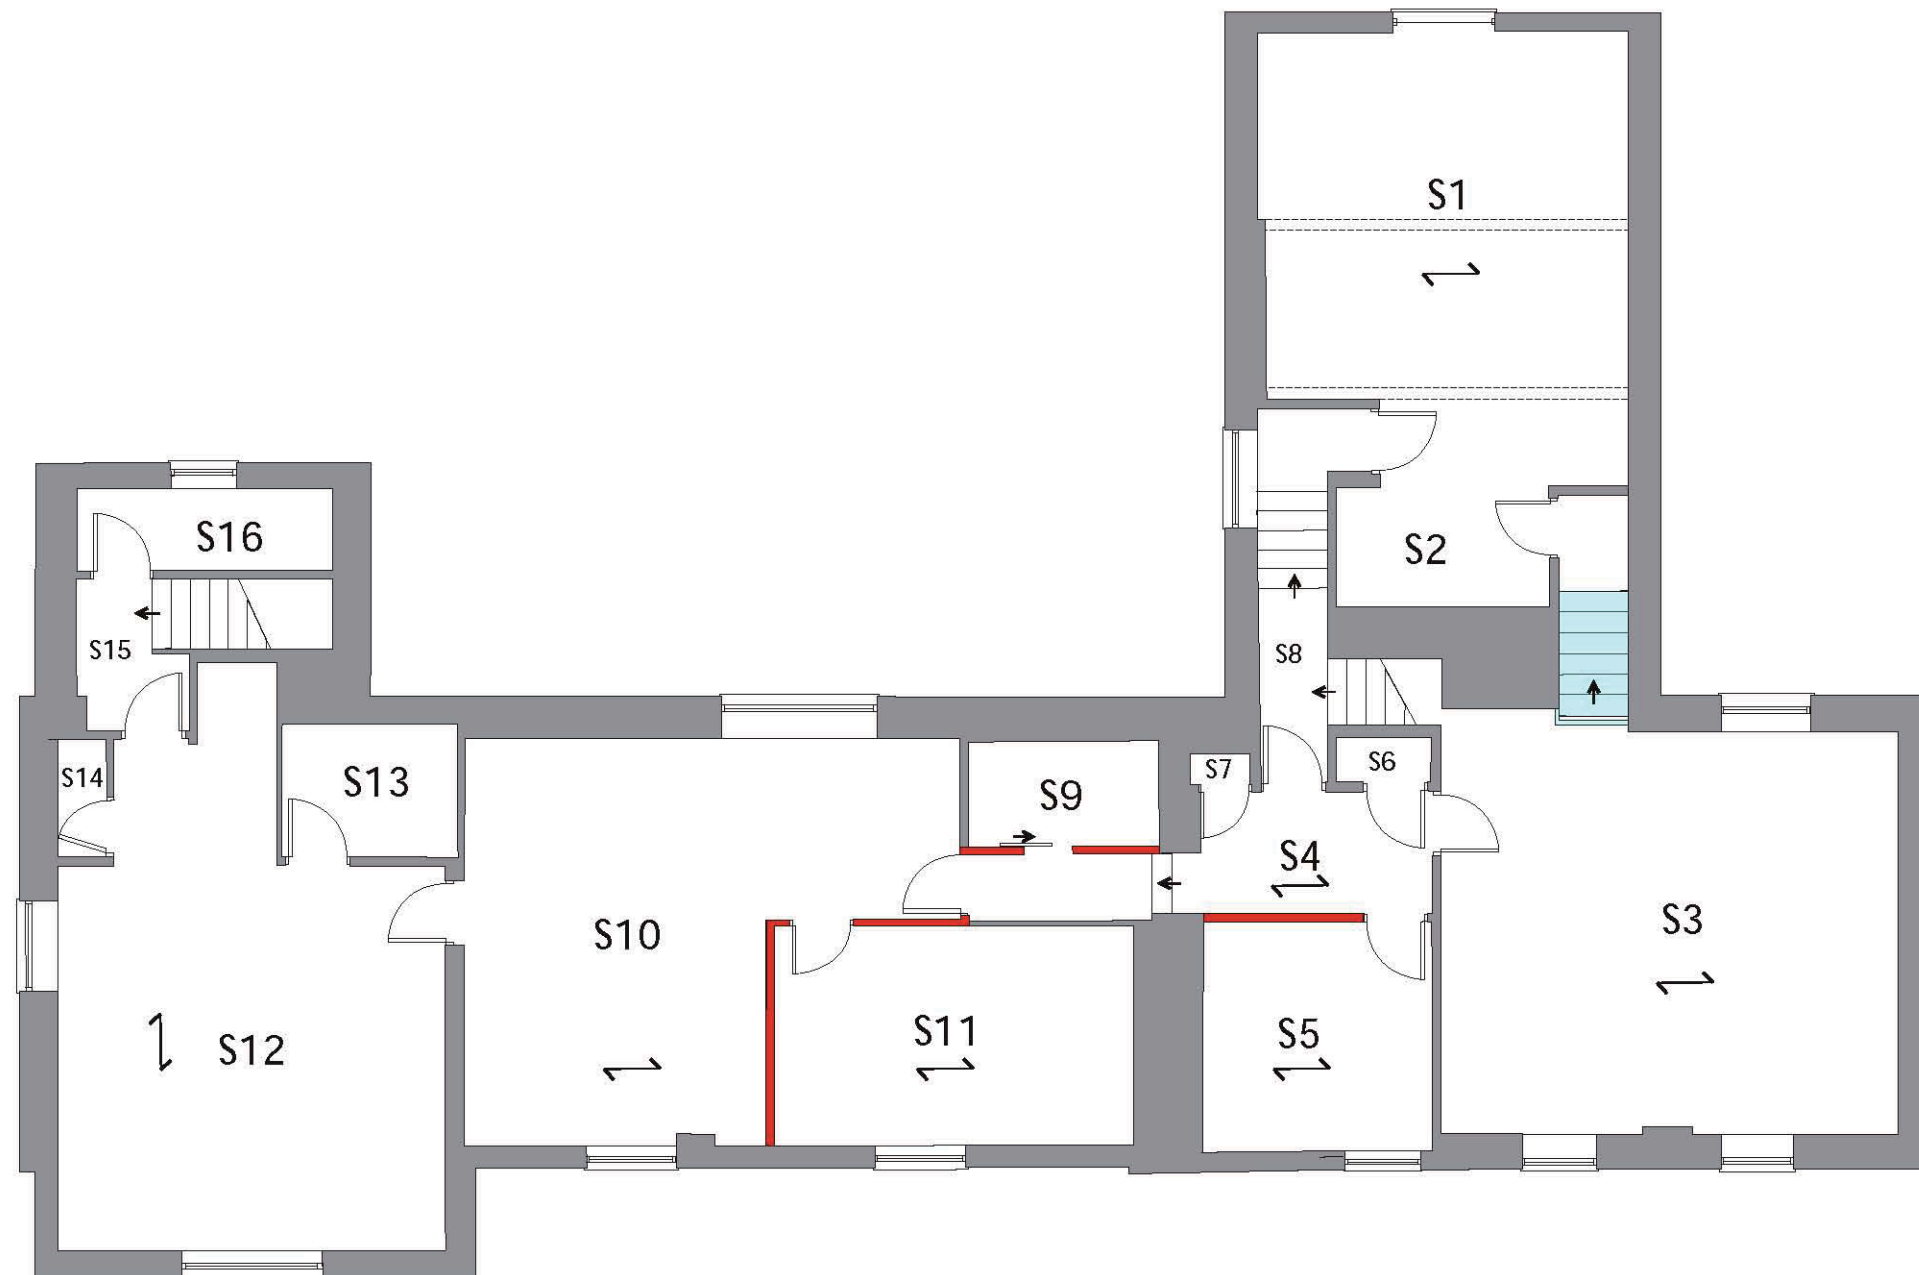
Fig 7

Room S3 retains nine pane sash windows in the front elevation and has a modern window inserted in the rear wall. Room S1 has exposed rafters and purlins with half lapped, bolted collars (Plate 12). The two doorways in this room were situated in lobbies added as fire breaks. Room S10 has modern windows inserted into the rear elevation. Room S5 has been subdivided from room S3, rooms S11 and S9 have been subdivided out of room S10. It is likely that these rooms were originally subdivided to form the living quarters of the house staff.

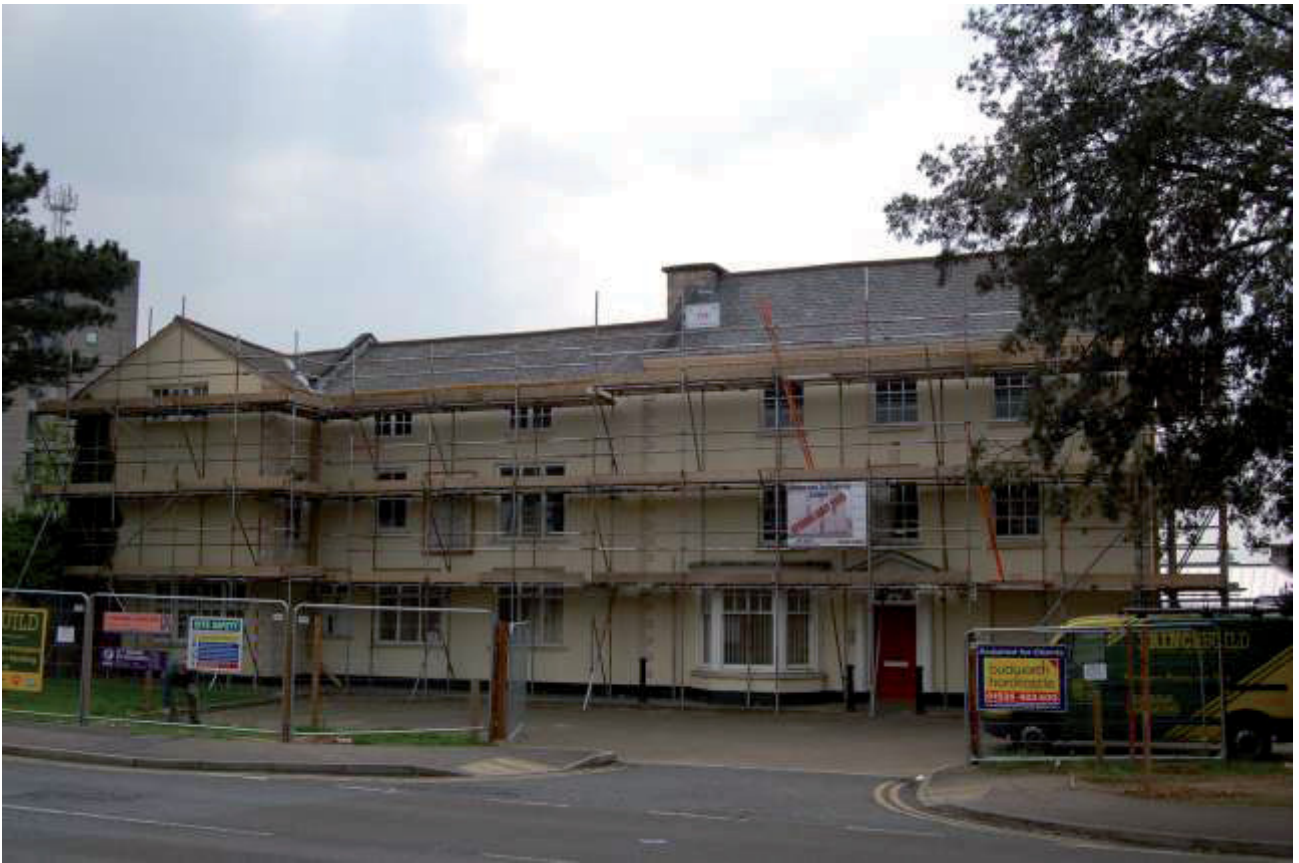
The exterior at the time of the survey was covered in scaffolding (Plate 1). The building is a late eighteenth-century stucco fronted house with a Welsh slate roof. It comprises three storeys, and three bays with a stone cornice moulding at eaves level. The windows on the principal elevation are fitted with sash windows beneath gauged heads with keystones. There is a later nineteenth-century canted bay window on the ground floor. The main entrance door comprises a four panel door in a surround with engaged columns, entablatures with swags and urns to frieze with an open pediment above a rectangular traceried fanlight.

Plate 1: The principal facade

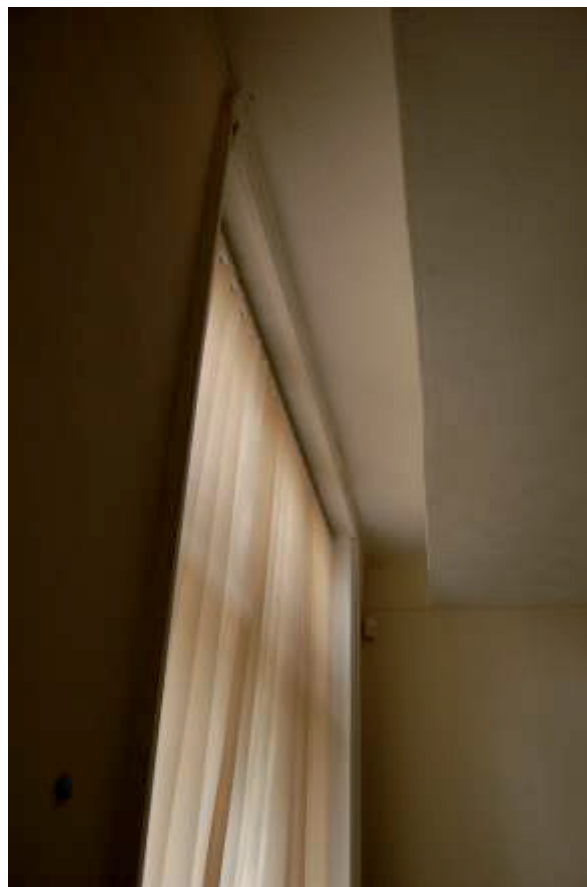
Plate 2: Lowered Ceiling Room G5

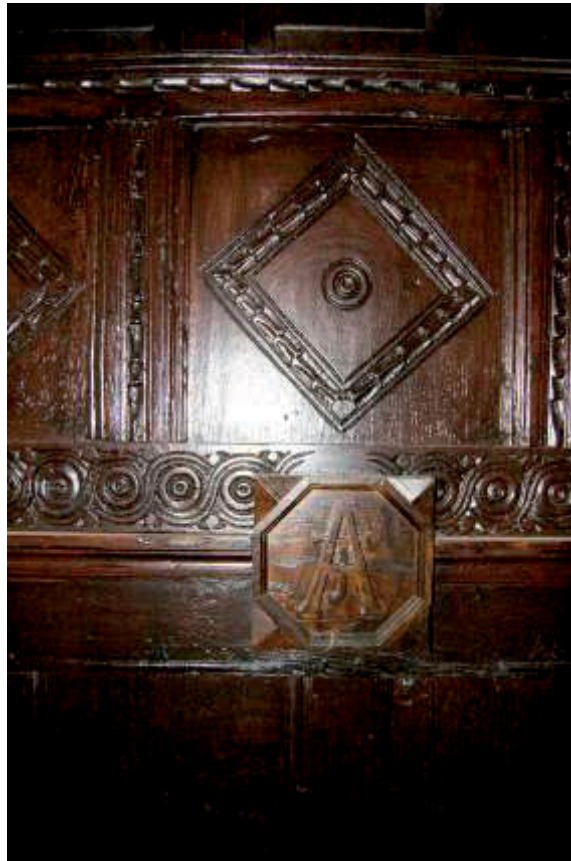
The principal entrance lobby G4 has surviving wood panelling with two monograms carved into two smaller panels. The initials are AJ and THG; it is not certain who AJ was, although THG is almost certainly Thomas Henry Gotch, the founder of the boot and shoe firm (Plates 3 & 4). The door to the lobby is of three panels with the top panel subdivided into nine lights with obscure glass. The windows in rooms G2, G3 and G21 are all probably original late eighteenth-century six pane sash windows, or are later replacements in the same style. The exceptions are the canted bay windows in rooms G21 and G1, which post date 1886, the window in G3 has a splayed opening and painted closed shutter boxes. The bay window in room G21 has an arched timber pelmet painted white (Plate 5). These rooms with G4 and G20 probably formed the original late eighteenth-century part of the house. Rooms G2 and G3 were originally one room but had been subdivided in the late twentieth-century for the insertion of a disabled toilet and creation of a small office.

Plate 3: Carved initials AJ in Room G4

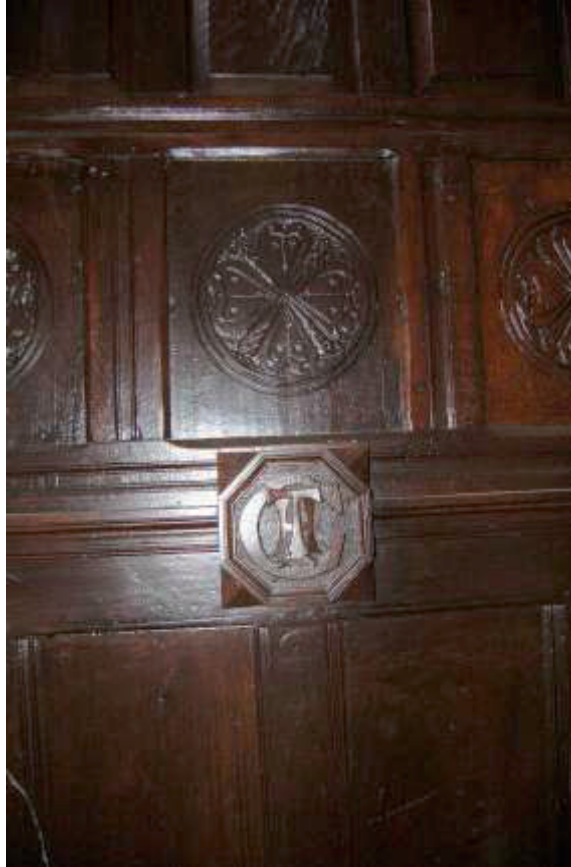
Plate 4: Carved initials THG in Room G4

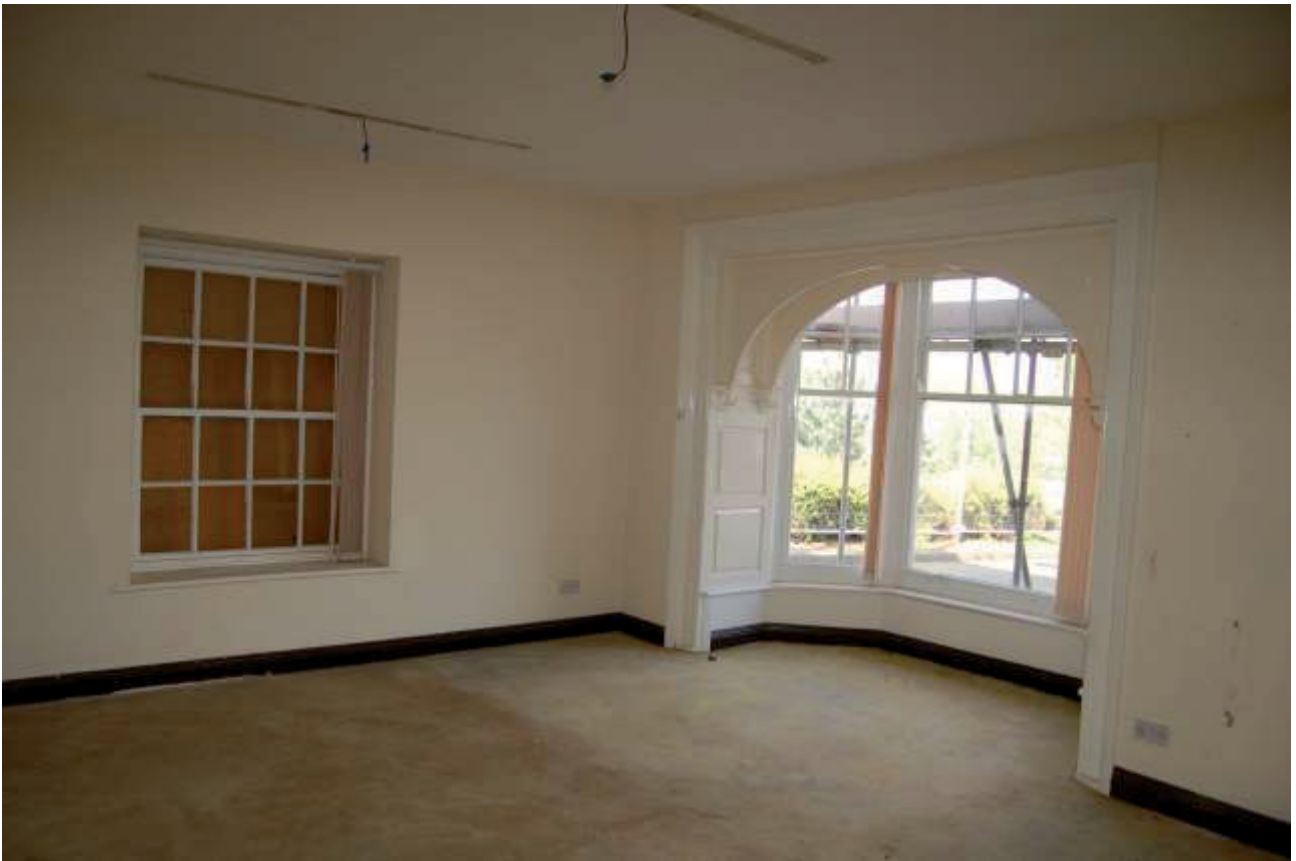
Plate 5: The arched timber pelmet in Room G21

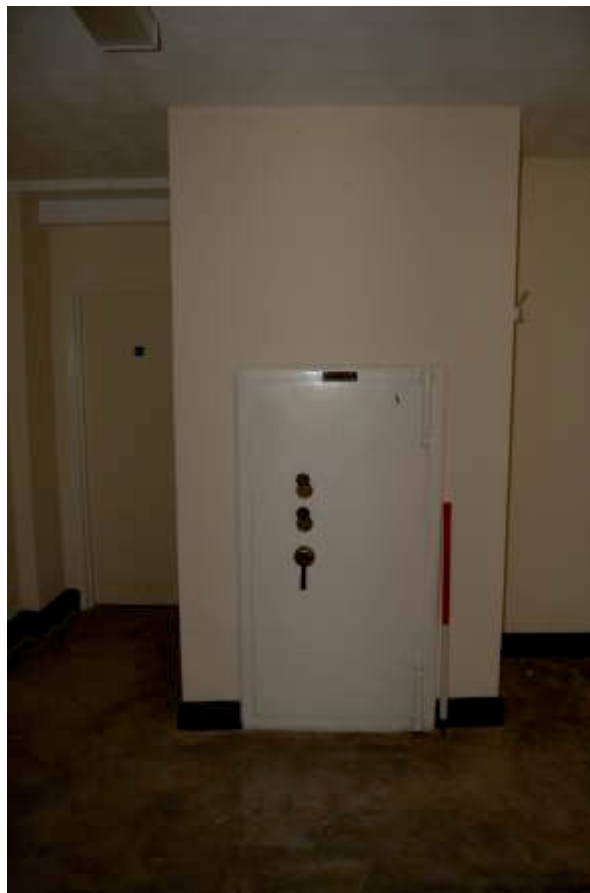
Room G5 has a 'Hobbs, Hart', safe built into the chimney breast (Plate 6). This room and room G6 has six light casement windows; the top three lights have a leaded pattern (Plate 7). These two rooms may have originally been one, as there is a stud wall dividing the two. Room G7 is a narrow room and may have been originally an entrance hall with a door where there is now a window. G8 appears to be unaltered.

Plate 6: The “Hobbs, Hart” safe in Room G5

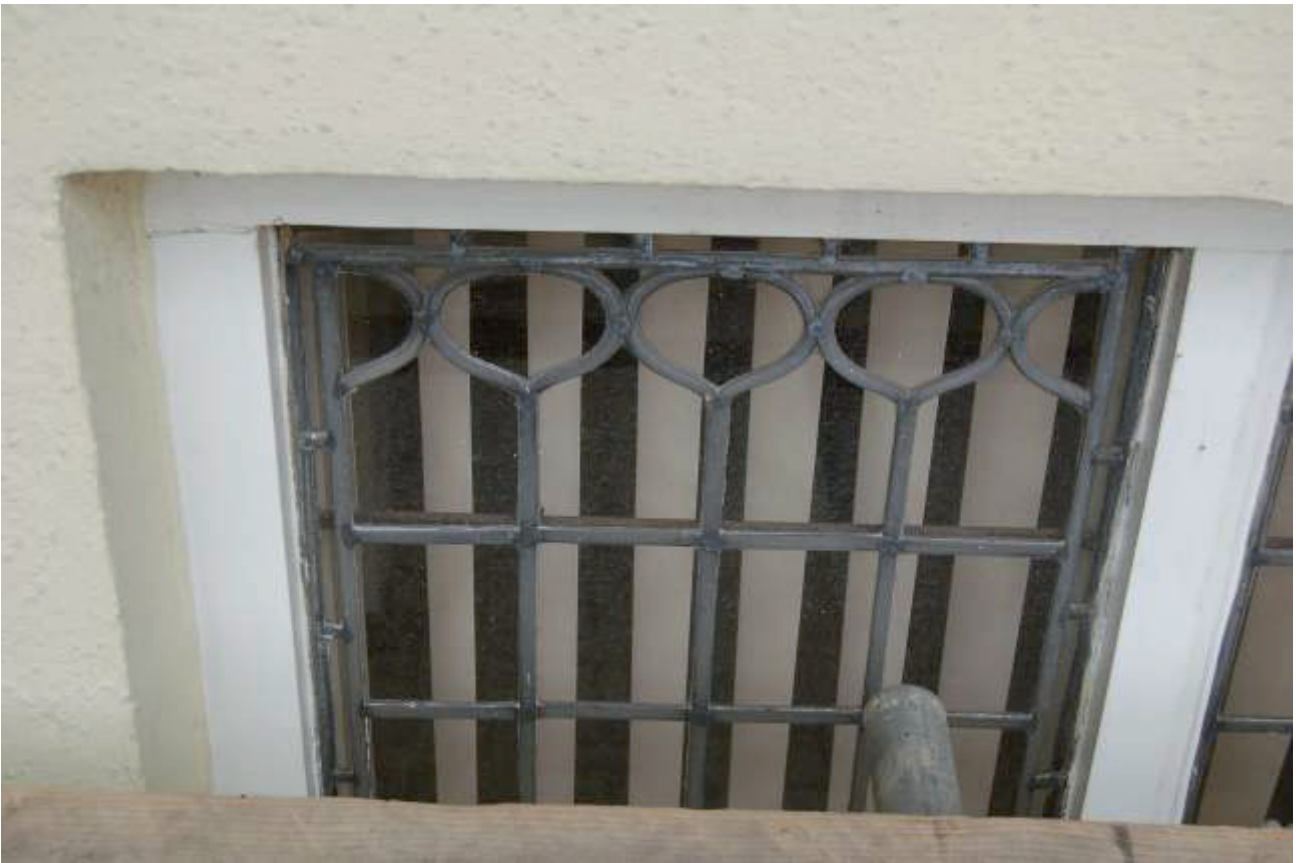
Plate 7: Detail of the leaded lights in Room G5-6

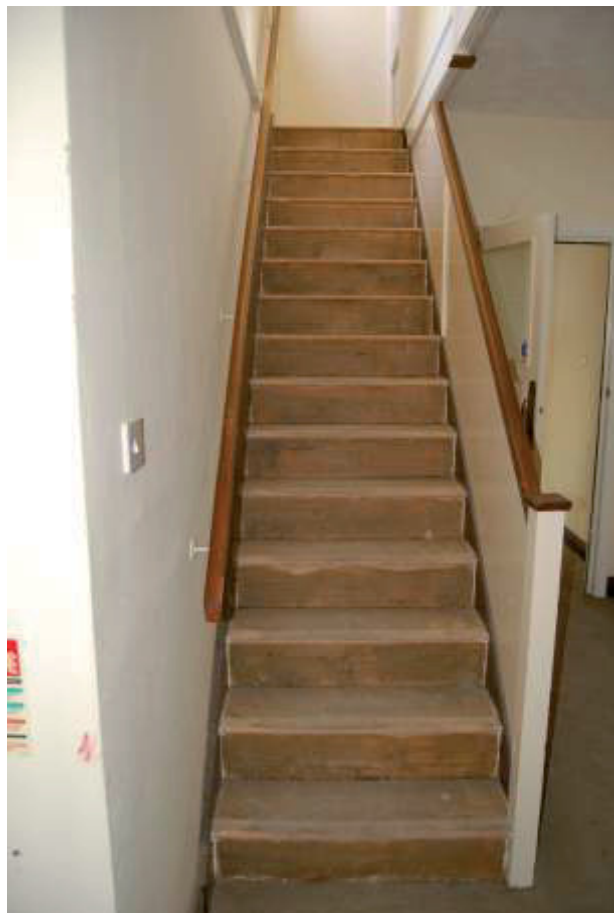
Plate 8: The modern stair in Room G16

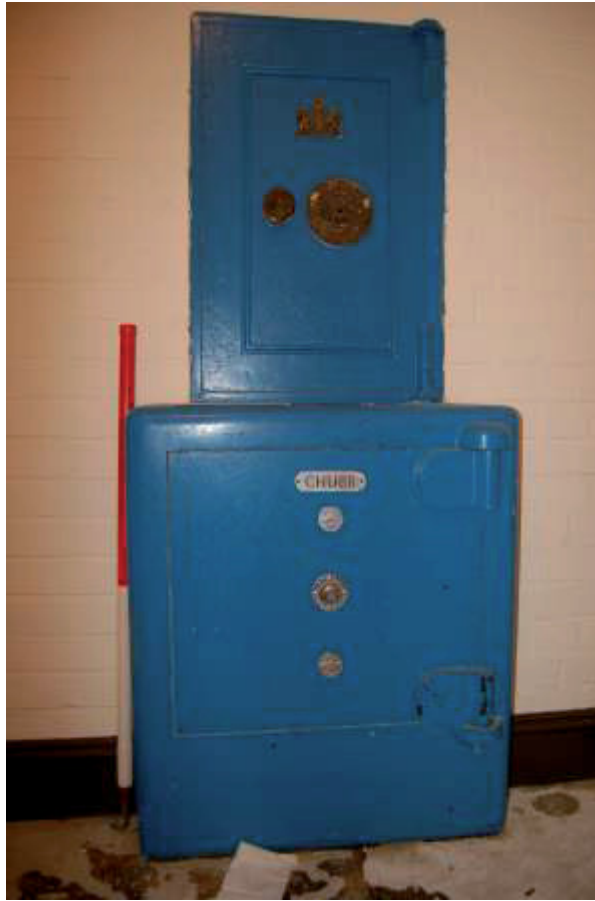
Rooms G9 and G10 seem to have originally formed a connecting corridor to the extension and perhaps into the stair well which currently has no access from the ground floor as it has been used as a fire exit for the first floor and now only opens to the outside rear. Rooms G16 and G17 are later lobby areas and form the hallway for the stairs to the first floor. The stairs have no balusters, their place being taken by a single thickness ply panel; the newel post is plain with a square section (Plate 8). Room G11, which is currently being used as a toilet, has two safes built into the wall, the top one a Phillips and Son, Birmingham and the bottom a Chubb, London (Plate 9).

Plate 9: The safes in Room G11

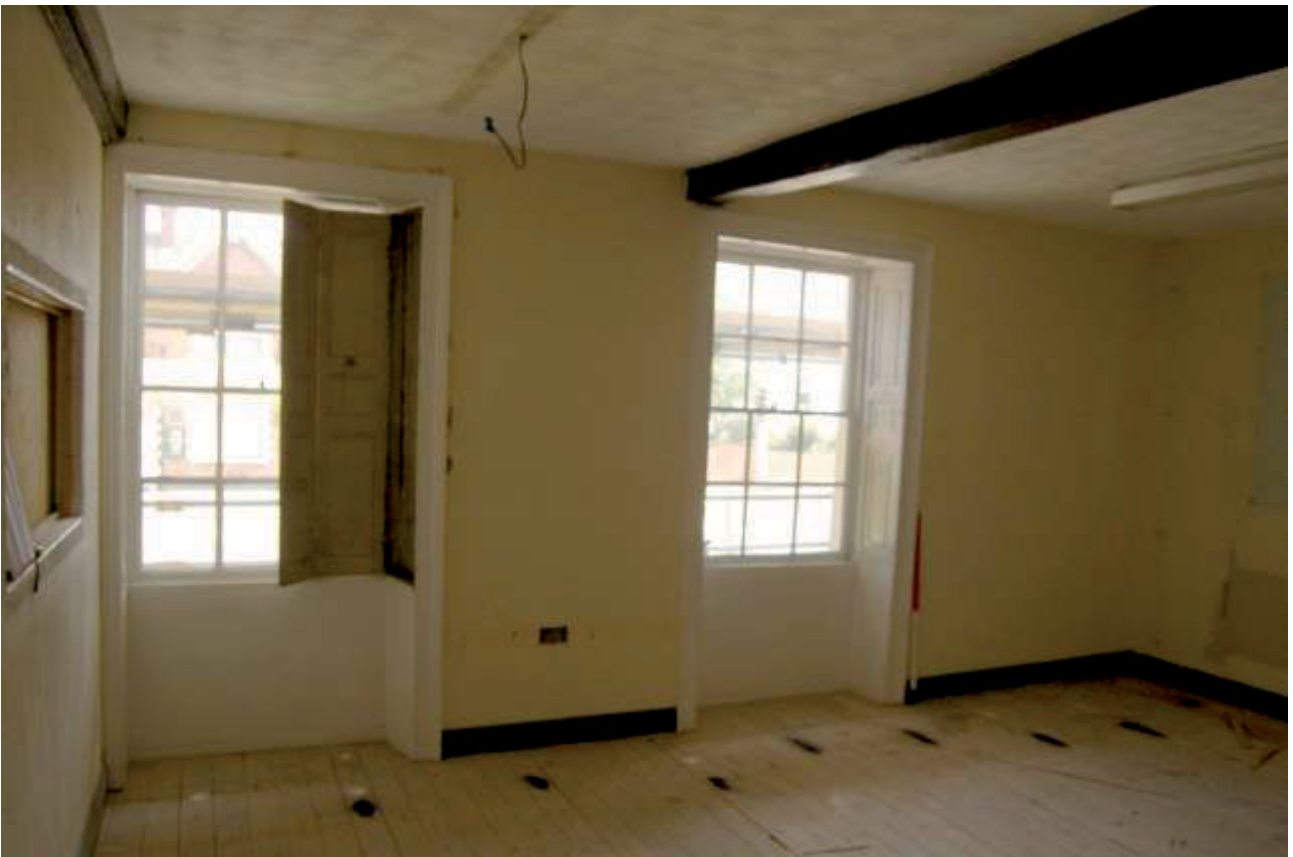
Plate 10: The sash windows and shutter boxes in Room F11

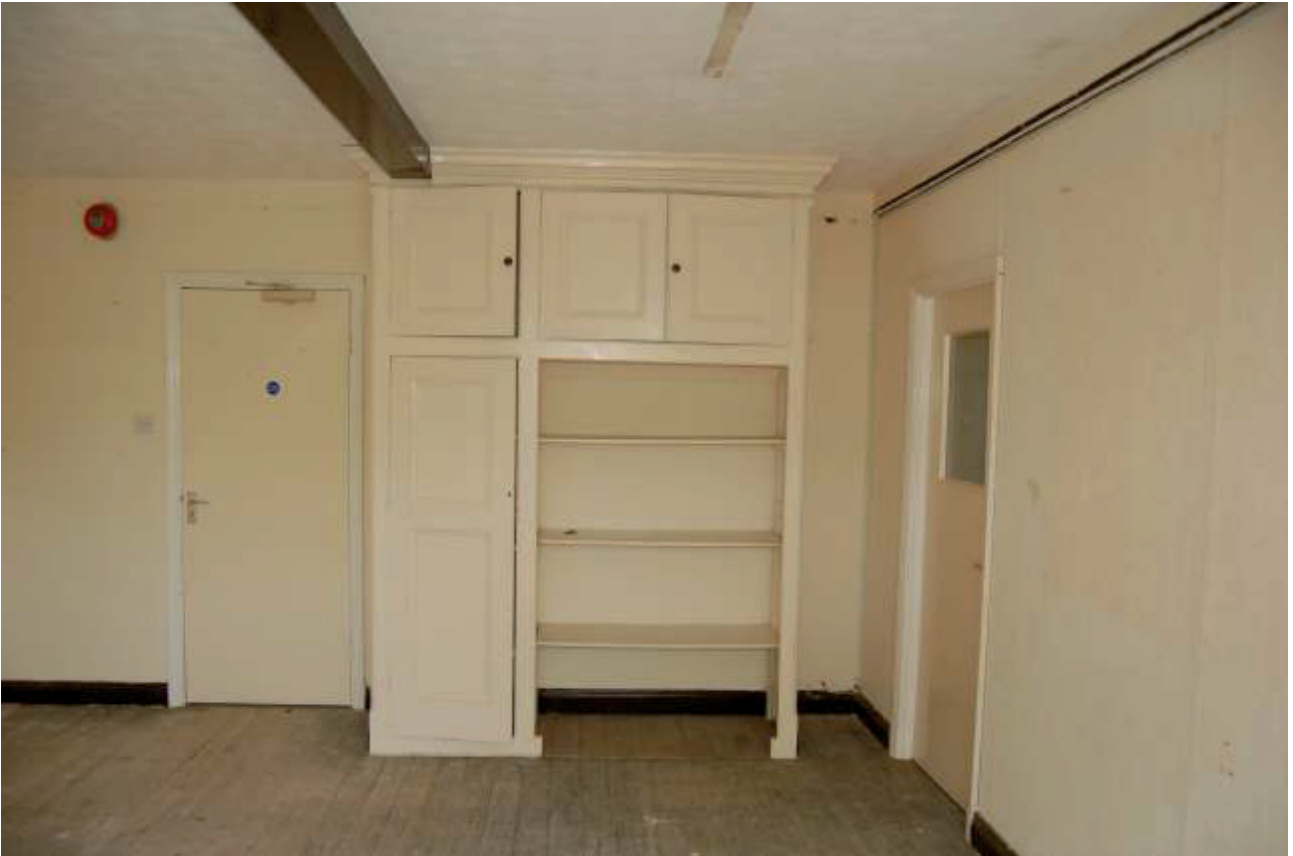
Plate 11: The cupboard in Room F5

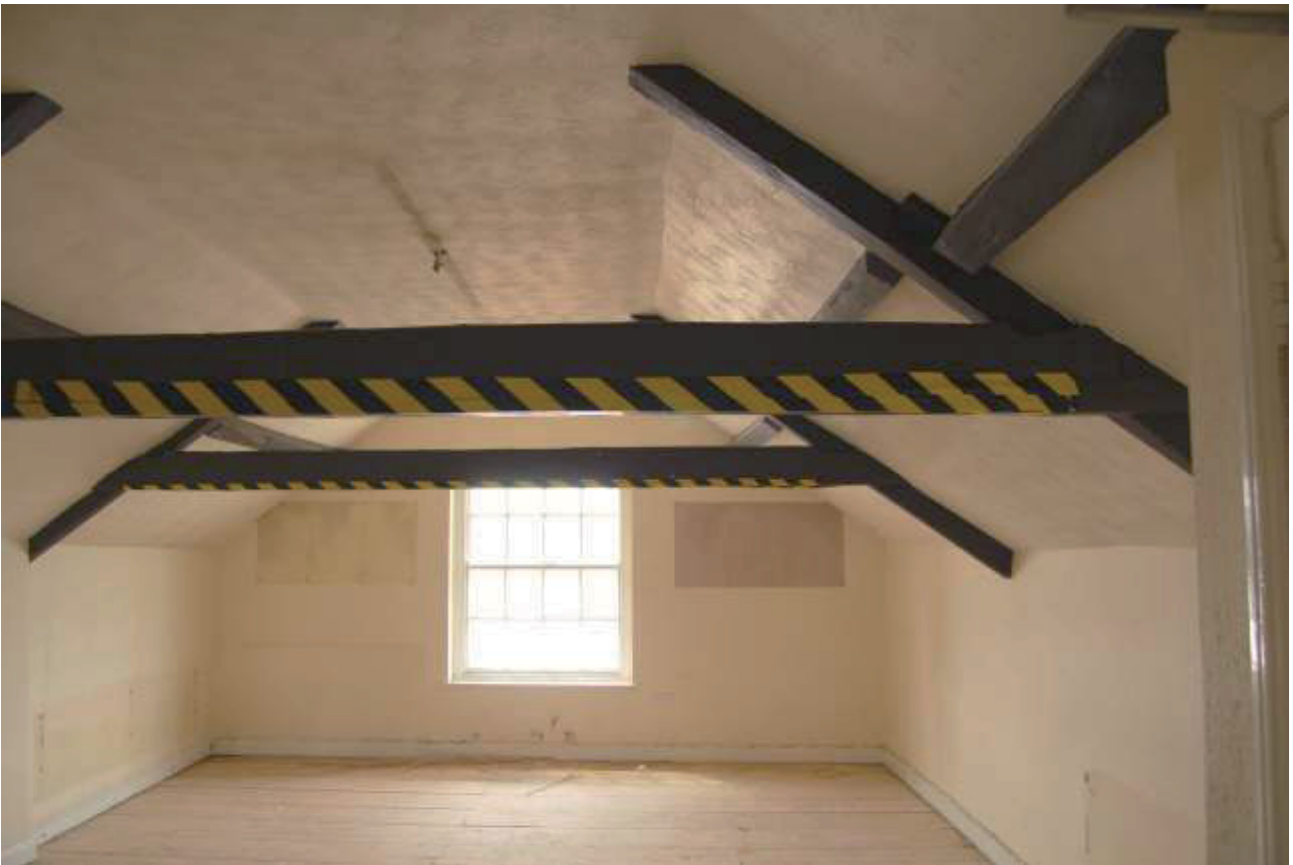
Plate 12: The exposed rafters and purlins in Room S1
